7 March 2008

MEMORANDUM

SUBJECT: Air Stripper Off-Gas Stack Installation and Catalytic Oxidizer Repairs– Chem Core Site (Site No. 915176), Buffalo, N.Y.

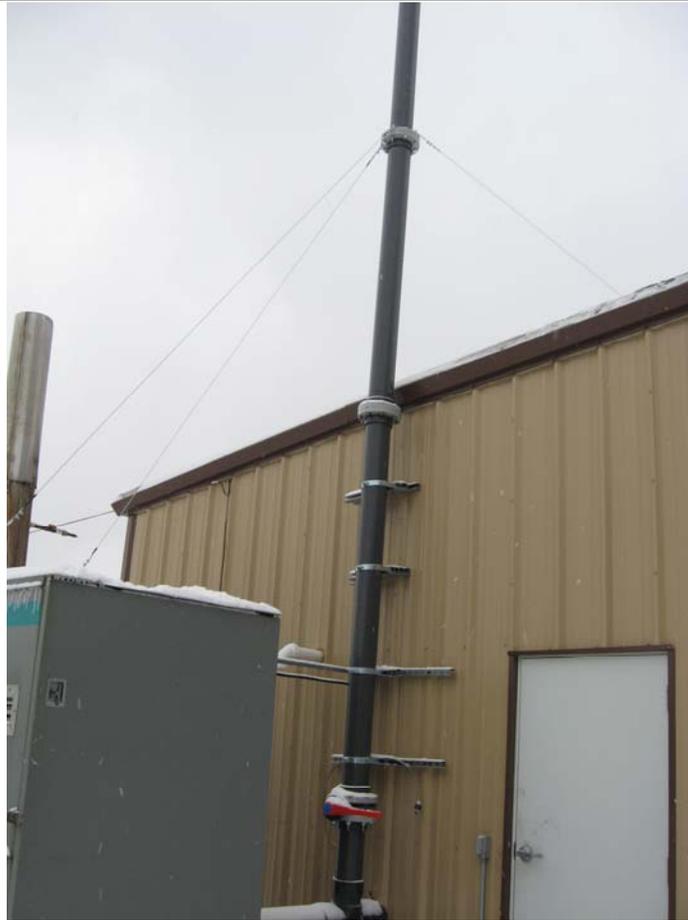
Photo 1: Completed Air Stripper Off-Gas Discharge Stack

An air stripper off-gas discharge stack was installed in the existing piping between the air stripper and catox unit from 3 to 5 March 2008. The stack is equipped with a butterfly valve which can be opened to allow for the catox to be bypassed during periods where off-gas treatment is not required. The stack was installed to a height of approximately 25 ft and constructed of 6-in. diameter Schedule 80 polyvinyl chloride. An air sampling port was installed on the discharge stack and configured to facilitate collection of samples at ground level. The stack was secured to the side of the building using a combination of metal struts (with anchors) and 1/8-in. steel cables, and supported at the base using a prefabricated concrete block.

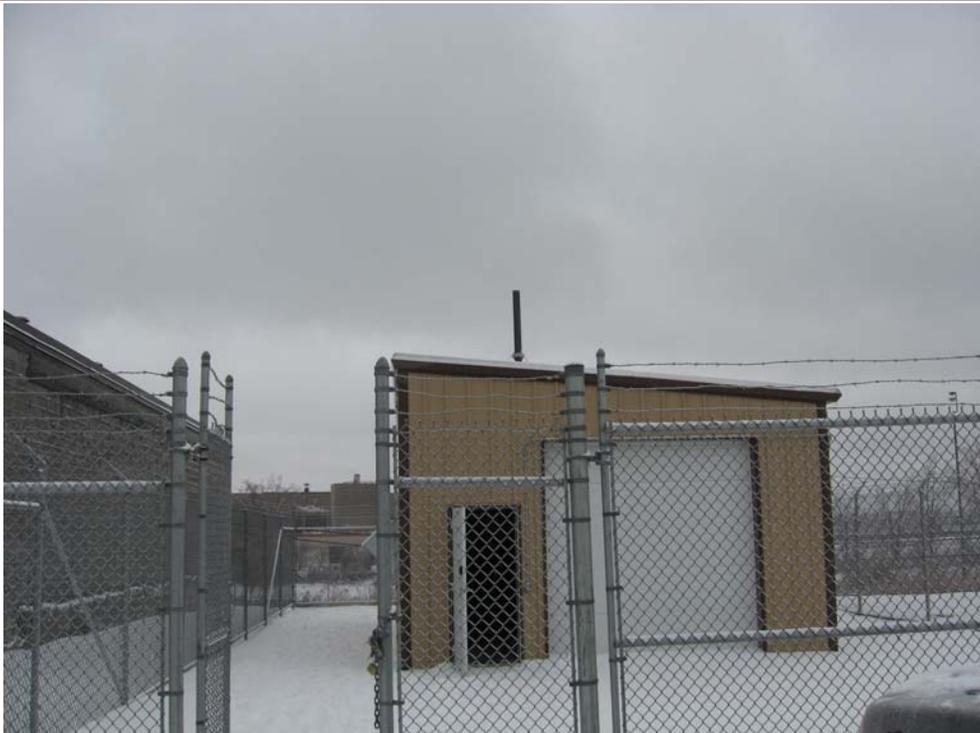
Photo 2: View of Air Stripper Off-Gas Discharge Stack from Niagara Street

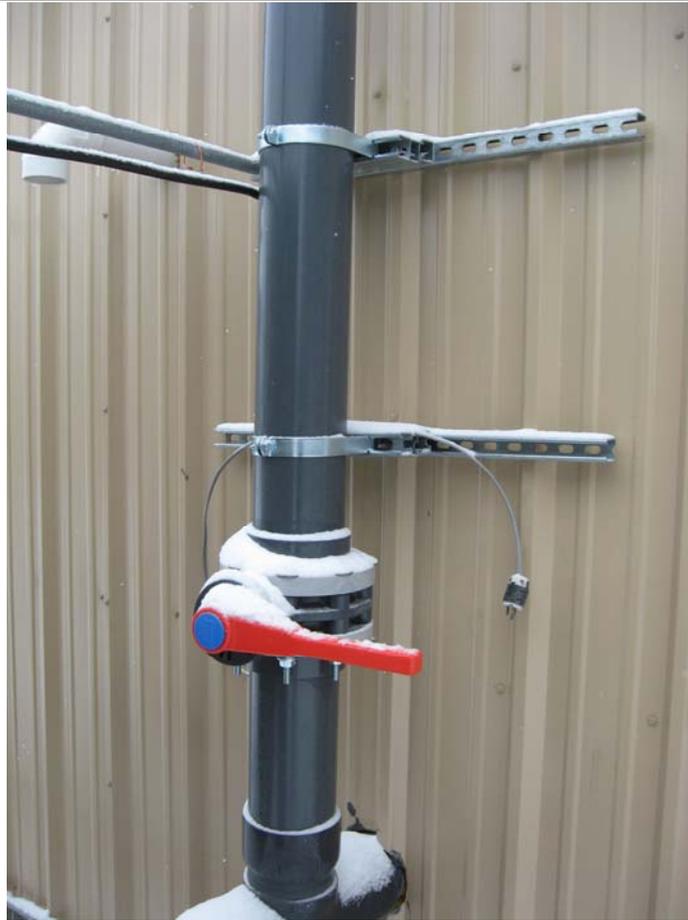
Photo 3: Butterfly Valve in Air Stripper Off-Gas Discharge Stack

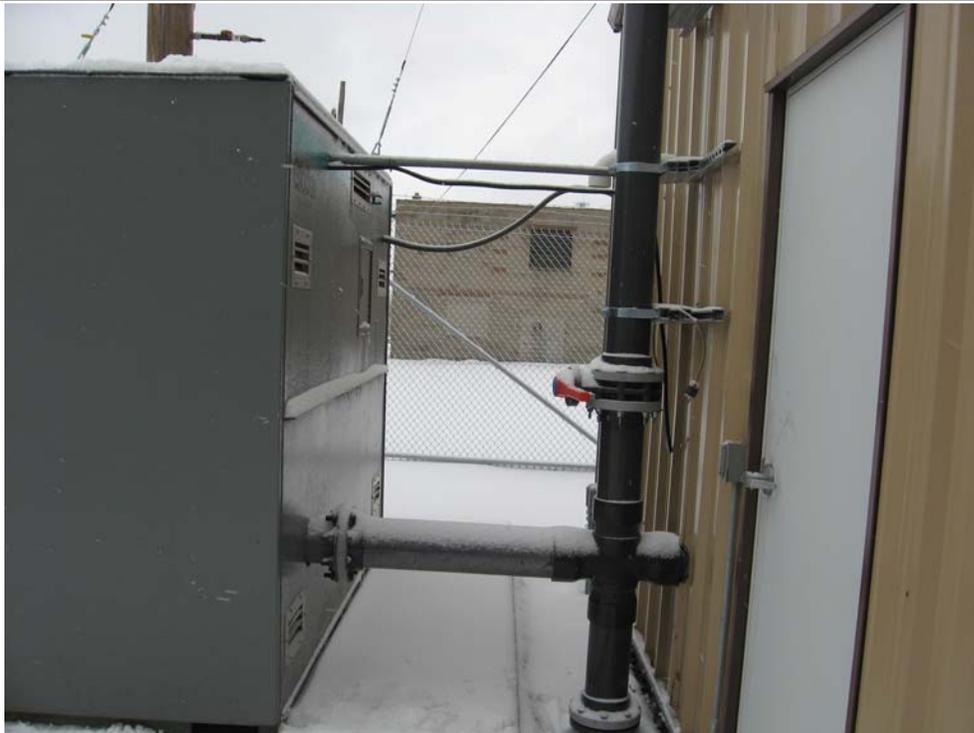
Photo 4: Base of Air Stripper Off-Gas Discharge Stack

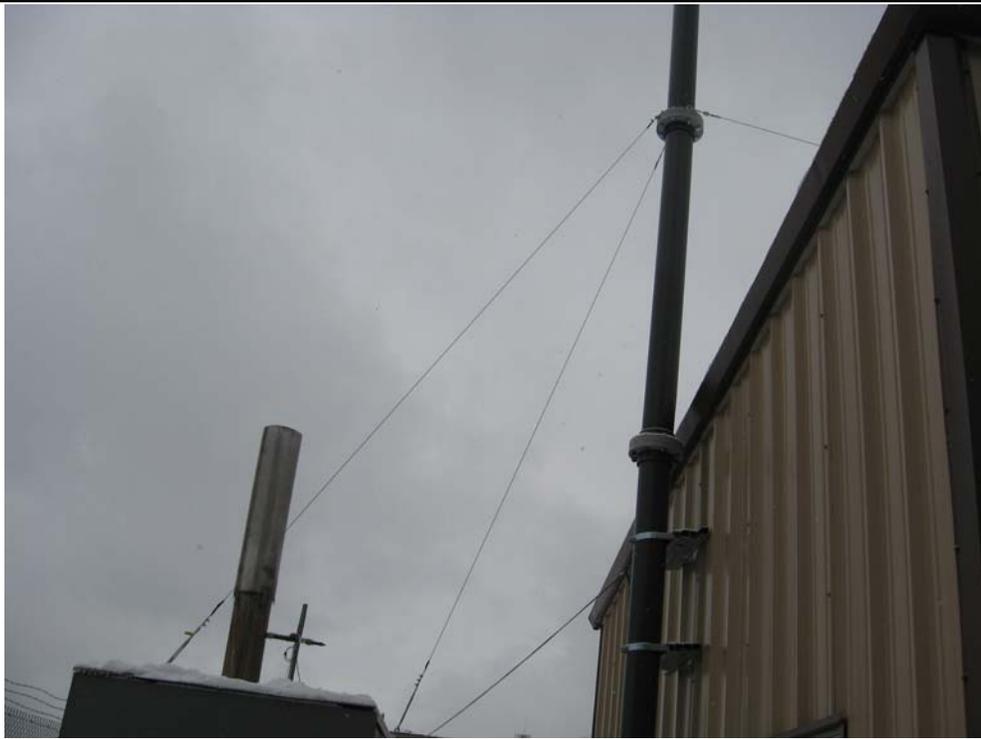
Photo 5: Completed Air-Stripper Off-Gas Discharge Stack

Adjusted cable lengths on emission stack to straighten up stack. Disassembled scaffold and cleaned up process building. Returned all rental equipment.

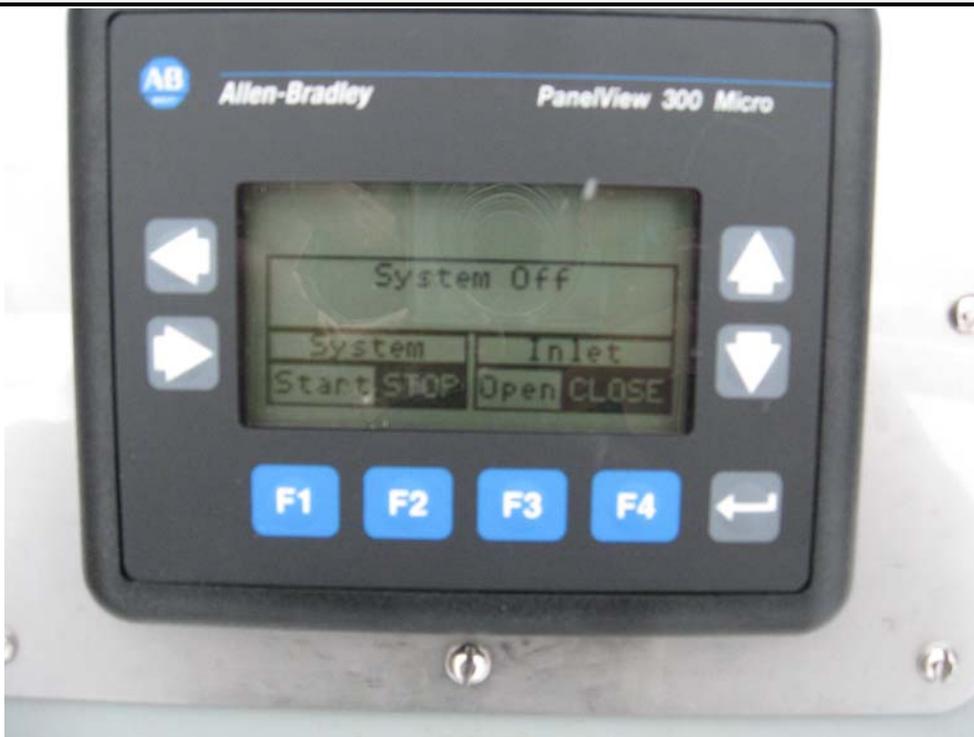
Photo 6: New MMI Display (Catox control panel)

The existing Multi Media Interface (MMI) on the catox control panel was replaced with a new Allen Bradley Microview 300 MMI display on 4 March 2008. A representative for the catox manufacturer (Enhancement, Inc. on behalf of Anguil Environmental Systems, Inc.) was on-site to provide technical services for the control panel repairs. Enhancement, Inc. also programmed

the new MMI while on-site and tested the component to verify proper operation. In addition, EA inspected and identified several minor gas leaks in the fuel supply piping where it connects to the catox unit, which were corrected during the site visit.
