# PHOTOLOG 2/26/09 Site Investigation Test Pits by TVGA

ABC Paving Site, NYSDEC Site No. 915179

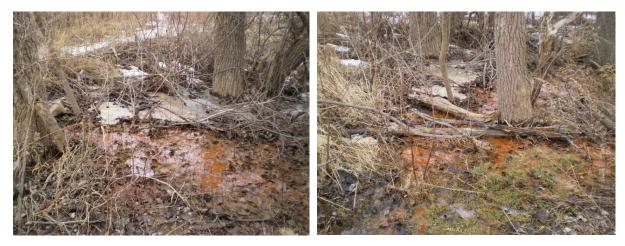
Impacted groundwater seep (February 26, 2009)

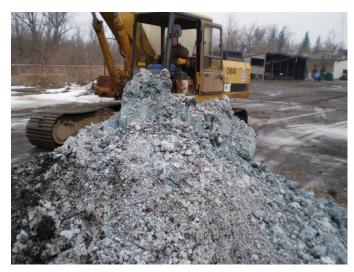
Lime waste fill

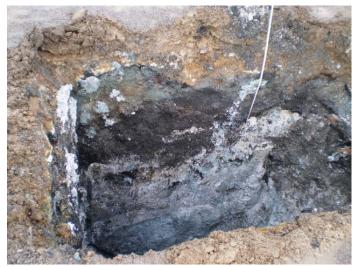
Lime waste fill, some blue staining from MGP purifier waste

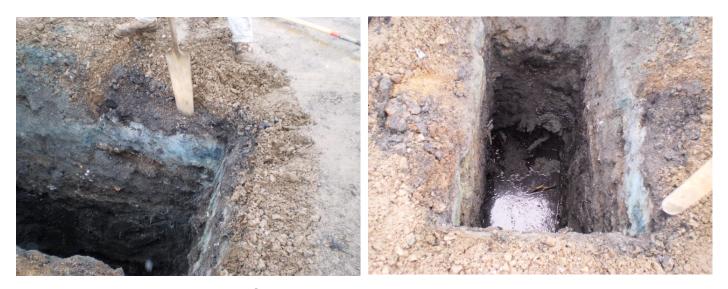
TP-1 profile: Upper layer contains slag/foundry sand like fill followed by a lime waste fill stained by MGP purifier waste

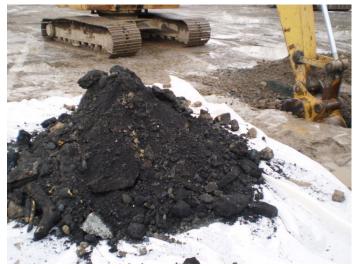
Rocky slag fill spoils, heavy petroleum odor

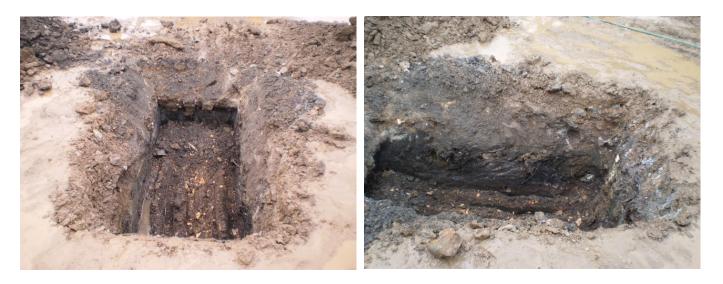
Completed test pit, note black slag fill, TP-3 profile mostly slag waste fill

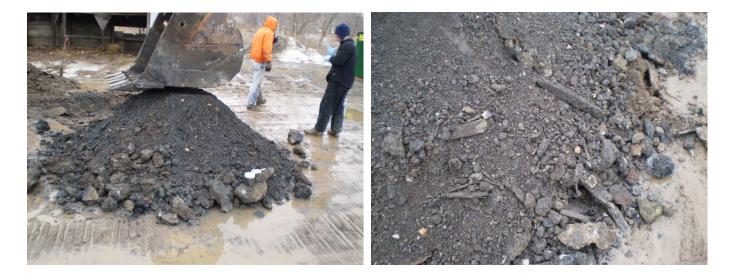
TP-4: mostly rocky slag fill, with cemented layers, unable to penetrate bottom layer

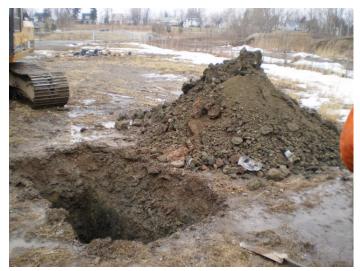
Rocky slag fill spoils with wood debris

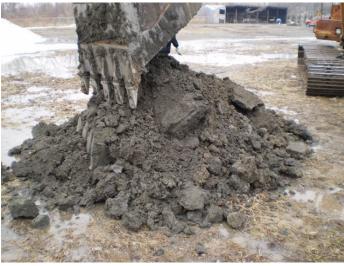
Upper soils mostly fill soil with some debris

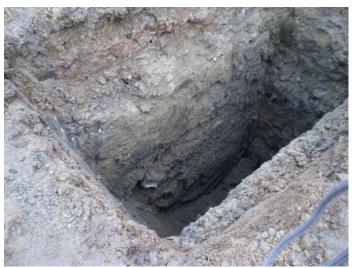
Lower soils contain more debris and some slag fill, sulfer smell

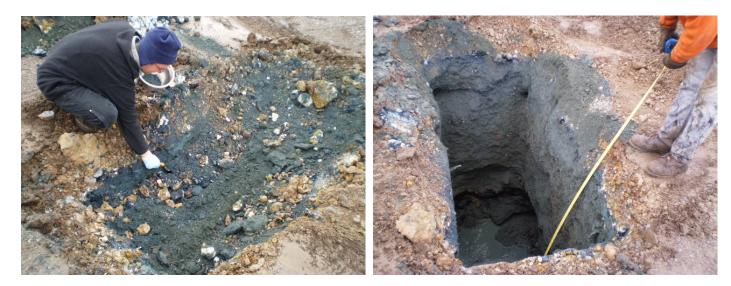
TP-5 profile: see description above

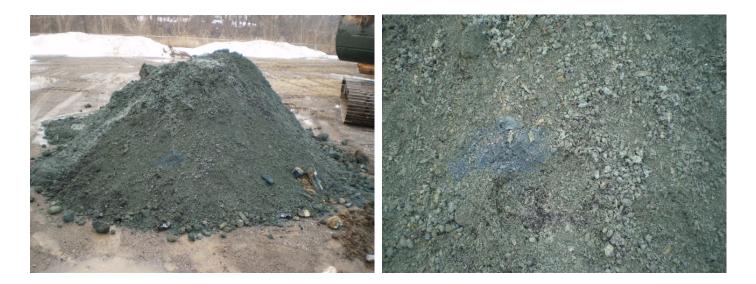
TP-6 profile: mostly MGP purifier waste (decomposed wood chips)

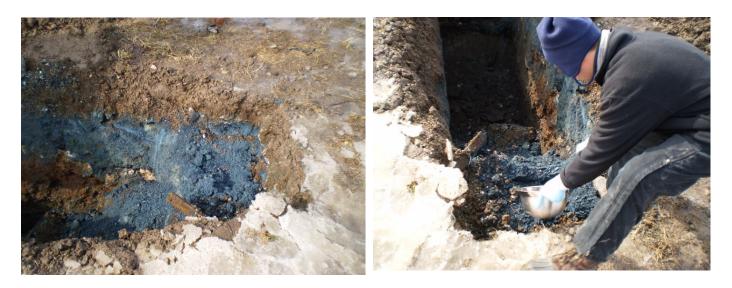
MGP purifier waste spoils

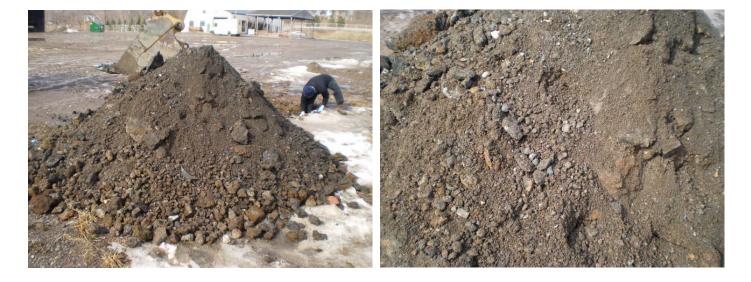
TP- 7 profile: layer of MGP purifier waste followed by rocky, cemented slag

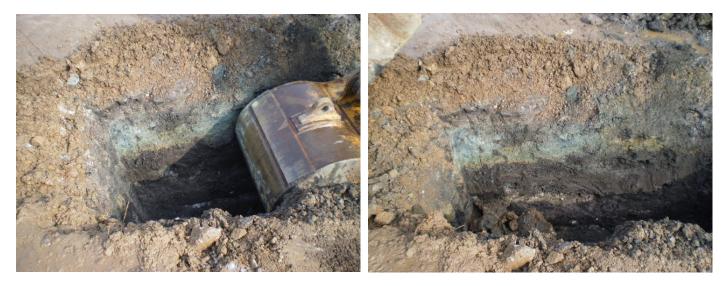
Mostly rocky slag fill spoils, with cemented layers, unable to penetrate bottom layer

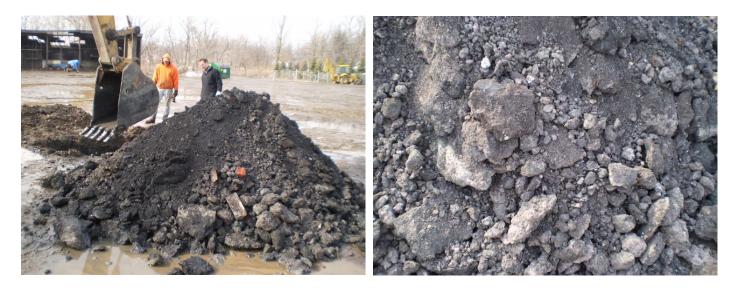
TP- 8 profile: mostly rocky, cemented slag with a layer of MGP purifier waste
