# EAST DELAVAN PROPERTY, LLC

**FROM:** Jon M. Williams  
**RE:** Site No. 915196 – Summary of Work to Date  
**DATE:** December 3, 2015

Re: Summary of Work to Date  
Former General Motors and American Axle and Manufacturing Site  
Portion of 1001 East Delavan Avenue, 1001 East Delavan Avenue, Buffalo, NY  
Site Number 915196

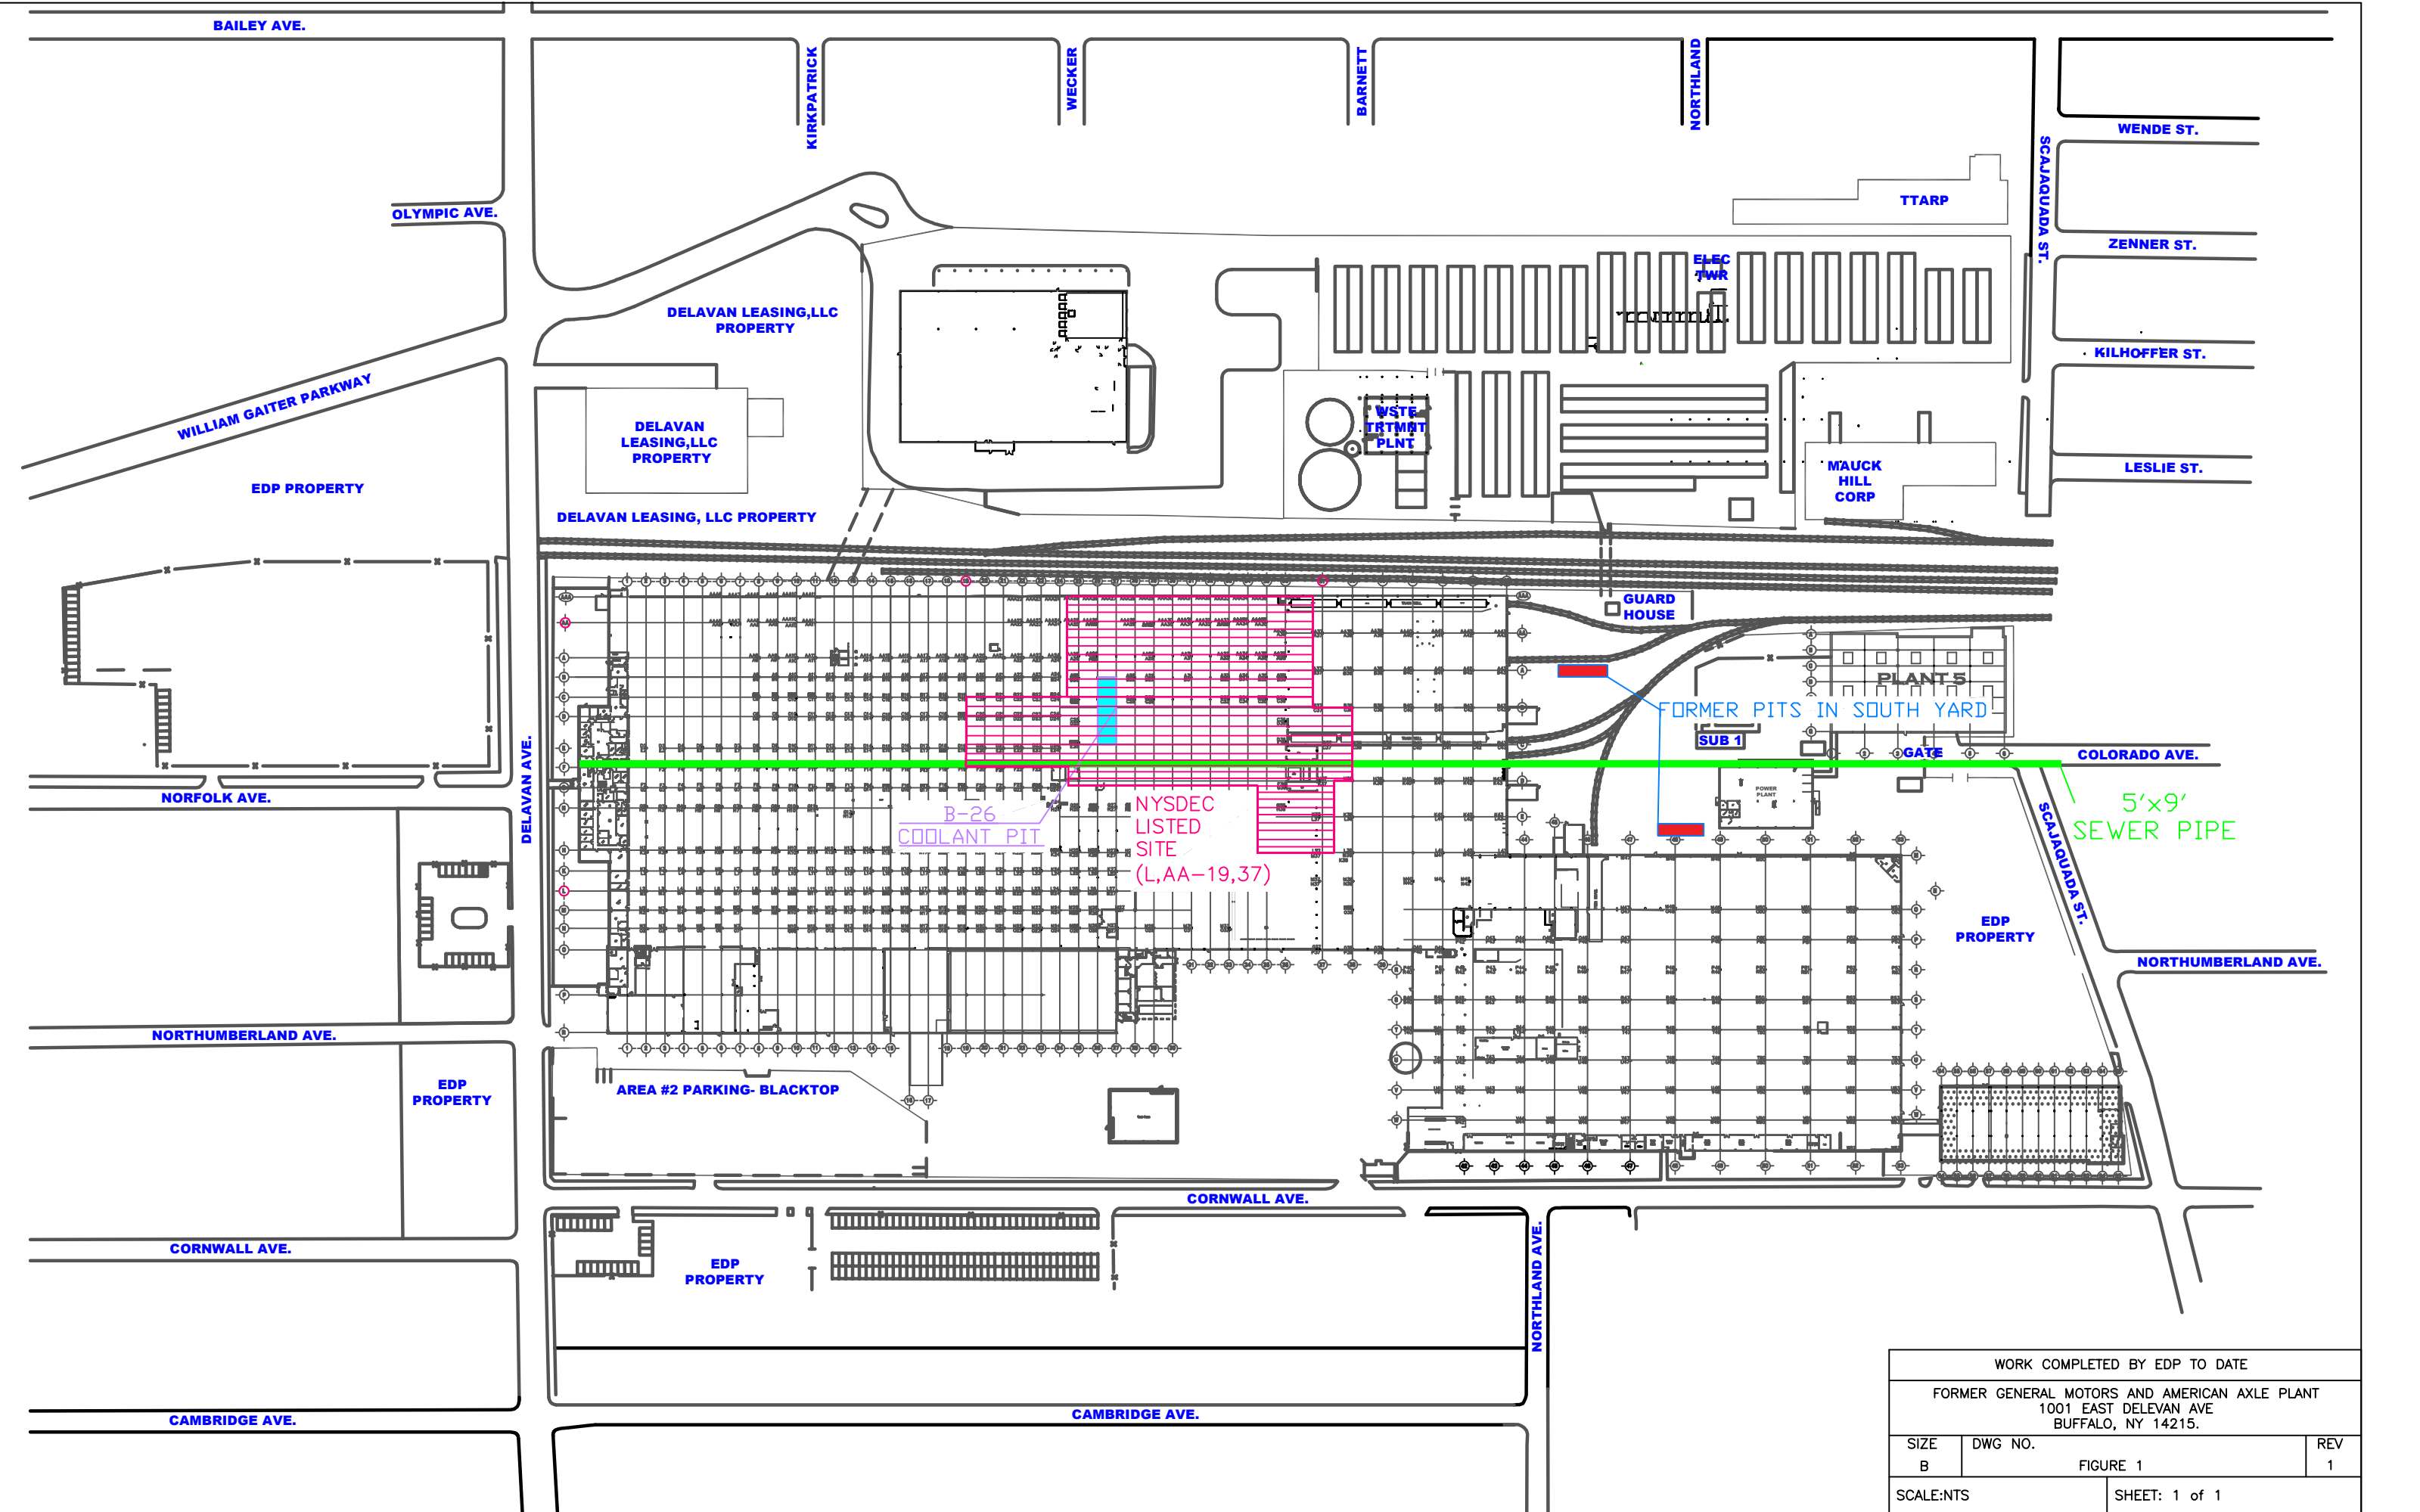
**Figure 1**

EDP has been following a multi-stage program to ensure the conditions remaining following the GM abandonment of their remedial program and RI/FS process do not deteriorate, and in fact EDP has significantly improved site conditions (Figure 1):

| WORK COMPLETED BY EDP TO DATE | | |

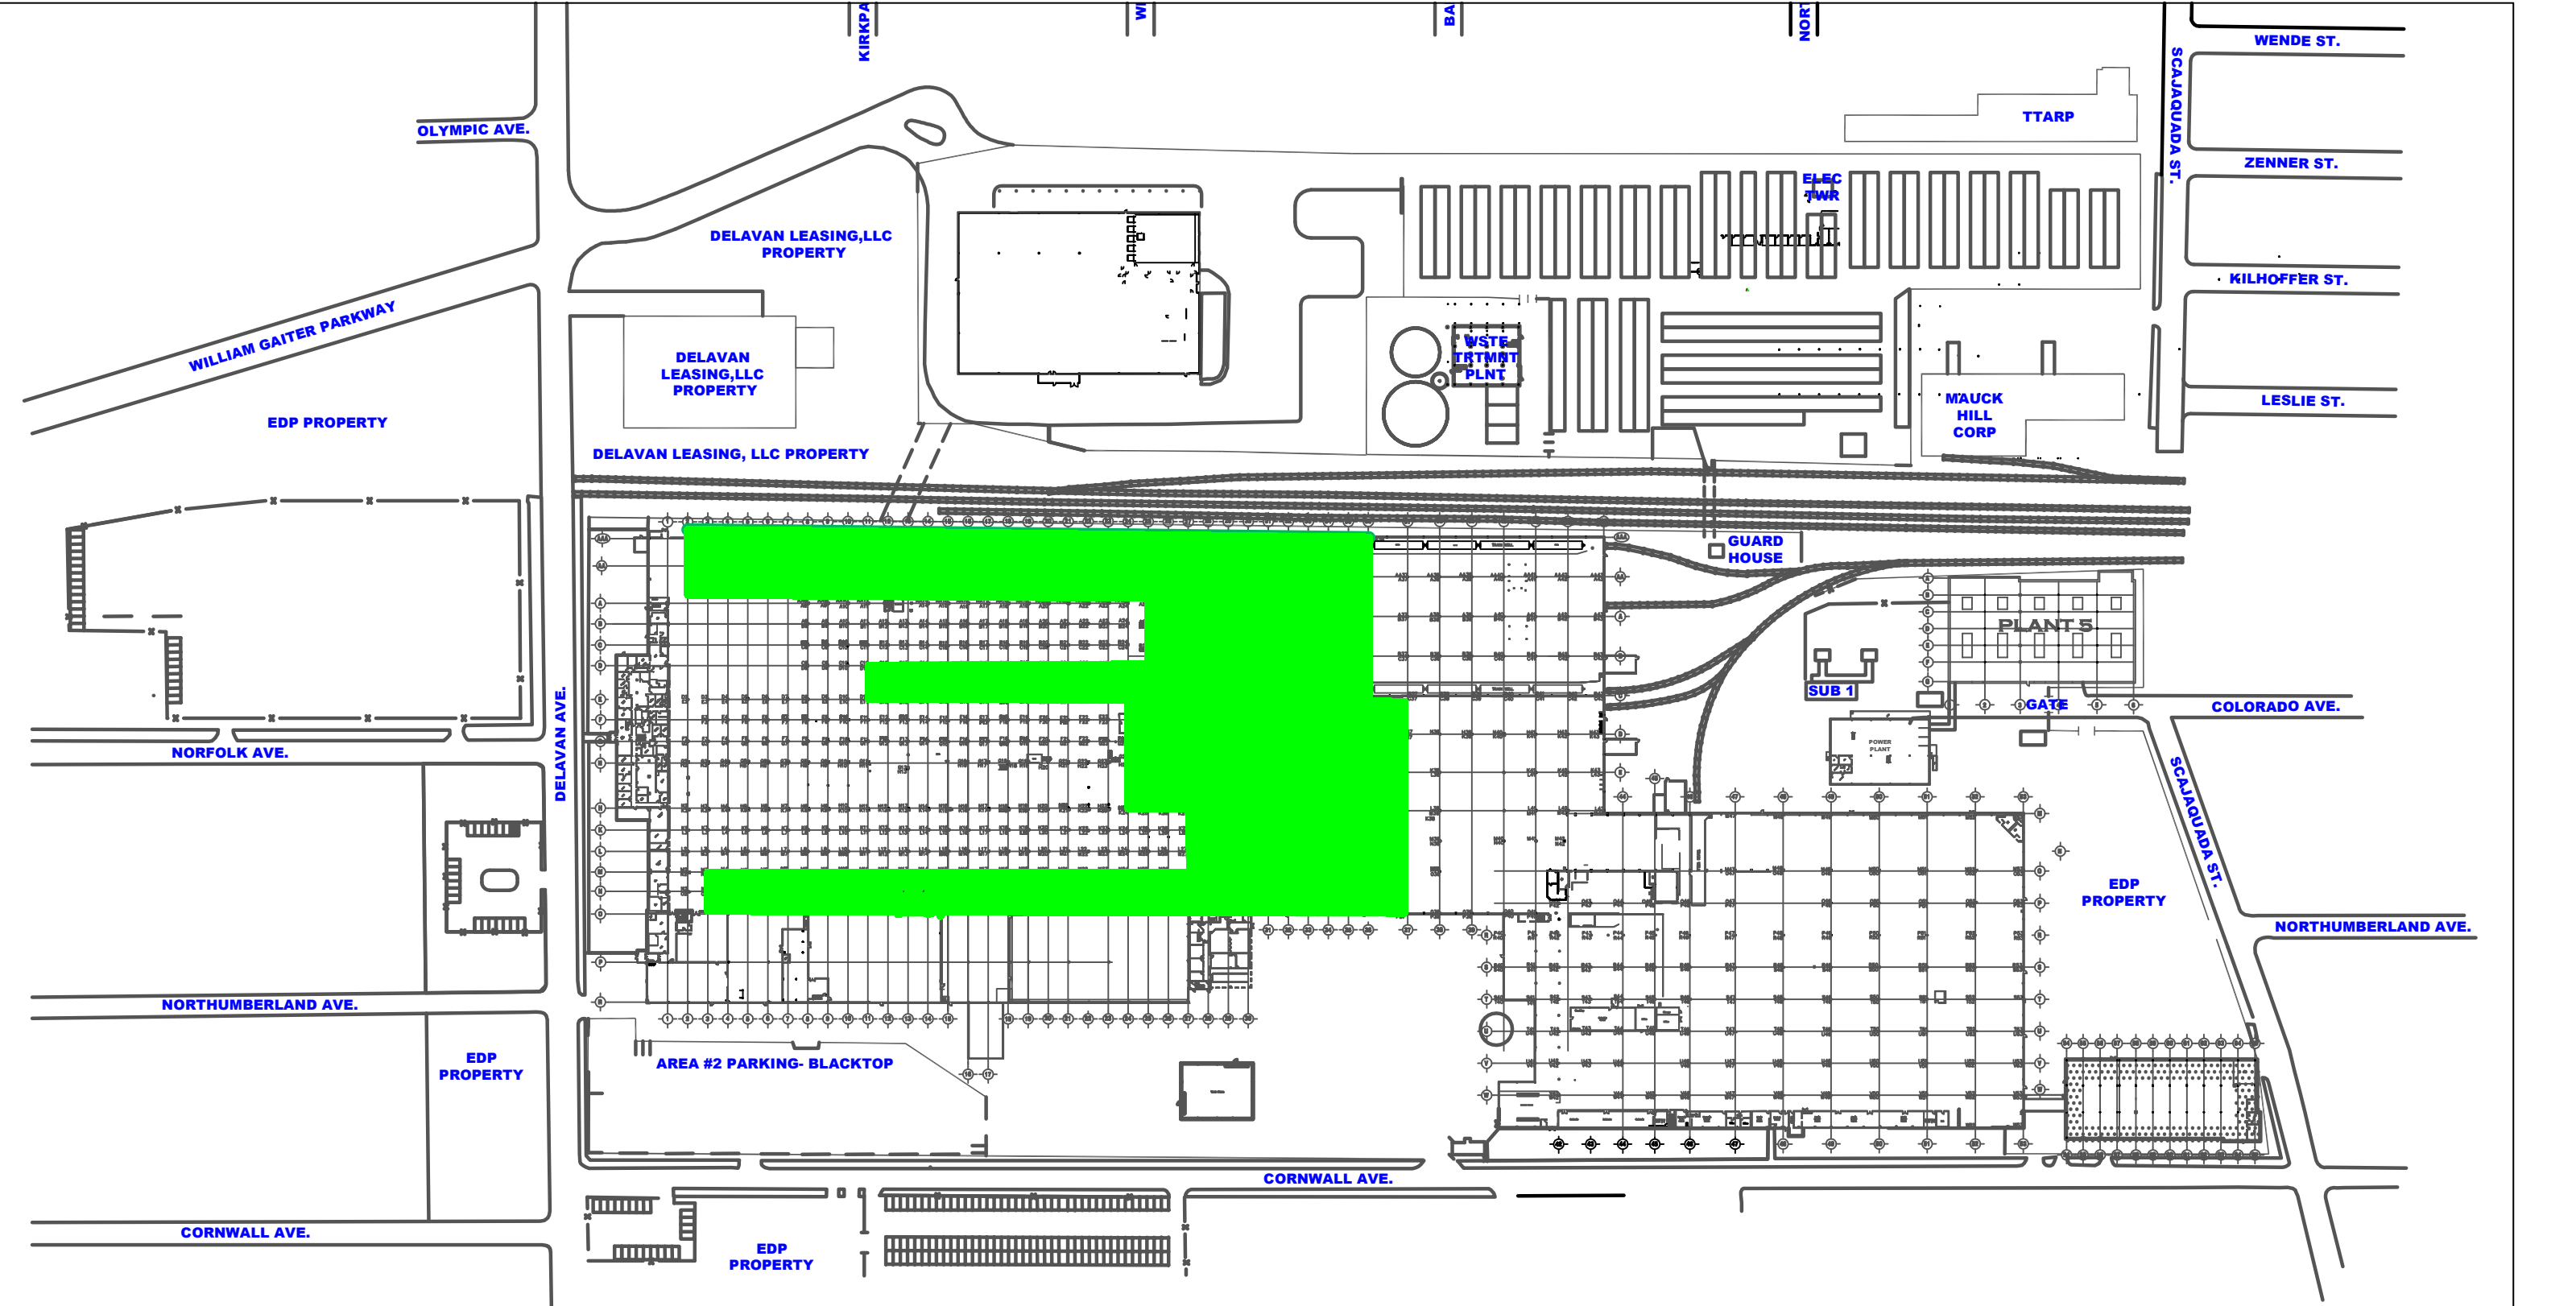
**INTERIOR AREA PRE-DEMOLITION: 1,210,323 SQ. FT.**  
**TOTAL AREA DEMOLISHED: 230,012 SQ. FT.**  
**INTERIOR AREA POST-DEMOLITION: 980,311 SQ. FT.**

| DEMOLITION WORK BY EDP TO DATE | | |

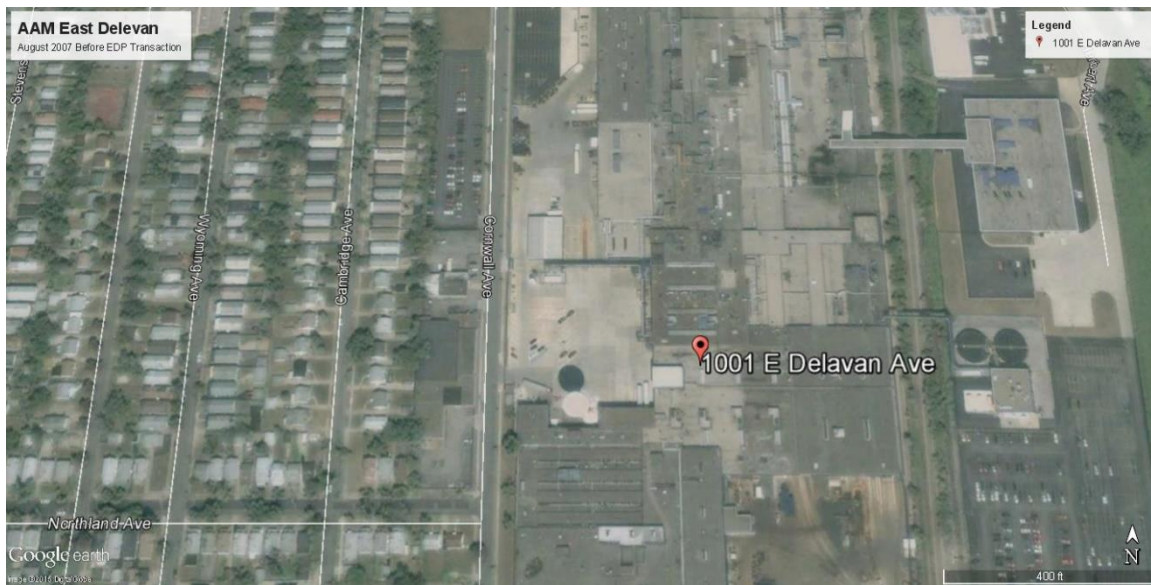
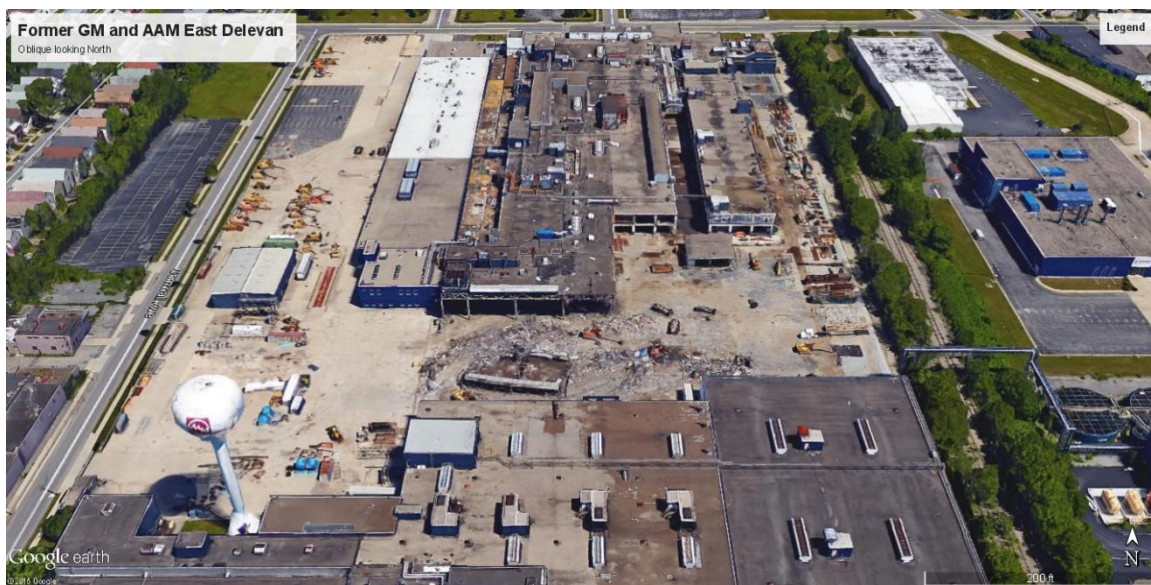
The American Axle Plant Site (Site) is a 5-acre area listed in the Registry of Inactive Hazardous Waste Disposal Sites in New York State as Site Number 915196 (Photograph 1), with a Classification of 2. The Site was listed as a result of releases to the environment by General Motors (GM). EDP purchased the facility with the knowledge and understanding that General Motors (GM) was responsible and under the 2006 Order with the NYSDEC to remediate the conditions caused by more than four decades of automotive parts manufacturing at the site. Approximately one year later, GM filed for protection under bankruptcy laws and stopped all activity at the Site. AAM, the subsequent owner and operator of the manufacturing facility declined to fulfill the responsibilities of the 2006 Order. East Delavan Property (EDP), the current owner of the Site and surrounding property, has never manufactured automotive parts at the Site, operated any of the manufacturing equipment that caused the releases to the environment, was not identified in the Order. EDP is not a party to or a signatory to the Order.

**Photograph 1**  
**Oblique View of Site**  
**(Looking North)**  
**Circa 2014**

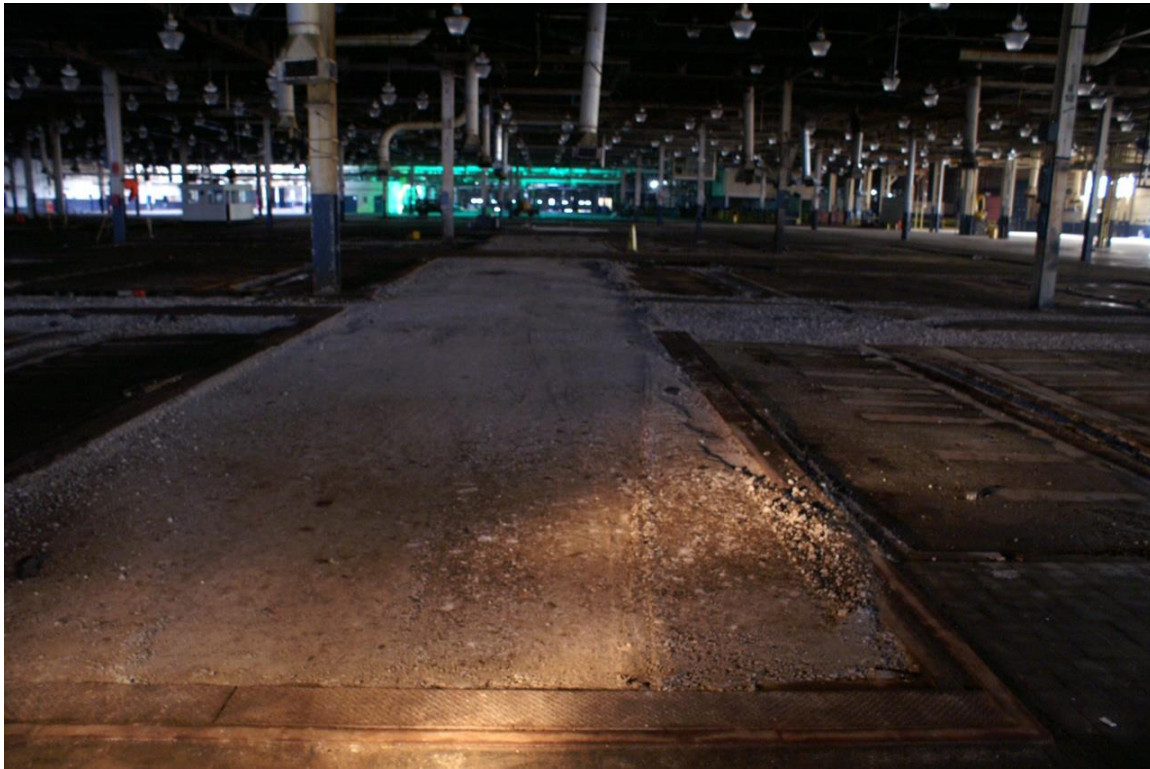
**Photograph 2**  
**View of Interior After Equipment Removed**  
**Circa 2009**

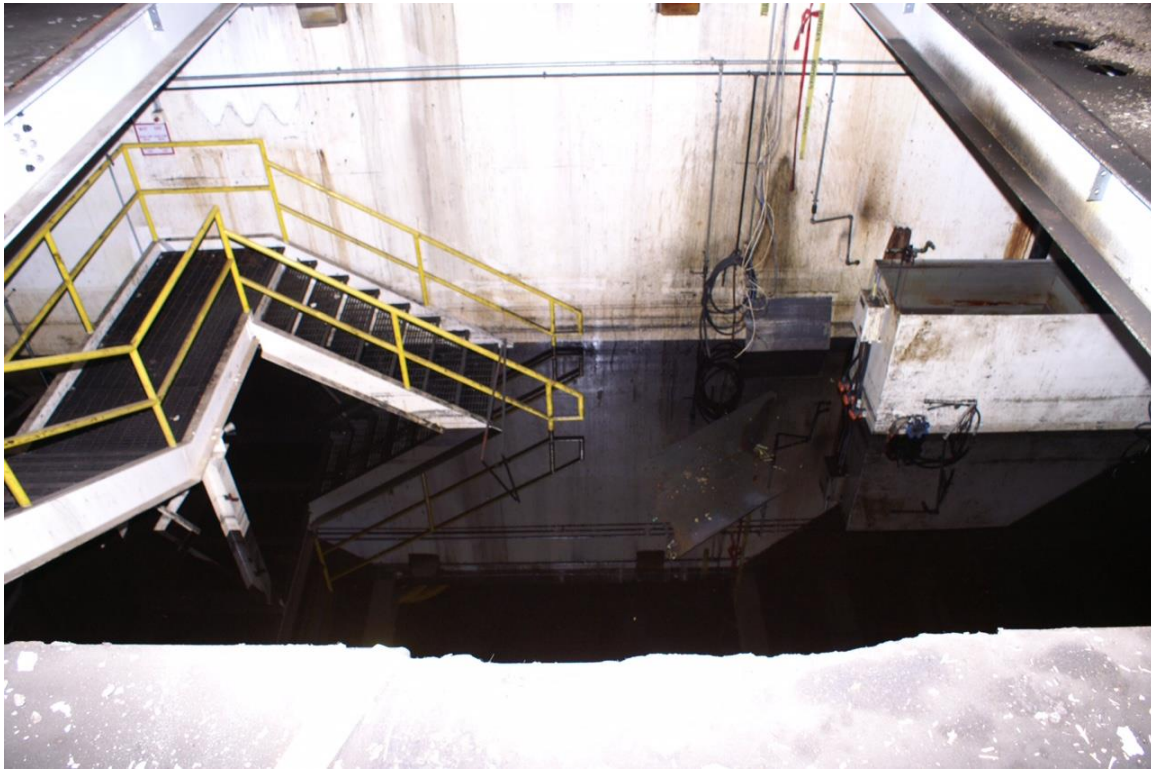
**Photograph 3**  
**Pit Containing Oily Substance and Wastewater**  
**Circa 2009**  
**(Before GM Bankruptcy)**

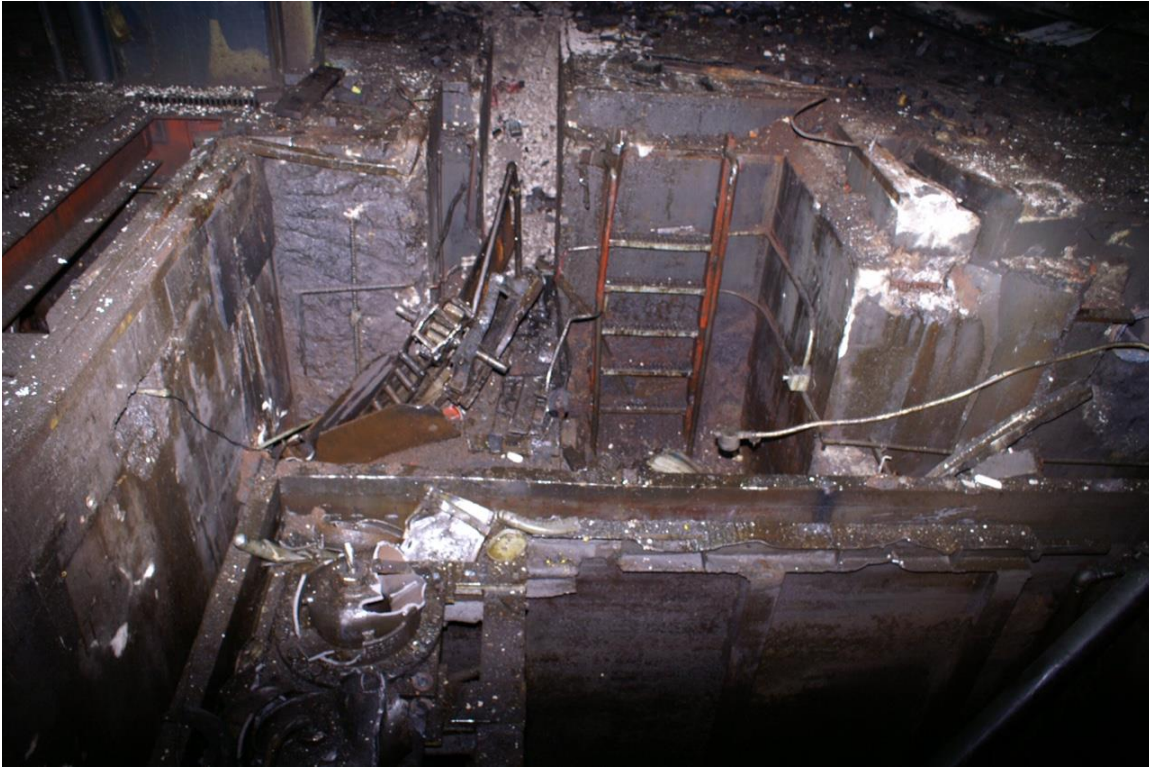
**Photograph 4**  
**Pit During Cleaning**  
**Circa 2009**  
**(Before GM Bankruptcy)**

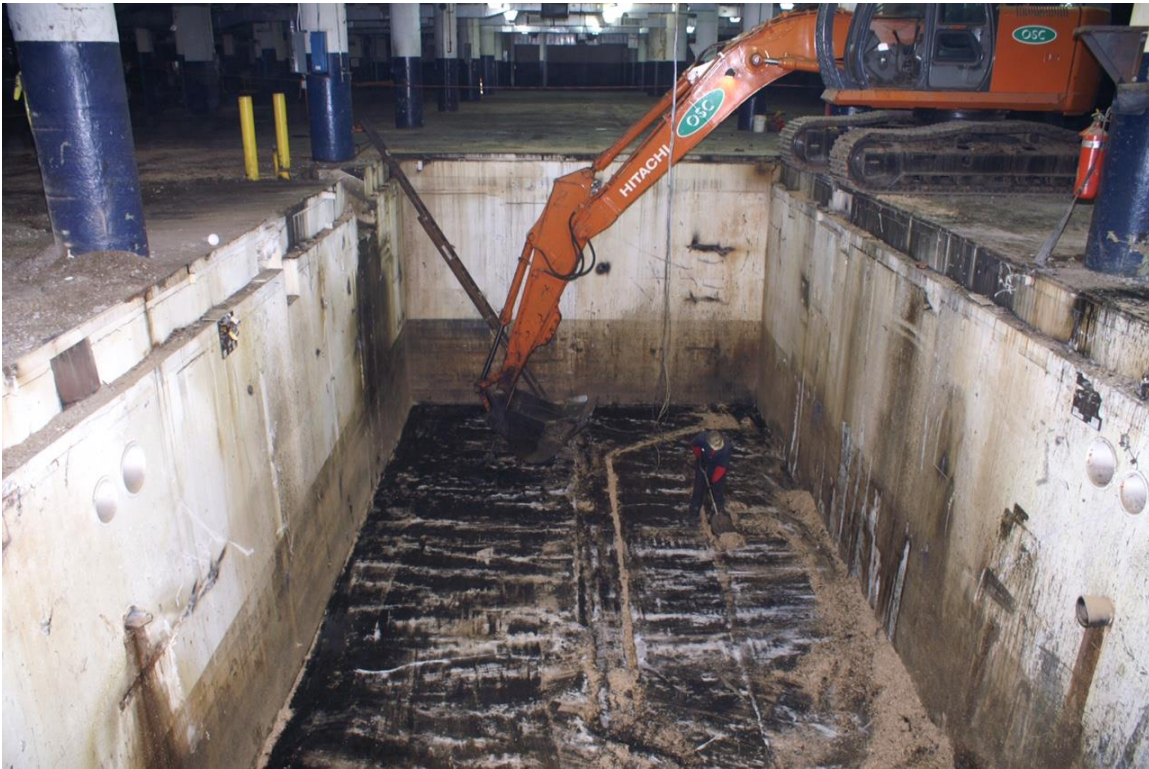
**Photograph 5**

**Pit During Cleaning**

**Note: Height of Worker Relative to Height of Staining of Wall; Indicative of Oily Wastewater Elevation and Pressure on Concrete**

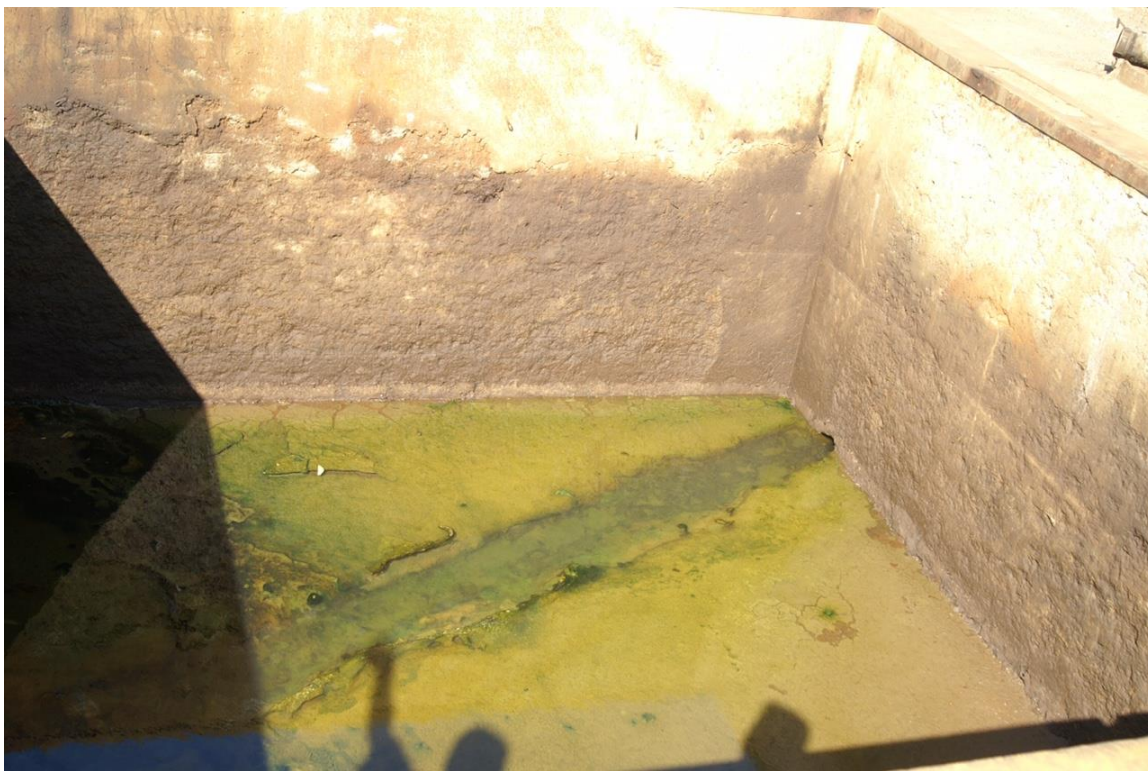
**Photograph 6**

**Pit During Cleaning**

**Notes: (1) Height of Staining of Wall; Indicative of Oily Wastewater Elevation and Pressure on Concrete**

**(2) Pipe Through Wall; Indicative of Possible Transport/Release Pathway**
