NYSDEC

Division of Environmental Remediation

Site: Colvin Eggert Plaza- Our Cleaners Site

Site No.: 915212

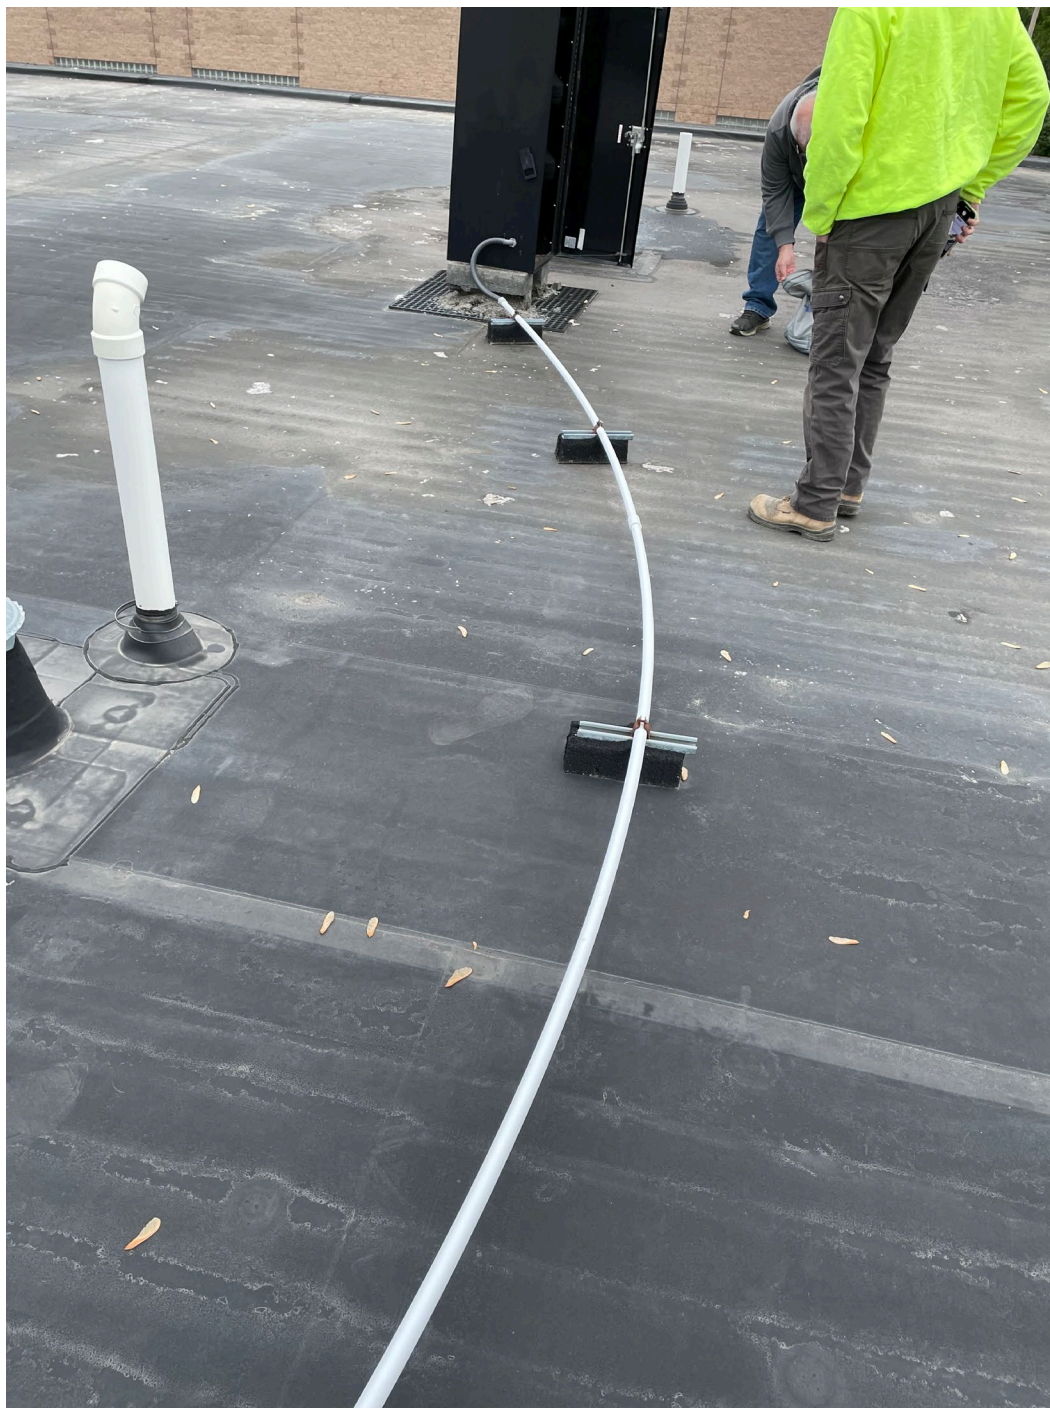
Electrical conduit leading to SSDS enclosure.

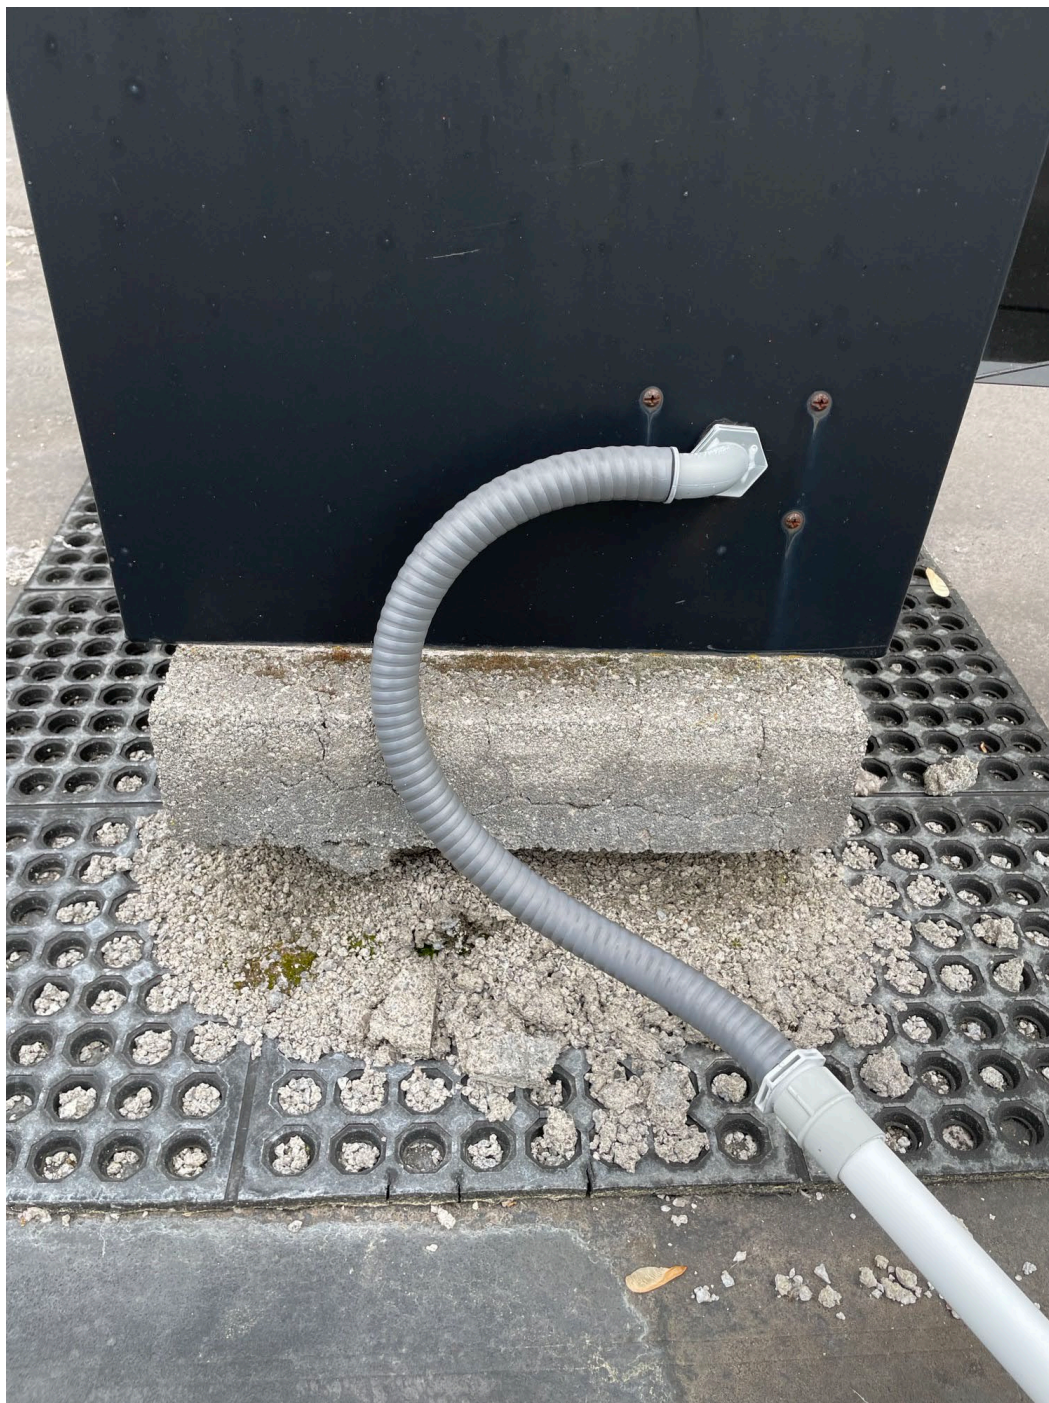
Crumbling cinder blocks supporting SDS enclosure.

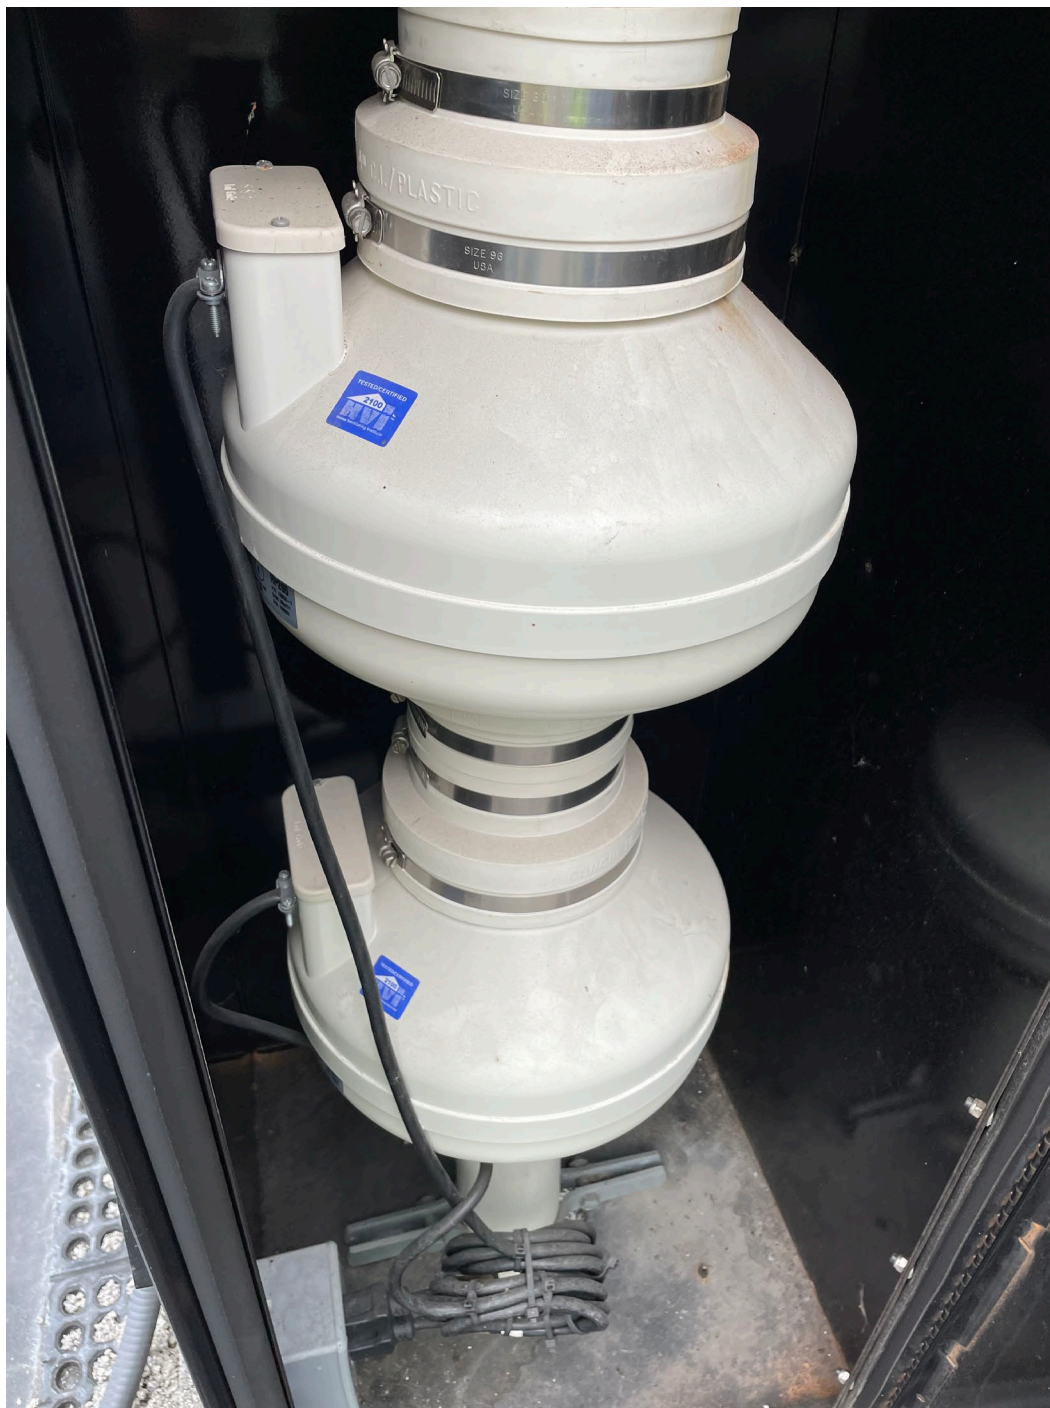
- NYSDEC onsite 10:00 am to 11:15 am to conduct annual inspection with Groundwater Environmental Services (GES) and Miller Environmental Group (MEG)
- Traveled to rooftop to access sub slab depressurization system. Unit was observed to be running and generally in good condition with air flow confirmed. Photo Ionization Detection (PID) meter confirmed no contaminants in exhaust. It was noted that the cinder blocks supporting the system enclosure had begun to crumble. MEG would make recommendation to replace. MEG installed vacuum pressure gauge below first blower. A small amount of vacuum pressure was reading however it was noted that the scale was too high (100 inches of water column) making it difficult to get an exact reading. Gauge may be replaced in the future.

SSDS unit.

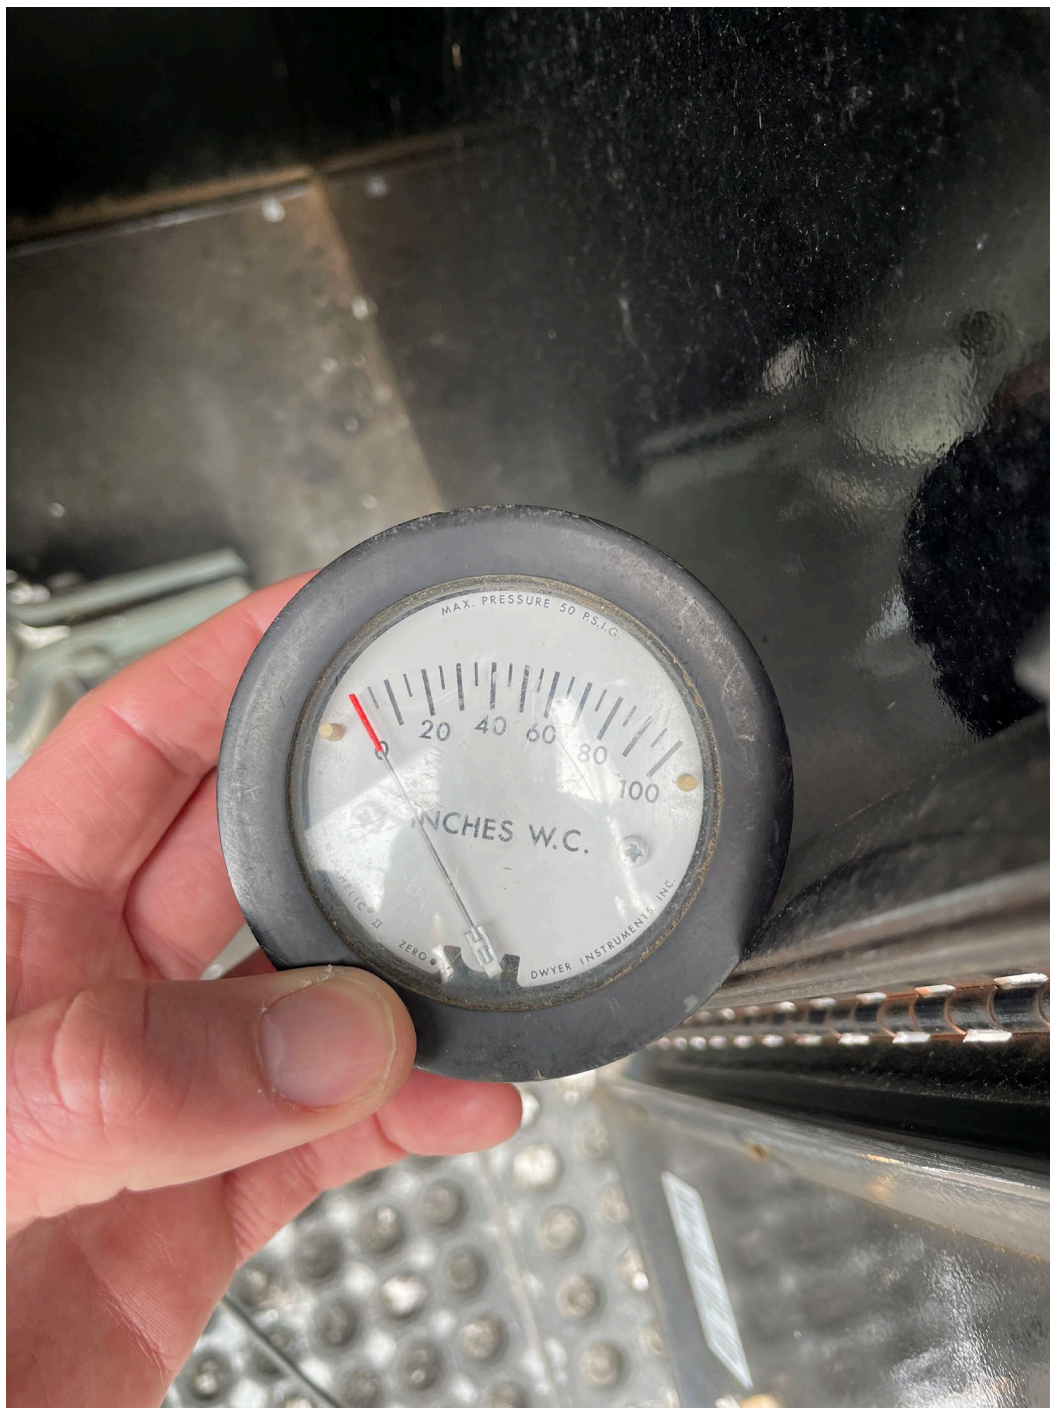
Vacuum pressure gauge scale.

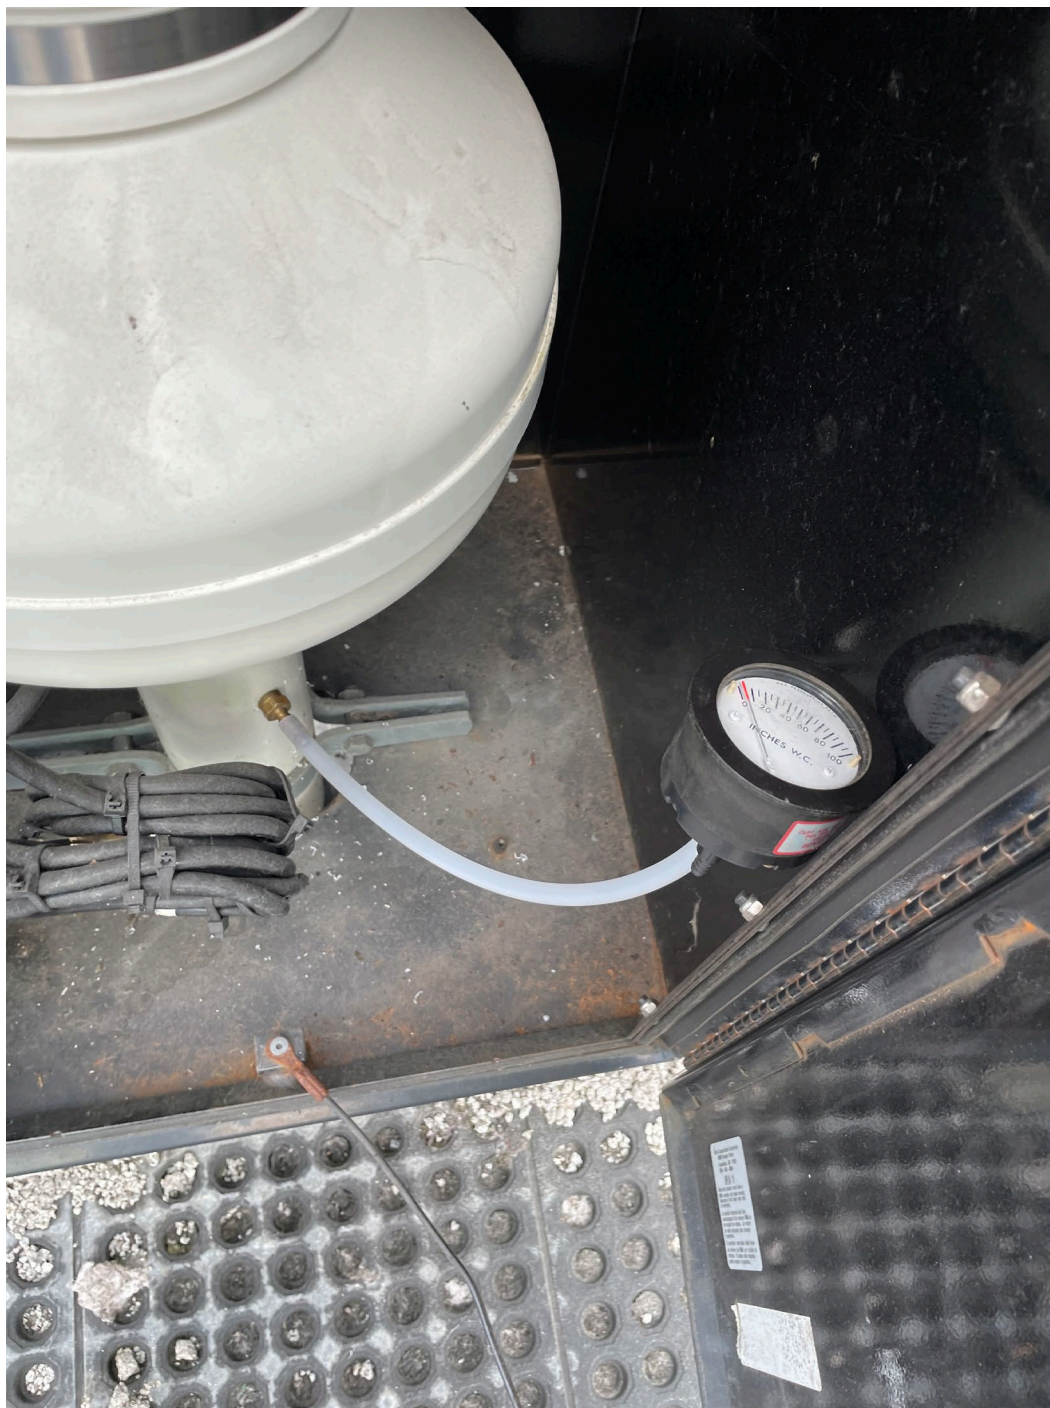
Installed gauge.

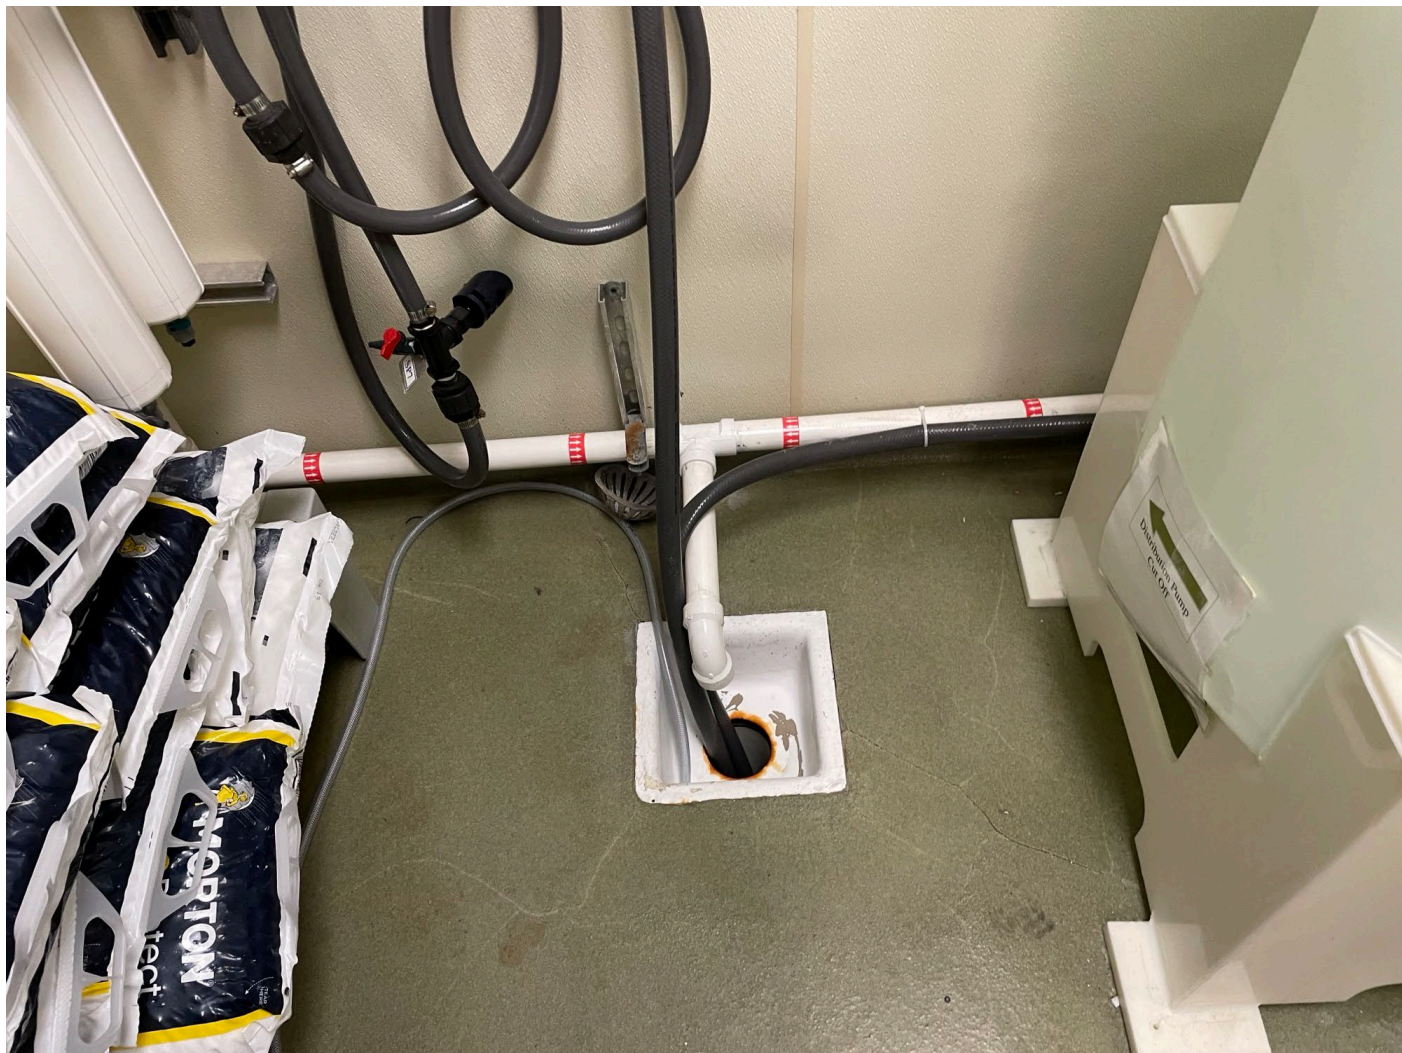
- Inspection of inside of US Renal Care building noted no cracks in floor or possible soil vapor exposure routes outside of designed floor drains in water treatment area.

Floor drain in water treatment room inside US Renal Care building.

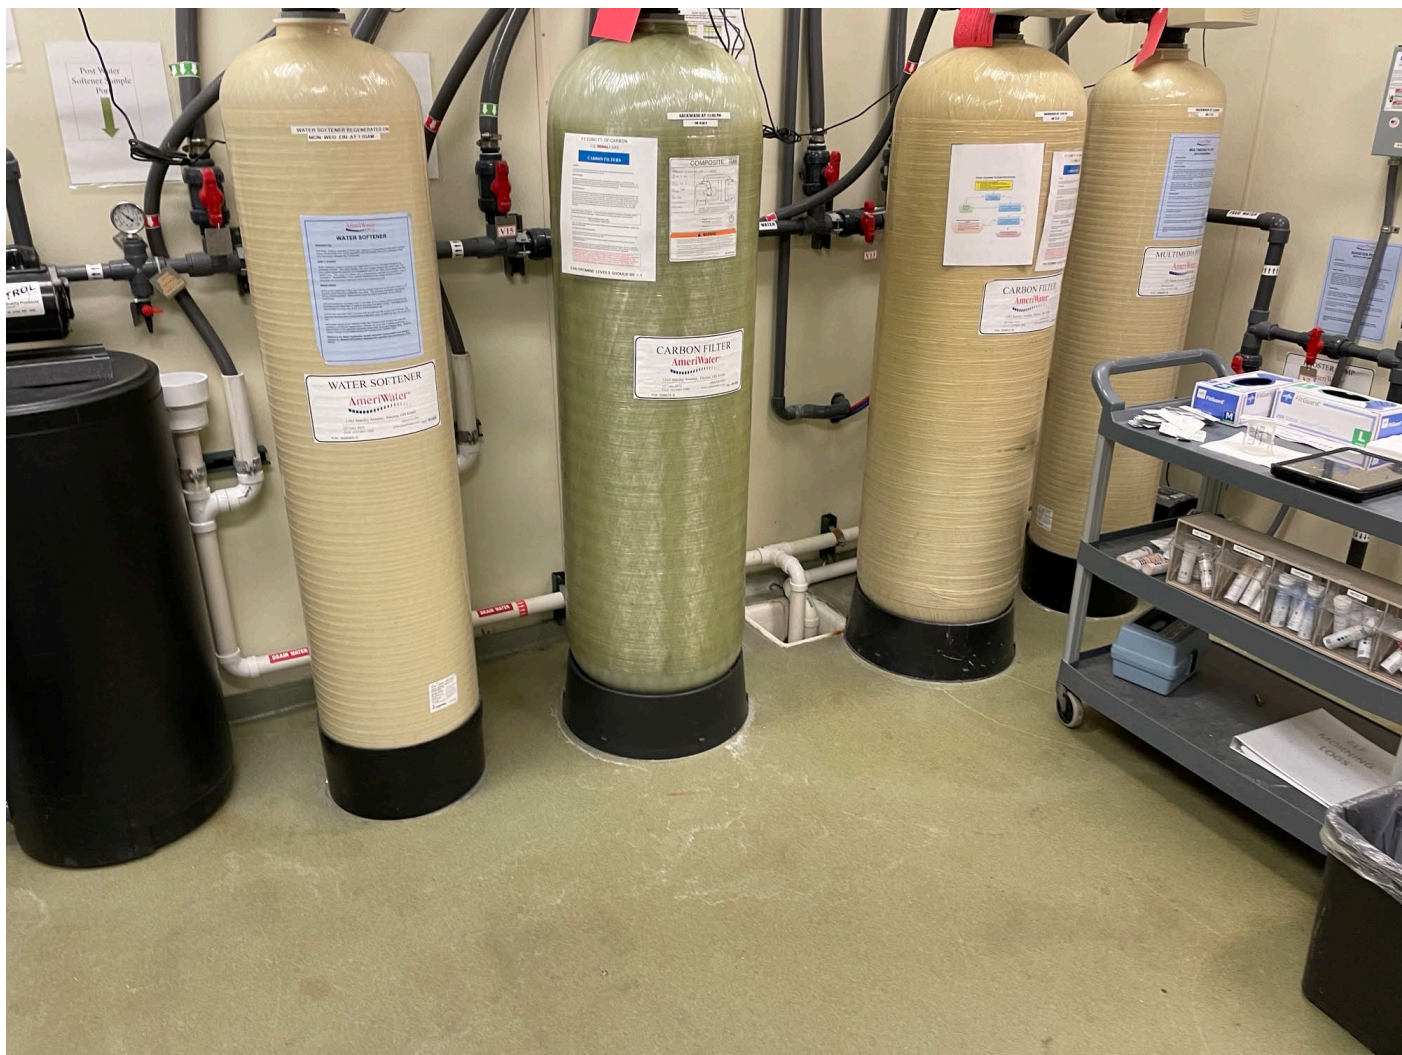
Floor drain in water treatment room inside US Renal Care building.
