Division of Environmental Remediation

Site Investigation - Scope of Work

**Riverview Industrial Center
5335 River Road
Town of Tonawanda
Erie County, New York**

March 2009

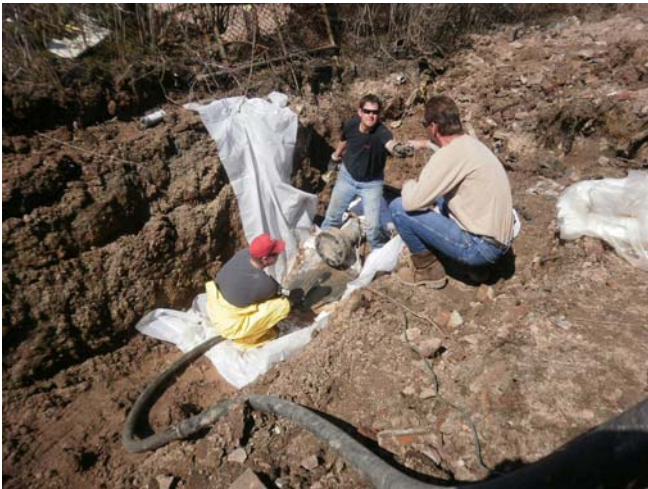
0-09 Flange removal Fluid Leaking

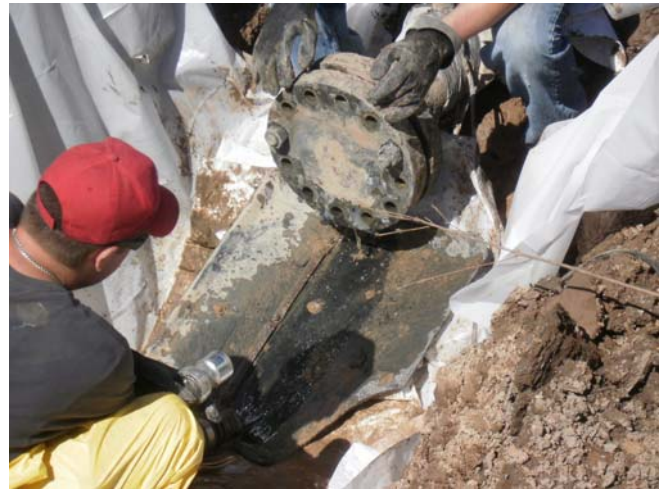
0-10 Flange removal Fluid Leaking

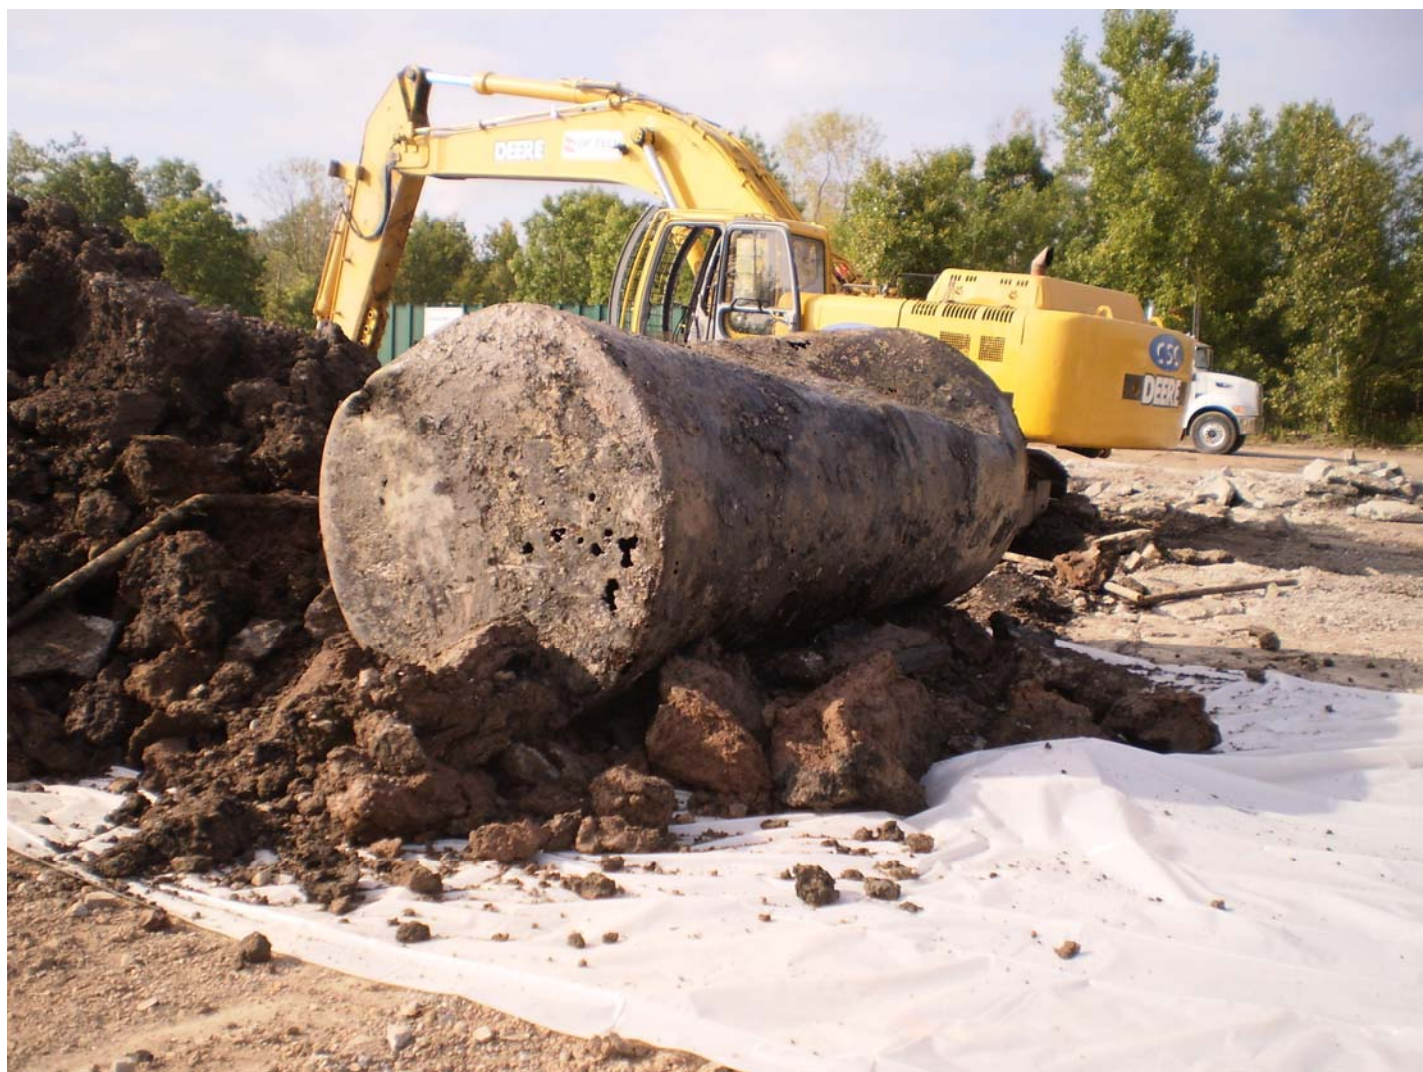
Figure 1 UST found 09/17/2009

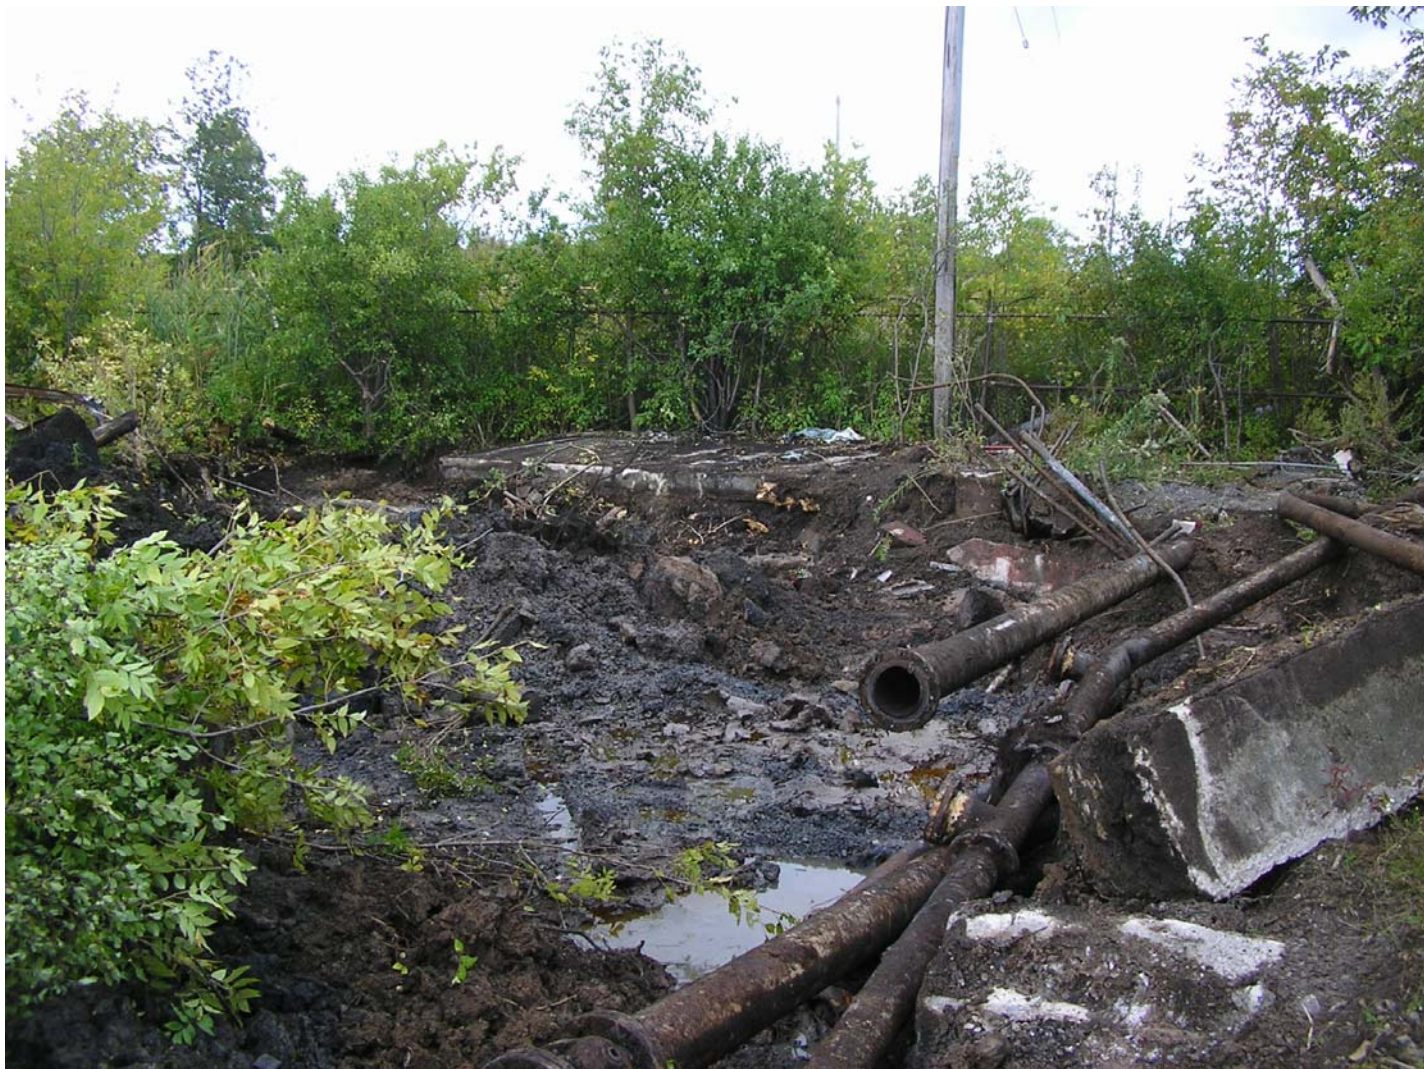
Figure 2 Oily debris in the SE corner

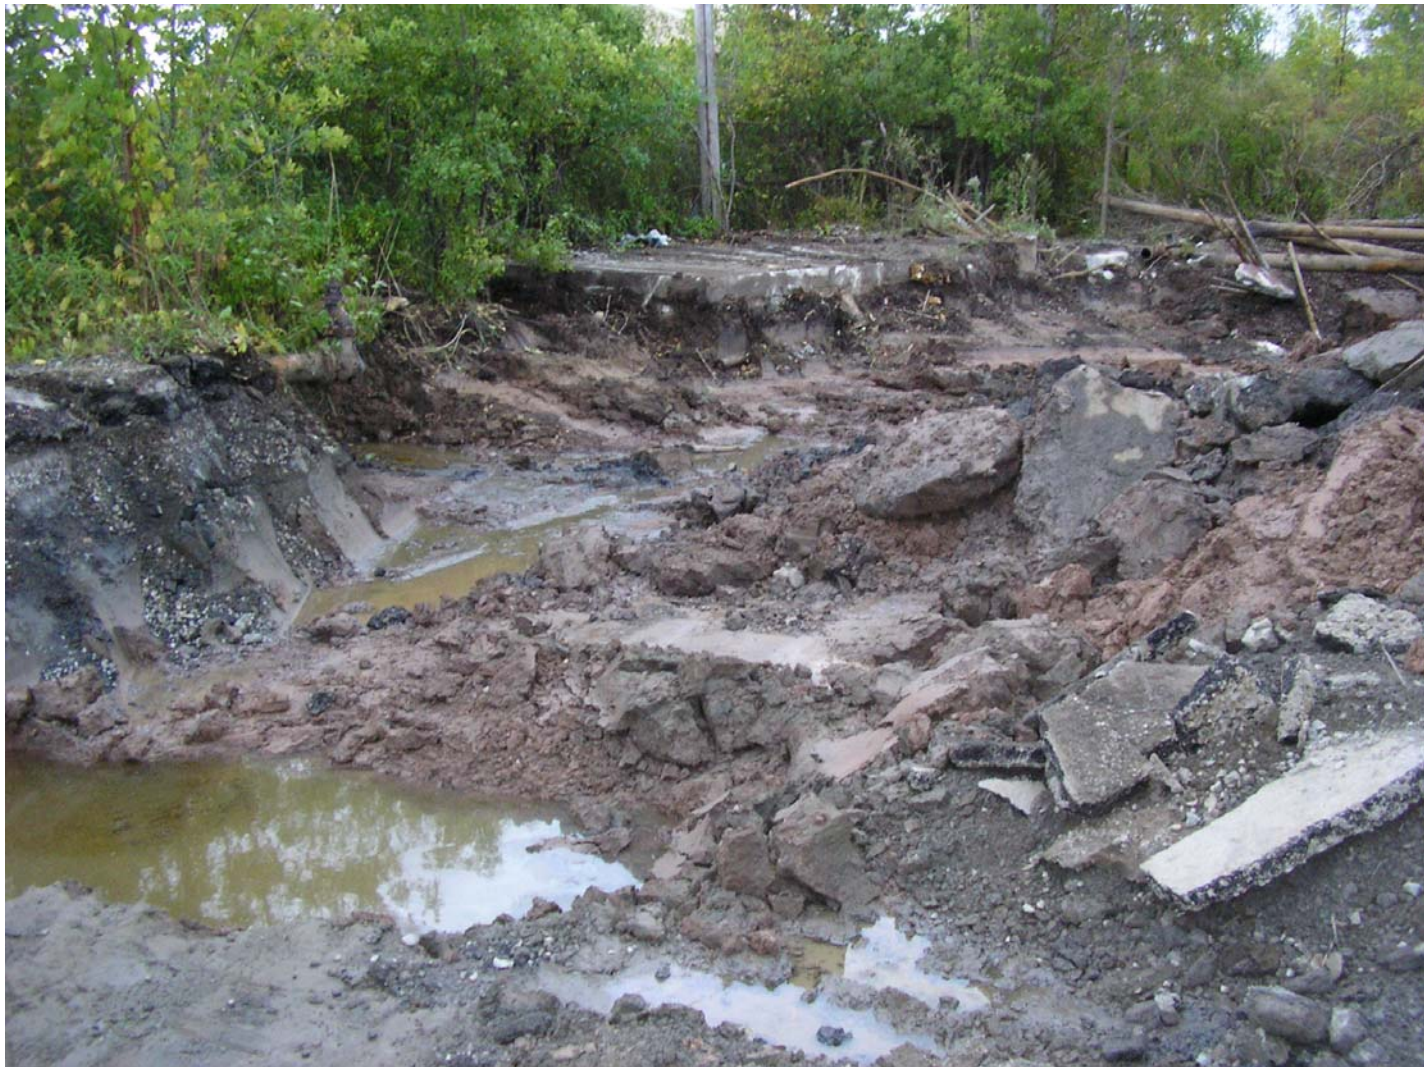
Figure 3 expanded excavation to the east

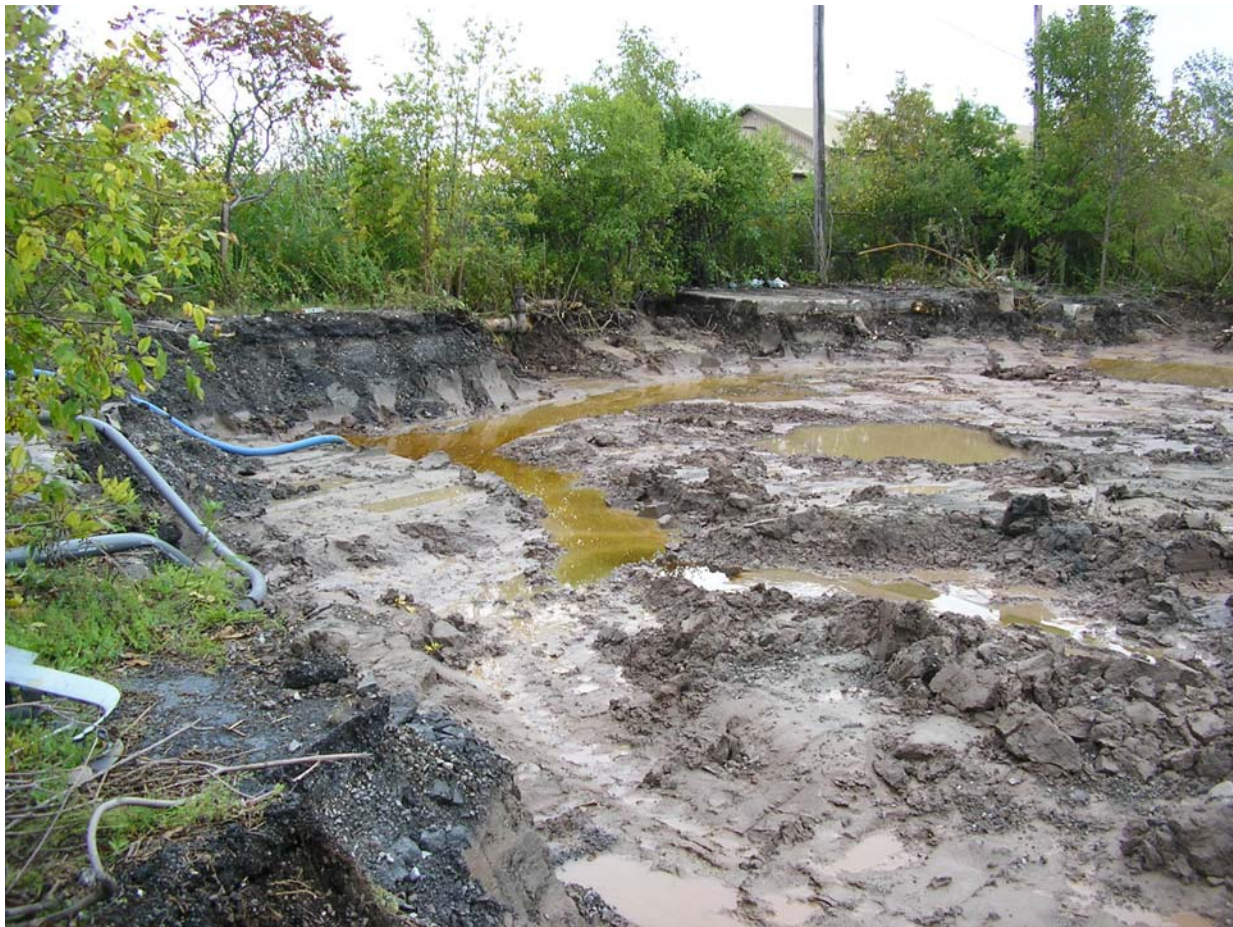
Figure 4 Oily water coming from excavation

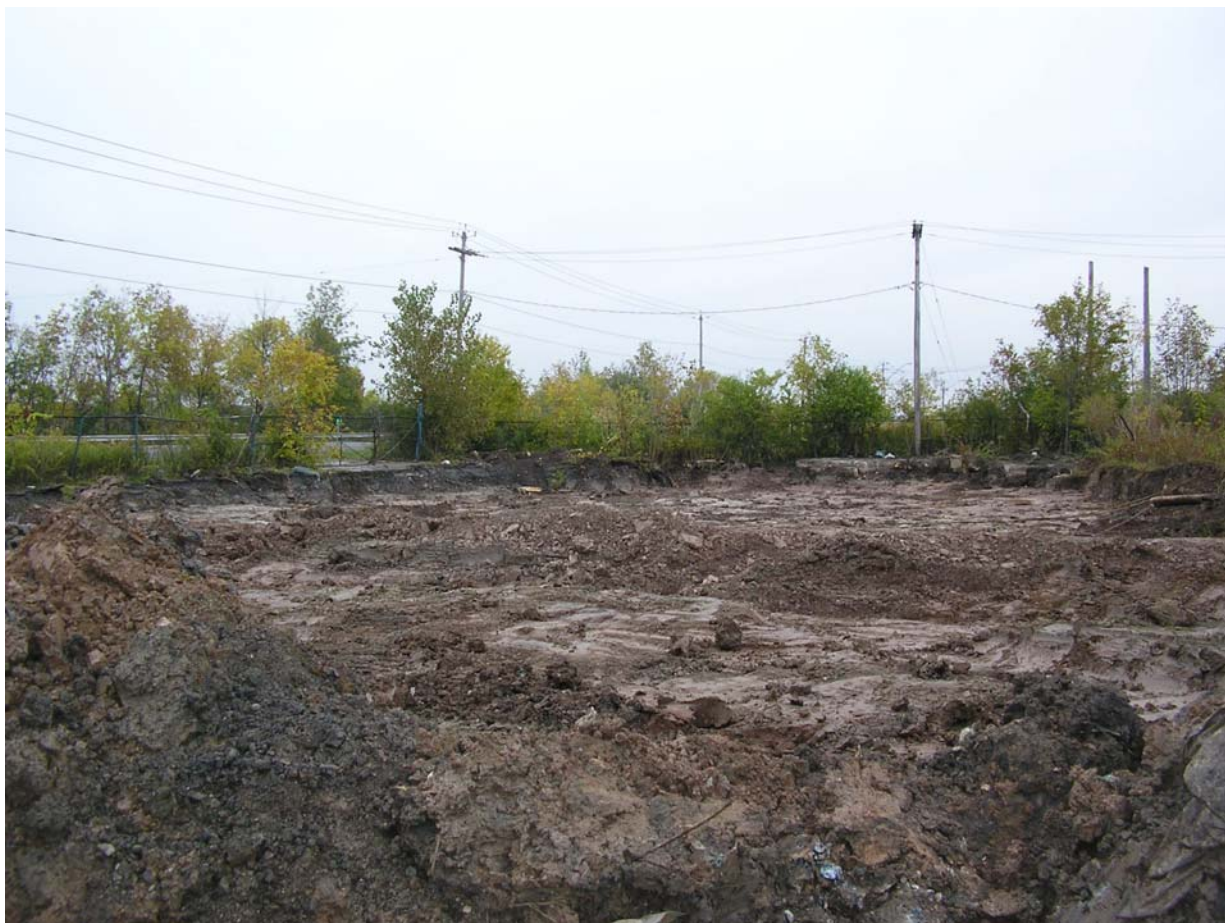
Figure 5 Berm created to prevent oily liquids from migrating east

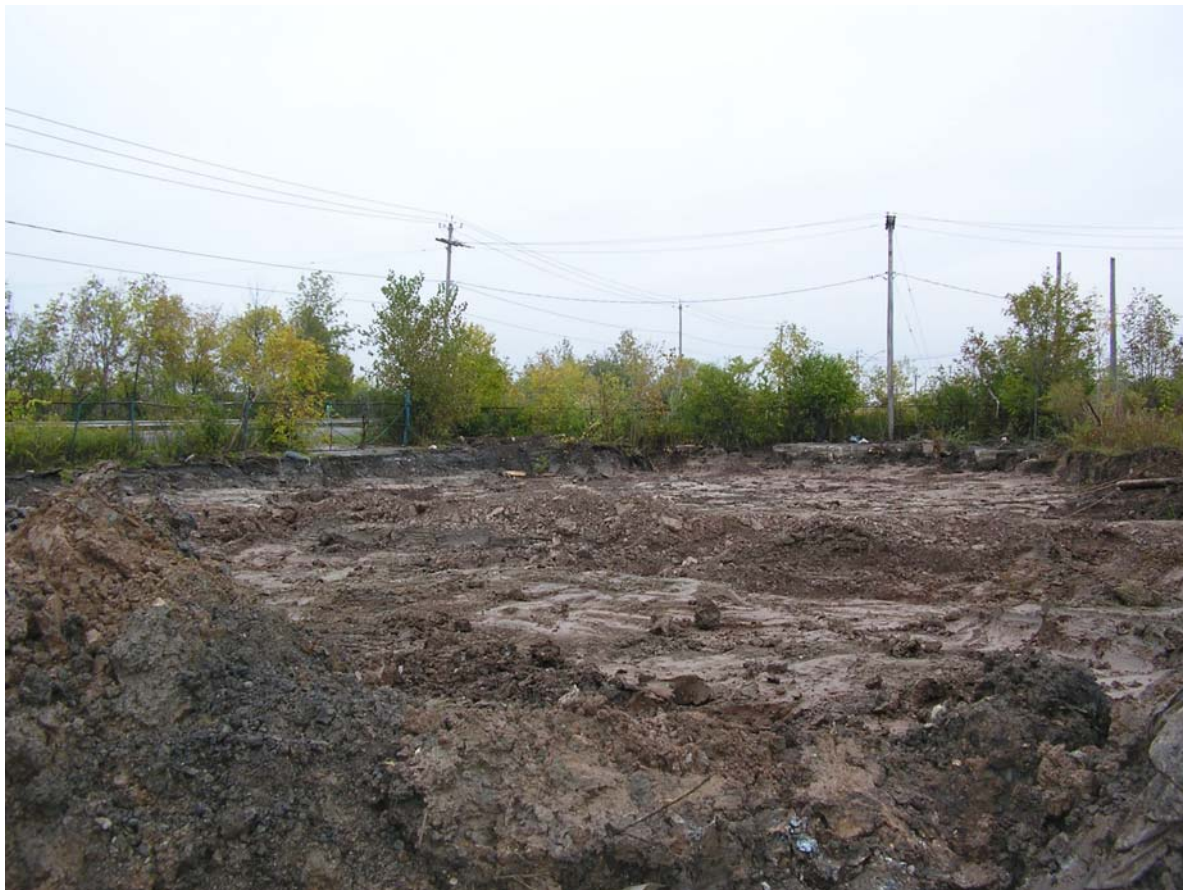
Figure 6 Extent of excavation facing NE

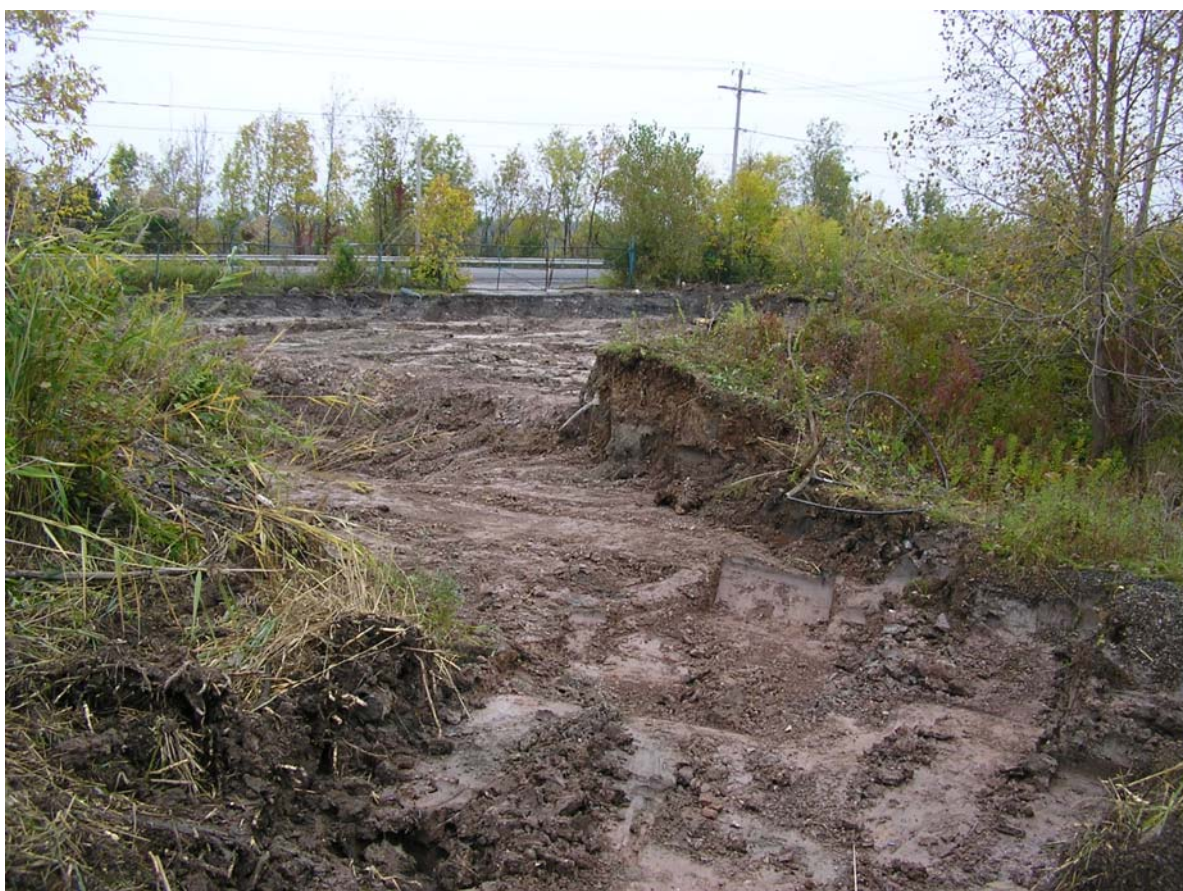
Figure 7 Excavated pipe trench to the south

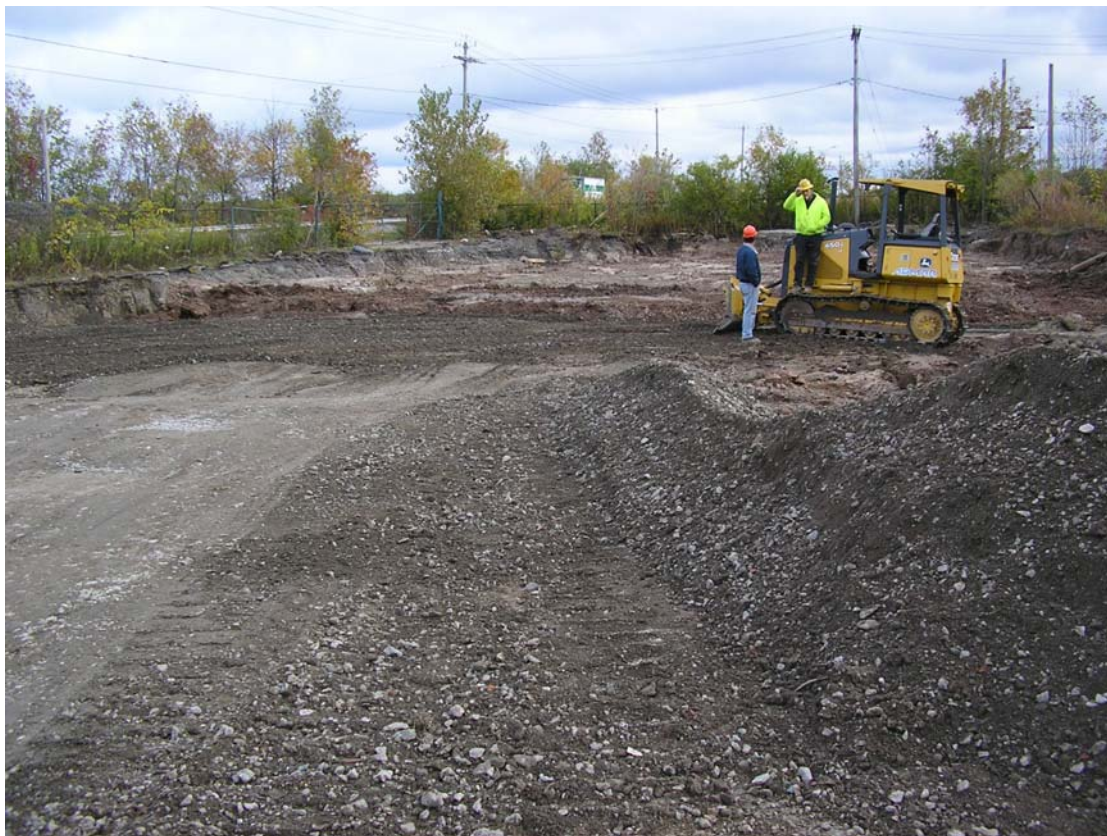
Figure 8 Backfilling of excavation with crushed concrete

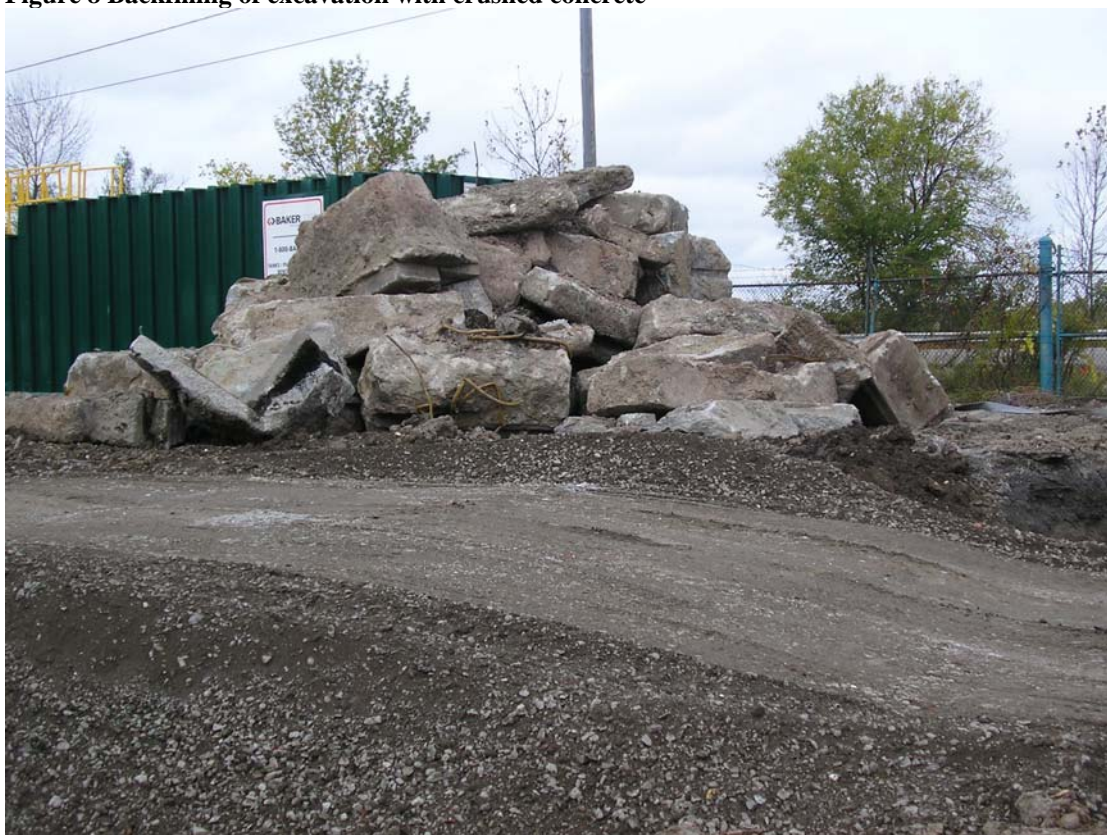
Figure 9 Contaminated concrete to be broken and disposed

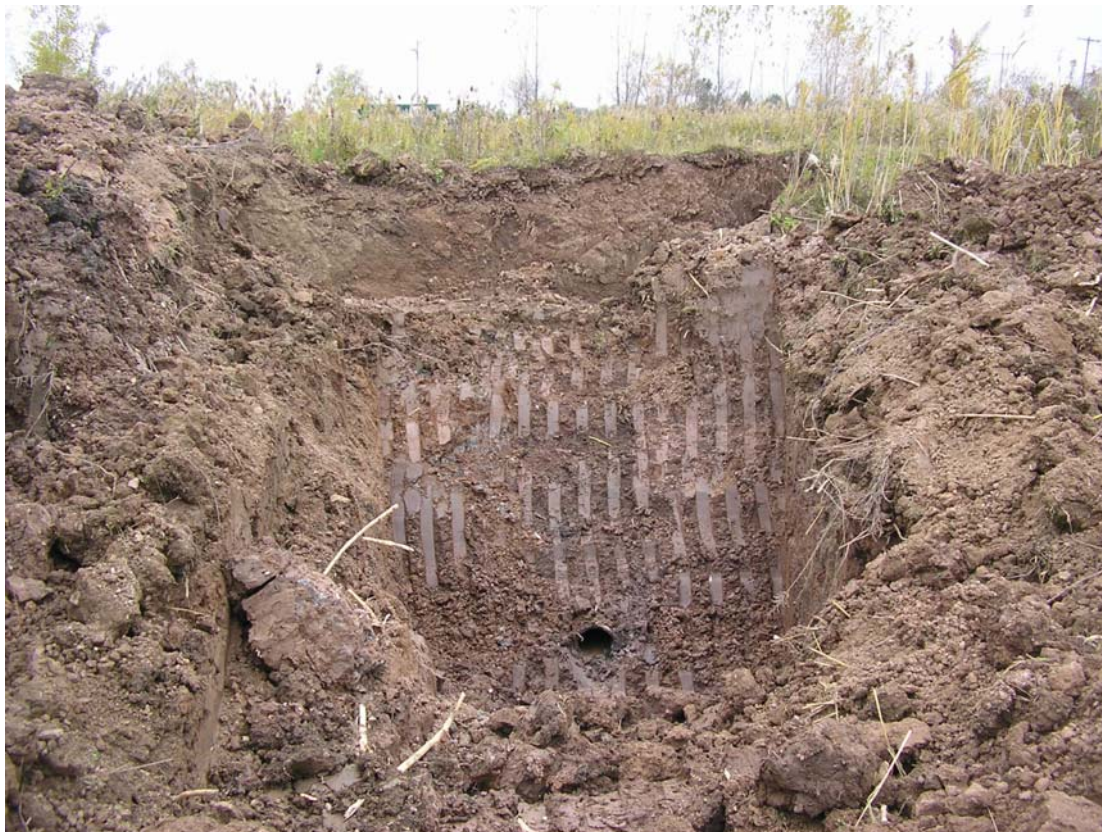
Figure 10 North end of 10" transite sewer pipe excavation

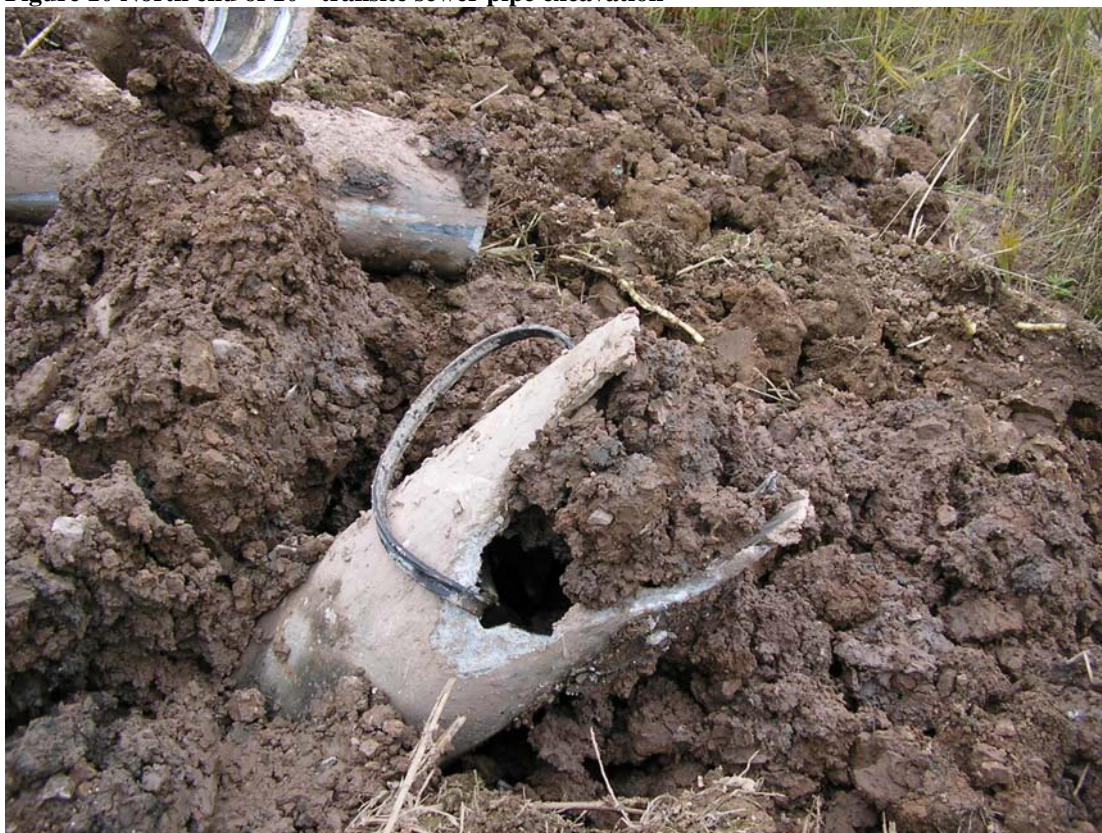
Figure 11 picture of 10" transite pipe

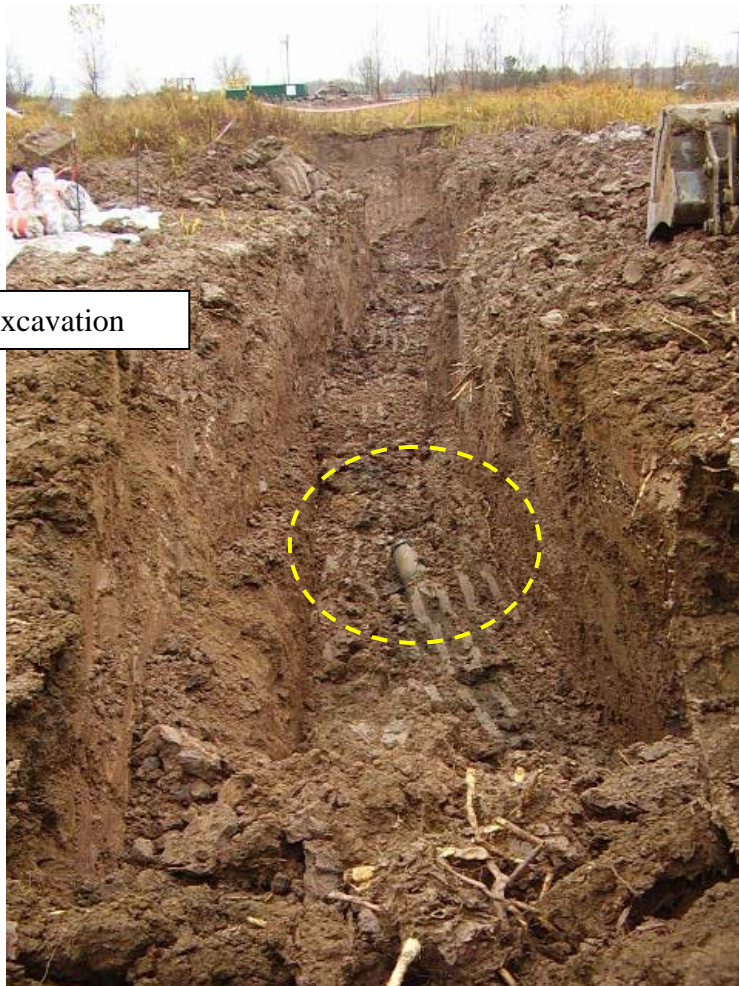
ACP pipe at bottom of the excavation

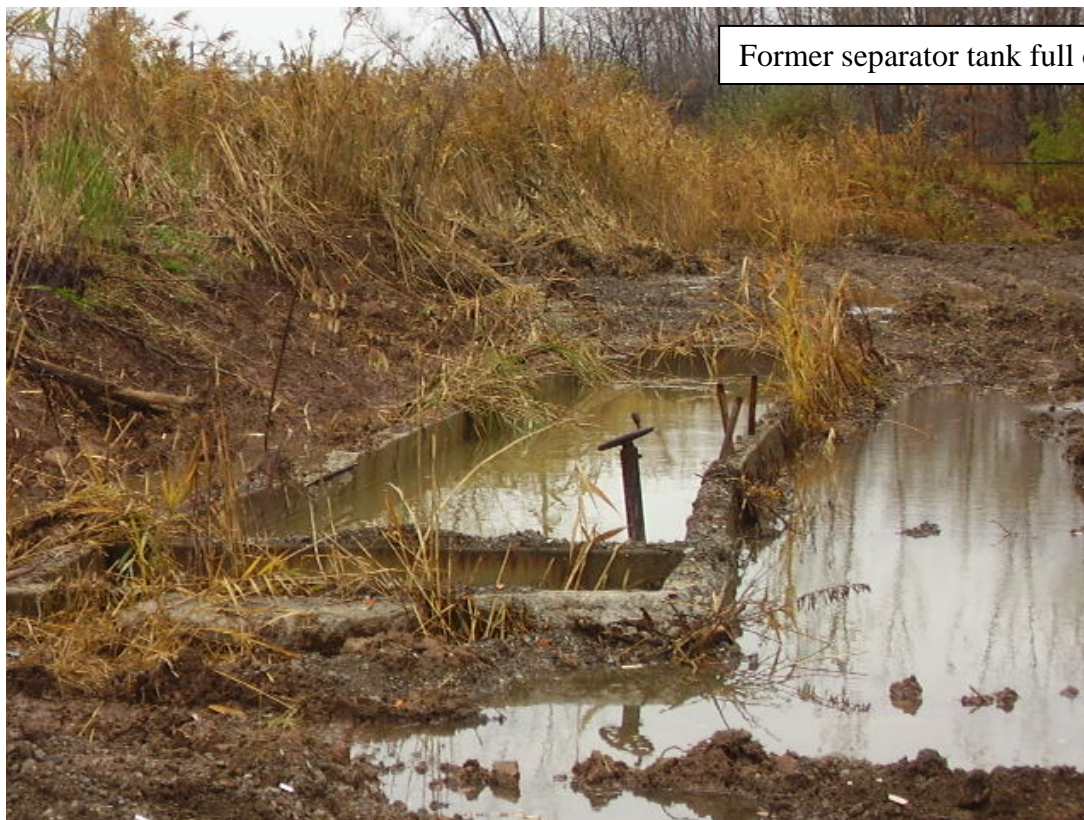
Former separator tank full of water

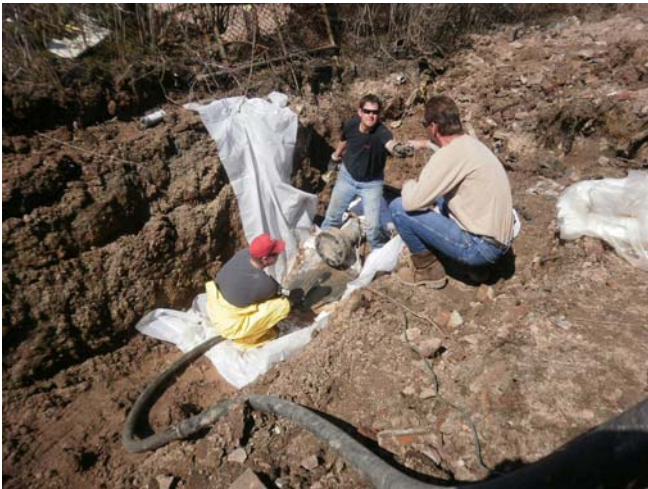
0-09 Flange removal Fluid Leaking

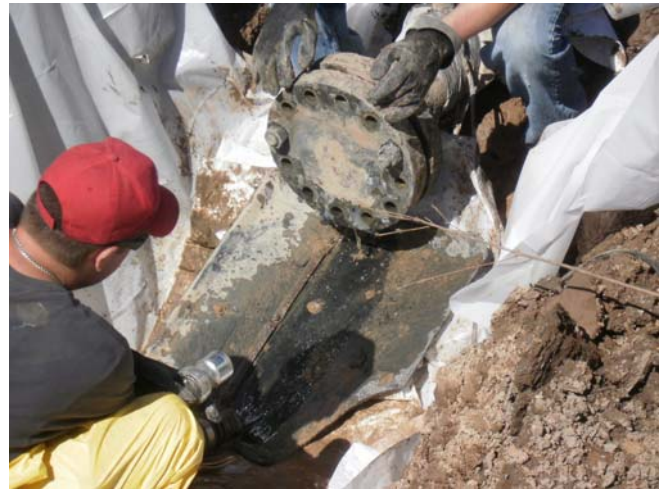
0-10 Flange removal Fluid Leaking
