September 29, 2011
Empire Project Number BEV-11-022

Reference: Report of Initial Information as Part of the
Phase I Preliminary Site Assessment Report
Vacant Site Located at 5565 River Road
Tonawanda, Erie County, New York
NYSDEC Site Number 915239

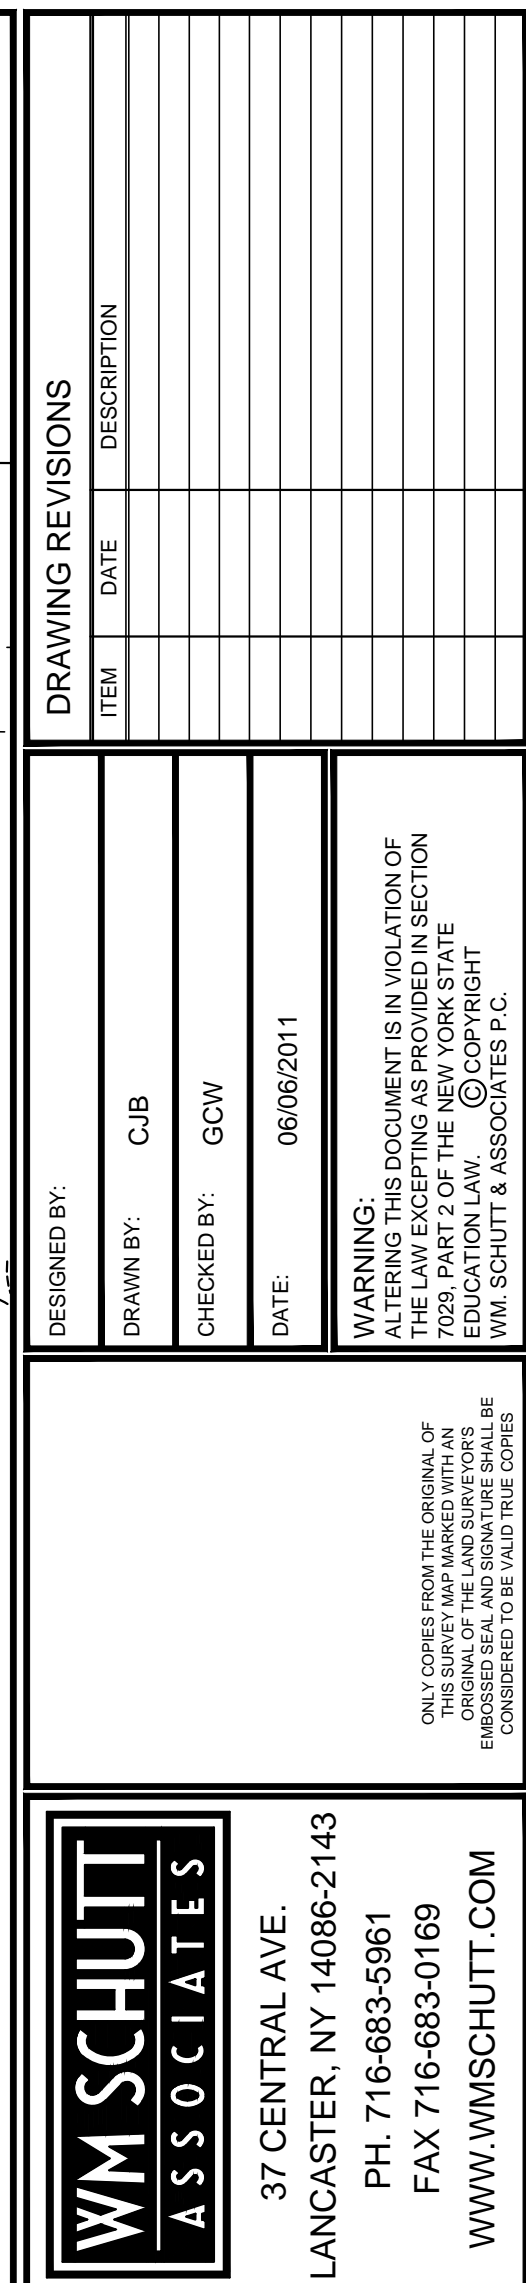
Survey Map

Schutt prepared a map of the site on the basis of their survey. The survey map is attached and includes topographic contours and volume estimates of the onsite fill materials. The estimated fill volume of the area north of Rattlesnake Creek (designated on the map as "Area A") is 68,789 cubic yards and the estimated fill volume for the area south of the creek (designated on the map as "Area B") is 30,617 cubic yards, for a total estimated fill volume of 99,406 cubic yards.

The surveyors also noted two "Barrel Areas" on the map where 55-gallon drums are present. Each of these two areas contains several drums, with a few drums found in other areas of the site, as discussed in the next section.

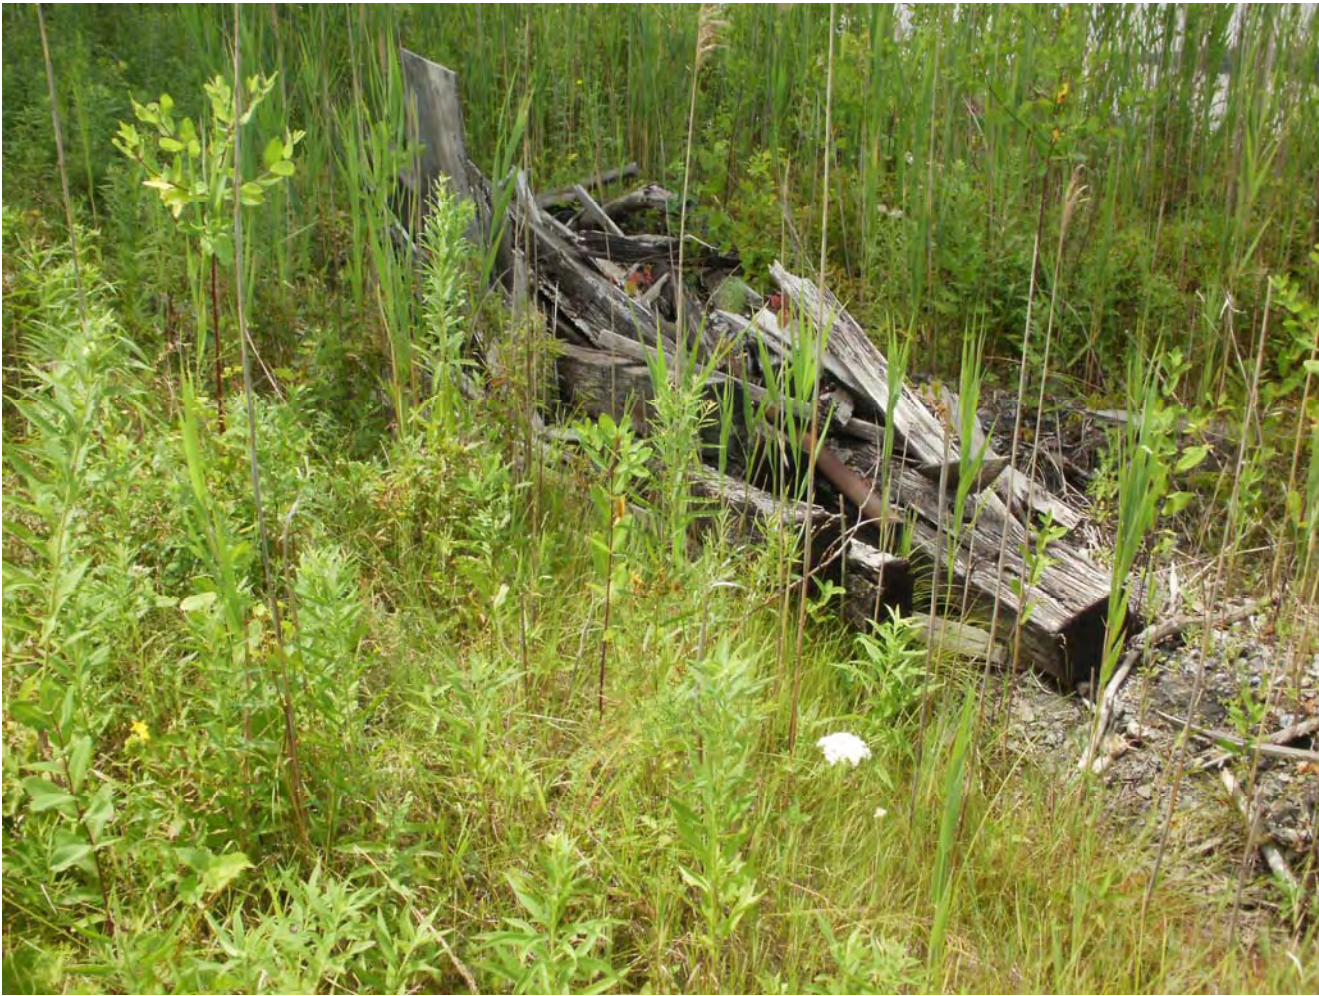
Photo 1 – Railroad ties at northeast corner of the site.

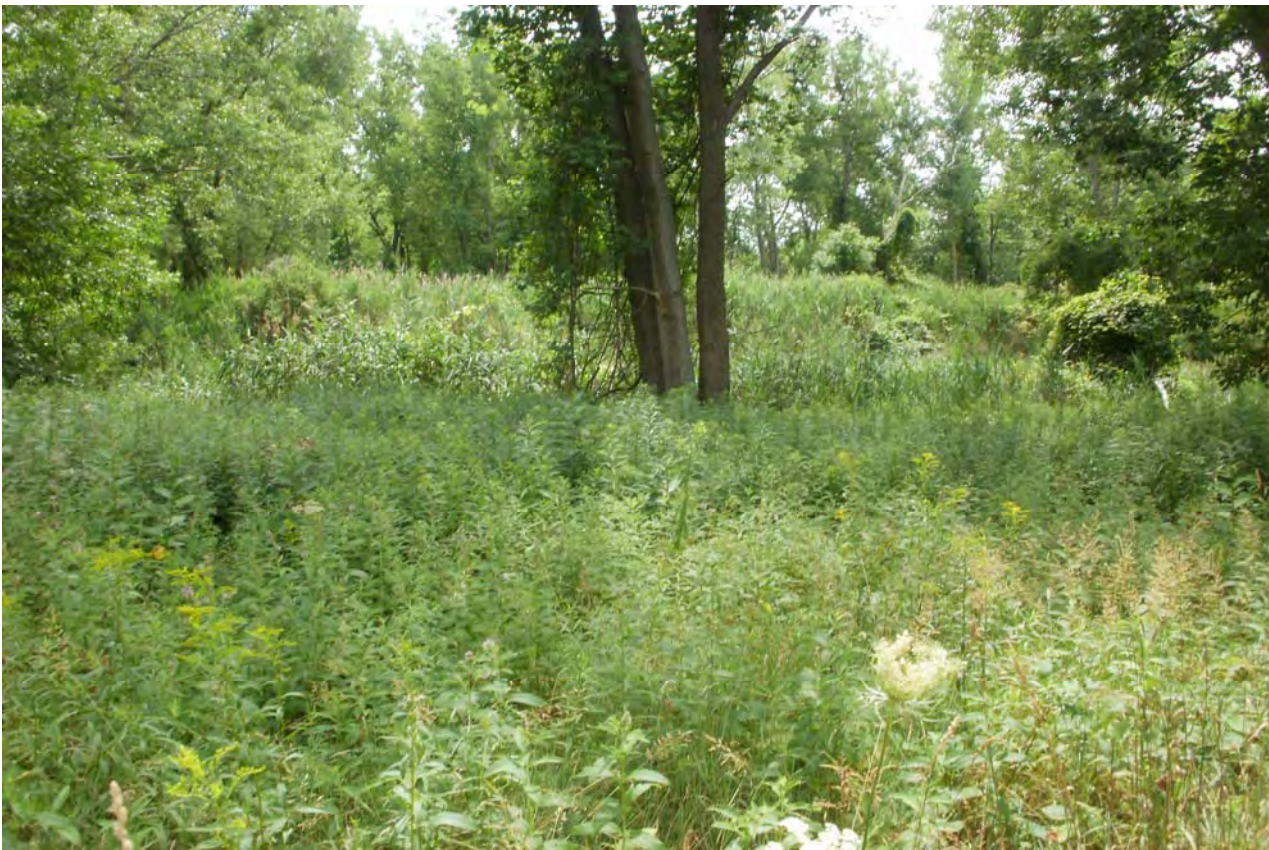
Photo 2 – Southward view of north side of fill bank in the northern portion of the site.

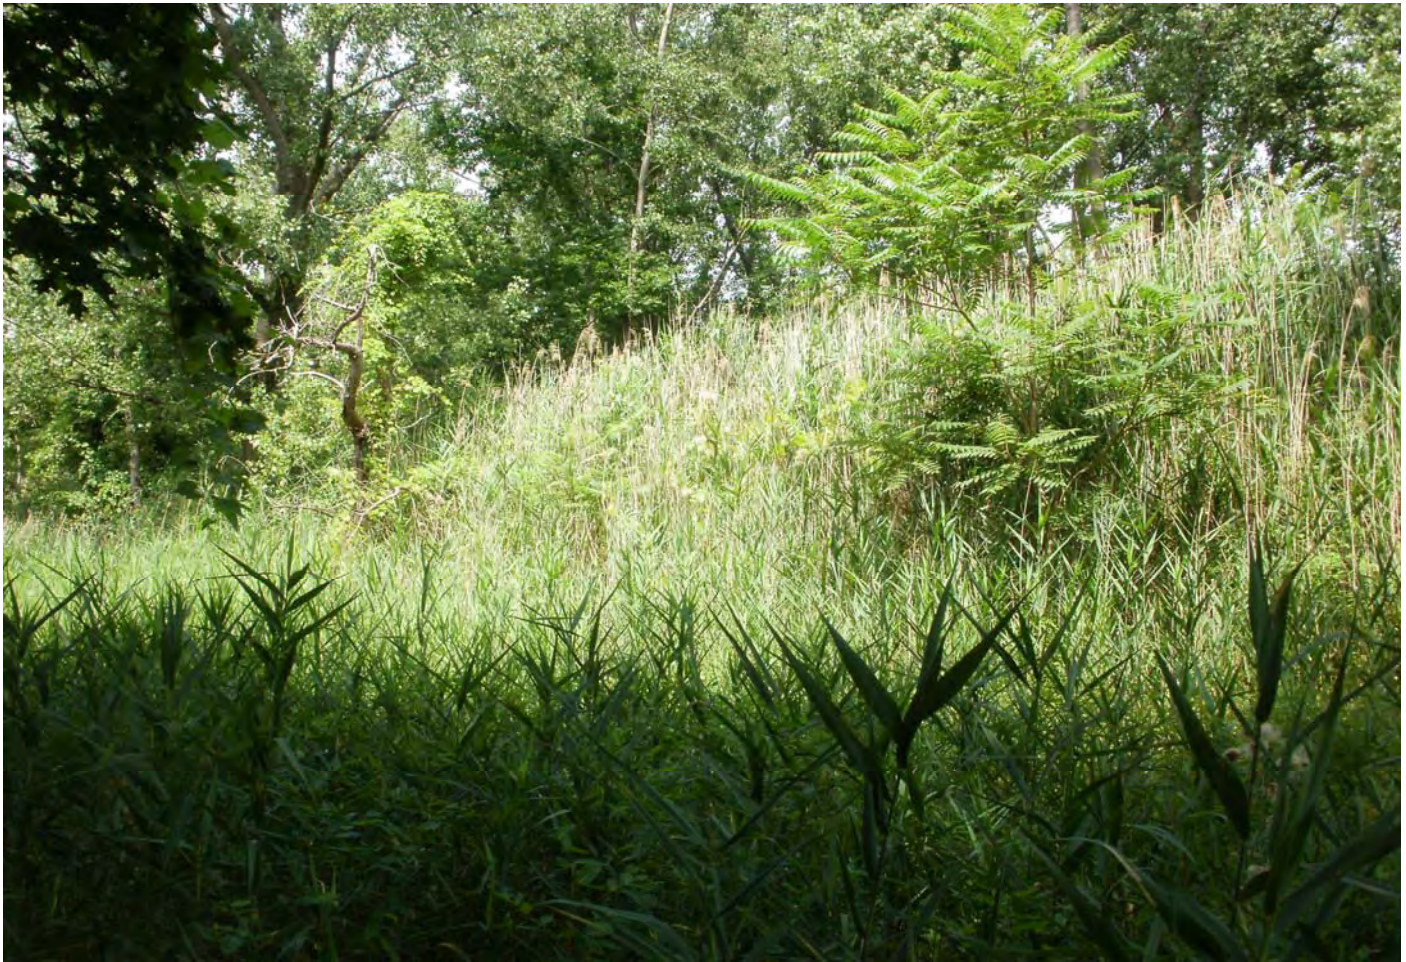
Photo 3 – Northward view of west side of north-south ridge of fill located adjacent to the west site boundary.

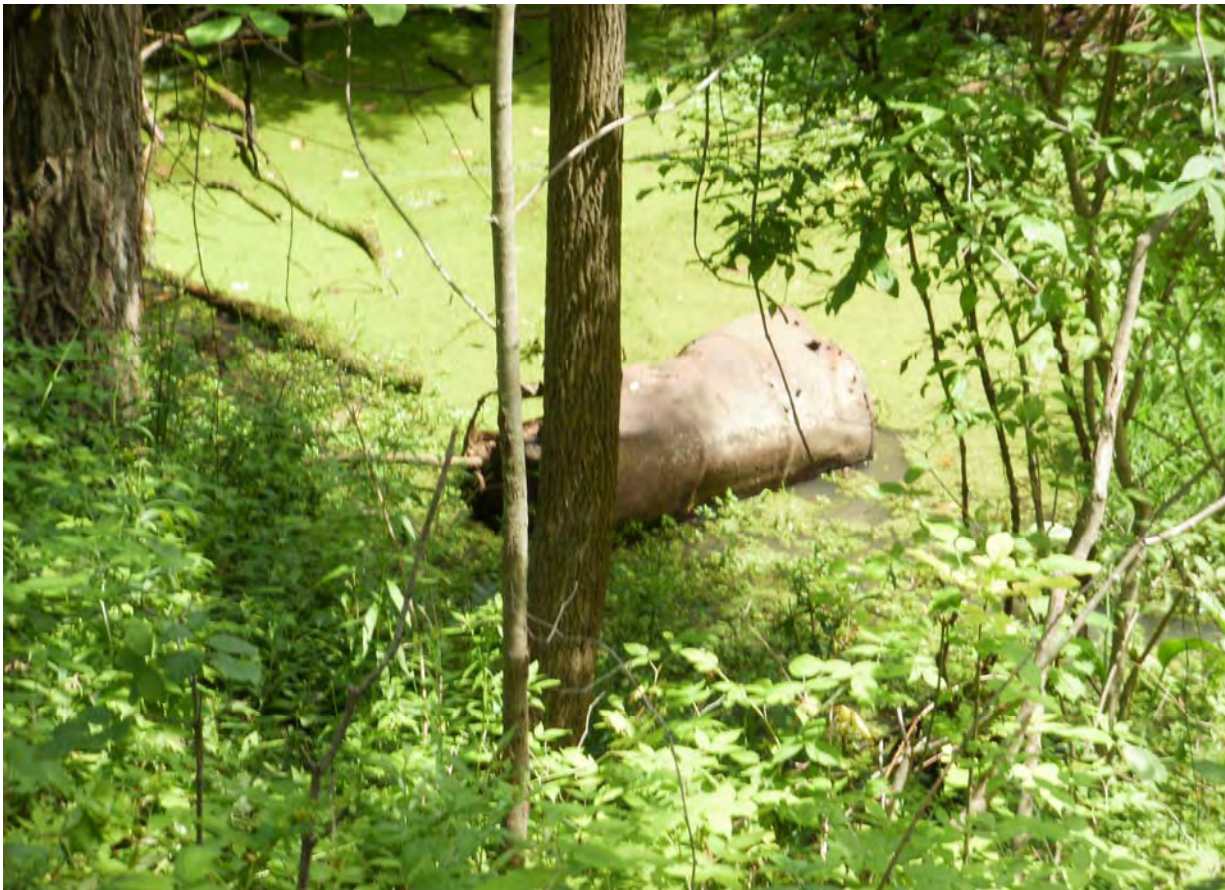
- Five empty drums were found near the north property line (photos 13, 14, & 15)
- One empty drum was found near the bottom of the western portion of the unnamed creek (photo 4)
- One accumulation of large concrete fragments was found to the northwest of the "Barrel Area" located near the south-central portion of the site (photo 7)
- Another accumulation of large concrete fragments was found near the south end of the north-south trending ridge of fill materials located along the northern half of the west site boundary (photo 9)

Photo 4 – Empty drum near the bottom of the western portion of the “valley” for the unnamed creek.

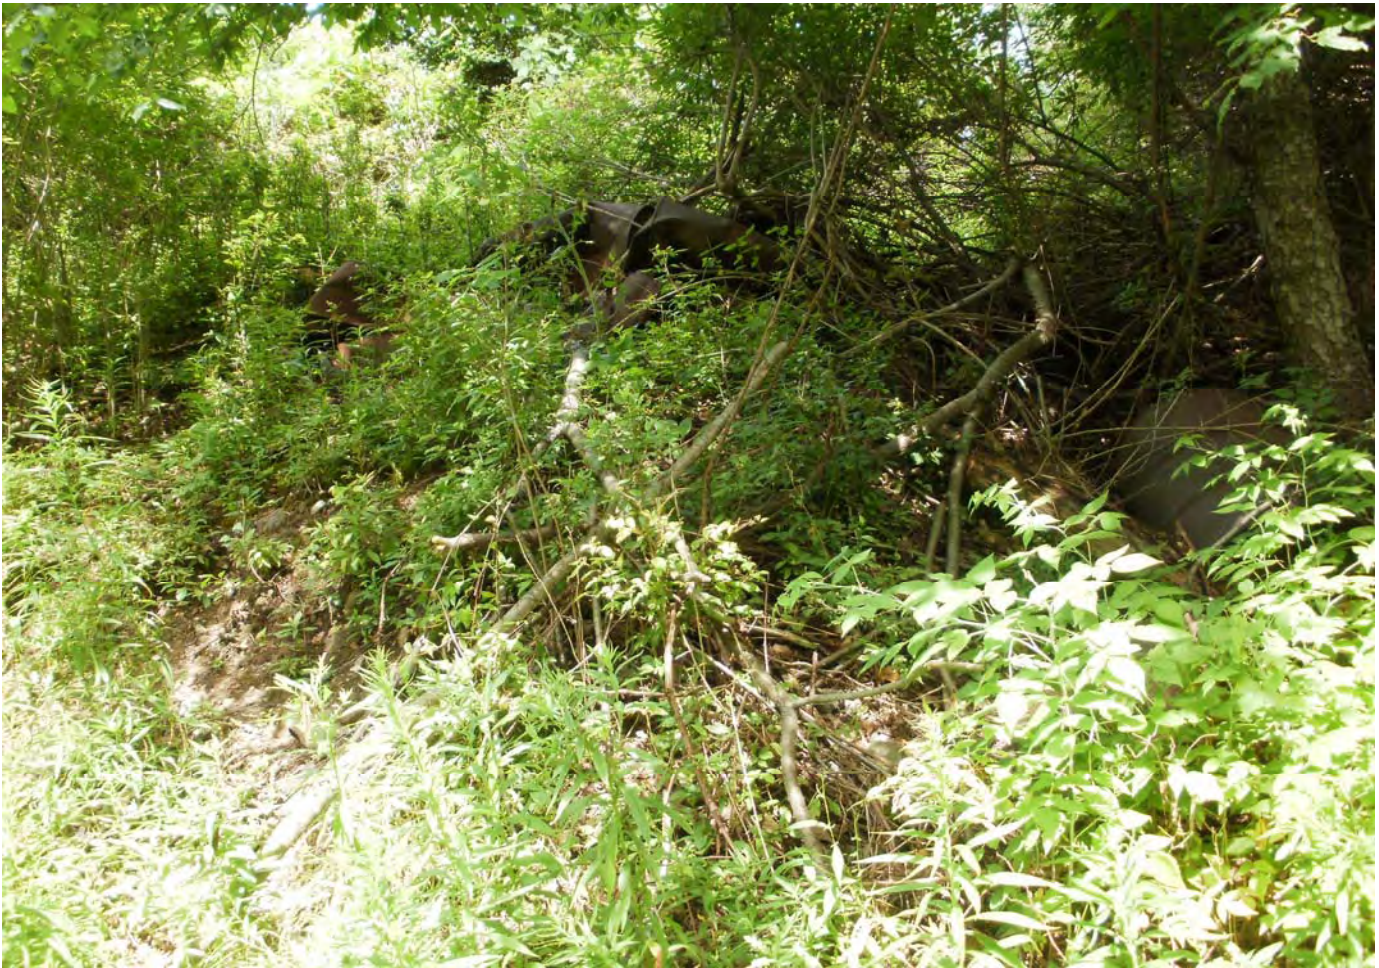
Photo 5 – Eastward view of “Barrel Area” adjacent to the central portion of the west site boundary.

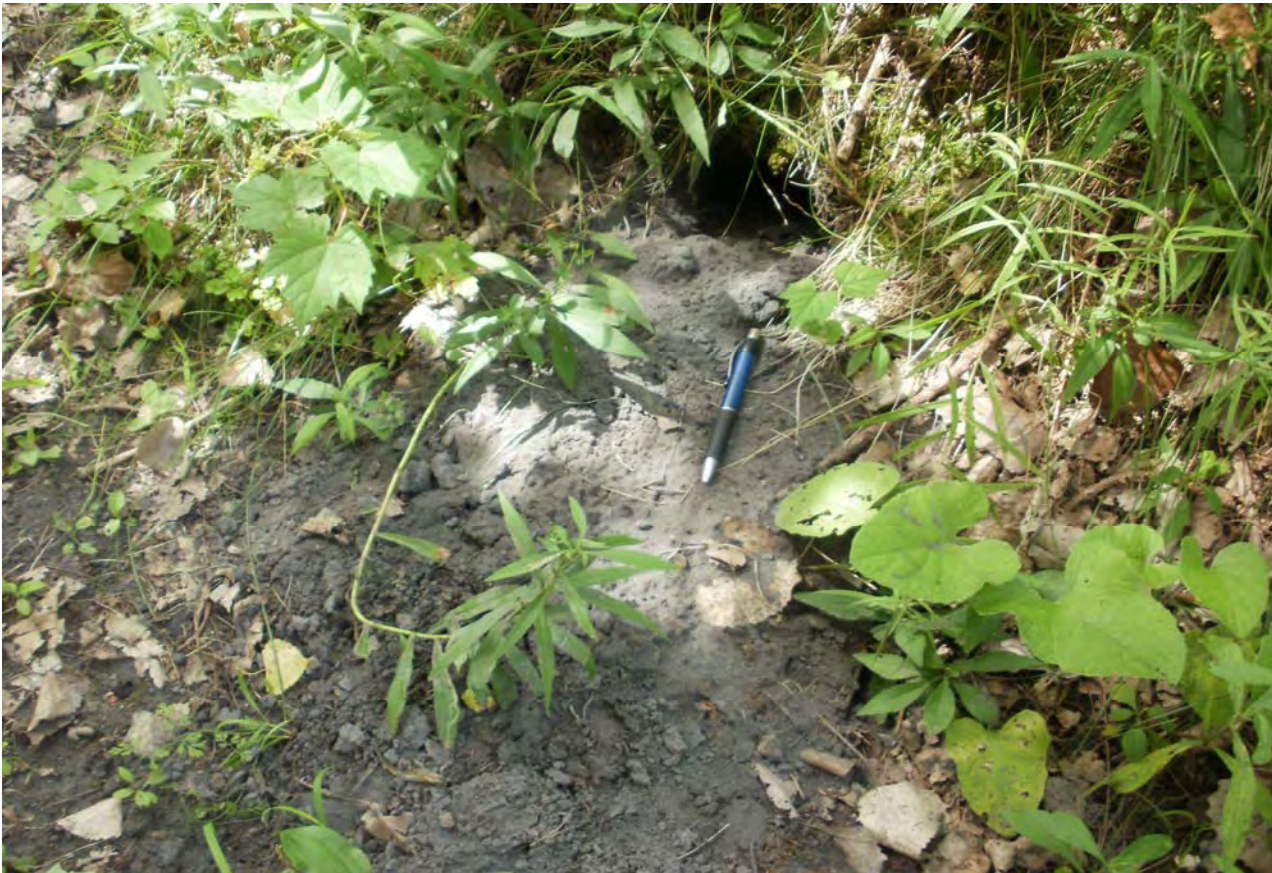
Photo 6 – Rodent burrow in south bank of southernmost fill accumulation area indicating gray, industrial fill.

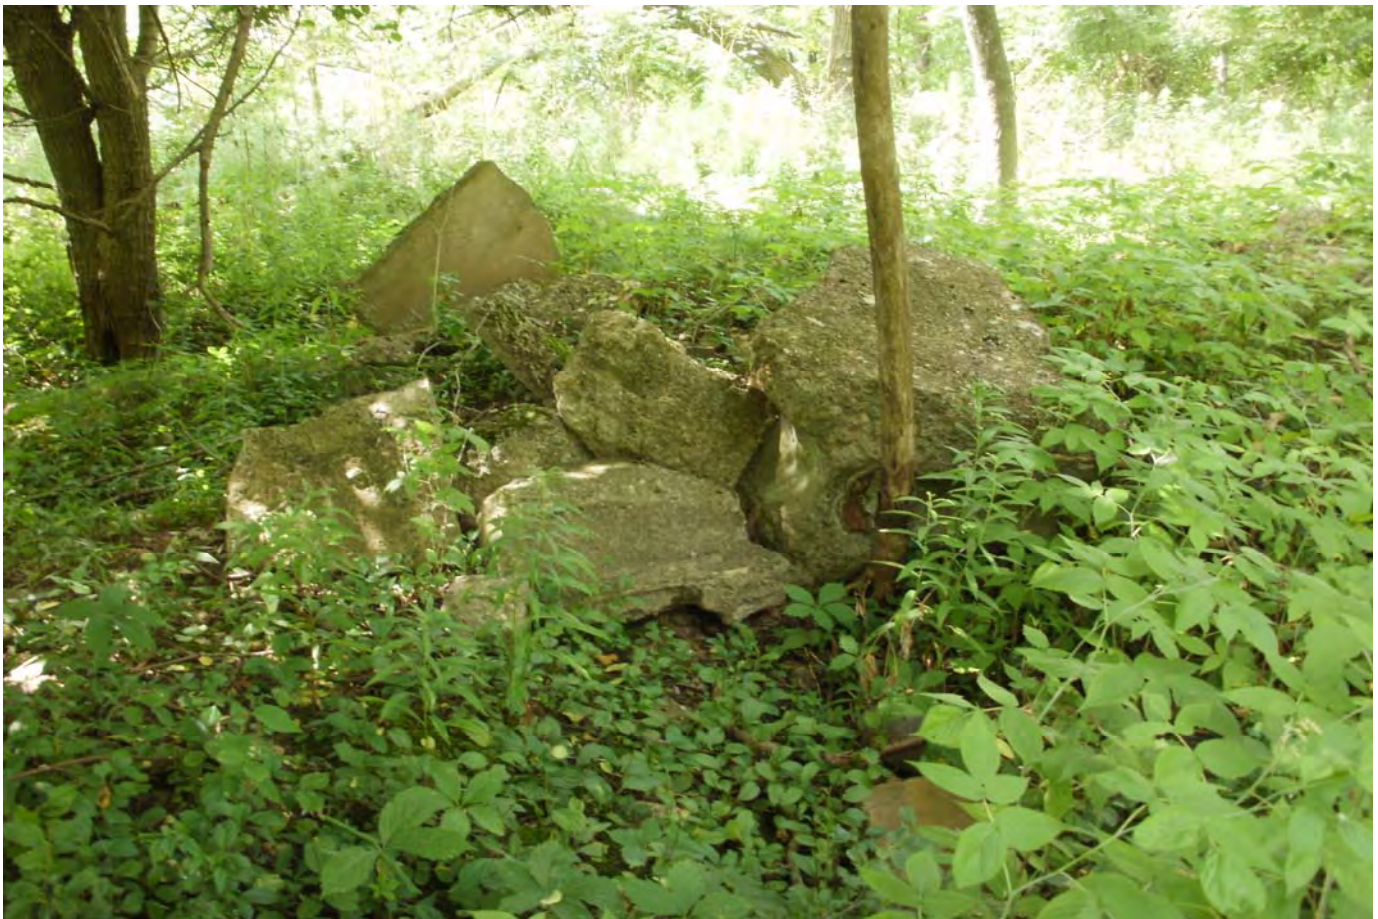
Photo 7 – Accumulation of large concrete fragments just south of the unnamed creek, near central portion of the site.

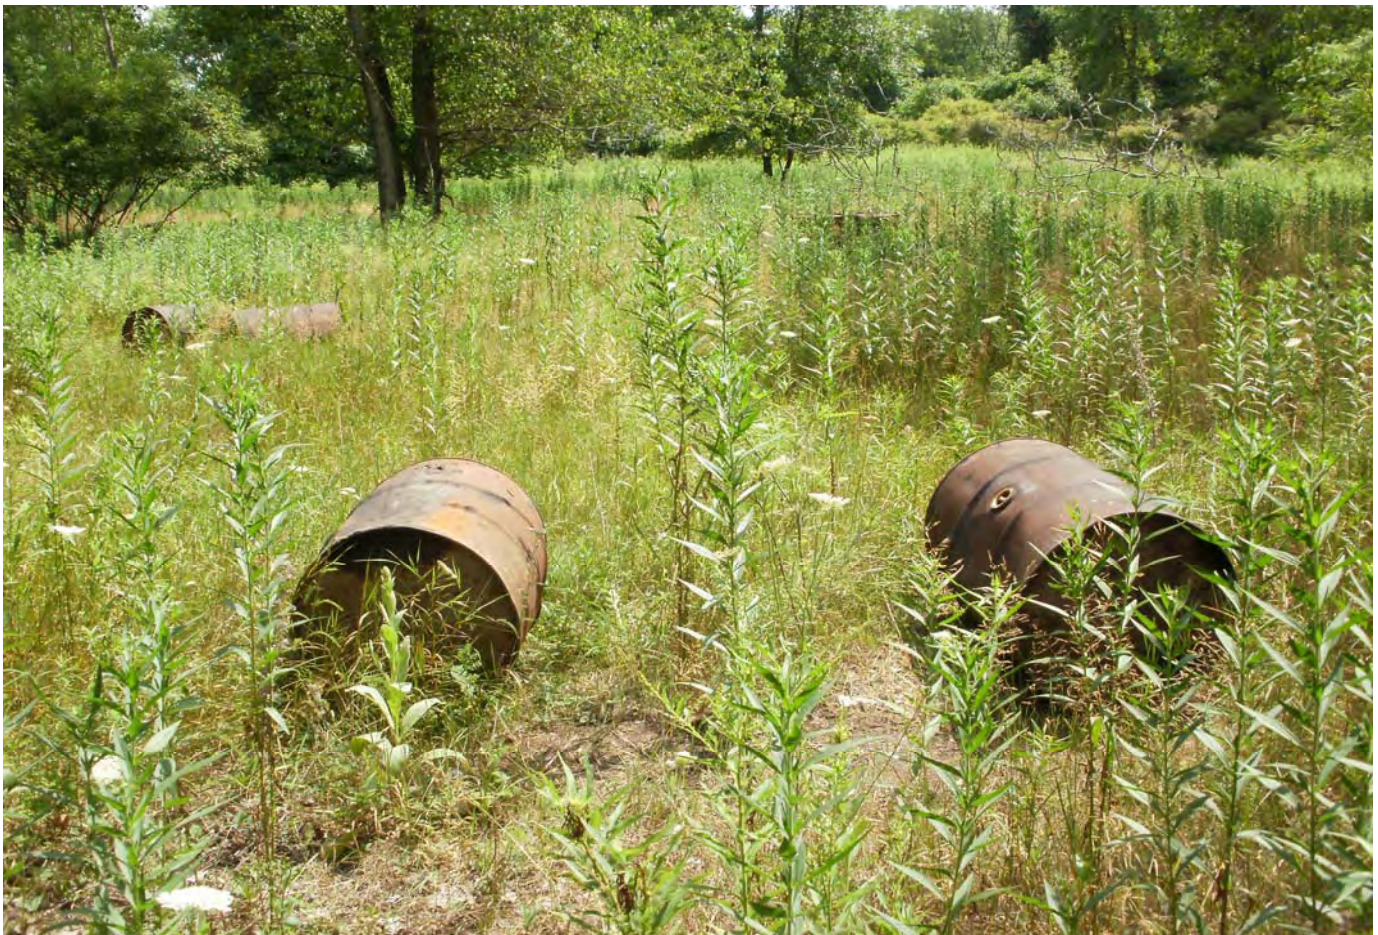
Photo 8 – Southward view of “Barrel Area” located near the central portion of the site, south of the unnamed creek.

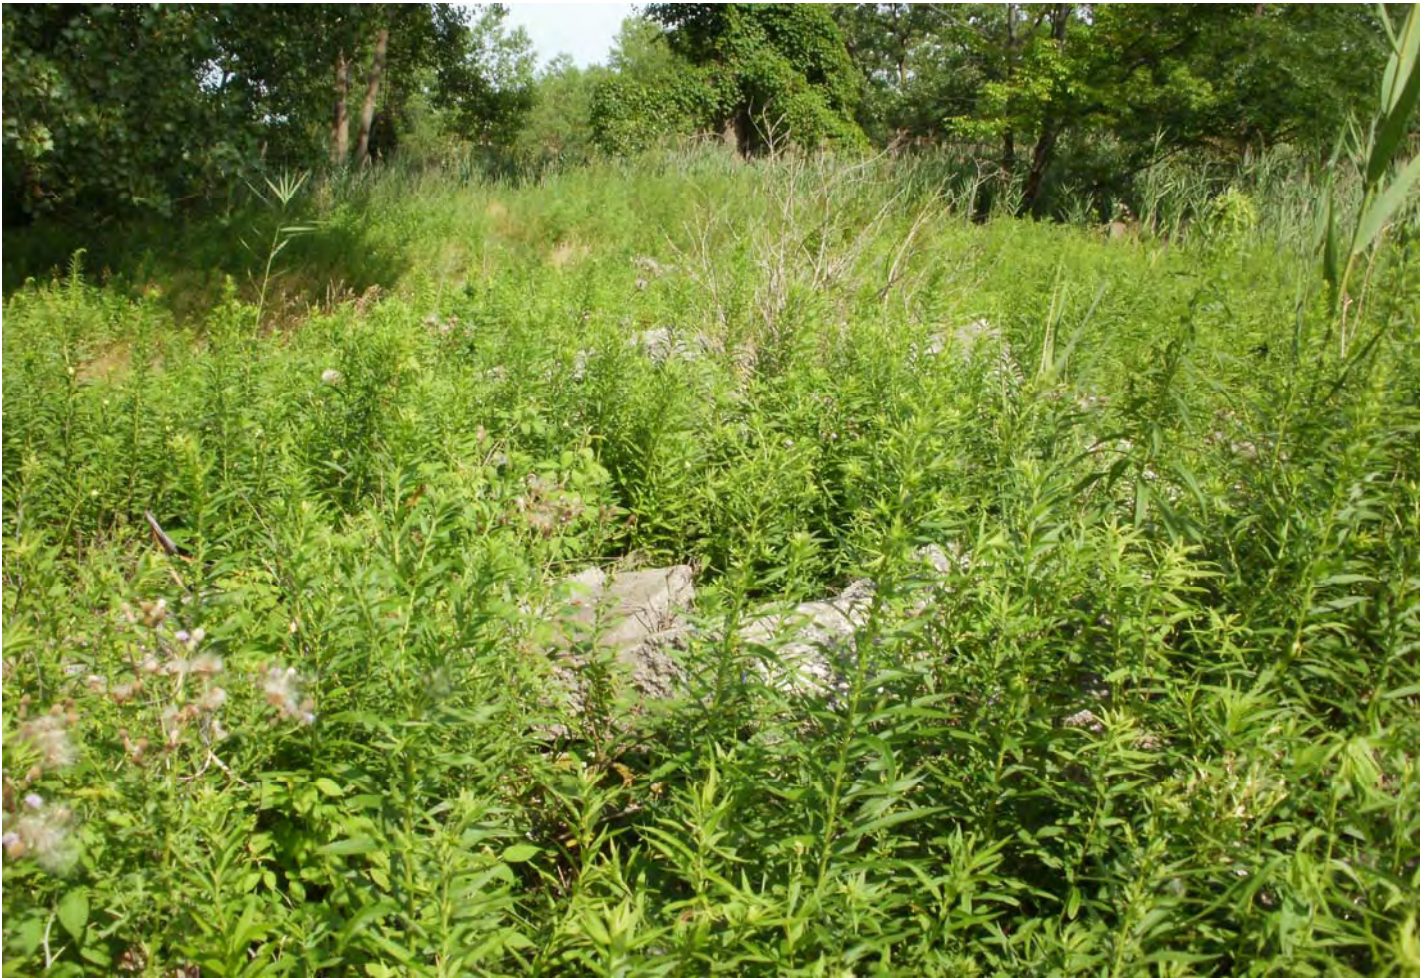
Photo 9 – Accumulation of large concrete fragments near south end of the north-south fill ridge along west site boundary.

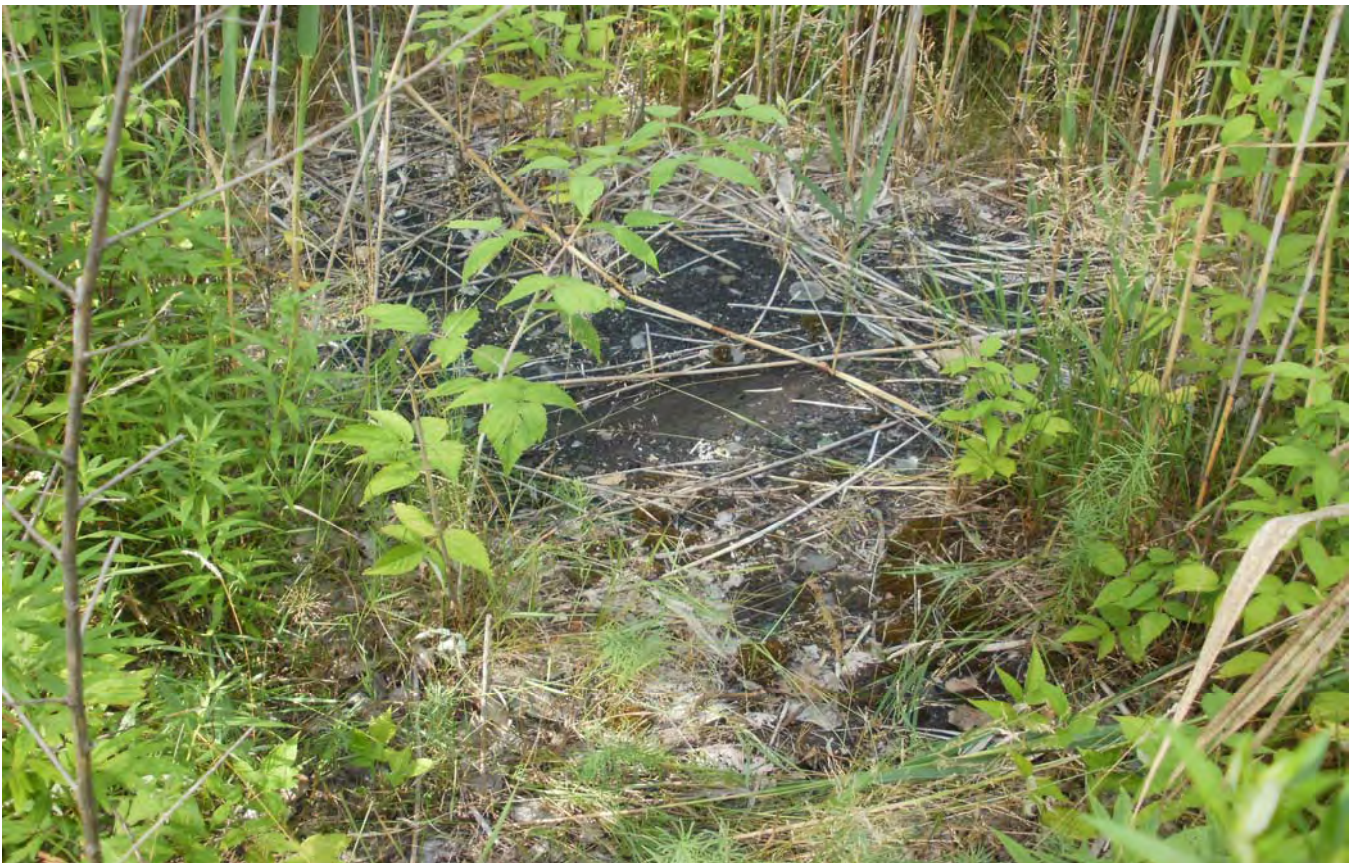
Photo 10 – Stressed vegetation with black fill near south end of the north-south fill ridge along west site boundary.

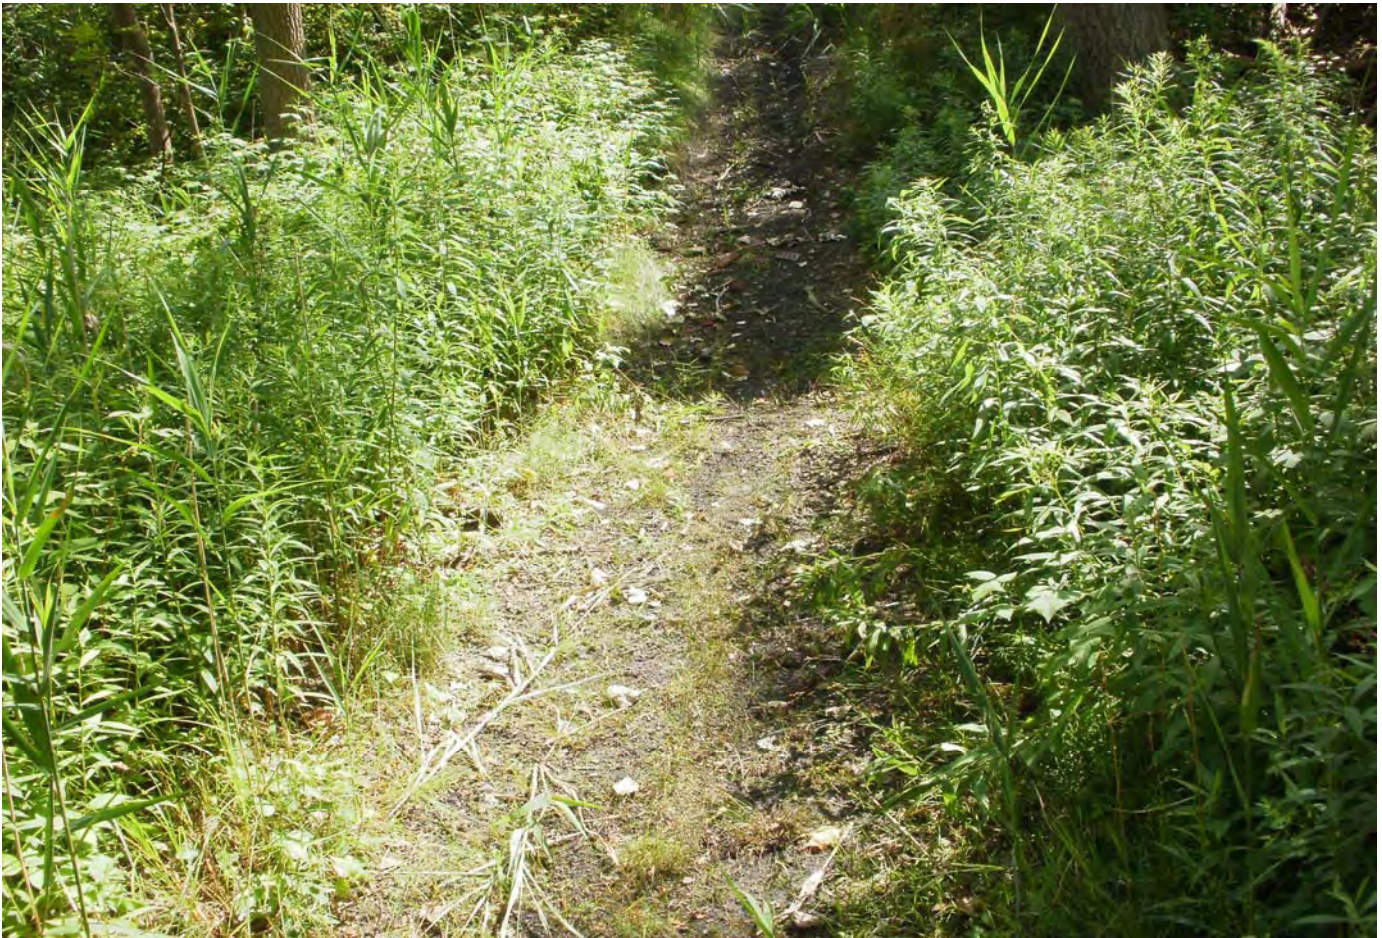
Photo 11 – ATV trail indicating fill materials at north end of the north-south fill ridge along west site boundary.

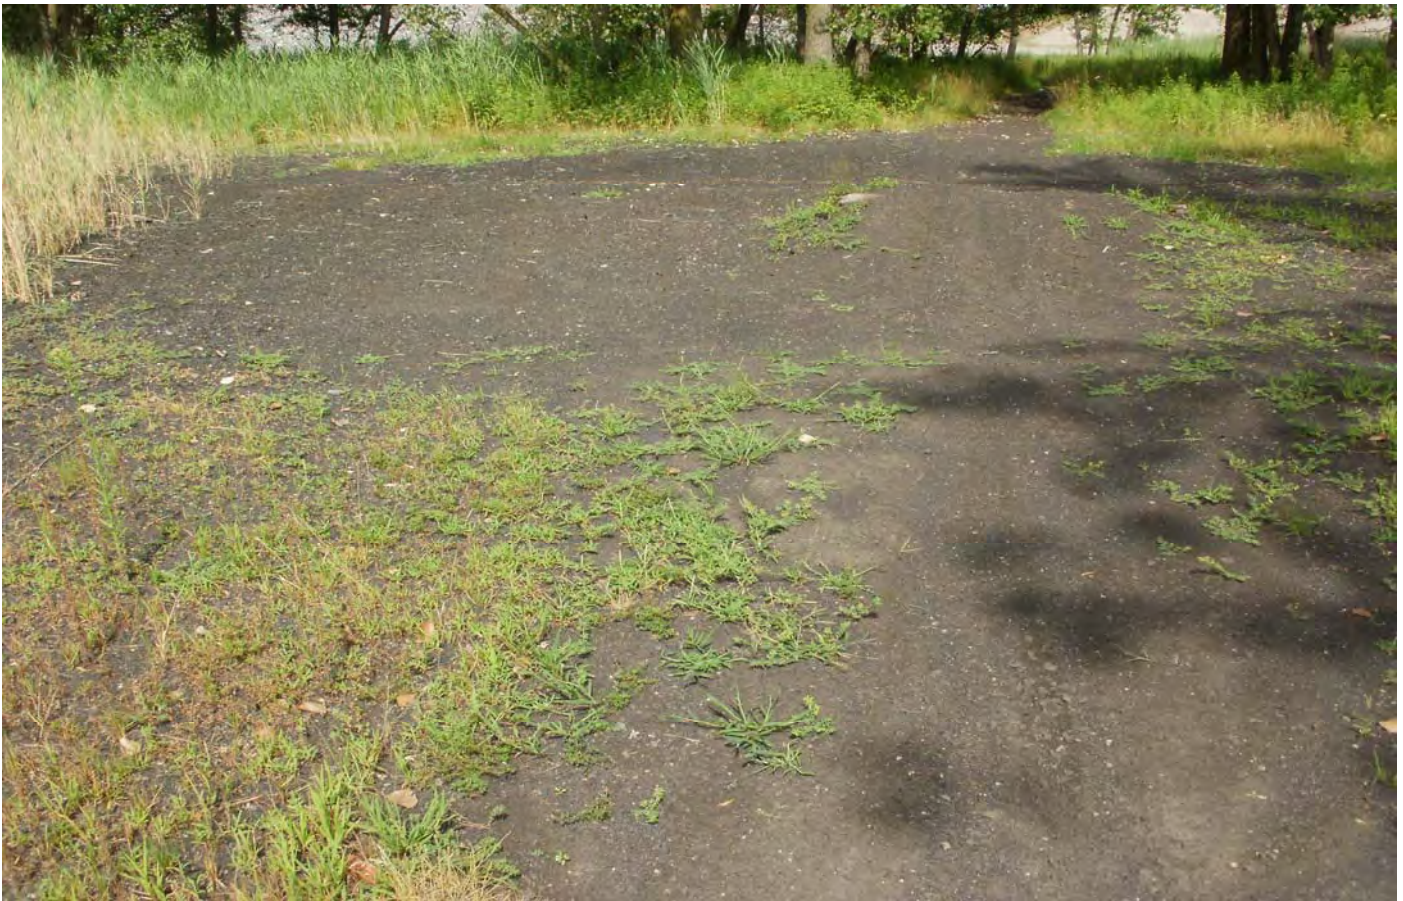
Photo 12 – ATV trail and area of apparent stressed vegetation with black fill materials on top of fill accumulation in the northern portion of the site.

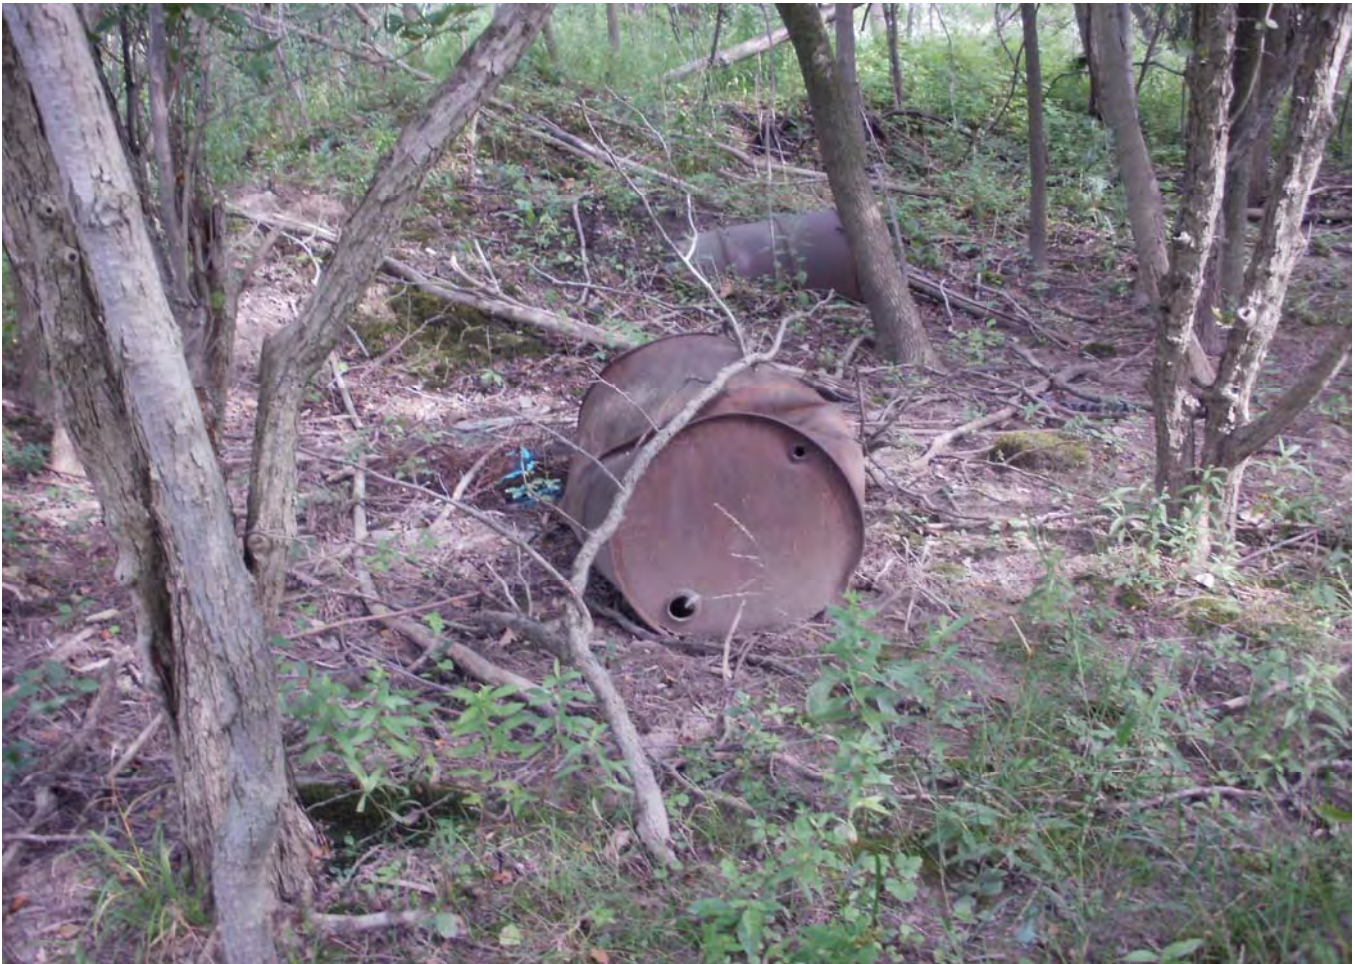
Photo 13 – Two empty drums near northwest corner of the site, at the edge of the fill area.

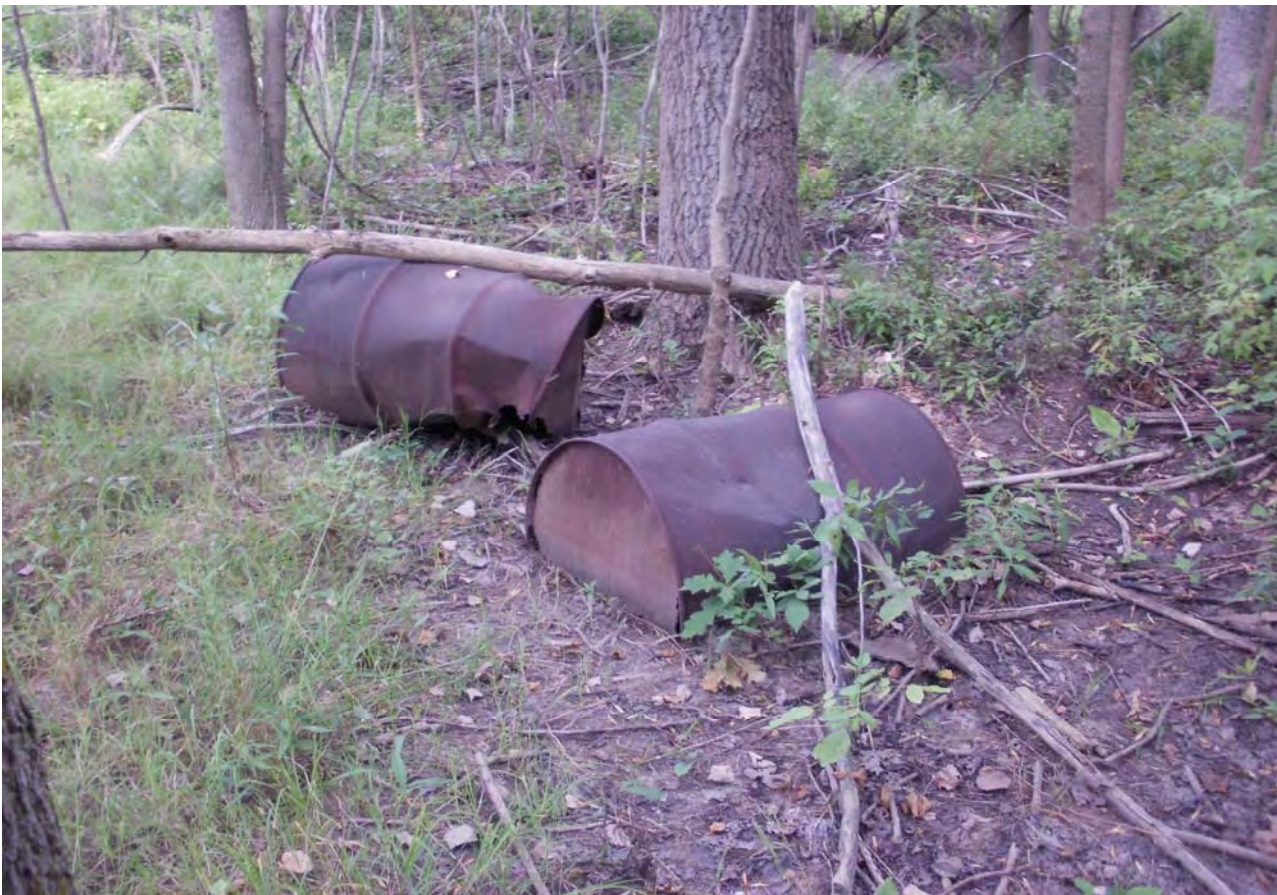
Photo 14 – Two drums near north edge of small fill area near central portion of north site boundary.

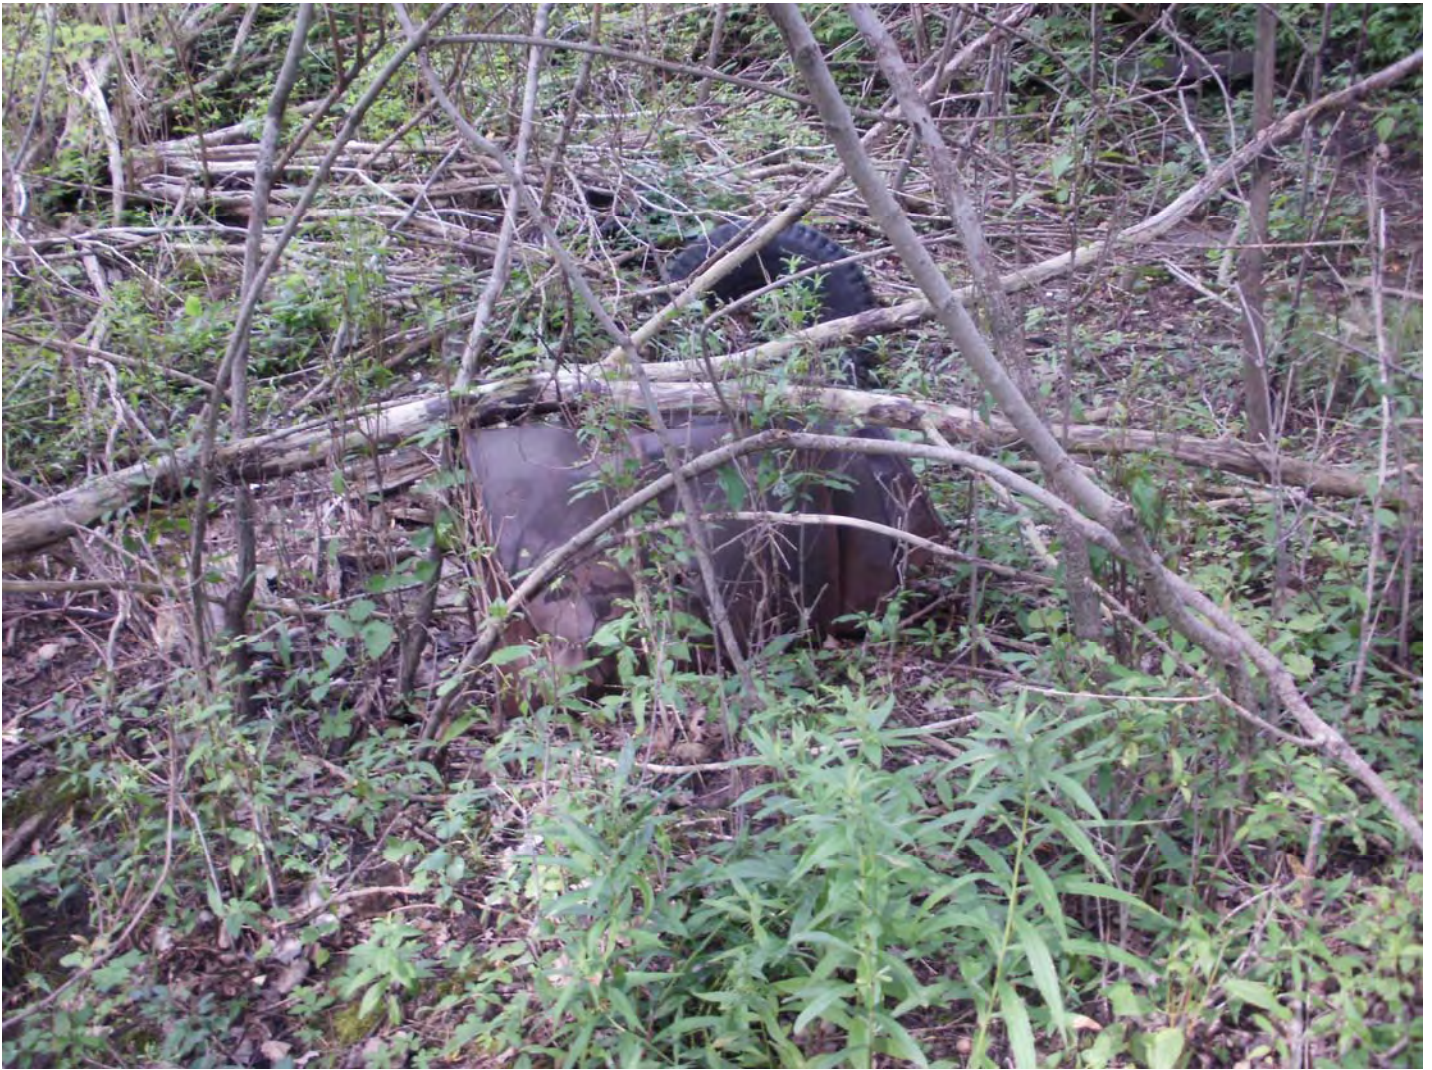
Photo 15 – One empty drum near north edge of small fill area near central portion of north site boundary.
