2015-2016 Storm Sewer and Floor Drain Observations  
Corrective Measure Implementation

<p>AECOM Project No.: 60442945</p>	<p>GE Parts and Repair Service Center 175 Milens Road Tonawanda, New York</p>	<p>Client Name: General Electric International, Inc.</p>
--	---	--

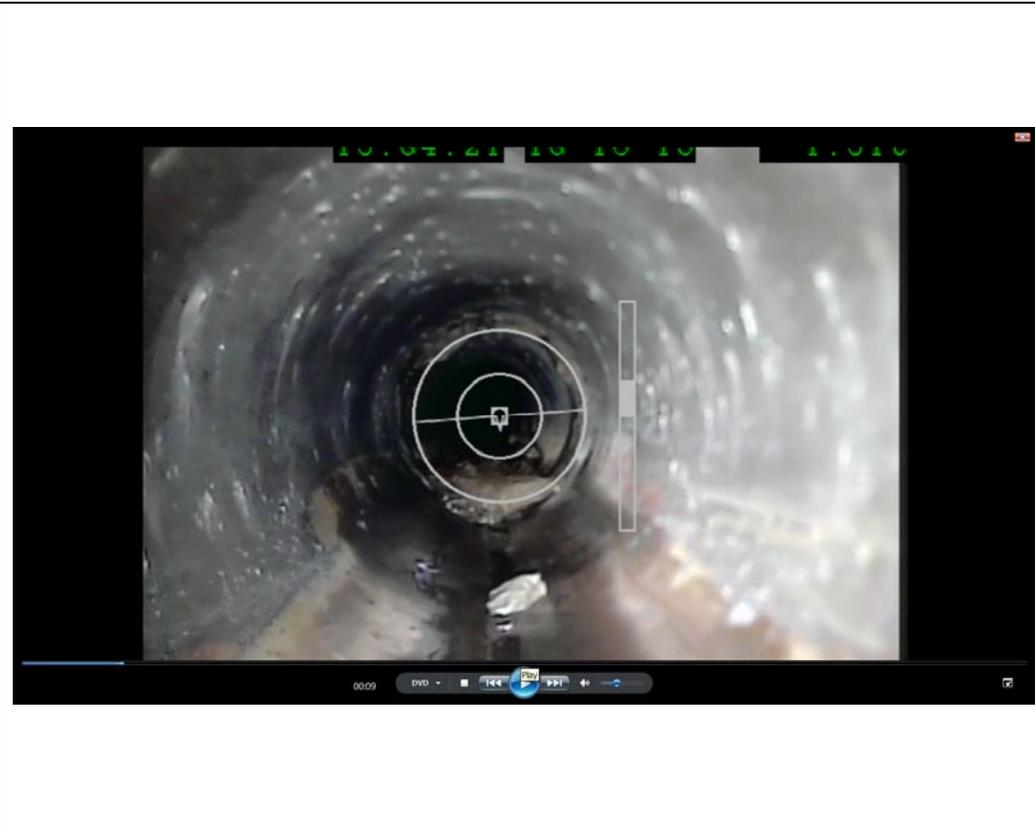
**PHOTO NO: 2**

**Description:**  
Storm (roof drain) line east of building and north of replaced pipe section. Debris and rock encountered approximately 3 feet north of new pipe connection. Appears to be roofing stone. Camera unable to navigate pipe. Visible section is sediment free and in good shape.

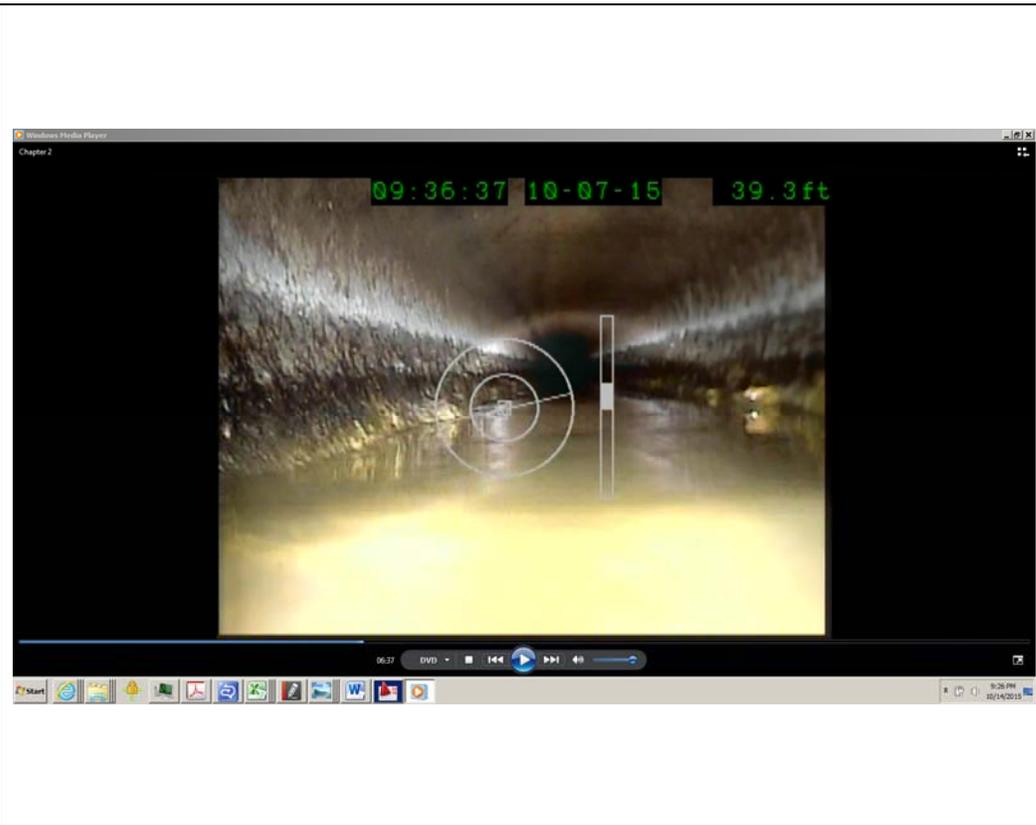
**PHOTO NO: 3**

**Description:**  
STMH-3 heading north (upstream) into temporary pipe. Cast iron pipe in generally good shape. Scale and deposit buildup visible. Loose sediment and debris not observed.

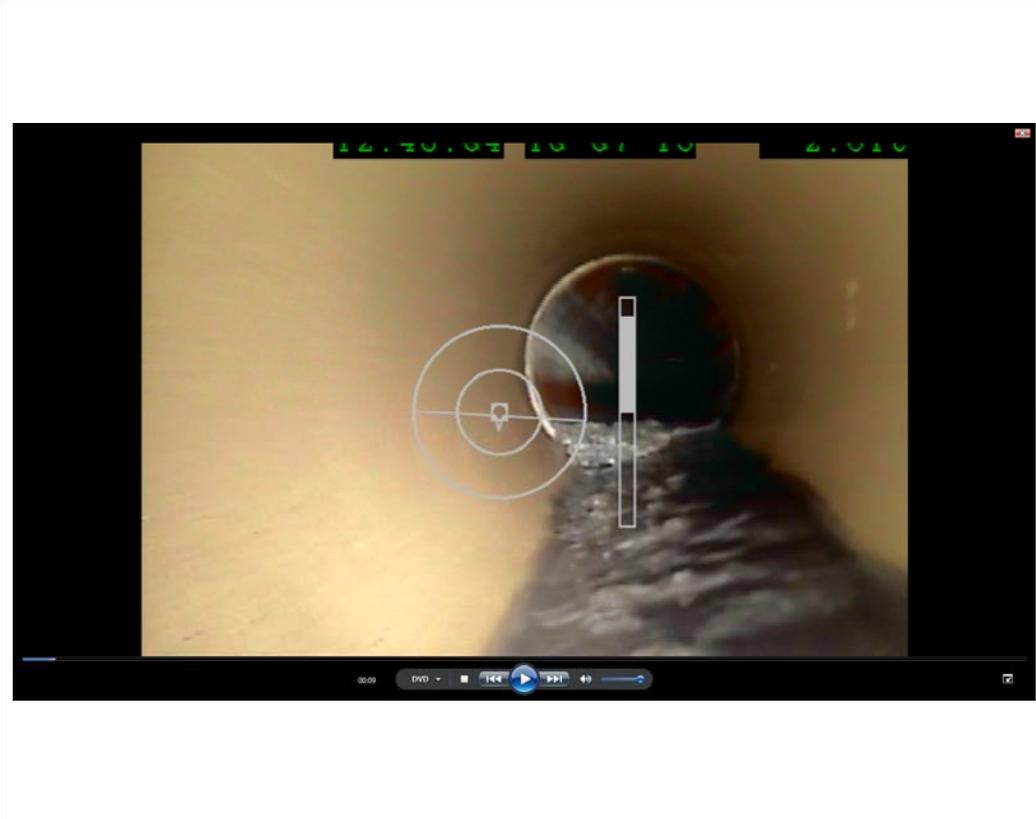
**PHOTO NO: 4**

**Description:**  
STMH-1 heading southeast (upstream) towards catch basin CB-3. Camera unable to proceed past approximately 4.5 feet; concrete appears to be intruding into the pipe at a pipe section joint. No loose sediment observed. Length of pipe viewed appears to be in good condition.

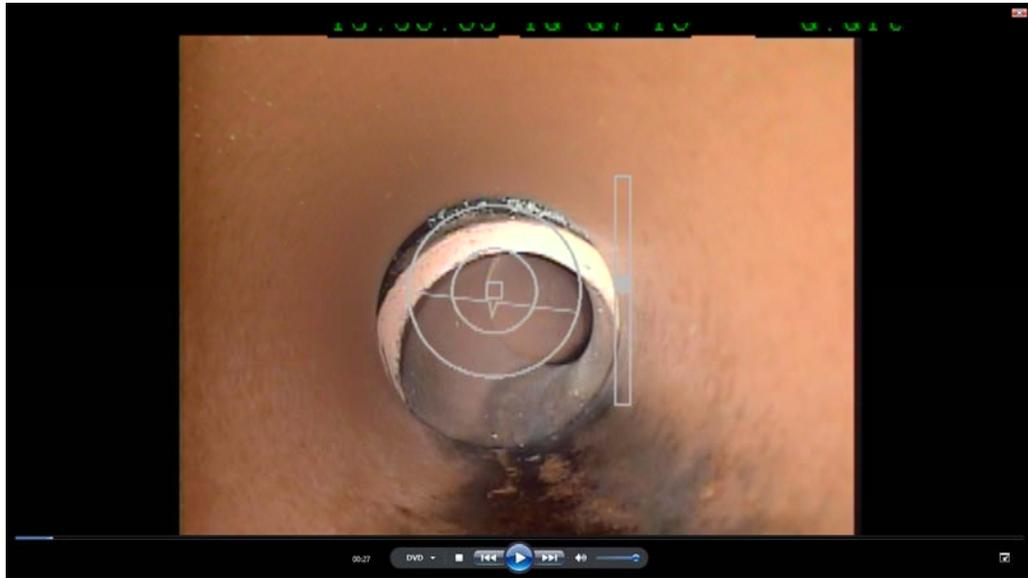
**PHOTO NO: 5**

**Description:**  
STMH-1 heading northwest (upstream) towards catch basin CB-1. Pipe is damaged with joints no longer aligned, which restricted camera footage. Pipe appears clean with some staining.

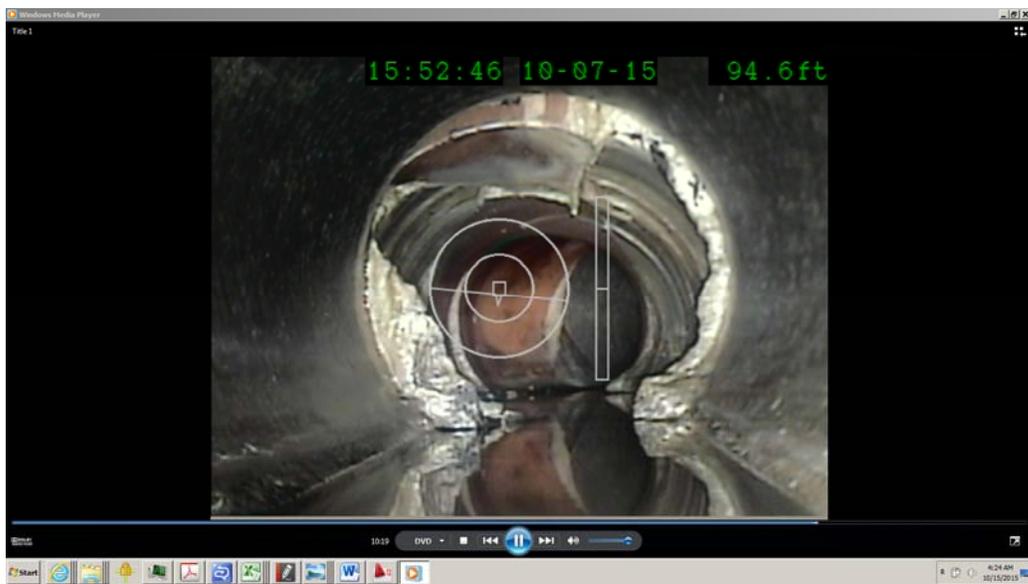
**PHOTO NO: 6**

**Description:**  
STMH-1 heading southwest (downstream) towards Milens Road. Pipe in good shape but joints have intruding concrete. Some hard deposits in pipe bottom that may be concrete. Directional change approximately 90 feet down from manhole that appears to be custom made sweep comprised of alternate pipe pieces to generate angle less than 90 degrees. Camera could not navigate past change. No sediment observed.

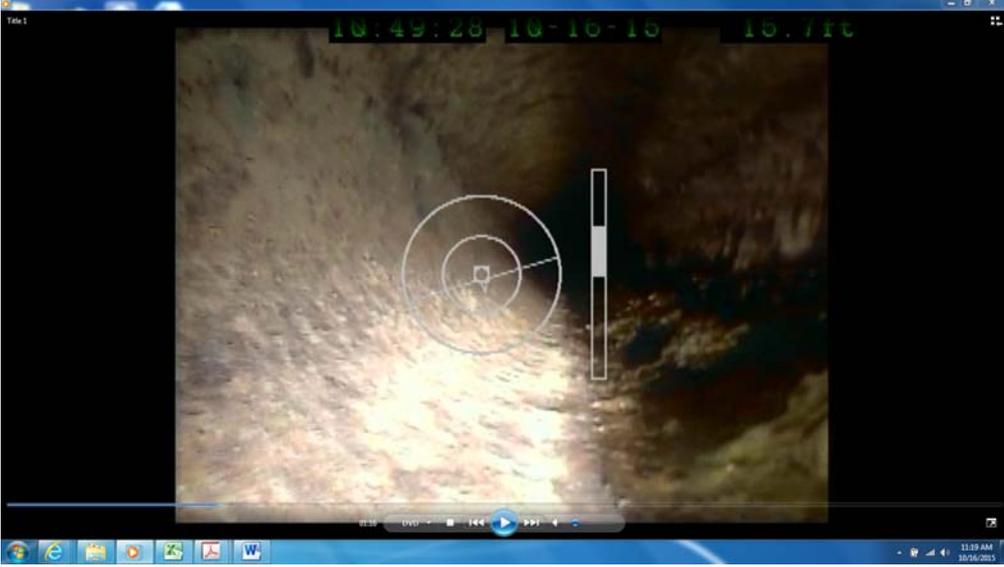
<p><b>PHOTO NO: 7</b></p>

<p><b>Date:</b> 10/16/15</p>	
<p><b>Direction:</b> East</p> <p><b>Description:</b> STMH-2 heading east (upstream) towards STMH-3. Pipe appears to be in fair shape. Staining, scale buildup, and petrified deposits are present. Loose sediment not observed after pipe was re-cleaned.</p>	
<p><b>PHOTO NO: 8</b></p>

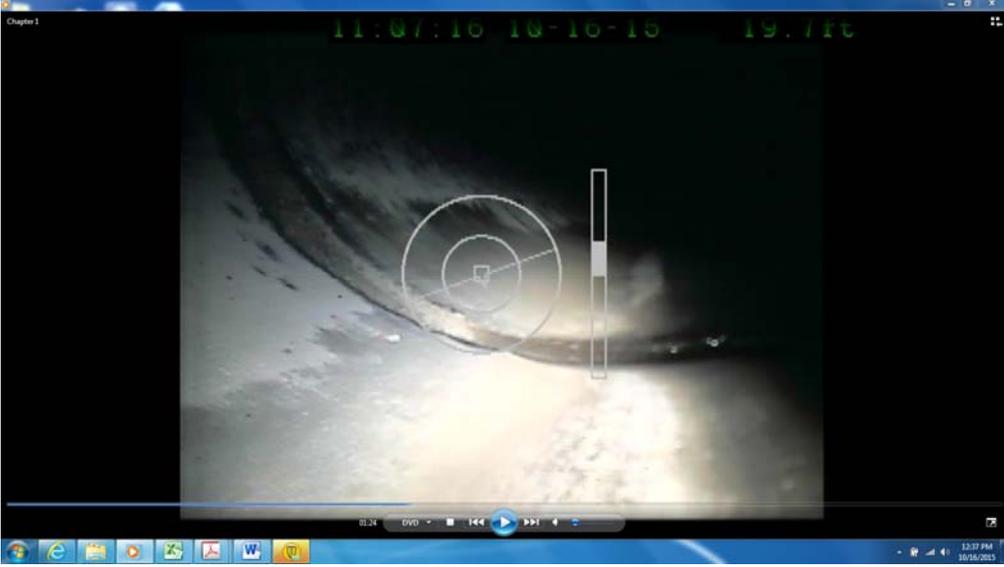
<p><b>Date:</b> 10/16/15</p>	
<p><b>Direction:</b> West</p> <p><b>Description:</b> STMH-2 heading west (downstream) towards STMH-1. Pipe in good shape and sediment not observed.</p>

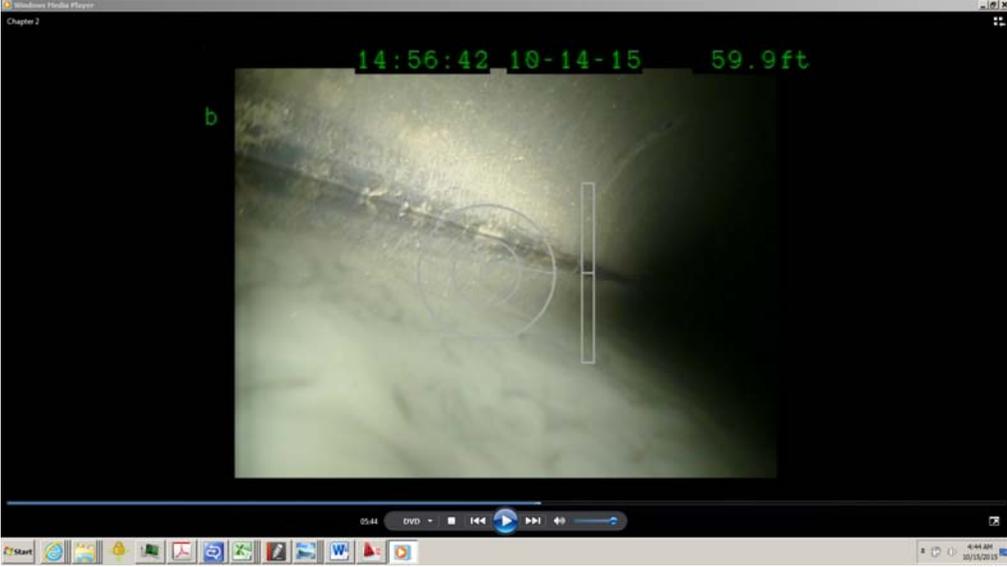
<p><b>PHOTO NO: 9</b></p>

<p><b>Date:</b> 10/14/15</p> <p><b>Direction:</b> East Northeast</p> <p><b>Description:</b> MH-1 heading east (upstream) towards DKP catch basin. Initial condition appears good, but standing water obscures view of pipe bottom. Several attempts made to get camera beyond approximately 30 feet in, and once it does the camera sinks below water level. After reversing, gray sediment can be seen bubbling up. Bottom of pipe appears to be broken. Camera cannot proceed.</p>	
<p><b>PHOTO NO: 10</b></p>

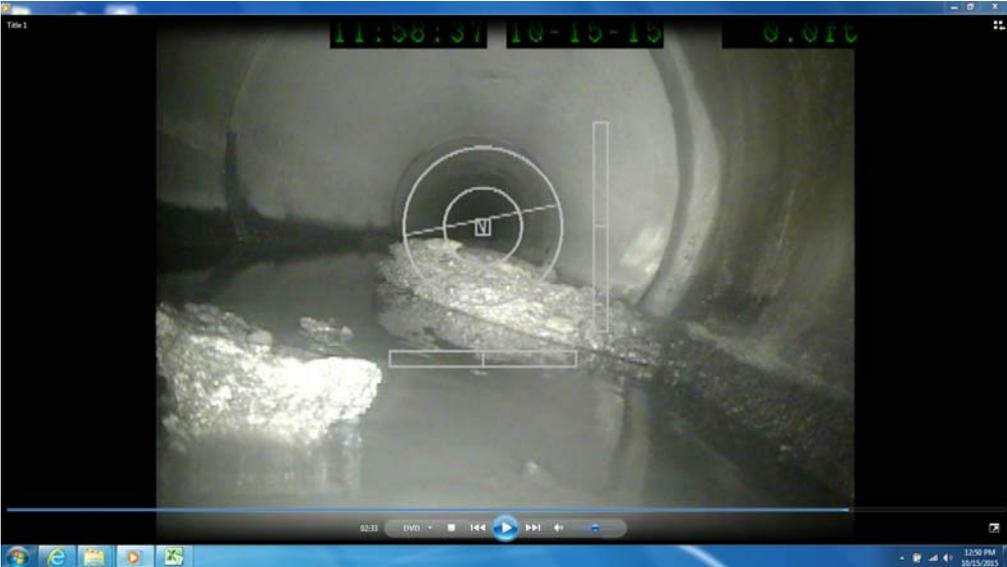
<p><b>Date:</b> 10/15/15</p> <p><b>Direction:</b> North</p> <p><b>Description:</b> MH-1 heading north (upstream) towards blind connection from GE facility. Large debris is present in pipe and camera cannot navigate further. Additional cleaning could result in damage to pipe.</p>

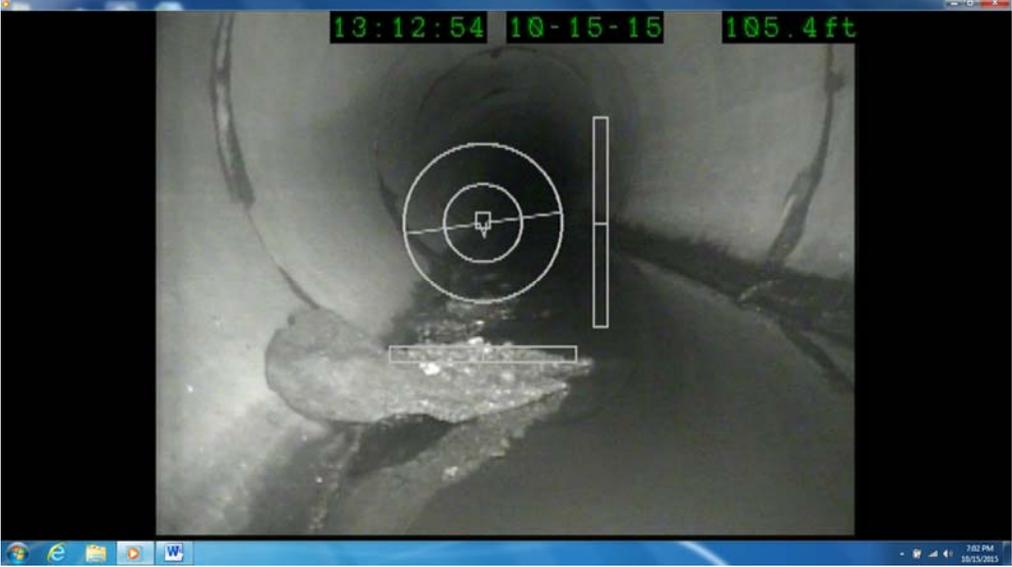
<p><b>PHOTO NO: 13</b></p>

<p><b>Date:</b> 10/15/15</p>	
<p><b>Direction:</b> North</p> <p><b>Description:</b> MH-3 heading north (upstream). Additional accumulation of hard deposits observed as continue north. It appears to be concrete. Loose sediment not observed.</p>

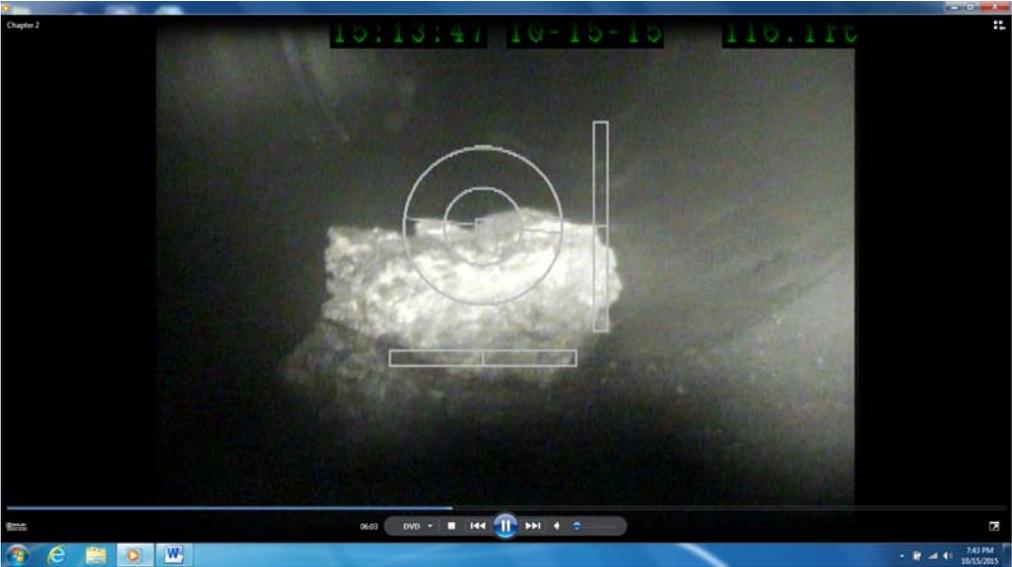
<p><b>PHOTO NO: 14</b></p>

<p><b>Date:</b> 10/15/15</p>	
<p><b>Direction:</b> North</p> <p><b>Description:</b> MH-4 heading north (upstream) towards MH-3. Pipe largely dry and can see bottom joints. No sediment observed. Large chunk of debris encountered at approximately 118 feet.</p>

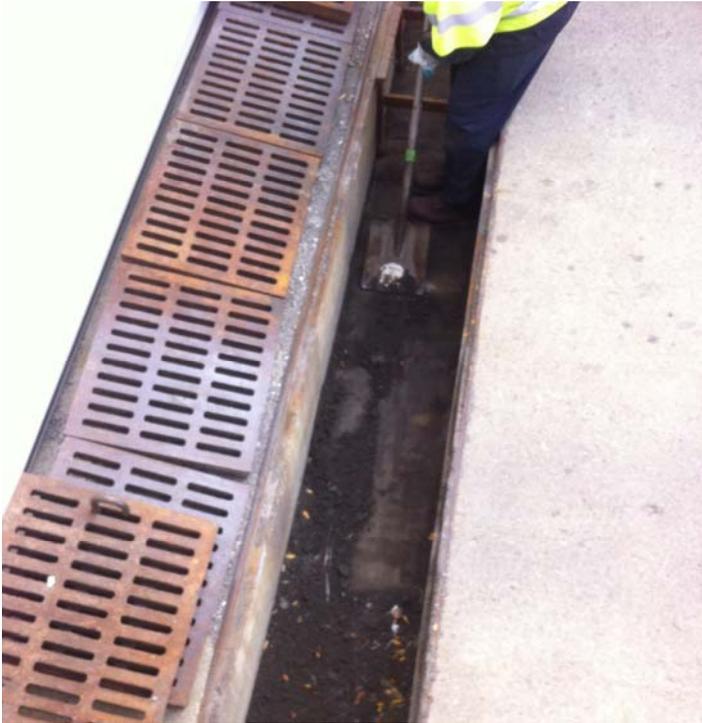
<p><b>PHOTO NO: 15</b></p>

<p><b>Date:</b> 10/02/15</p>	
<p><b>Direction:</b> East</p> <p><b>Description:</b> View of outside trench drain in the concrete ramp to the depressed loading dock. Bulk debris being shoveled out.</p>

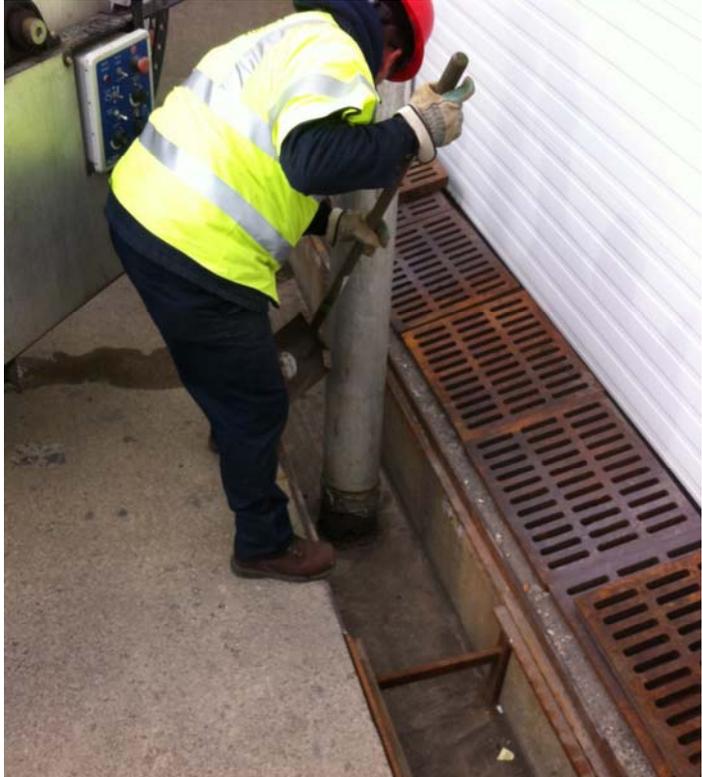
<p><b>PHOTO NO: 16</b></p>

<p><b>Date:</b> 10/02/15</p>	
<p><b>Direction:</b> West</p> <p><b>Description:</b> View of ramp trench drain after bulk debris removal. Structure is in good shape. Clean Harbors Field Services (CHFS) preparing to wash drain.</p>

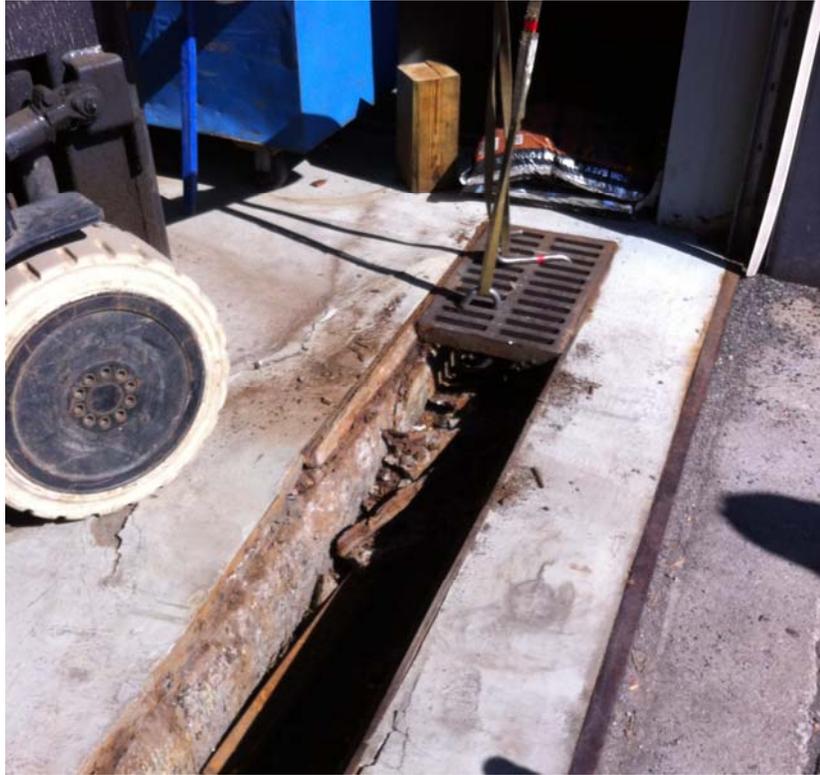
**PHOTO NO: 17**

**Description:**  
View of interior trench drain at the at-grade truck bay adjacent to and west of depressed loading dock. As grates are removed, the supporting metal frame and concrete crumbled. Trench itself was intact. Effluent drain pipe from trench was previously filled.

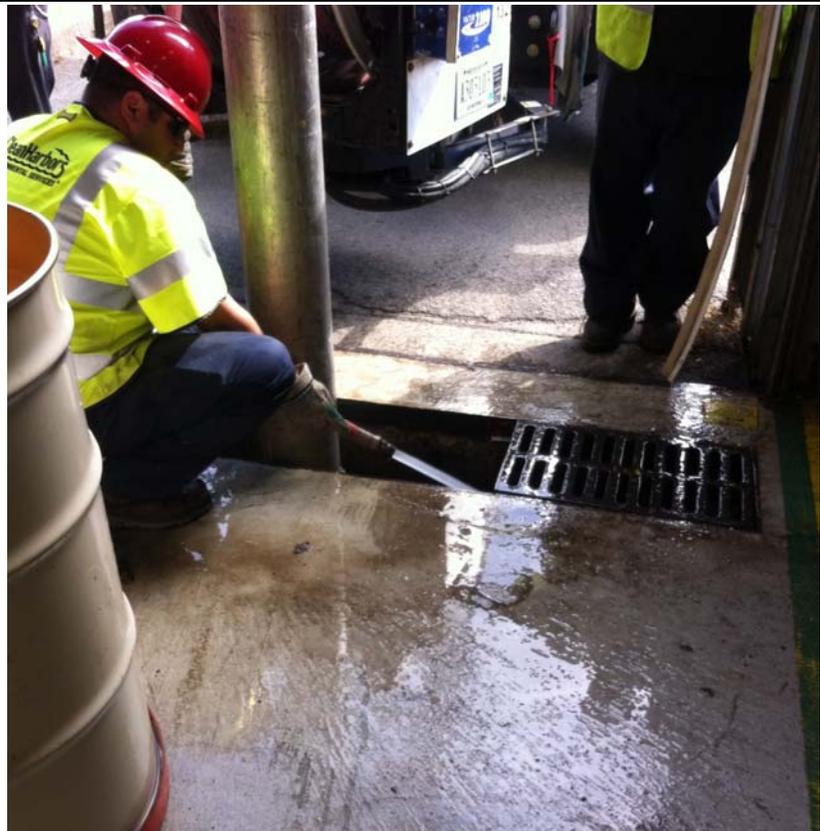
**PHOTO NO: 18**

**Description:**  
View of trench drain inside building for the at-grade truck bay west of depressed dock. CHFS is rinsing drain structure and capturing water with vacuum truck.

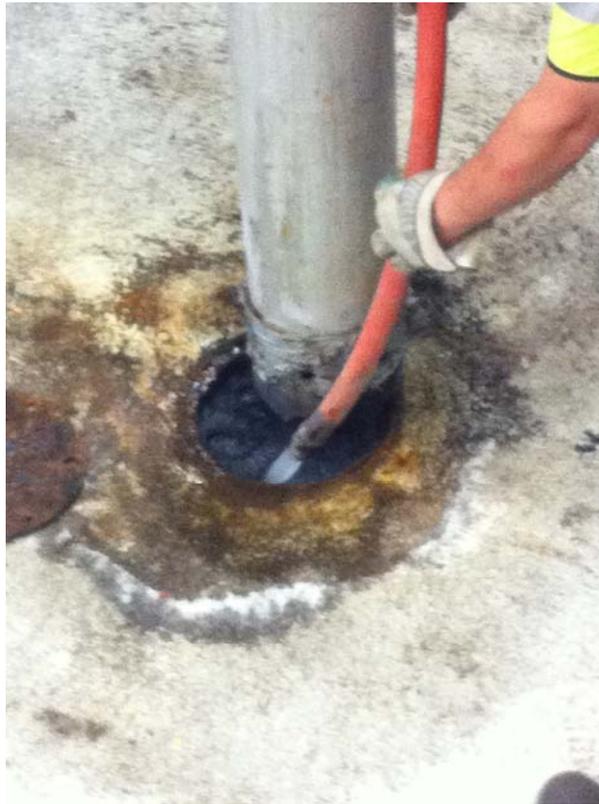
**PHOTO NO: 19**

**Description:**  
View of CHFS cleaning floor drain in depressed dock.

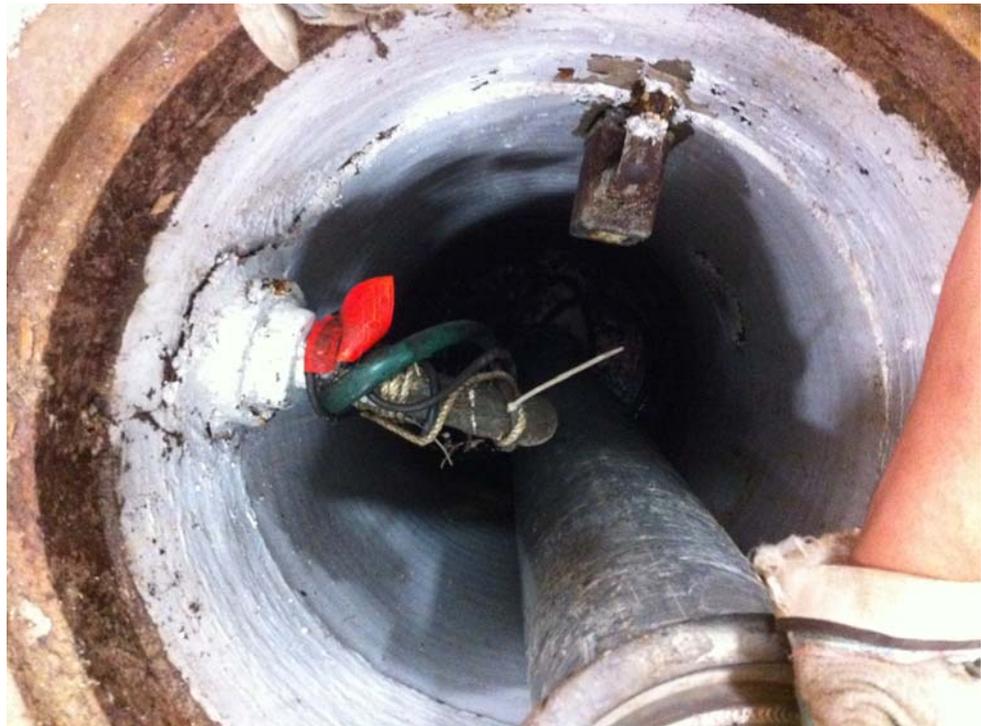
**PHOTO NO: 20**

**Description:**  
View of the sump structure west of the depressed dock that receives water from the floor drain (see Photo No. 19). CHFS is using vacuum truck to remove water as they flush the drain from depressed dock.

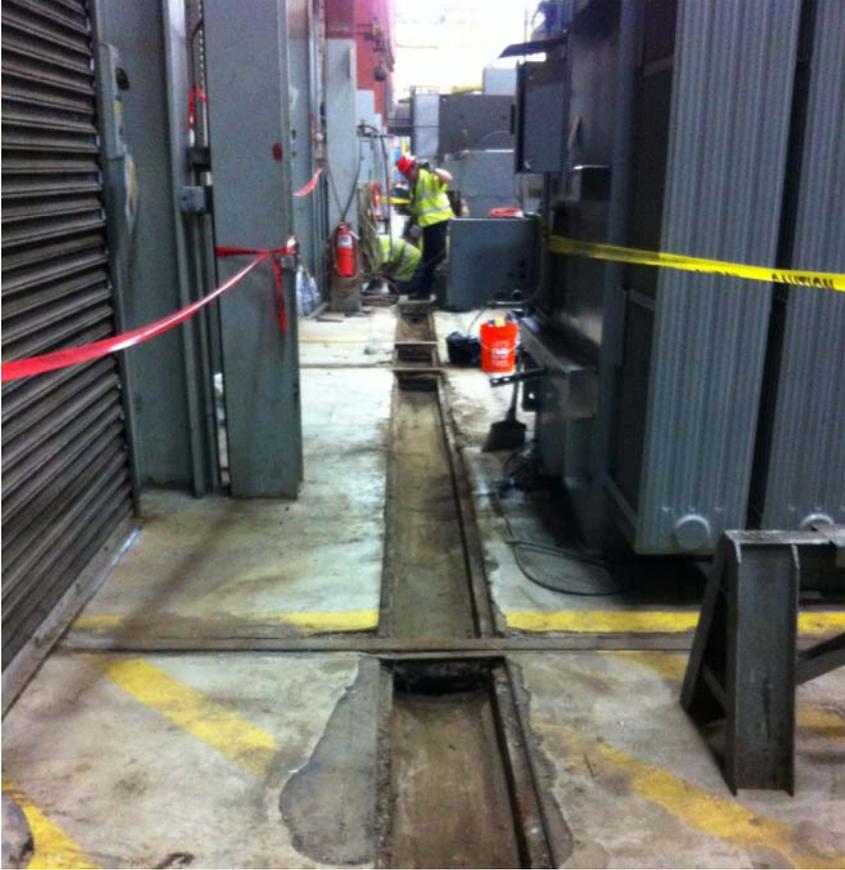
<p><b>PHOTO NO: 21</b></p>

<p><b>Date:</b> 10/01/15</p>	
<p><b>Direction:</b> South</p> <p><b>Description:</b> View of the rail bay trench drain (inside building). Removal of cover plates led to damage of nearby epoxy coating and concrete. In the background, CHFS personnel are examining connection to sump prior to cleaning activities.</p>

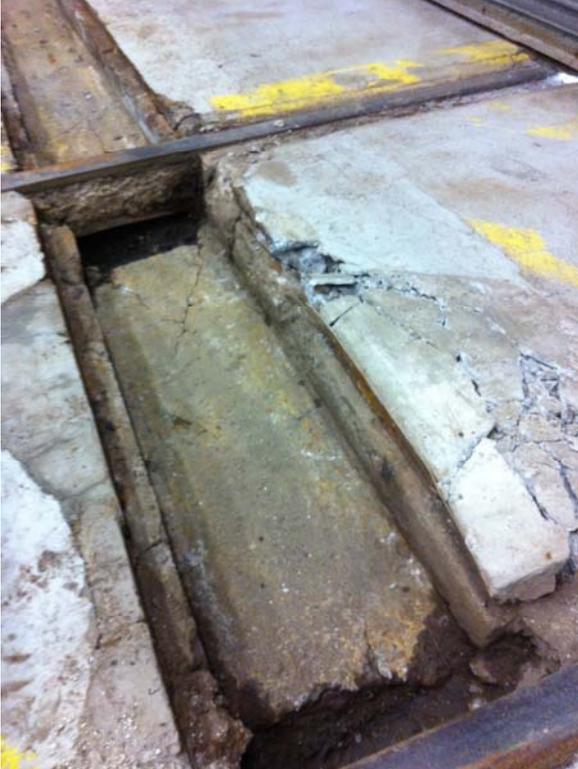
<p><b>PHOTO NO: 22</b></p>

<p><b>Date:</b> 10/02/15</p>	
<p><b>Direction:</b> North</p> <p><b>Description:</b> View of the rail bay trench drain (inside building). Removal of cover plates led to damage of nearby epoxy coating and concrete. Trench integrity issues became clear as the drain was cleaned.</p>
