Pratt and Lambert CA Site

DER Site Management, 04/04/2012

Photos with Notes

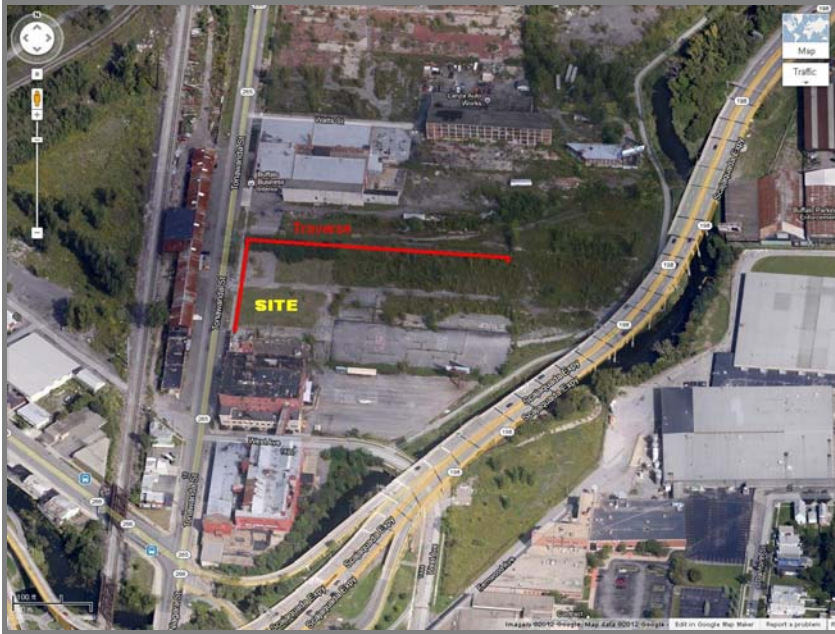
Recon trip Buffalo to assess site contition. Carl Hoffman and Will Welling visited the former Pratt and Lambert site to visually assess the site contition. We parked on Tonawanda Street. The site is fenced along Tonawanda street and across the northern property line. This was the path we walked and we looked towards the property interior.

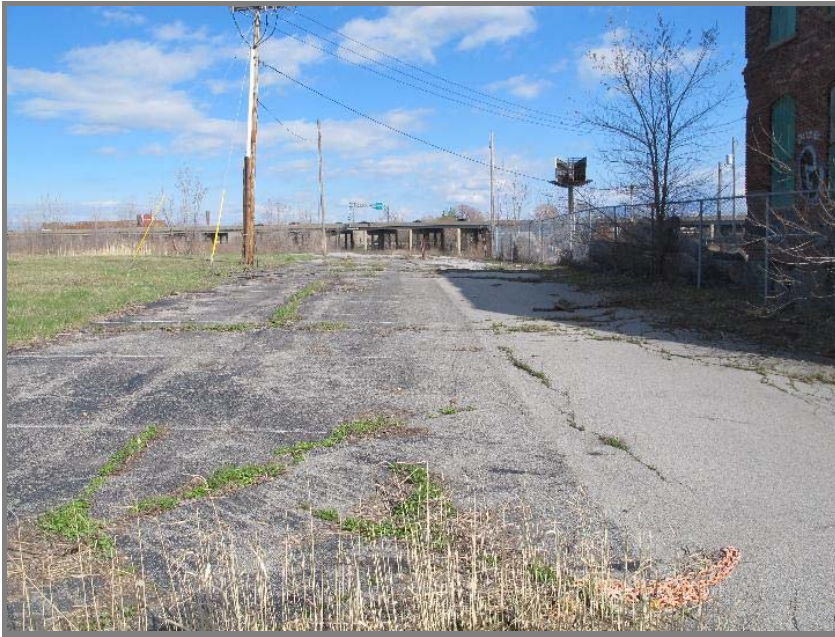
Upon arrival we took this photo looking east. Camera was aimed above or looking through the fence fabric. We stayed outside of the fence.

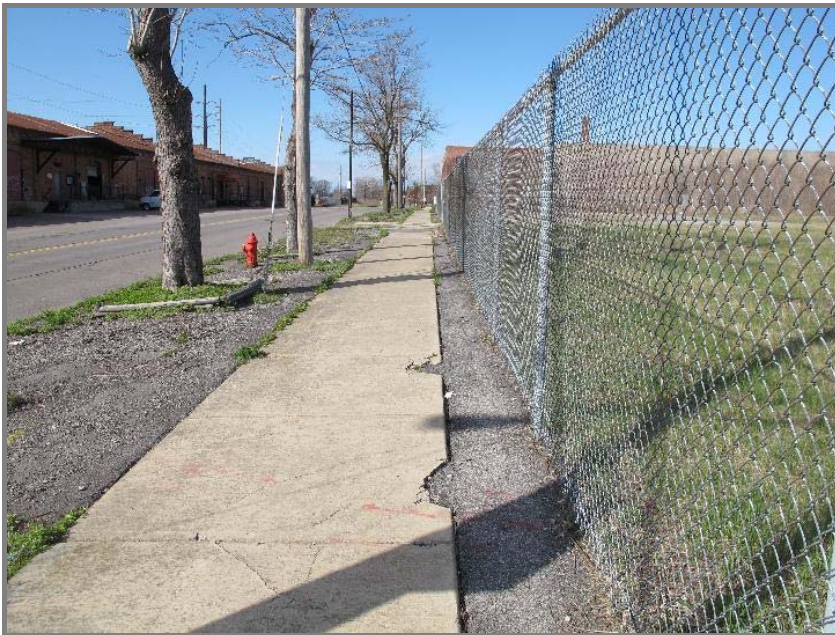
Carl and I walked along the Tonawanda Street sidewalk perimeter. Direction is looking north.

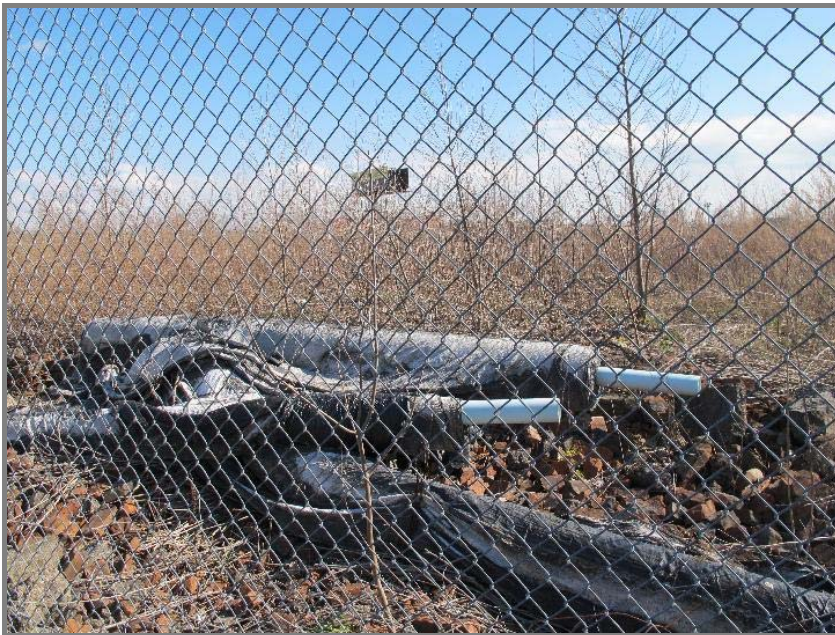
We continued walking around the fenced perimeter. We turned the corner to the right, heading east. We could see rolls inside the fence.

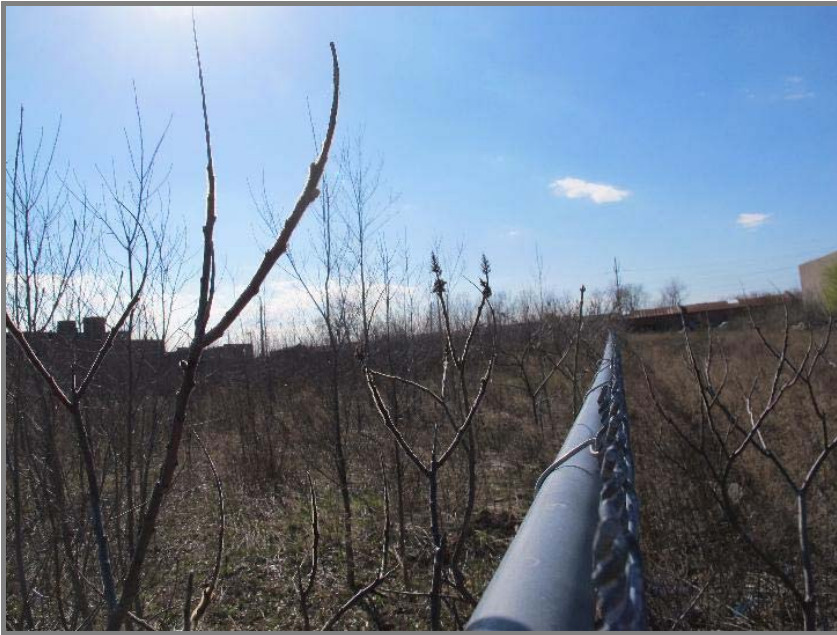
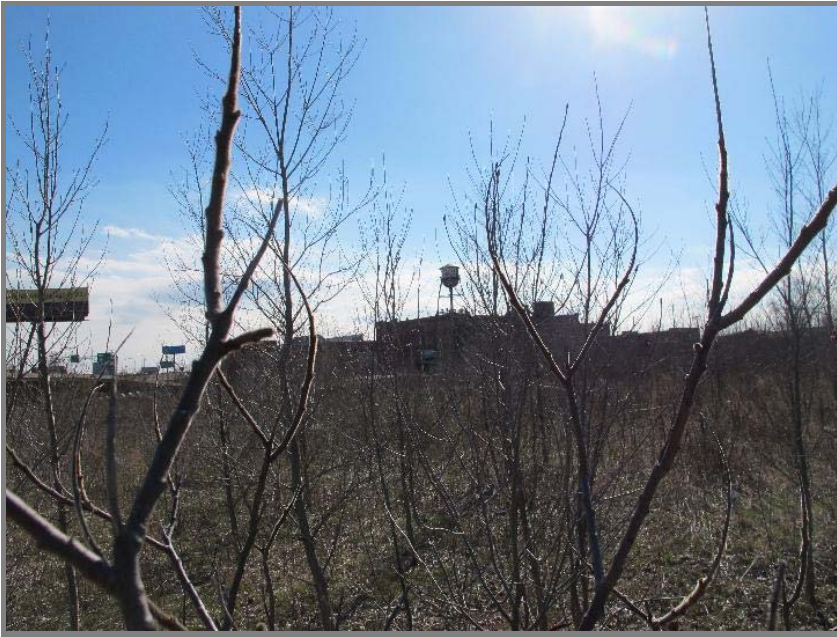
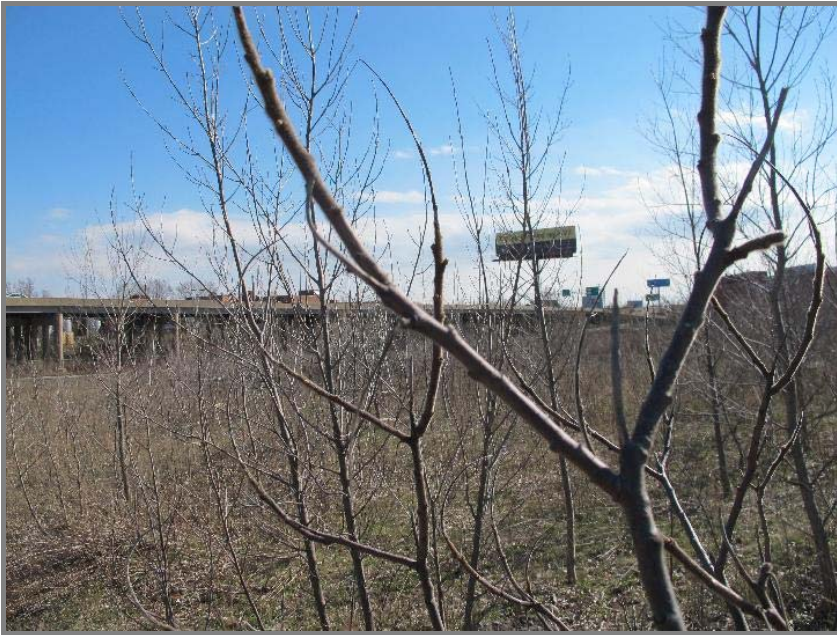
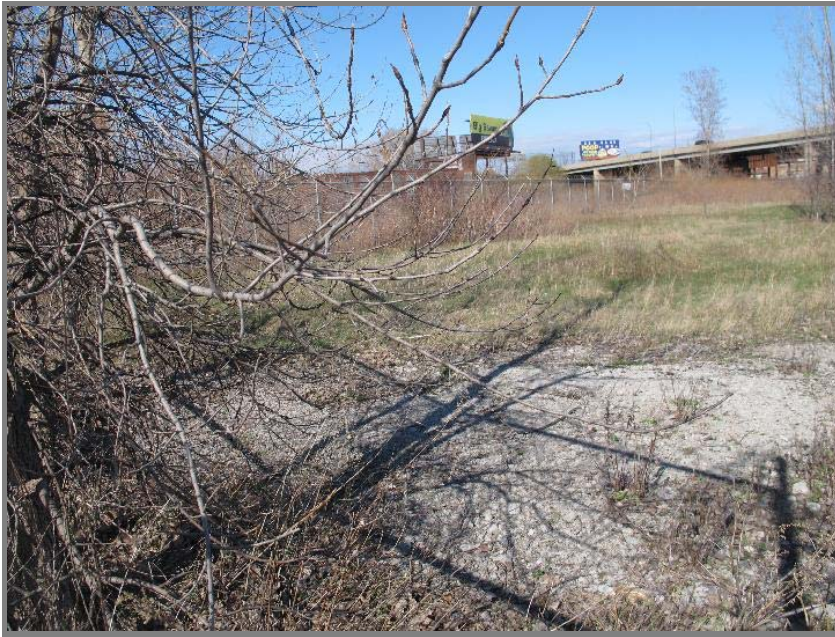
Panorama swinging south to east, over the top of the fence on the northern boundary.

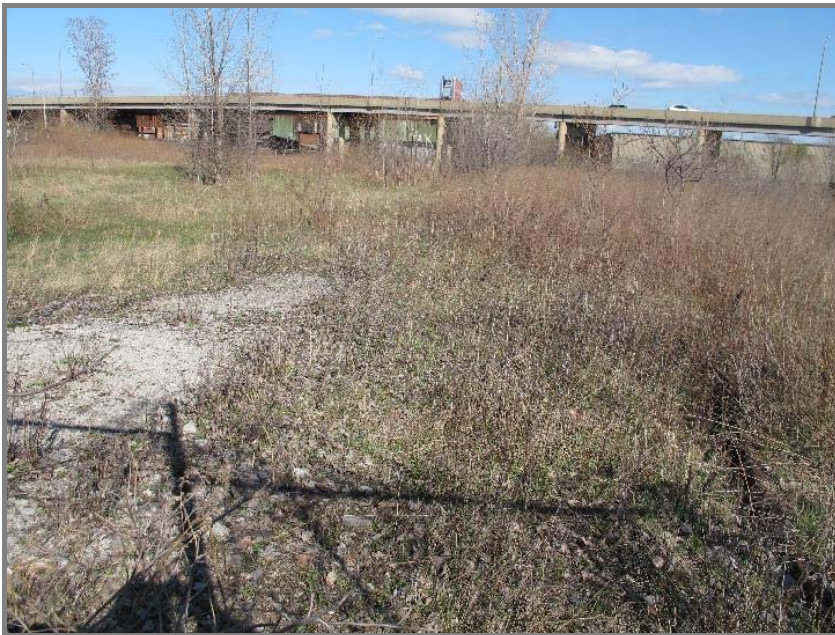
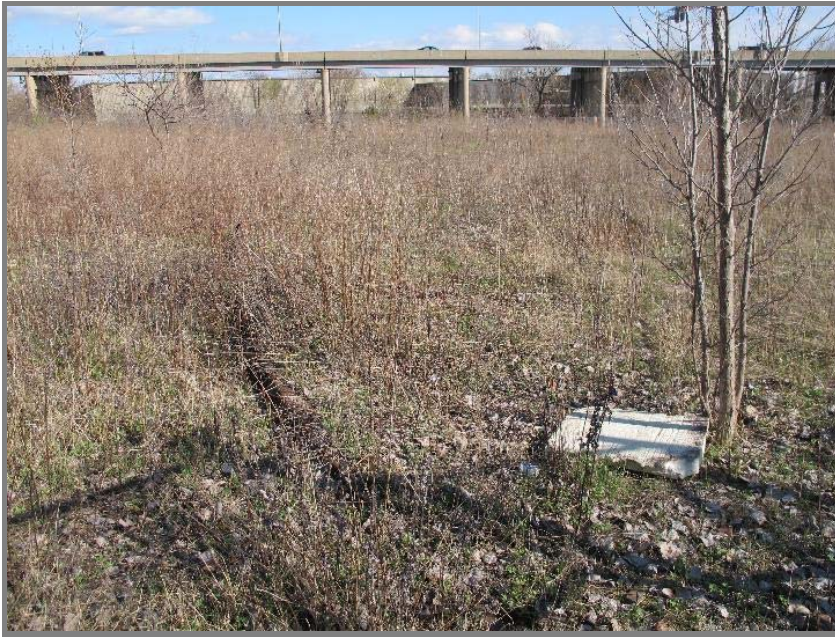
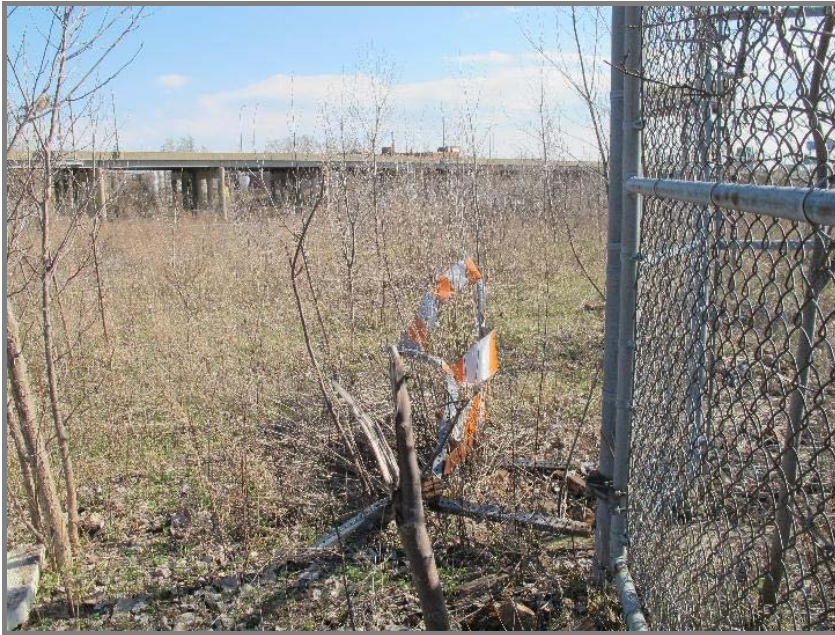
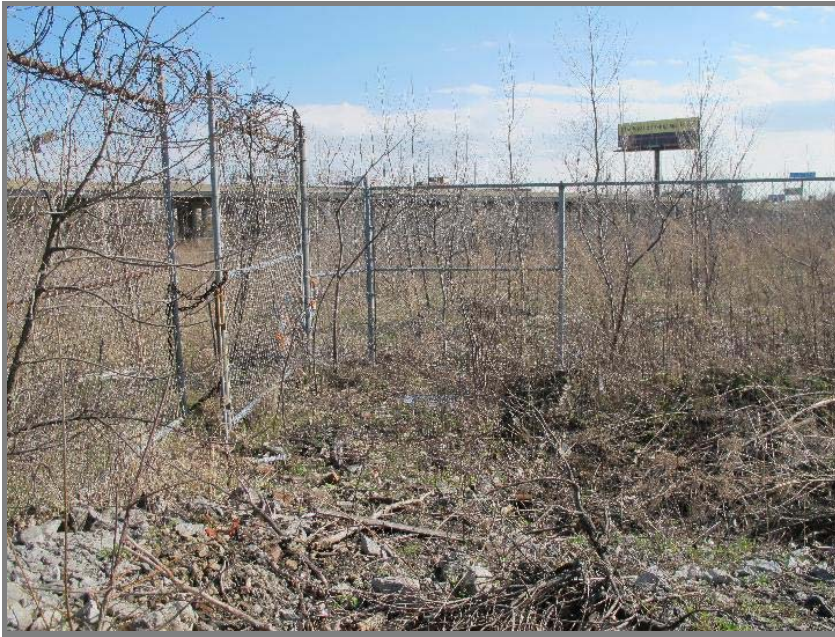
Near the distant fence corner. We entered briefly and then walked back the way we came.

Near the distant fence corner.
We entered briefly and then
walked back the way we came.

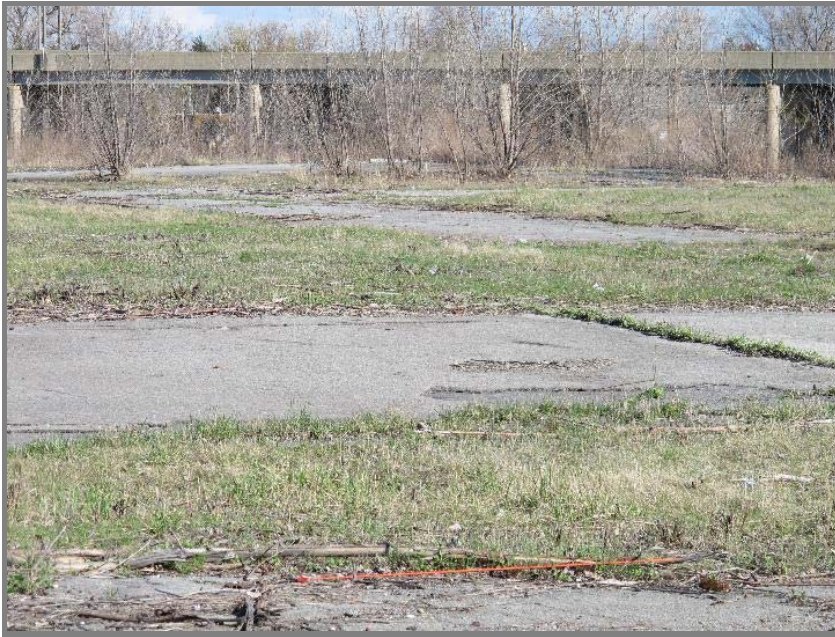
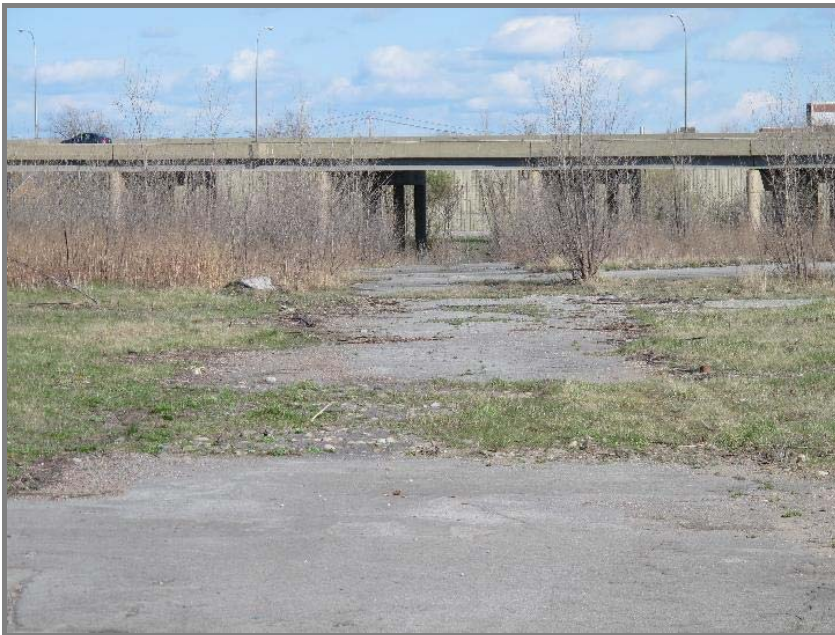
Photo of the interior from the sidewalk along Tonawanda Street. Camera held above head.
