INSPECTION REPORT

Site Number: 932110

Date: January 14, 2014

Site Name: Vanadium Corporation of America

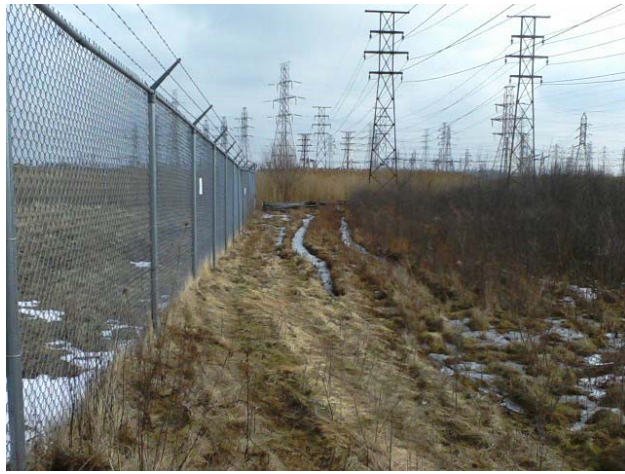
01142014-01 Ditch South of OU2.jpg

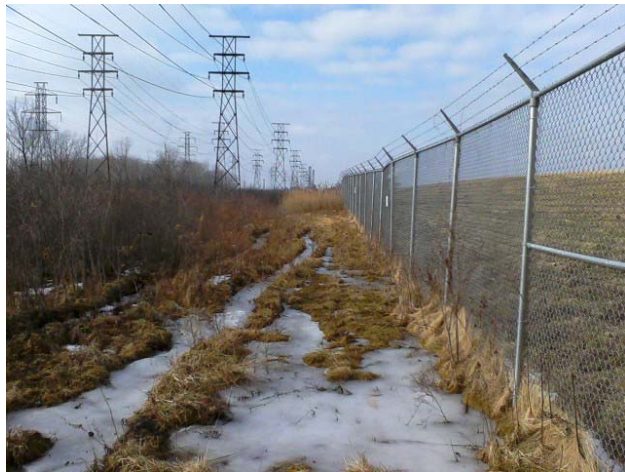
01142014-02 Ditch South of OU2.jpg

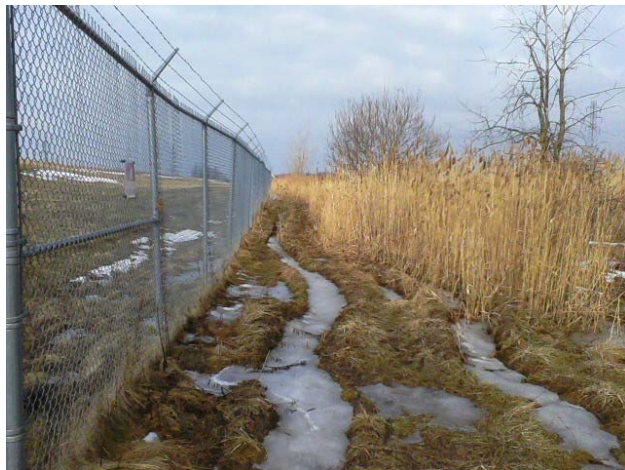
01142014-03 Ditch East of OU2.jpg

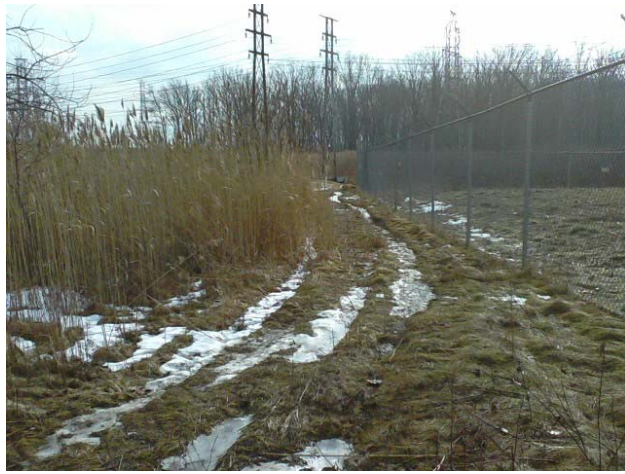
01142014-04 Ditch East of OU2.jpg

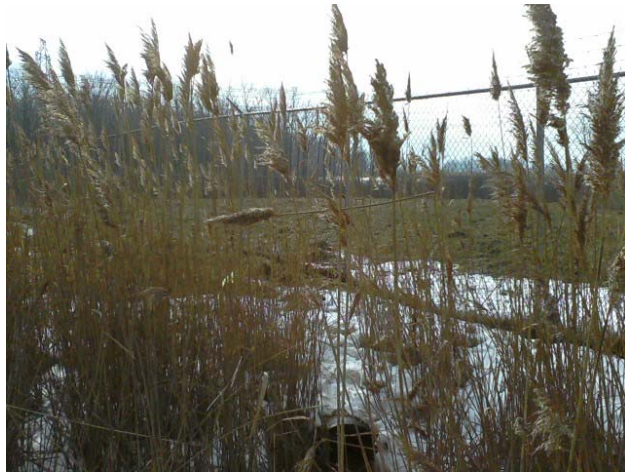
01142014-05 24 inch culvert at OU2.jpg
