FIELD INSPECTION REPORT

Date: November 29, 2010
Site Name: Vanadium OU-2
Site Number: 932001
Location: Witmer Rd; Niagara Falls(C), Niagara County
Project Engineer: Michael Hinton, NYSDEC - Buffalo
Covering Inspector: Brian Sadowski, NYSDEC - Buffalo
Site Owner: Airco Properties
RP Contact: Chip McLeod, Greenstar Engineering P.C. Phone: 716-475-6623
Contractor: Bob Broomfield, Greenstar Solutions LLC Phone: 716-662-8412
Time on site: 1341
Time off site: 1406

Purpose of Visit: Inspect thermal heat welding of liner patches around newly installed monitoring wells.

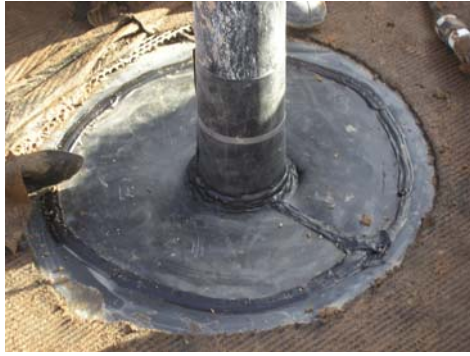
PZ-02 Final.JPG

Findings/Work Performed: Inspected final thermal liner patch welds at PZ-02. Observed that HDPE liner and boot used to patch is the same or equivalent to cap material. Observed work procedure to be thorough and results to be seal tight around the well patch circumference, base and vertical boot riser with SS clamp at outer well casing. PZ-01 done as same. All 'HW' excavated was characterized, placed in a roll off and disposed accordingly. Construction areas were backfilled to cap grade.
