DAILY INSPECTION REPORT

Report No. 003

FMC OU2 (Site No. 9-32-014)

NYSDEC Division of Environmental Remediation

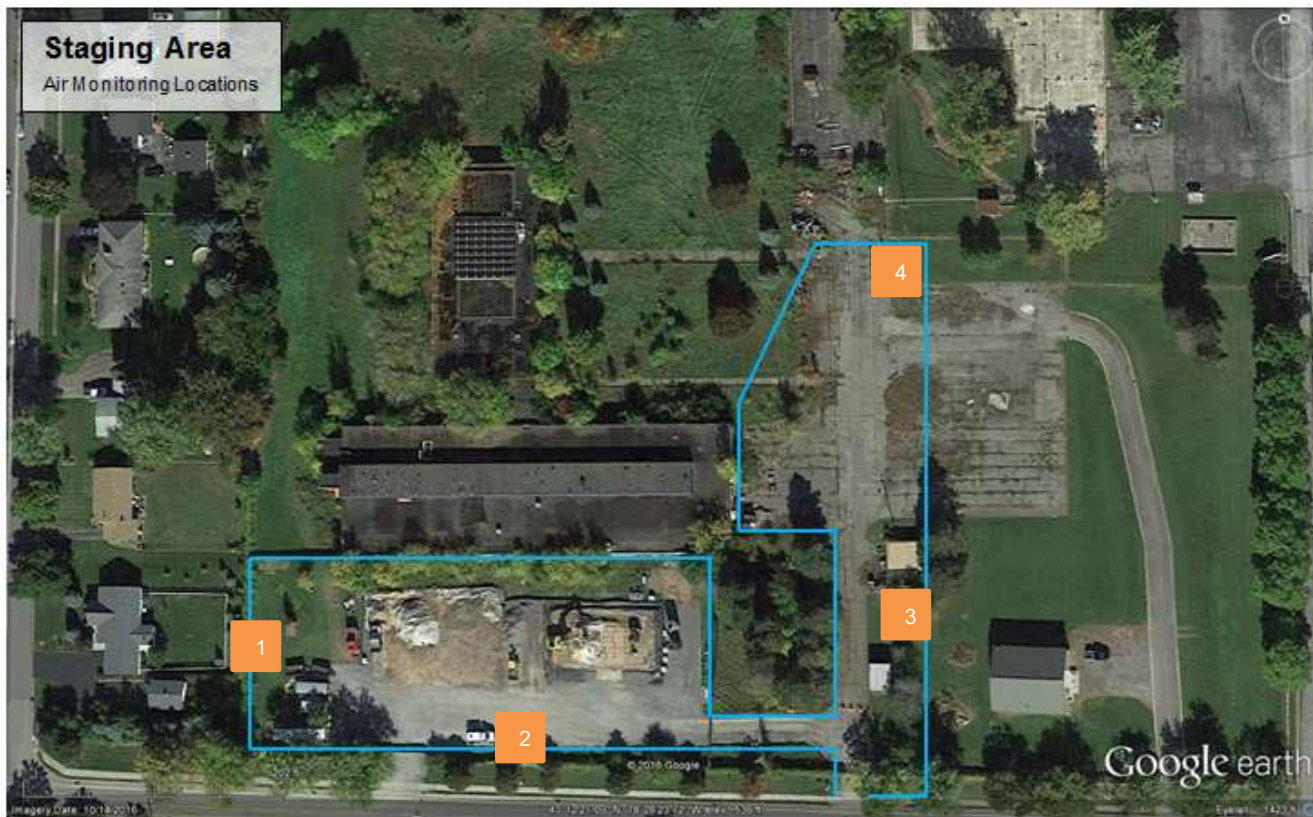
Property Air and Vibration Monitoring Unit Key

Notes: Air monitor DM-8 was not used due to a missing component of the monitor. Air monitor DM-4 was out of service, being cleaned and tested in the trailer after possible error readings on 4/21/20.

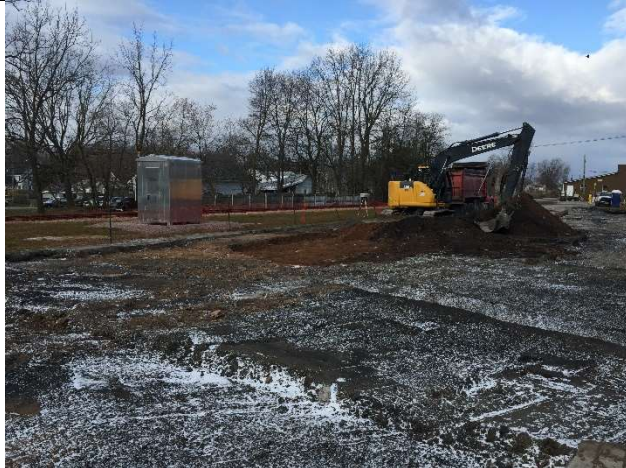
N15: View of excavation and direct loading. View looking southwest.

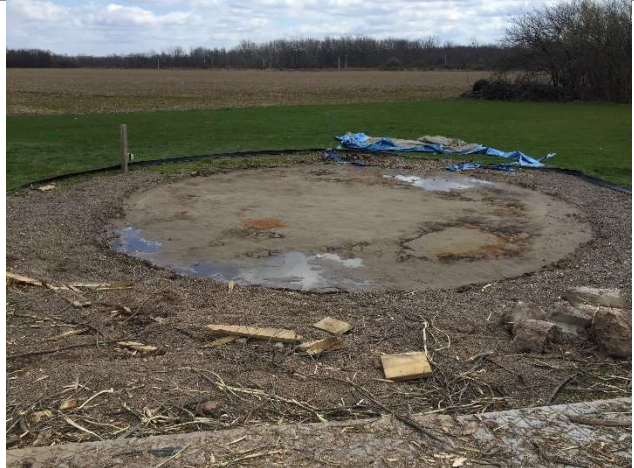
L3: Pool removed. View looking south.

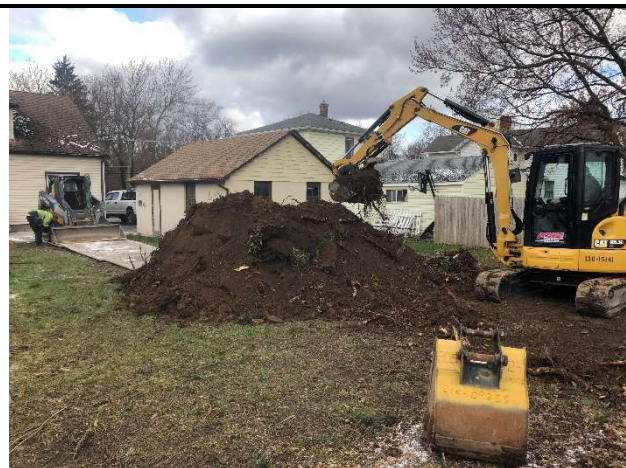
S6: NVES excavating east side of the property. View looking northwest.

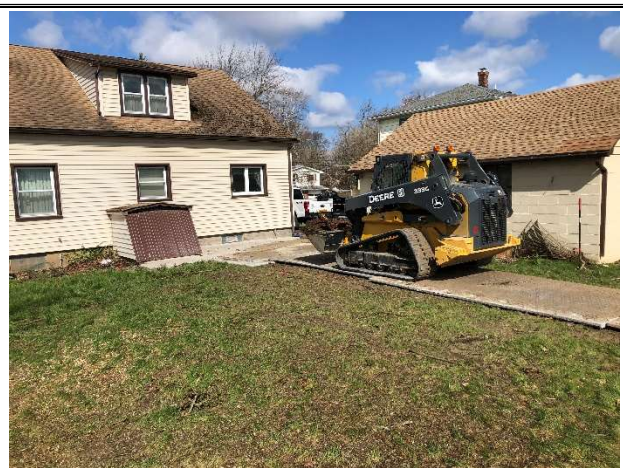
S6: Skid steer transporting excavated soil to trailer for transport to the staging area. View looking northwest.
