DAILY INSPECTION REPORT

Report No. 014

FMC OU2 (Site No. 9-32-014)

NYSDEC Division of Environmental Remediation

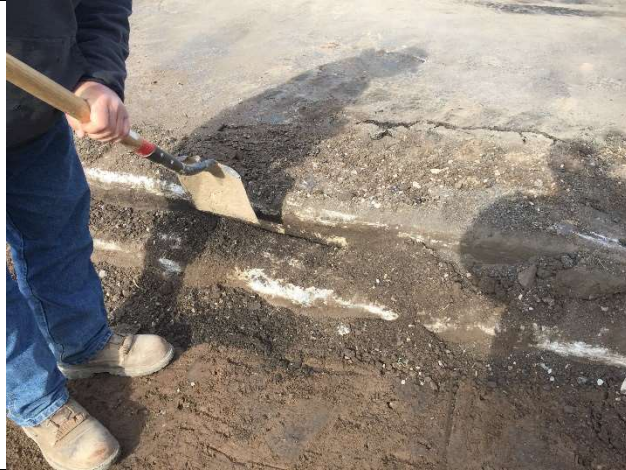
L3: NVES excavating along edge of driveway, which is asphalt over concrete. View looking west.

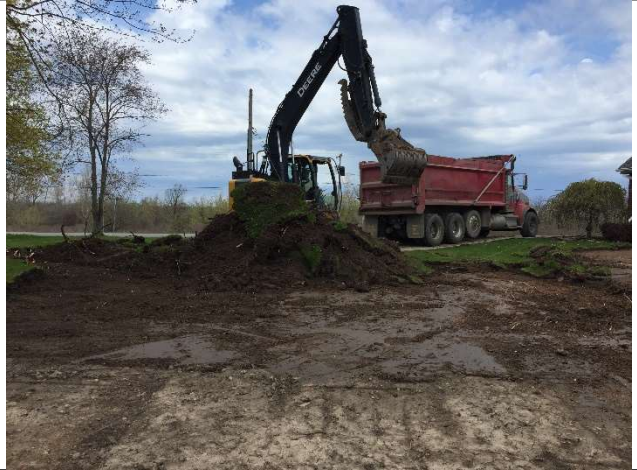
L3: NVES direct loading excavated material for disposal. View looking northeast.

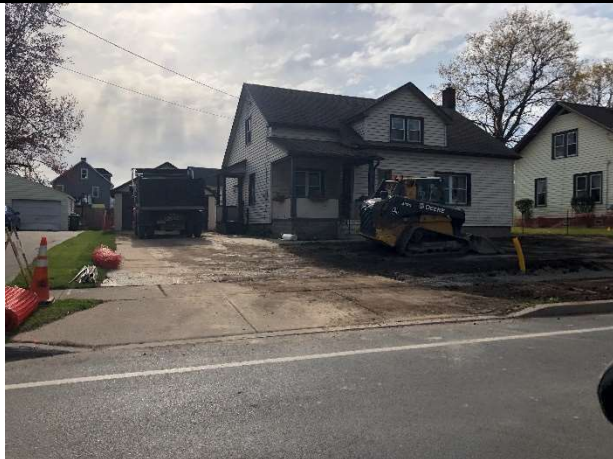
S6: NVES backfilling with topsoil. View looking east.

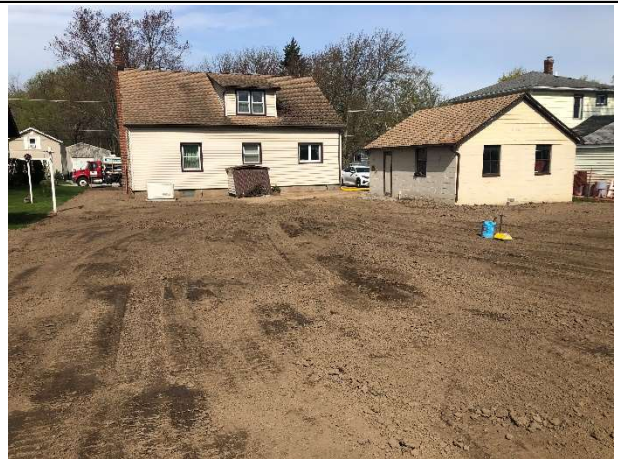
S6: SJB performing compaction tests. View looking west.

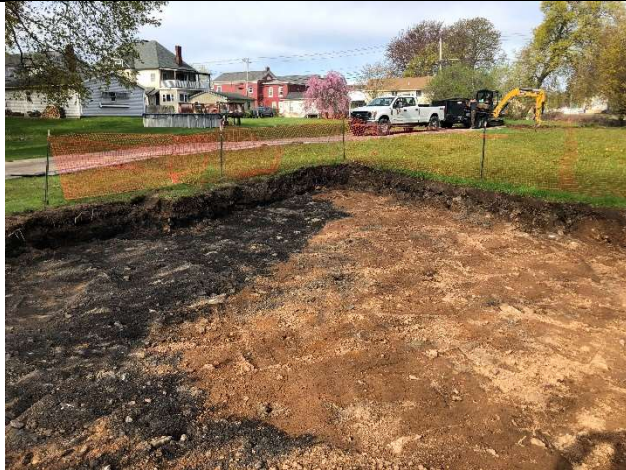
B1: Southwest corner of eastern excavation area. View looking southwest.

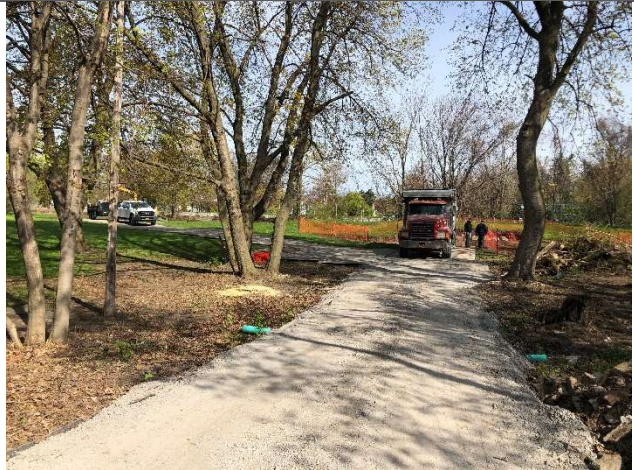
B1: Excavation north of B3, backfilling eastern excavation. View looking north.

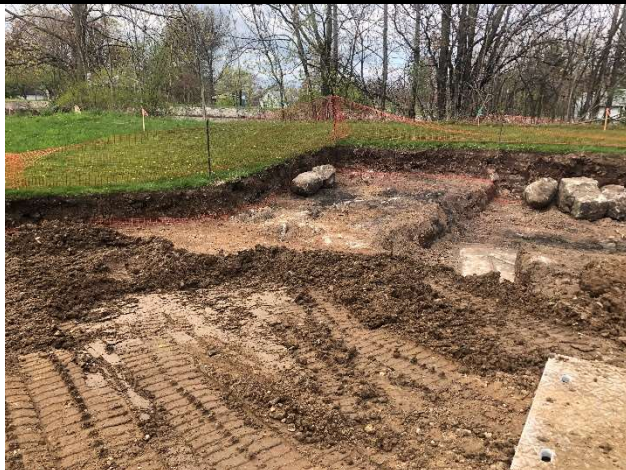
B1: NVES backfilling eastern excavation with common fill. View looking northwest.

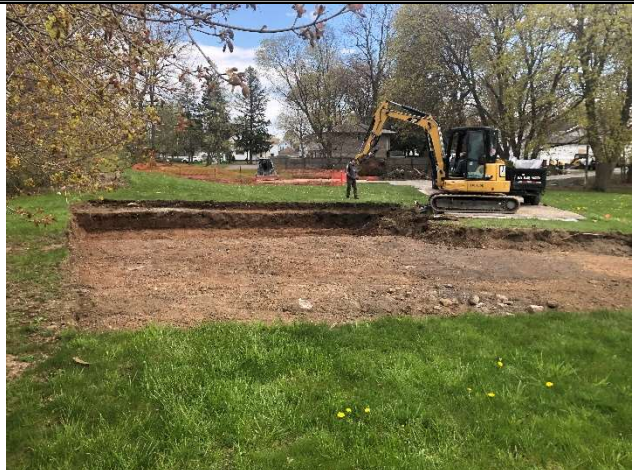
B1: NVES excavating north of B3. View looking east.
