DAILY INSPECTION REPORT

Report No. 015

FMC OU2 (Site No. 9-32-014)

Date: 05-08-2020

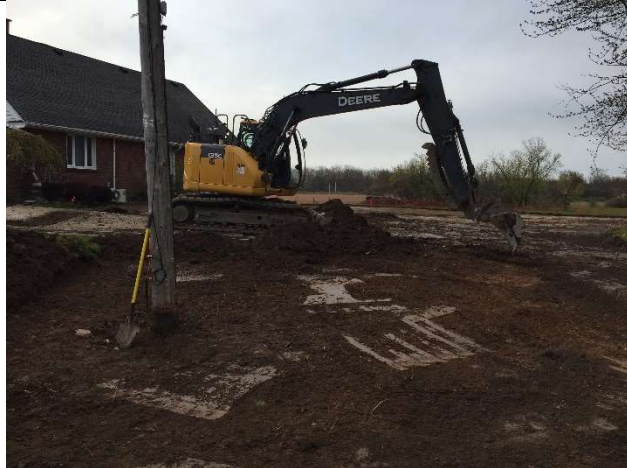
L3: NVES excavating the northwest corner of the property. View looking south.

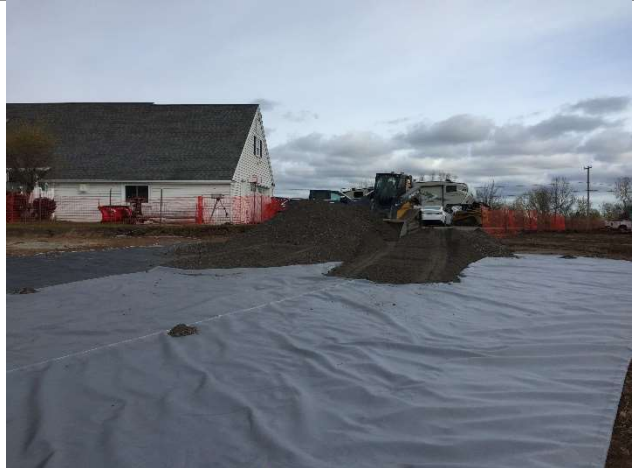
L3: NVES placing stone over geotextile fabric for barn subbase. View looking north.

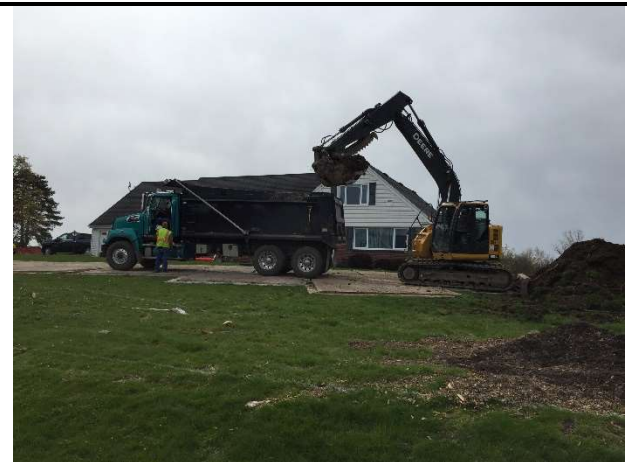
L3: NVES direct loading excavated material. View looking south.

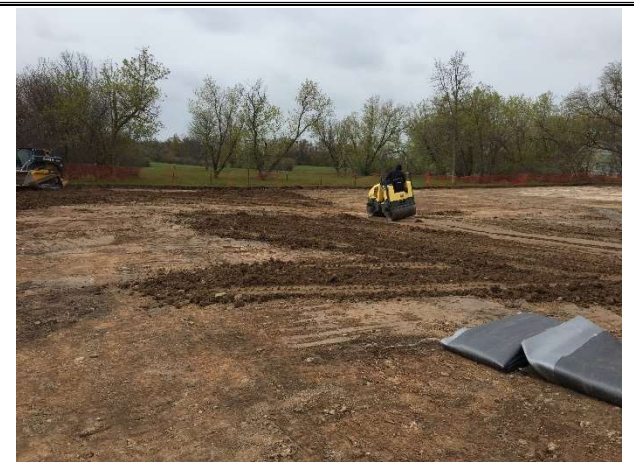
L3: NVES compacting common fill. View looking southwest.

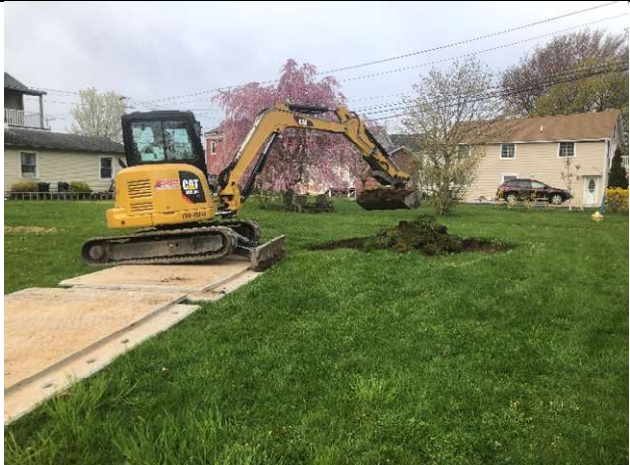
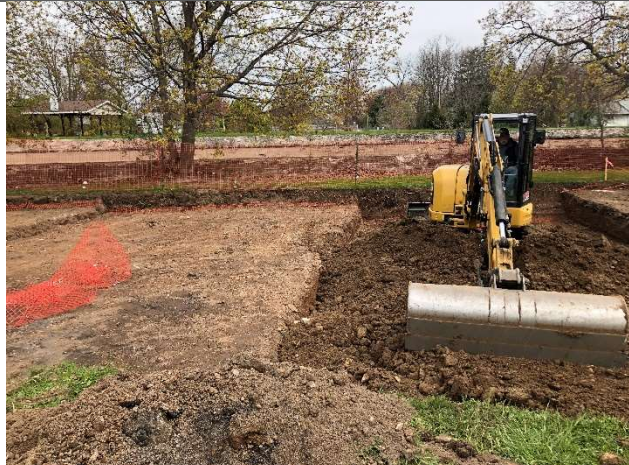
<p>B1: NVES excavating the northeast section of the property. View looking southwest.</p>	<p>B1: NVES backfilling with common fill. View looking north.</p>
-	-
-	-
Comments	
<p>Site Inspector(s): Greg Jones, Jose Ramirez</p>	<p>Date: 5/8/2020</p>
