DAILY INSPECTION REPORT

Report No. 016

FMC OU2 (Site No. 9-32-014)

Date: 05-11-2020

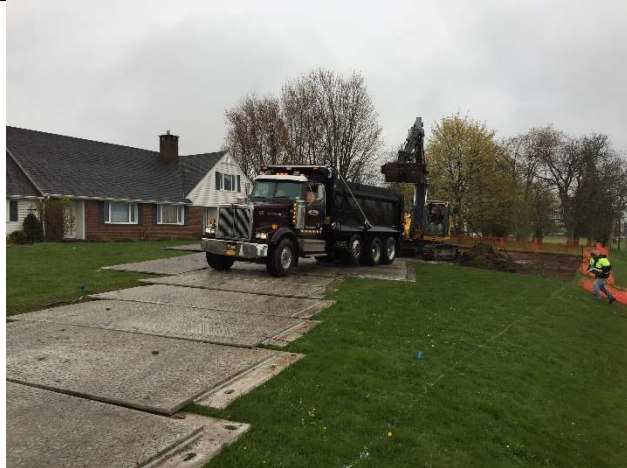
L3: NVES excavating the north side of the property. View looking southwest.

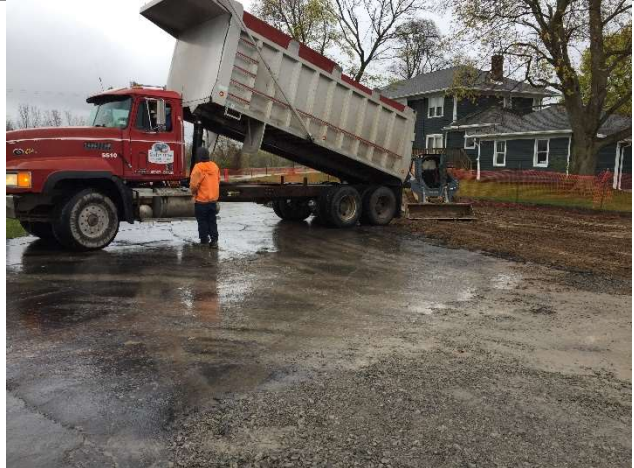
L3: NVES backfilling with common fill. View looking northeast.

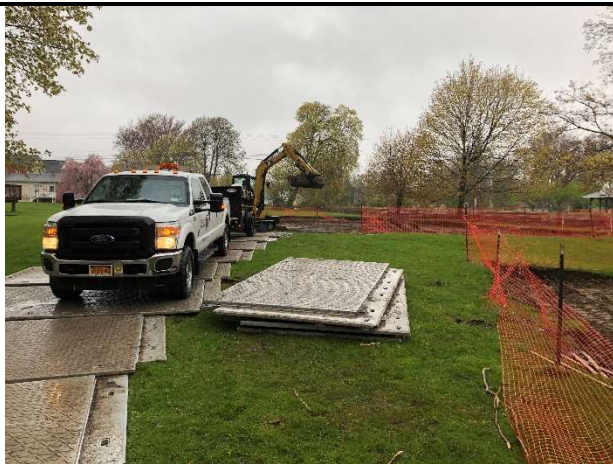
B1: NVES excavating from the northeast corner of the property. View looking north.

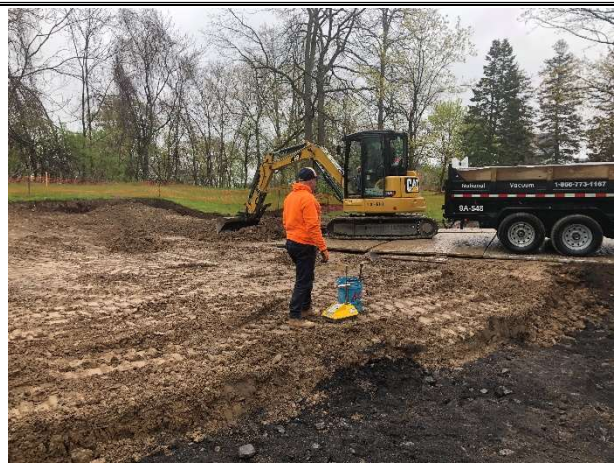
B1: NVES backfilling the northeast corner of the property, SJB performing compaction test. View looking east.
