Annual Hyde Park Gorge Walk, August 11, 2004

Notes by Will Welling and Brian Sadowski

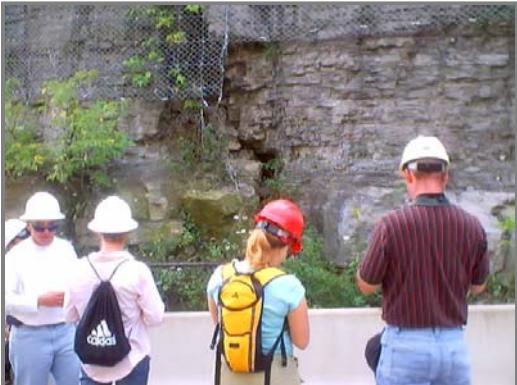
Photo 3, left. GF-1S. Dry, no odor, "same as last year," said Jim Thornton. Comments in quotes which follow are from Jim Thornton or the consensus of group members who were present for the 2003 walk. This seep location is in the Pekin / Gothic formations.	Seep 1. Dry, sparse vegetation, seep basin is clear and dry, no odor. Seep conditions have not changed since 2000.

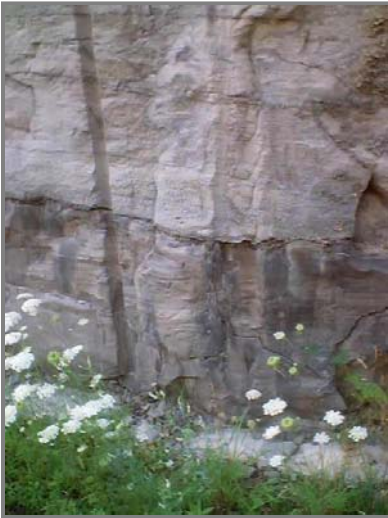
Photo 5, left. Rock wall in the vicinity of Culvert Number 8 - near the base of the contact between Gothic and DeCew formations.

Culvert 8 Inlet and outlet clear and dry. No action required. Same as 2000 - 2003.

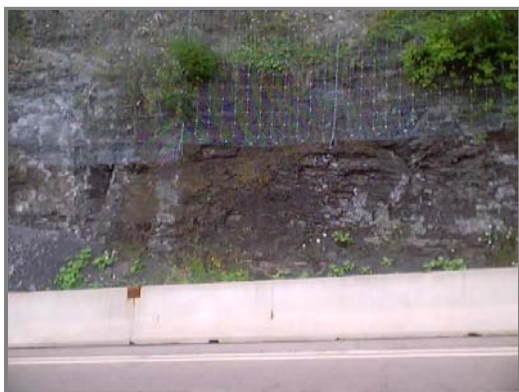
Photo 7, left. GF-16 located at the contact between the Lockport (above) and Rochester (below).

Seep 16. Approximately 320' north of the north fence line of seep 1. Slightly moist rock face at north and south ends. Moisture is from the Lockport/Reynales contact. No action required. Same conditions as 2000-2003.

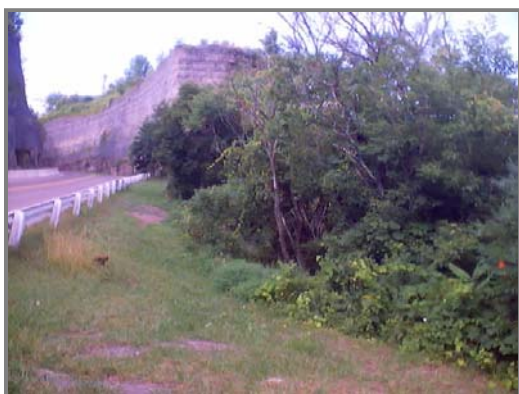
Photo 8, left. View back up the road, up-section. Foreground vegetation edge on right obscures Culvert 7. Both the inlet and outlet are obscured by trees and cover, "same as last year."

Culvert 7. Dry, no flow, inlet buried. Outlet not observed due to heavy vegetation. No action required. Same as 2000 - 2003.

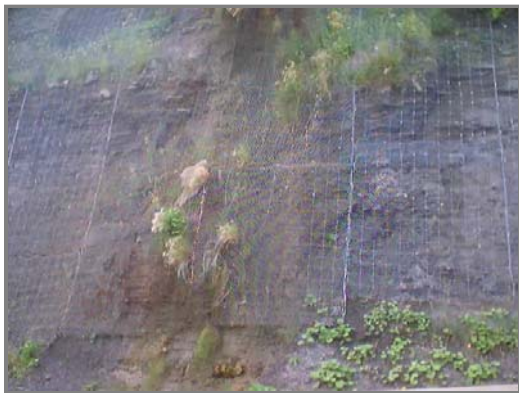
Photo 9, left. GF-S2, moist rock wall, vegetation growing on the fencing, except for 1-3 gpm flow, it's "the same as last year."

Culvert 6 just below the vegetation and slightly to the left, out of view: water is flowing past. "I don't think anything goes in here."

Seep 2 (Culv. 6). Damp area 0 to 30 feet north of seep (from Lockport/Rochester contact). Steady flow (~1 gpm), minor green algae and grass on face of Rochester Shale, several wet and dripping areas, seep basin totally full of rock. No fence present. Same conditions as noted in 2000- 2003.

Seep 2. (Ditch line) No odor, green moss, heavy vegetation. Heavy talus in ditch. Same conditions as in 2002, 2003.

Culvert 6. Standing water at the outlet, water is clear, no odor, no flow. Inlet buried at Seep 2. No action required. Same as 2000 - 2003.

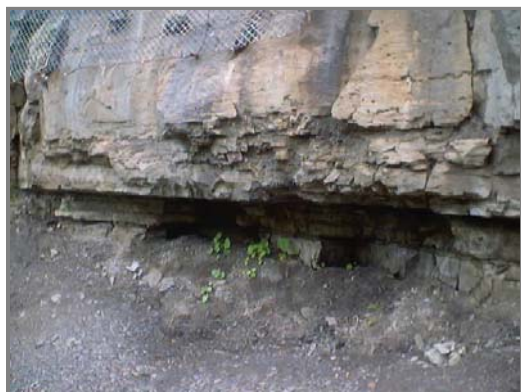
Photo 10, left. GF-S17 Slight drip. "Same as last year," said Tami.

Seep 17a. North - area approximately 150' north of the north wall of seep 2. Slightly dripping at the Irondequoit/Reynales contact. Portion of Irondequoit is damp. No action required. Basically same conditions as previous years.

Seep 17b. South - dry No action required.

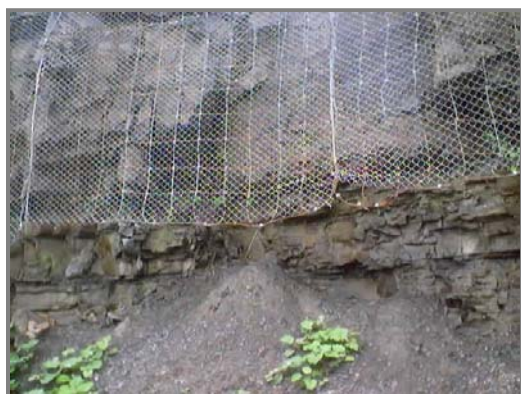
Photo 11, left. GF-S14, at the Irondequoit / Renaldi contact. Renaldi is the more fractured formation. This seep is about 30 feet wide. "Same as last year."

Seep 14. Approximately 80' to 100' south of the south fence line of seep 3. Wet face on Reynales approximately 30' wide. Slight dripping originates from the Irondequoit/Reynales contact. No action required. Same conditions as 2000-2003.

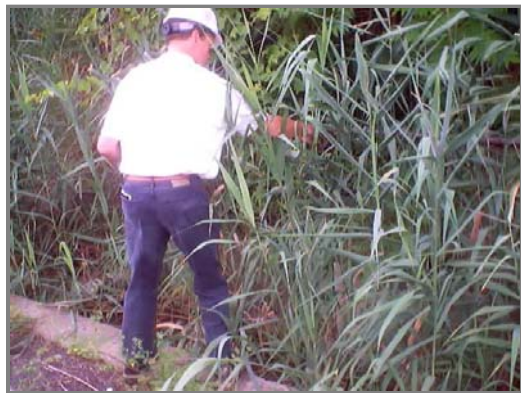
Photo 12, left. GF-S3 and Culvert 5. This location is in the vicinity of the Bleed Run Culvert. Heavy *Phragmites* vegetation, wet location. The culvert shows a slight flow. This damp rock face is the Upper Grimsby.

Seep 3 (Top). Very heavy *Phragmites* reeds on north and south sides of the concrete box Bleed Run Culvert. Area is dry Area fenced. Same conditions as in 2002, 2003.

Seep 3 (Bottom) Culvert 5. Heavy vegetation. Seep basin is clear. Rocks are wet but no standing water in basin (deepest portion) at Bleed Run Culvert. Remediated. Same as 2002 and 2003. Culvert 5. Inlet is open. Slightly flowing. Outlet has standing water, slight flow. No odor. No action required.

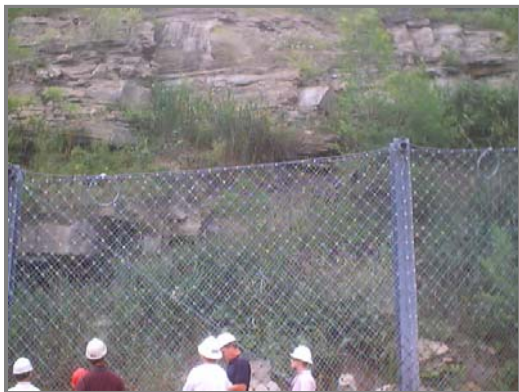
Photo 13, left. **Culvert 4**. Dry stone, pea gravel-size, behind fence. "Same as last year-- a little damp"

Culvert 4. Inlet is open and dry. Outlet is dry. No flow. No action required. Same as 2000 -2003.

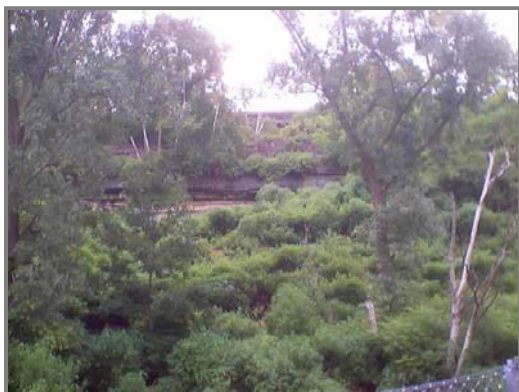
Photo 14, left. **GF-S4**, flowing. Tall cliff, slime hanging from rock ledge. Active flow, 3-5 gpm flow at the time of this walk.

Seep 4. Flowing water (4 to 5 gpm). Heavy vegetation, no odor. Fence in place. Same as 2002 and 2003.

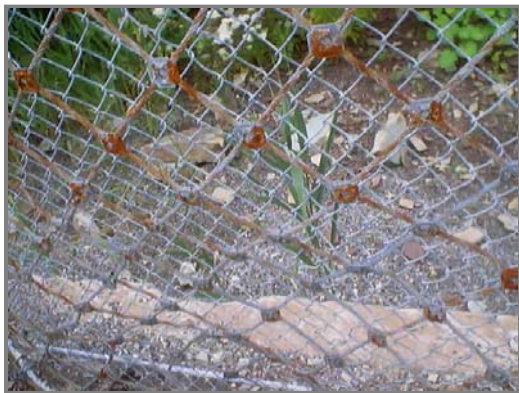
Photo 15, left. Rust on fencing at **GF-S4** and **Culvert 3** is caused by road salt in plow-thrown snow.

Culvert 3. Inlet is open. Dry soil. Outlet is damp. No action required. Same as 2000 -2003.

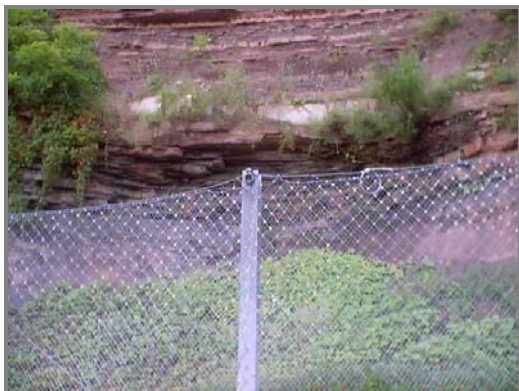
Photo 16, left. **GF-S20** and **Culvert 2**. Water is dripping from the bowl-shaped, concave, cliff face.

Seep 20. Area 80' to 100' north of the north fence line of **seep 4** at the base of the Grimsby Sandstone down into the Power Glen Shale. Slightly dripping. No action required. Basically the same conditions as in 2002 and 2003.

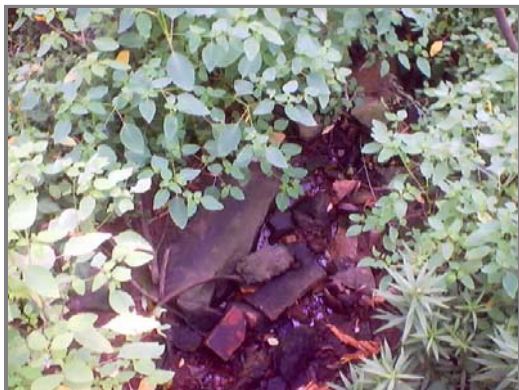
Photo 18, left. **Culvert 2** has slight flow. There is growth of Staghorn sumac with a lot of dead branches and wilted vegetation at this location (not shown).

Culvert 2. Inlet is buried. No odor Outlet has significant vegetation, a slight flow (less than 0.5 gpm), moss, no odor. No action required. Same as 2000 -2003.

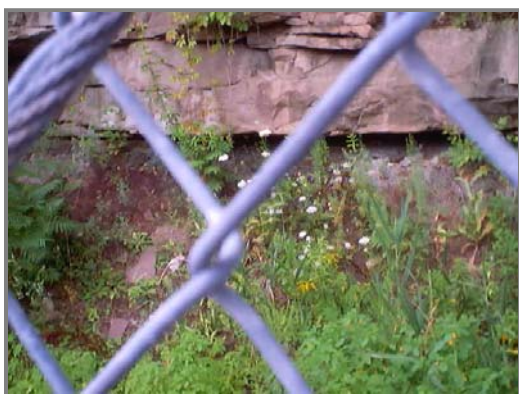
Photo 19, left. **GF-S19**. Damp area, no visible flow in ditch.

Seep 19. Approximately 120' south of the south end of the wing wall. Queenston/Whirlpool rock face damp. No visible flow in ditch. Heavy vegetation. No action required. Basically the same conditions as in 2002 and 2003.

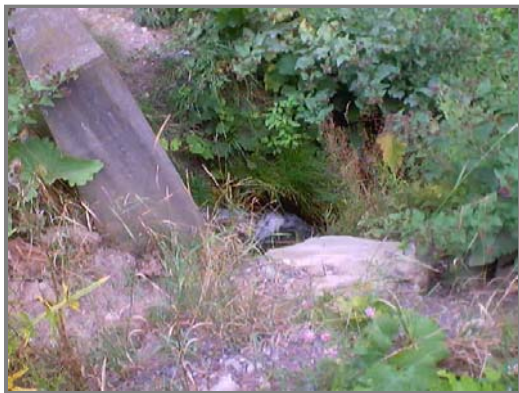
Photo 20, left. **Seep 12** is flowing 30-40 gpm. **Culvert 1** is dry (no Photo). We then left the power authority roadway and hiked along the river edge trail. It began to rain.

Seep 12. Steady flow out of culvert from NYPA south tunnel. Flow approximately 30 to 40 gpm. No odor, noticeable algae in pipe. Sampling discontinued after 2001 due to history of non-detects.

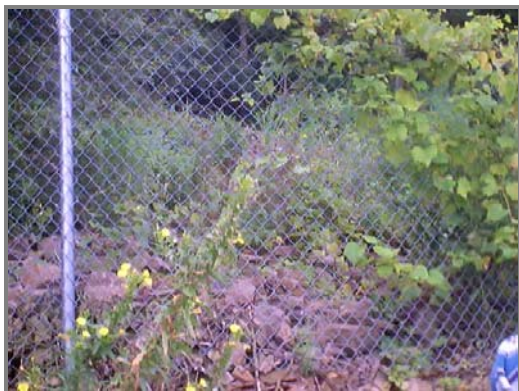
Photo 21, left. **Bloody Run**. When the weather is hot, one can smell volatiles at this location. There was no odor this year, Brian commented.

Bloody Run. Fenced-in area by the river shoreline. No visible flow, no odor, heavy talus. Fence is in place and in good condition. Same as in 2000 through 2003.

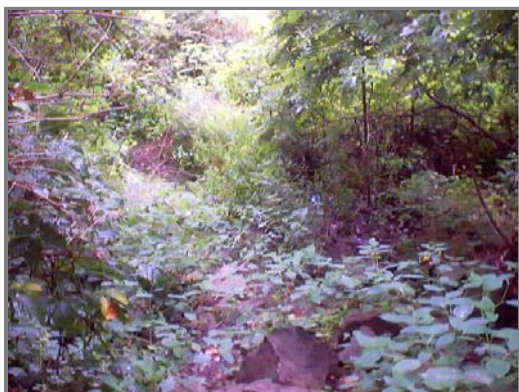
Photo 22, left. GF-S11 was dry. Remains of railroad stonework can be present at this location and others along the trail along the river edge.

Seep 11a. Inlet area at water's edge covered with local rock. Sediment infilling. Remediated. Same as 2000, 2001, 2002, and 2003

Seep 11b. Dry (south of Bloody Run Fence) Same as 2000, 2001, 2002, and 2003

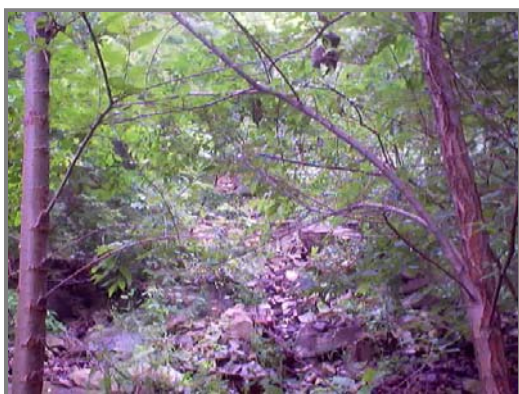
Photo 23, left. GF-S21

Seep 21. Area 375' south of Seep 7 (Devil's Hole Stairs) by the river - dry. Same as 2001, 2002, and 2003.

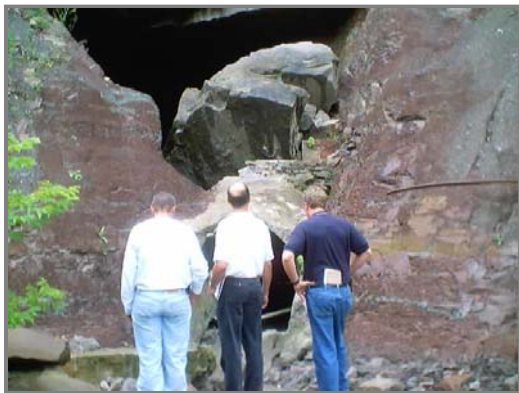
Photo 24, left. Garfield Avenue Sewer storm water overflow. Smell of sewage. Since it was raining, we didn't linger long at this location!

The former railroad along the river edge was damaged numerous times from slides. Note the narrow-gauge rail jutting from the bank. This rail may be from a buried section of track. It's only about two inches tall and an inch across - very small rail!

Garfield Avenue Sewer. No flow at exposed original outlet, typical sewer odor, continual caving into former archway (Whirlpool Sandstone) Standing water in pipe. Additional washouts since 1998. Parks Dept built a pedestrian walkway (with two 36" diameter culverts) across the path in the summer of 1999. One culvert inlet completely buried.

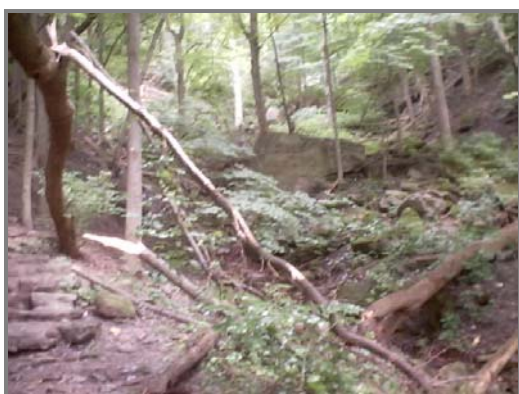
Photo 25, left. GF-S7

Seep 7 a,b. Covered with local rock. Heavy vegetation. Remediated. Same as 2001-2003.

Seep 7 c. Some exposed channel flow between rocks. Remediated. Same as 2001-2003.

Seep 7 d. Wet and flowing (15 to 20 gpm) over top of Irondequoit (waterfall). No odor. Sampled September 24, 2003. Non-Detect for all parameters - same as 1999, 2000, 2001, and 2002.

Seep 7 e,f,g,h,i. Flowing water beneath rocks. Heavy vegetation. Some exposed channel flow. No action required.

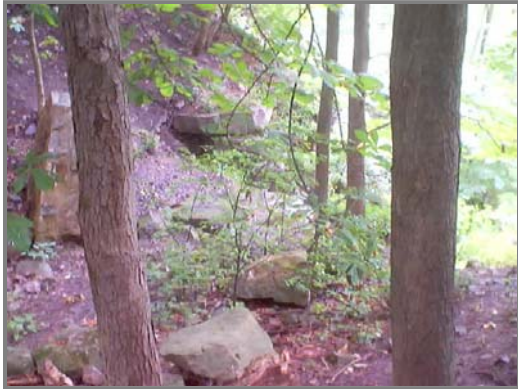
Photo 26, left. GF-S5 or GF S6.

Seep 5. Damp rock face, slight dripping. Remediated. Same as 2001-2003.

Seep 6. Moist rock face with slight dripping. Remediated. Same as 2001-2003.

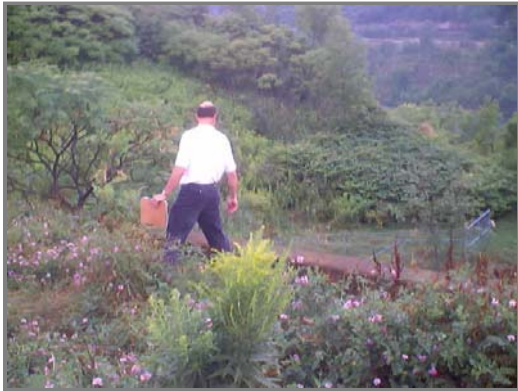
Photo 27, left. GF-S3. Top of the box culvert connected to Garfield Street Sewer. There's water flowing in the culvert.
