## Hooker - Hyde Park Landfill Community Monitoring

### Niagara River Gorge Inspections

August 11, 2004 and August 19, 2006

Photos and Notes by Will Welling and Brian Sadowski, NYSDEC; and Jim Thornton, CRA

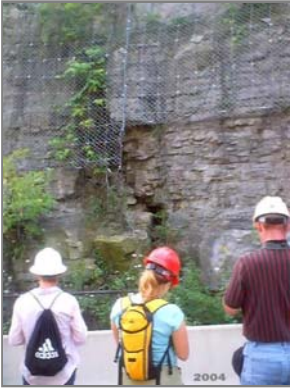
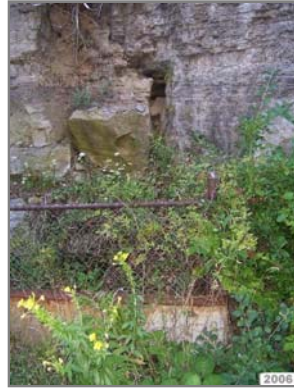
NYSDEC 2004: GF-15. Dry, no odor, "same as last year," said Jim Thornton. This seep location is in the Pekin/Gothic formations.  
NYSDEC 2006: 8:33AM Seep 1. Very dry, normal vegetation.

CRA 2004: Seep 1. Dry, sparse vegetation, seep basin is clear and dry, no odor. Seep conditions have not changed since 2000.

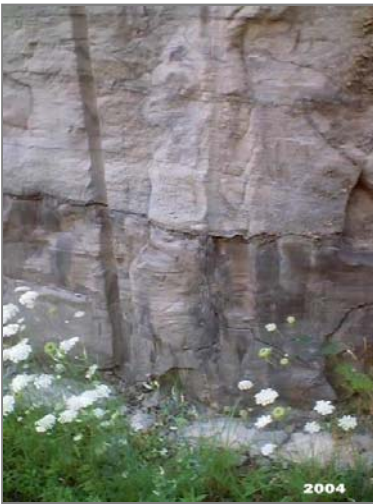
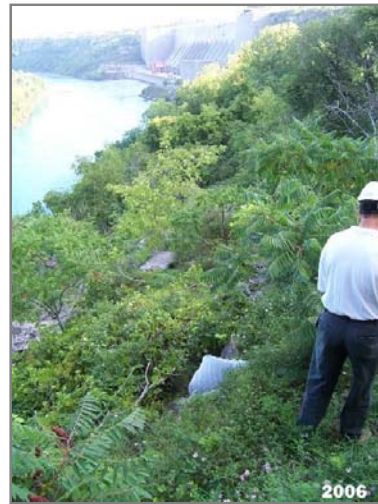
NYSDEC 2004: Rock wall in the vicinity of Culvert Number 8 - near the base of the contact between Gothic and DeCew formations.  
NYSDEC 2006: 8:40AM Culvert 8. Dry. Culvert 8 inlet is buried beneath rocks. No odor.

CRA 2004: Culvert 8 Inlet and outlet clear and dry. No action required. Same as 2000 - 2003.

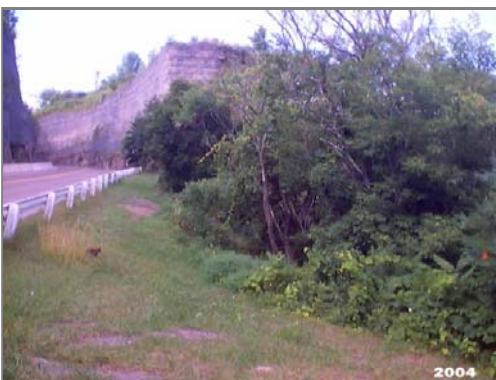
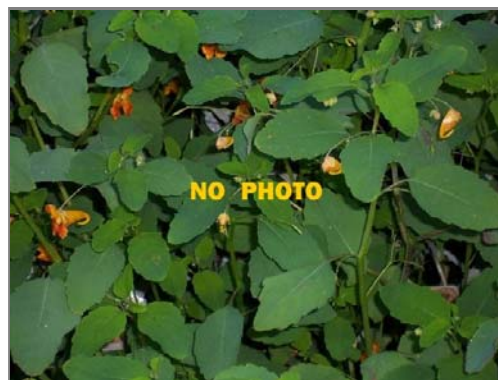
NYSDEC 2004: View back up the road, up-section. Foreground vegetation edge on right obscures Culvert 7. Both the inlet and outlet are obscured by trees and cover, "same as last year."

CRA 2004: Culvert 7. Dry, no flow, inlet buried. Outlet not observed due to heavy vegetation.

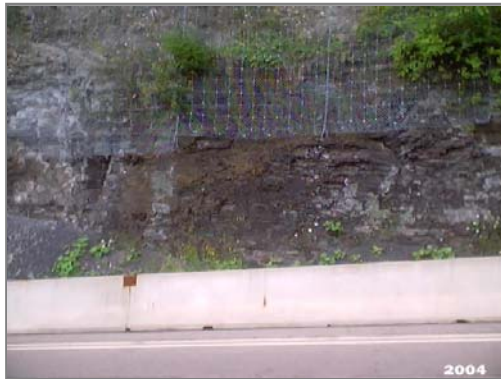
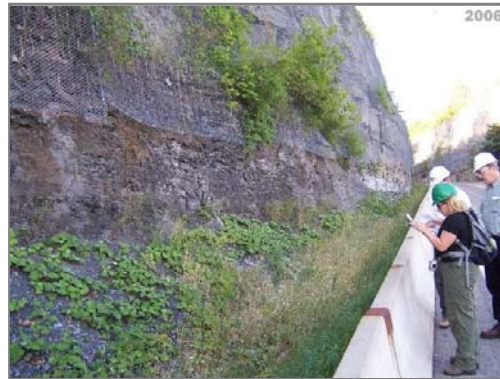
NYSDEC 2004: GF-16 located at the contact between the Lockport (above) and Rochester (below).  
NYSDEC 2006: 8:45AM GF-16. Moist.

CRA 2004: Seep 16. Approximately 320' north of the north fence line of seep 1. Slightly moist rock face at north and south ends. No action required. Same conditions as 2000-2003.

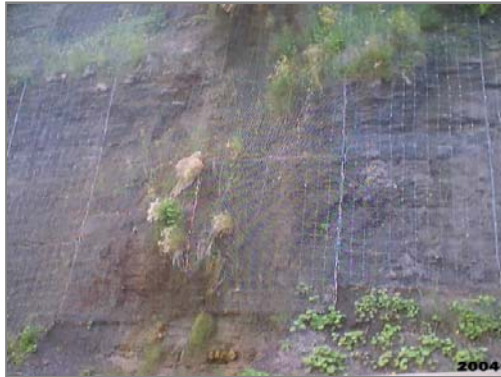
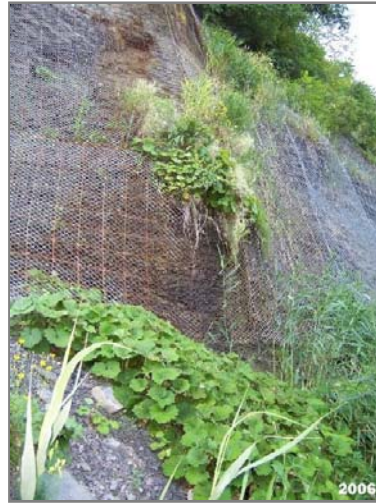
NYSDEC 2004: GF-S2, moist rock wall, vegetation growing on the fencing, except for 1-3 gpm flow, it's "the same as last year."  
NYSDEC 2006, 8:50AM, Seep 2 is located at the barrier with a mark.

CRA 2004, Seep 2 (Culv. 6). Damp area 0 to 30 feet north of seep (from Lockport/Rochester contact). Steady flow (~1 gpm), minor green algae and grass on face of Rochester Shale, several wet and dripping areas, seep basin totally full of rock. No fence present. Same conditions as noted in 2000- 2003.

Seep 2. (Ditch line) No odor, green moss, heavy vegetation. Heavy talus in ditch. Same conditions as in 2002, 2003.

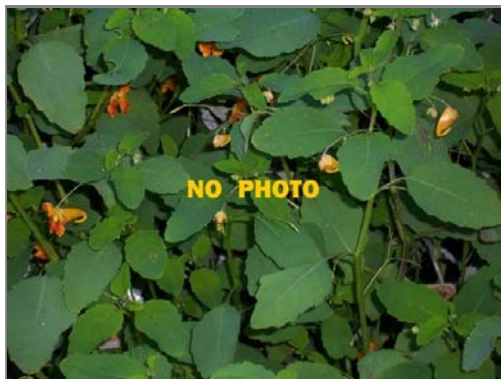
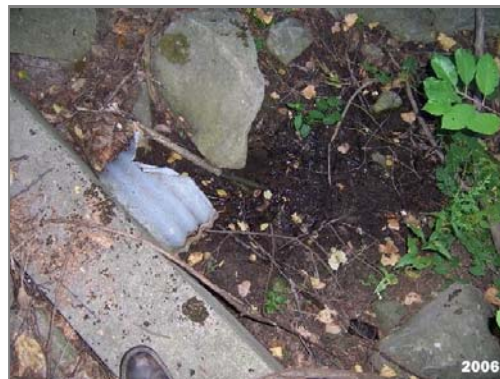
NYSDEC 2004: Culvert 6 just below the vegetation and slightly to the left, out of view: water is flowing past. "I don't think anything goes in here."  
NYSDEC 2006: 9:00am Culvert 6, standing water.

CRA 2004: Culvert 6. Standing water at the outlet, water is clear, no odor, no flow. Inlet buried at Seep 2. No action required. Same as 2000 - 2003.

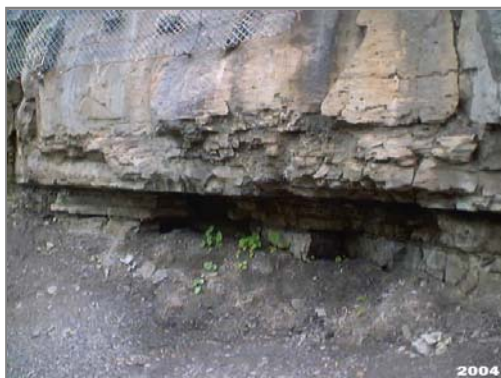
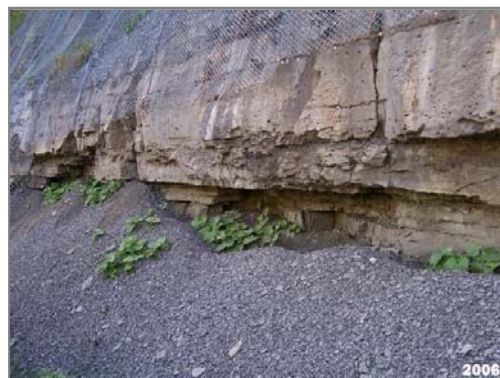
NYSDEC 2004: GF-S17 Slight drip. "Same as last year," said Tami.

CRA 2004: Seep 17a. North - area approximately 150' north of the north wall of seep 2. Slightly dripping at the Irondequoit/Reynales contact. Portion of Irondequoit is damp. No action required. Basically same conditions as previous years.

Seep 17b. South - dry. No action required.

NYSDEC 2006: 9:00AM, Drips at 17A, (slightly north)/ Rust on screen over rock wall.

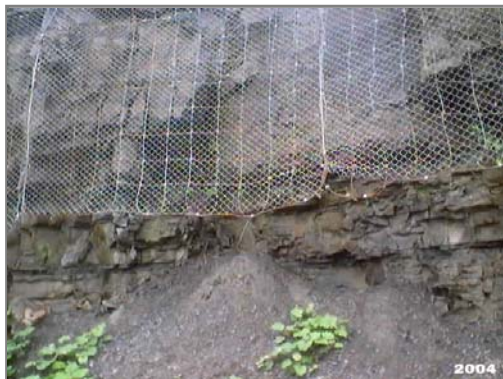
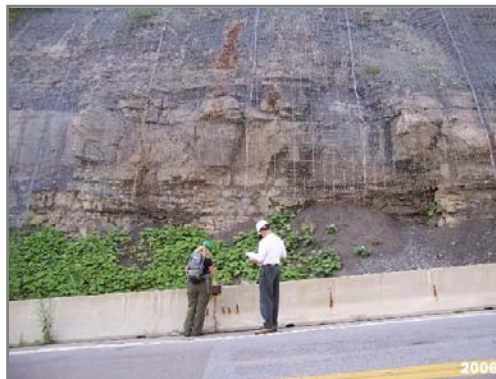
NYSDEC 2004: GF-S14, at the Irondequoit / Renaldi contact. Renaldi is the more fractured formation. This seep is about 30 feet wide. "Same as last year."

NYSDEC 2006: 9:00AM, Drips at 17A, (slightly north)/ Rust on screen over rock wall. DEC 2006: 9:00AM, Jim and Tami standing in front of Seep 14. We had difficulty determining Seep 17 from Seep 14.

CRA 2004: Seep 14. Approximately 80' to 100' south of the south fence line of seep 3. Wet face on Reynales approximately 30' wide. Slight dripping originates from the Irondequoit/Reynales contact. No action required. Same conditions as 2000-2003.

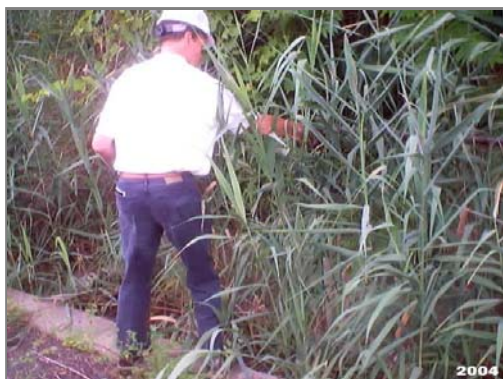
CRA 2004: Seep 3 (Top of seep). Very heavy *Phragmites* reeds on north and south sides of the concrete box Bloody Run Culvert. Area is dry Area fenced. Same conditions as in 2002, 2003.

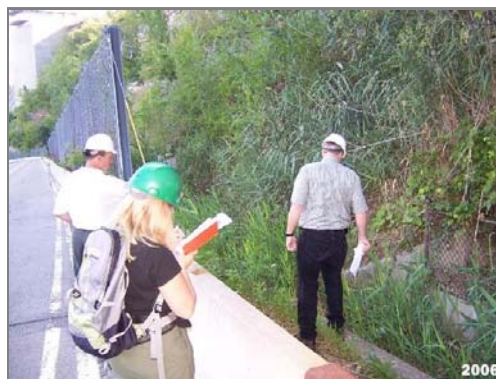
NYSDEC 2004: This location is in the vicinity of the Bloody Run Culvert. Heavy *Phragmites* vegetation, wet location. The culvert shows a slight flow. This damp rock face is the Upper Grimsby.

NYSDEC 2006: 9:23AM, Culvert 5.

CRA 2004, continued: Seep 3 (Bottom of seep) Culvert 5. Heavy vegetation. Seep basin is clear. Rocks are wet but no standing water in basin (deepest portion) at Bloody Run Culvert. Remediated. Same as 2002 and 2003. Culvert 5. Inlet is open. Slightly flowing. Outlet has standing water, slight flow. No odor. No action required.

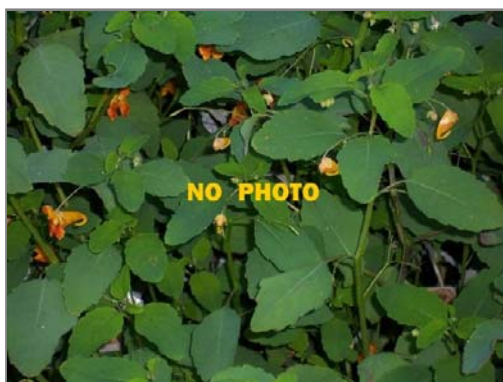
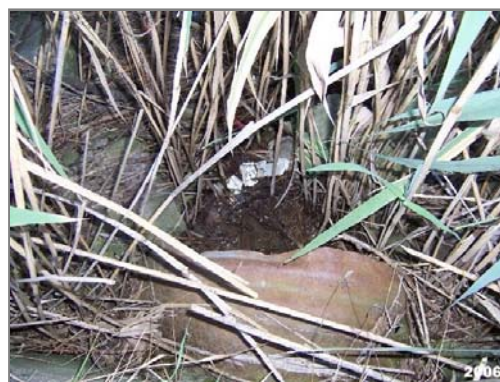
NYSDEC 2004: No comment. NYSDEC 2006: 9:27AM, *Phragmites* growing near Seep 18.

CRA 2004: Seep 18. Seep is 0 to 75' north of the north wall of seep 3. Vegetation on dripping rock face (Upper Grimsby). Ditch line is dry. Basically the same conditions as 2003.

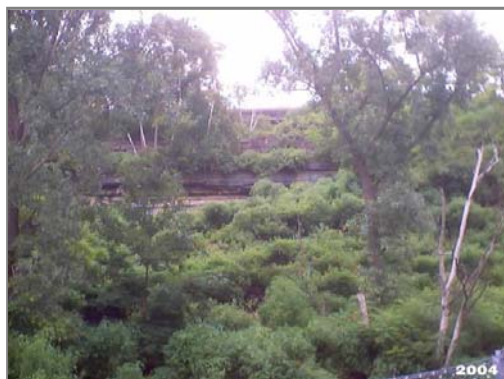
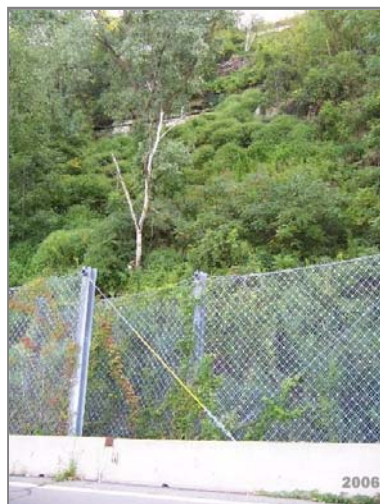
NYSDEC 2004: GF-S4, flowing. Tall cliff, slime hanging from rock ledge. Active flow, 3-5 gpm flow at the time of this walk.  
NYSDEC 2006: 9:27AM, Seep 4. No observed flow but it may be damp. Heavy vegetation. A little further down, about 1 gpm dripping flow. Heavy "snapdragons" *Impatiens capensis* and vines.

CRA 2004: Seep 4. Flowing water (4 to 5 gpm). Heavy vegetation, no odor. Fence in place. Same as 2002 and 2003.

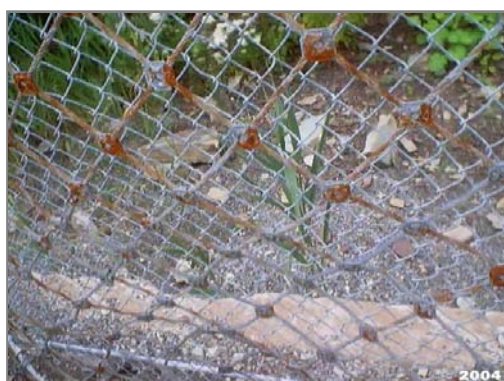
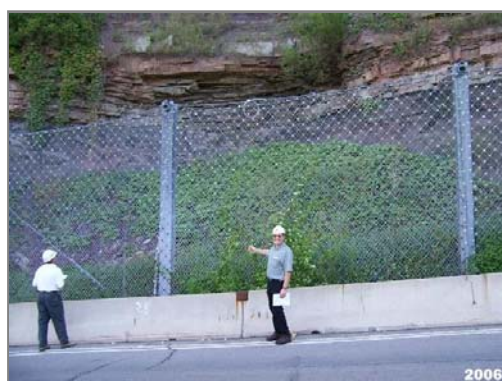
NYSDEC 2004: Rust on fencing at GF-S4 and Culvert 3 is caused by road salt in plow-thrown snow.  
NYSDEC 2006: 9:27AM, Heavy vegetation.

CRA 2004: Culvert 3. Inlet is open. Dry soil. Outlet is damp. No action required. Same as 2000 -2003.

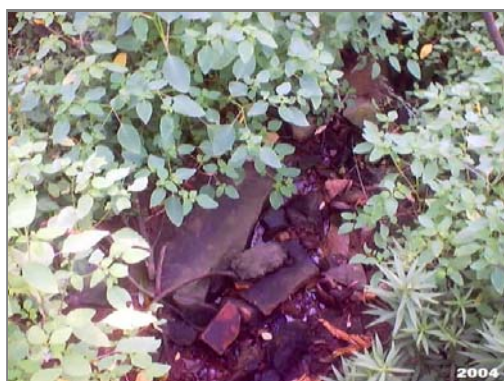
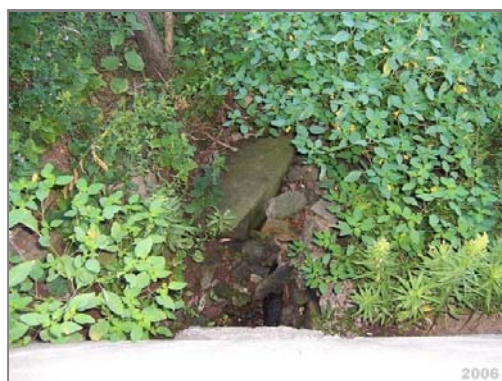
NYSDEC 2004: Culvert 2 has slight flow. There is growth of Staghorn sumac with a lot of dead branches and wilted vegetation at this location (not shown).  
NYSDEC 2006: 9:27AM, No flow. Dead sumac trees.

CRA 2004: Inlet is buried. No odor. Outlet has significant vegetation, a slight flow (less than 0.5 gpm), moss, no odor. No action required. Same as 2000 -2003. 2006, right.

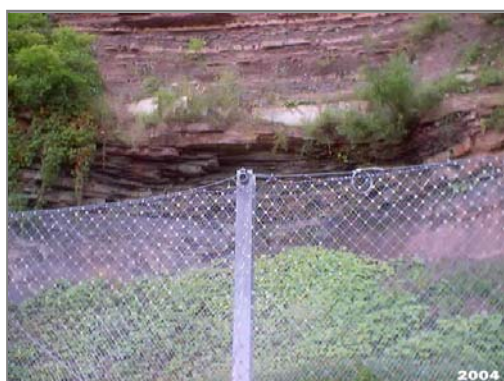
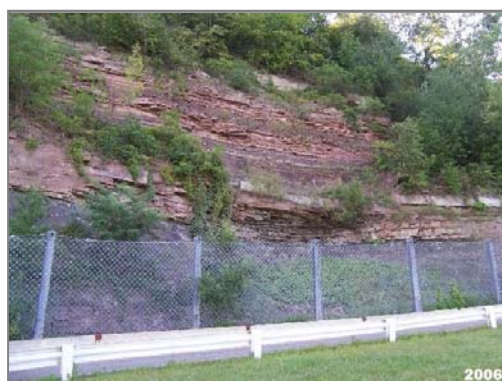
NYSDEC 2004: GF-S20 and Culvert 2. Water is dripping from the bowl-shaped, concave, cliff face.  
NYSDEC 2006: 10:05AM, Seep 20.

CRA 2004: Seep 20. Area 80' to 100' north of the north fence line of Seep 4 at the base of the Grimsby Sandstone down into the Power Glen Shale. Slightly dripping. No action required. Basically the same conditions as in 2002 and 2003.

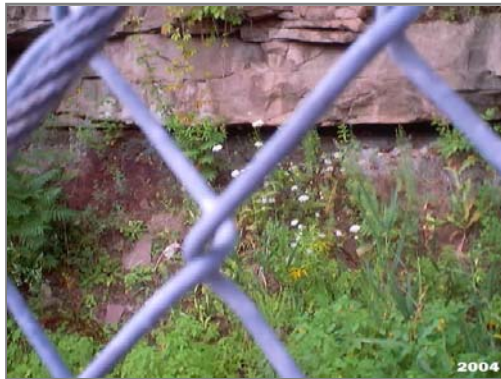
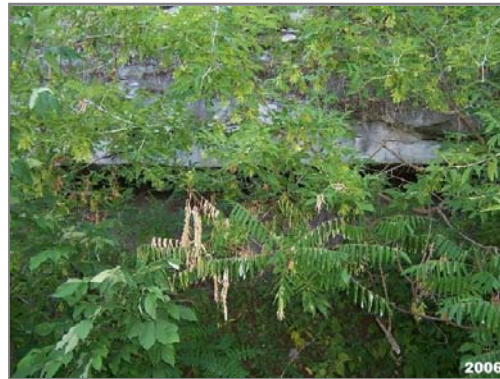
NYSDEC 2004: GF-S19. Damp area, no visible flow in ditch.  
NYSDEC 2006: 10:12AM Damp.  
CRA 2004: Seep 19. Approximately 120' south of the south end of the wing wall. Queenston/Whirlpool rock face damp. No visible flow in ditch. Heavy vegetation. No action required. Basically the same conditions as in 2002 and 2003.

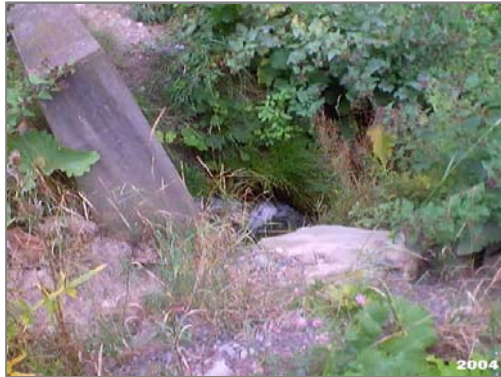
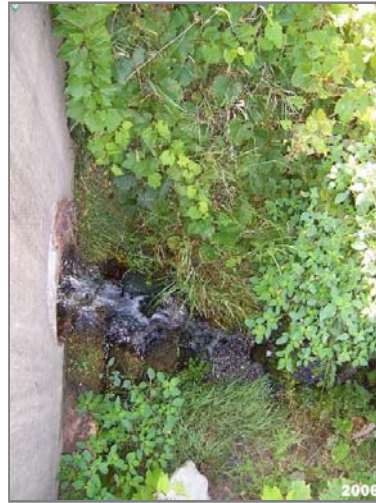
NYSDEC 2004: Seep 12 is flowing 30-40 gpm. Culvert 1 is dry (no Photo). We then left the power authority roadway and hiked along the river edge trail. It began to rain.  
NYSDEC 2006: 10:12AM Running flow 10 - 20 gpm.  
CRA 2004: Seep 12. Steady flow out of culvert from NYPA south tunnel. Flow approximately 30 to 40 gpm. No odor, noticeable algae in pipe. Sampling discontinued after 2001 due to history of non-detects.

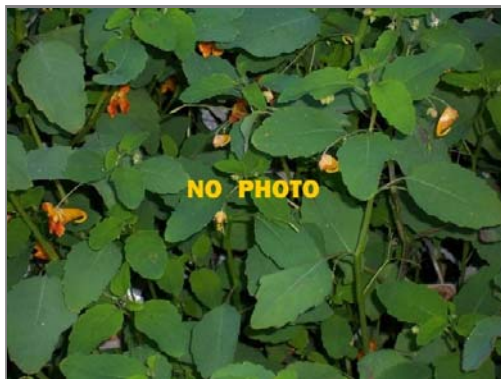
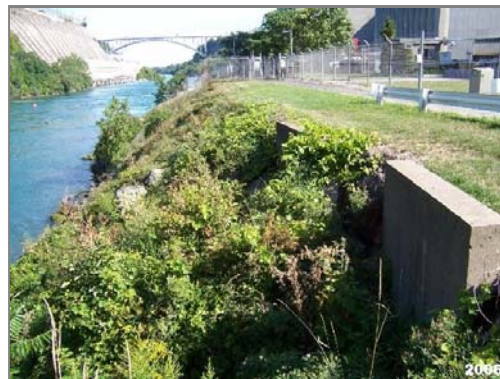
NYSDEC 2004: No comment.  
NYSDEC 2006: 10:19AM, can't see the outlet, heavy vegetation.  
Culvert 1 (background) and Culvert 12 (foreground).  
CRA 2004: Culvert 1. Picks up ditch flow to Drop Inlet at bottom of NYPA access road. Dry. No action required. Same as 2000 -2003.

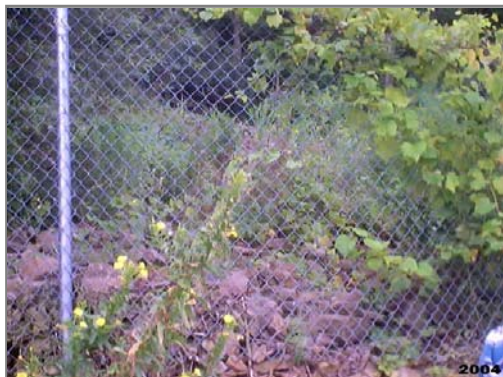
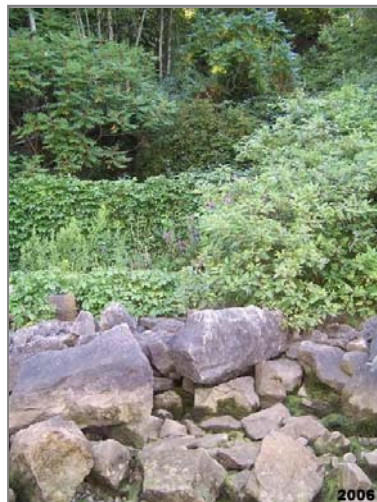
NYSDEC 2004: **Bloody Run**. When the weather is hot, one can smell volatiles at this location. There was no odor this year, Brian commented.  
NYSDEC 2006: 10:33AM, Fenced-in vine-covered fence. Algae on talus. No visible flow.

CRA 2004: **Bloody Run**. Fenced-in area by the river shoreline. No visible flow, no odor, heavy talus. Fence is in place and in good condition. Same as in 2000 through 2003.

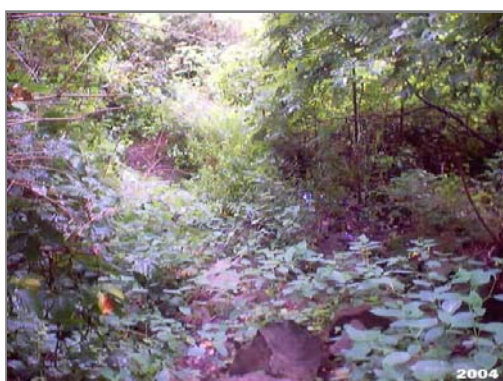
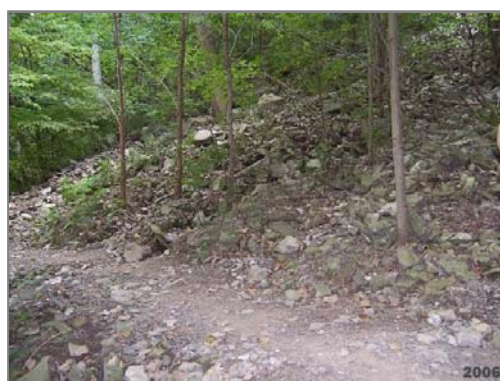
NYSDEC 2004: **GF-S11** was dry. Remains of railroad stonework can be present at this location and others along the trail along the river edge.  
NYSDEC 2006: 10:33, Dry.

CRA 2004: **Seep 11a**. Inlet area at water's edge covered with local rock. Sediment infilling. Remediated. Same as 2000, 2001, 2002, and 2003  
**Seep 11b**. Dry (south of Bloody Run Fence) Same as 2000, 2001, 2002, and 2003.

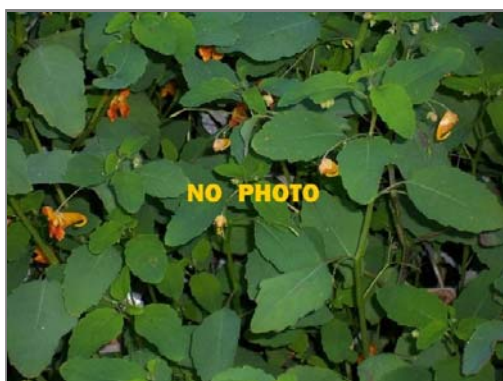
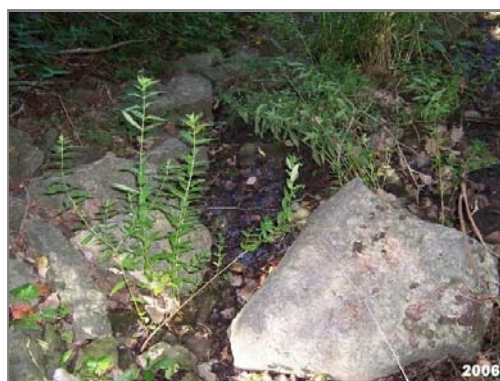
NYSDEC 2004: **Seep 8**. Approximately 5 gpm flow. Some vegetation, no odor. No action required.  
NYSDEC 2006: 10:33AM, very wet, tiny flow. Vegetation.

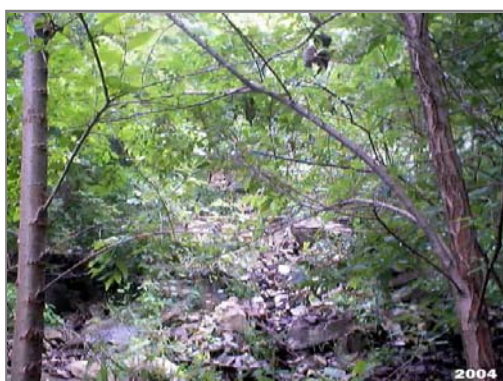
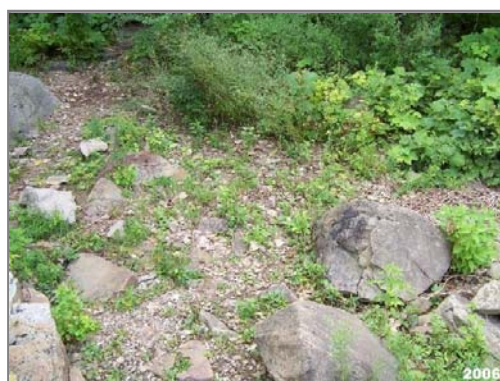
NYSDEC 2004: **GF-S21**.  
NYSDEC 2006: 10:45AM, **Seep 21** photographed near the river edge up from two potholes. We weren't sure this was the seep location. It was dry.

CRA 2004: **Seep 21**. Area 375' south of **Seep 7** (Devil's Hole Stairs) by the river - dry. Same as 2001, 2002, and 2003.

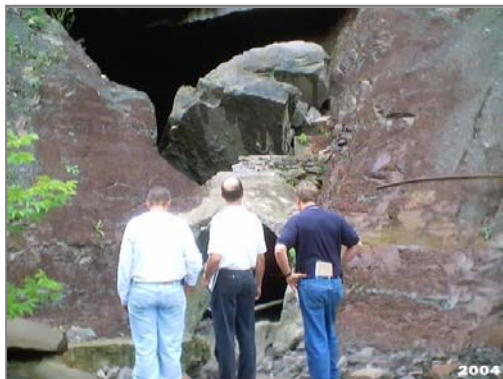
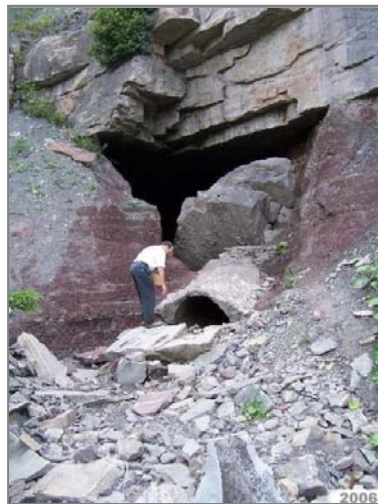
NYSDEC 2004: Garfield Avenue Sewer storm water overflow. Smell of sewage. Since it was raining, we didn't linger long at this location!  
NYSDEC 2006: 10:33AM, This locale really stinks of sewer! Tomatoes were growing as usual. Walkway is totally destroyed.

CRA 2004: Garfield Avenue Sewer. No flow at exposed original outlet, typical sewer odor, continual caving into former archway (Whirlpool Sandstone) Standing water in pipe. Additional washouts since 1998. Parks Dept built a pedestrian walkway (with two 36" diameter culverts) across the path in the summer of 1999. One culvert inlet completely buried.

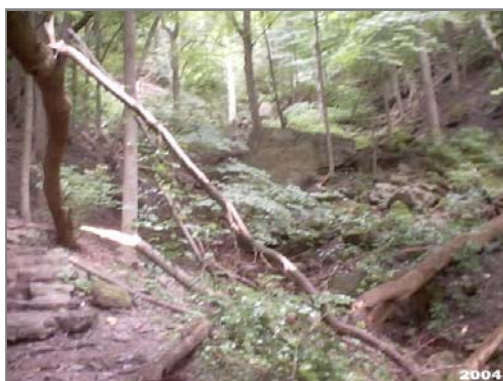
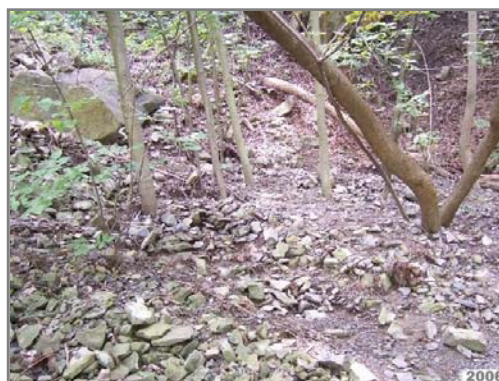
NYSDEC 2004: GF-S7. 7c flow beneath rocks.  
CRA 2004: Comments below

7e and 7h are located along the stone steps. At 7h we could hear water running beneath the stones.  
NYSDEC 2006: 11:00AM, GF-S7.

Seep 7 a,b Covered with local rock. Heavy vegetation. Remediated. Same as 2001-2003.

Seep 7 c. Some exposed channel flow between rocks. Remediated. Same as 2001-2003.

Seep 7 e,f,g,h,i. Flowing water beneath rocks. Heavy vegetation. Some exposed channel flow. No action required.

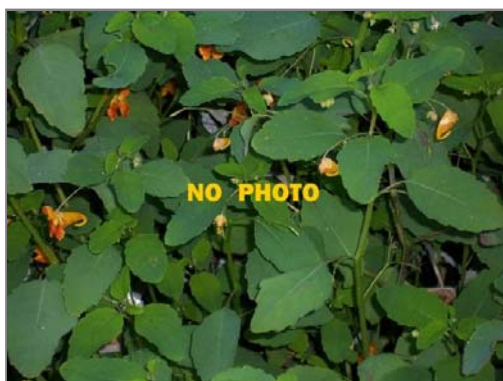
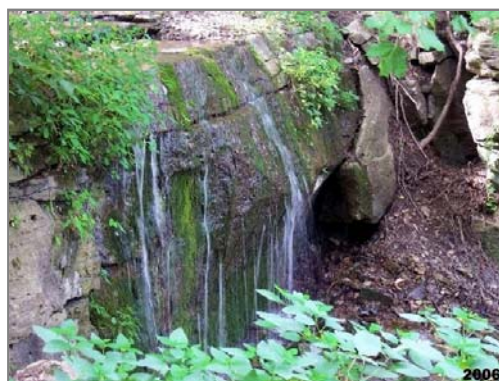
NYSDEC 2004: Seep 7d, wet and flowing (15 to 20 gpm) over top of Irondequoit (waterfall).  
NYSDEC 2006: 11:00AM, Seep 7d, flowing waterfall

CRA 2004: Seep 7d, wet and flowing (15 to 20 gpm) over top of Irondequoit (waterfall). No odor. Sampled September 24, 2003. Non-Detect for all parameters - same as 1999, 2000, 2001, and 2002.

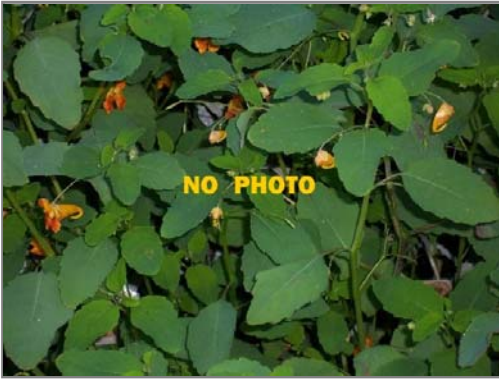
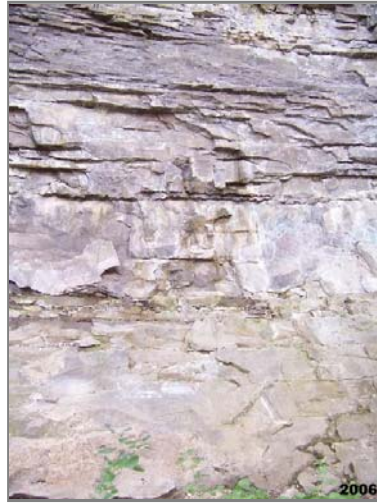
NYSDEC 2004: Not certain of Seep 5's location.  
NYSDEC 2006: 11:45AM, Seep 5. Occasional drip.

CRA 2004: Seep 5. Damp rock face, slight dripping. Remediated. Same as 2001-2003.

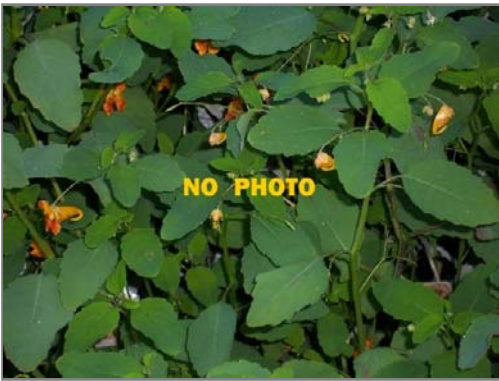
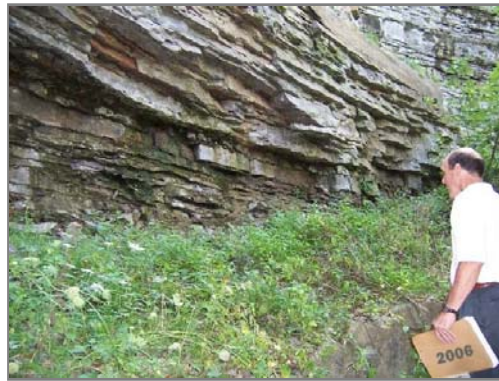
NYSDEC 2004: No comment.  
NYSDEC 2006: 11:33AM, Moist.

2004: Seep 6. Moist rock face with slight dripping. Remediated. Same as 2001-2003.

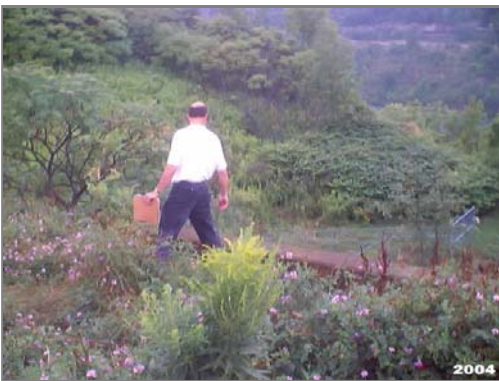
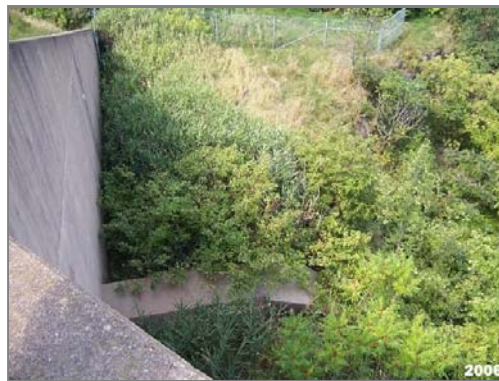
NYSDEC 2004: GF-S3. Top of the box culvert connected to Garfield Street Sewer. There's water flowing in the culvert.  
NYSDEC 2006: 11:45AM, GF-S3. *Phragmites* are growing below at the location of the seep.

CRA 2004: Top of the box culvert connected to Garfield Avenue sewer. there's water flowing in the culvert. End of 2004 walk at 11:30AM.
