Hyde Park Landfill 2009 Gorge Inspection Walk

DER Site Management, 7/21/09

Photos with Notes

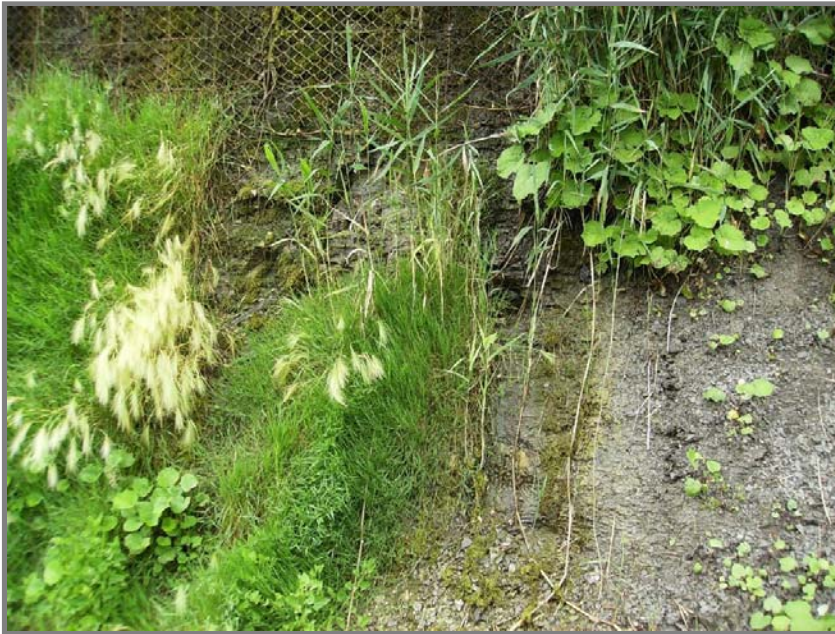
Seep 2 on access road. Typical flow. I was catching up to the group who had gathered at the foot of the hill. Due to a mis-understanding, I met the rest of the participants at the bottom of the hill at the entrance to the gorge path.

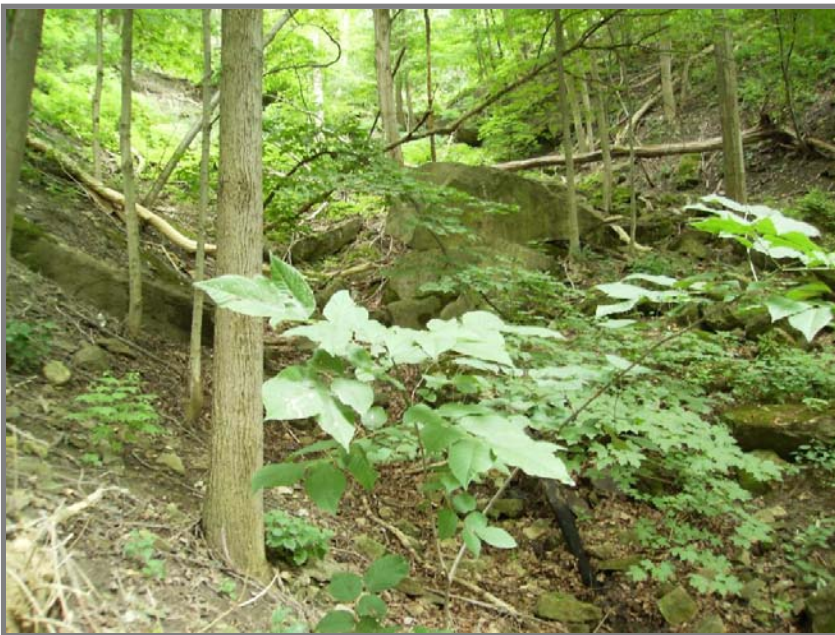
Minor flow beneath the rocks and vegetation not very visible here.

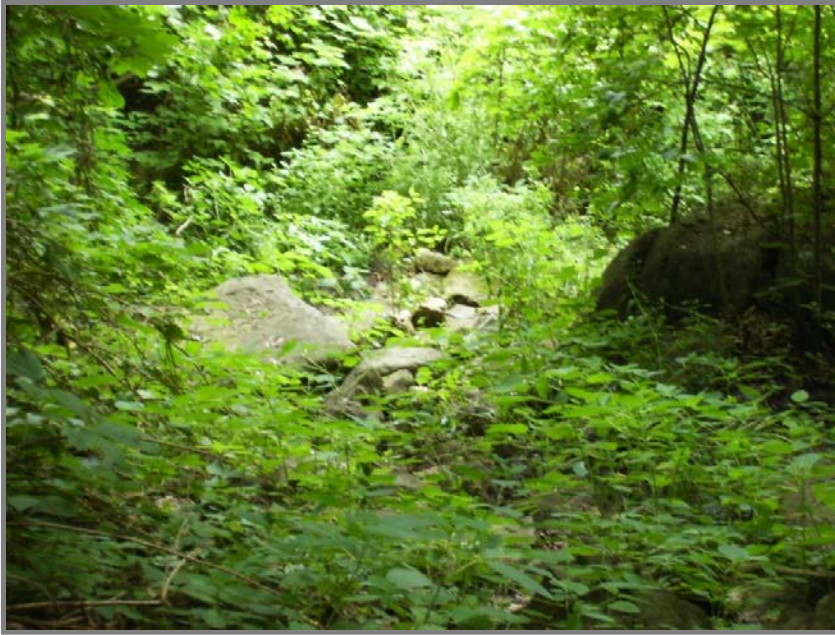
Minor flow beneath the rocks and vegetation not very visible here.
