Hooker-Hyde Park Landfill Gorge Inspection

DER Site Management, 06/08/2011

Report by Will Welling, NYSDEC

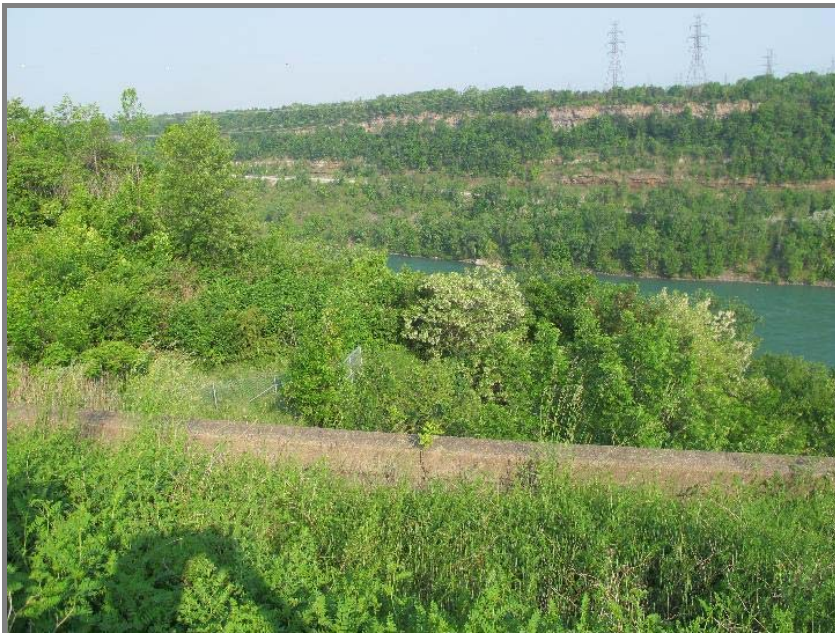
8:47 AM. Walk to Seep "3 Upper," the wing wall with seep holes, overlook. "3 Top" is overgrown. "3 Lower" - same as last time.

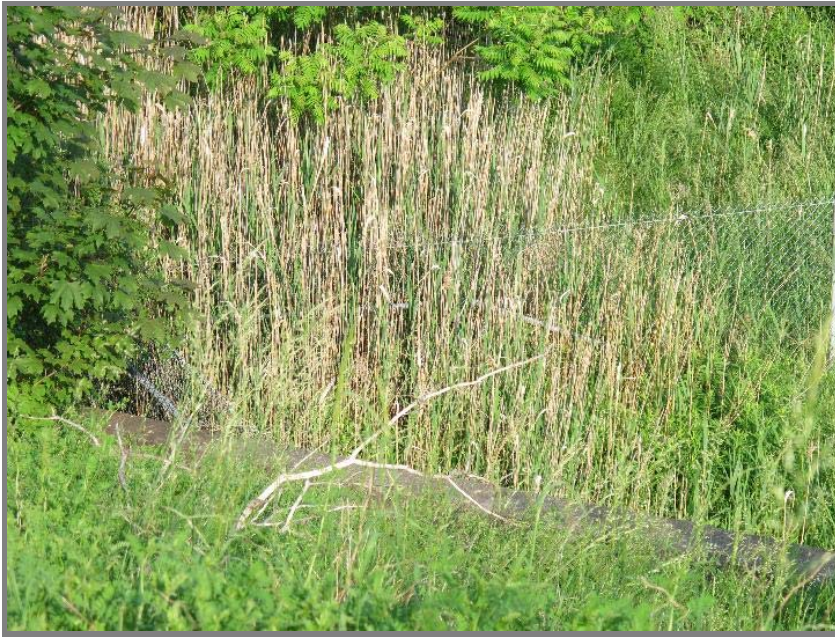
8:52 AM. We left hard hats at the wall and began walking down into the gorge on the stone steps. Seeps 5 and 6 were moist, dripping. Same as last time.

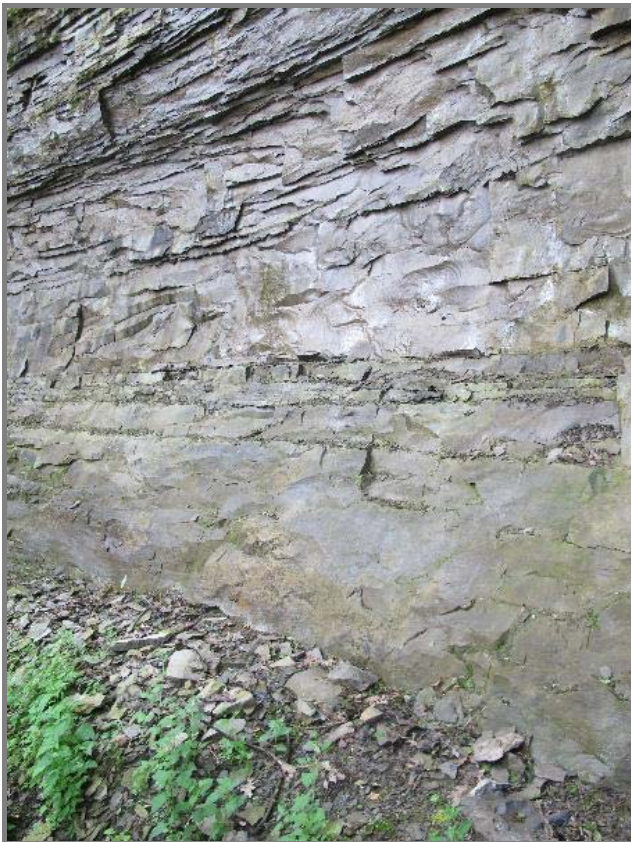
9:04 AM. Seep 5

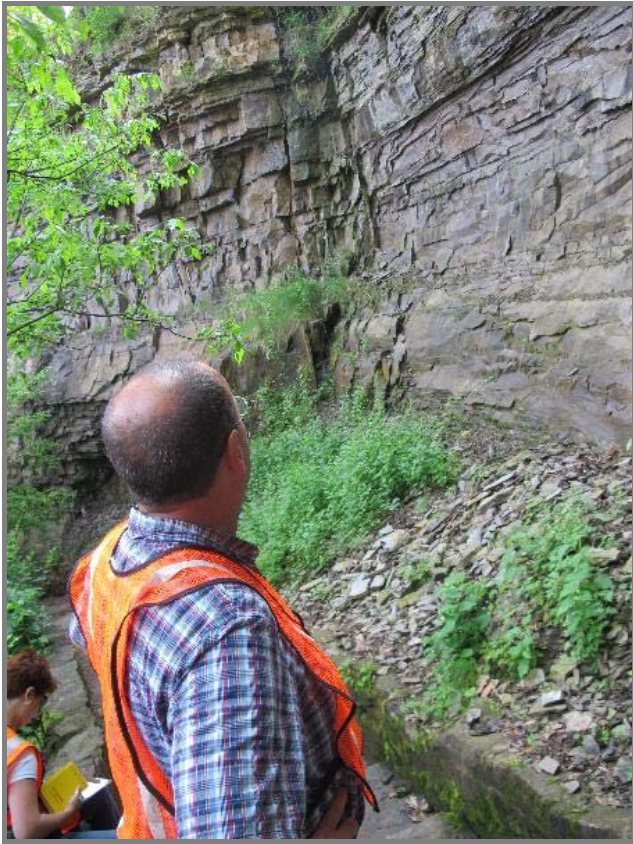
9:04 AM. Seep 6.

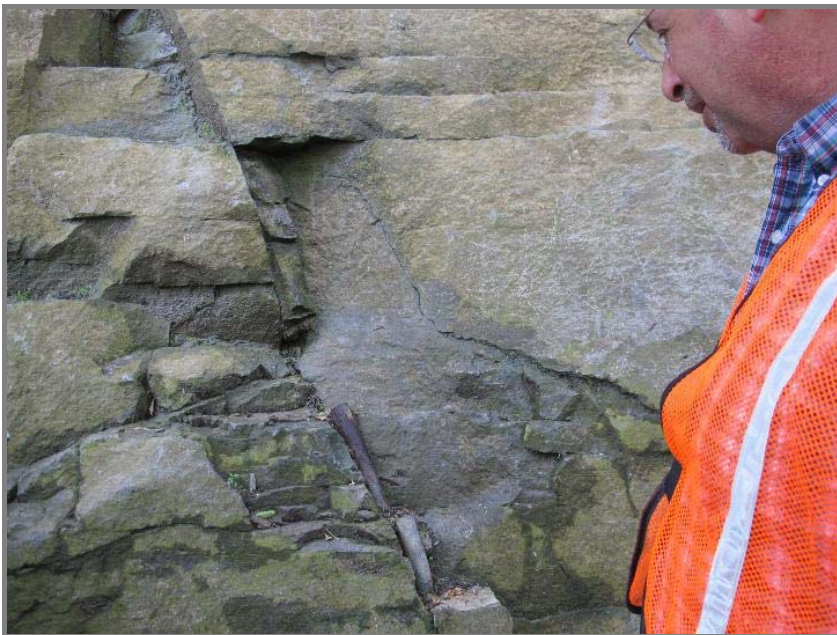
9:08 AM. Matt Forcucci pointed out two pieces of pipe. A galvanized pipe runs under the right hand edge, collecting water.

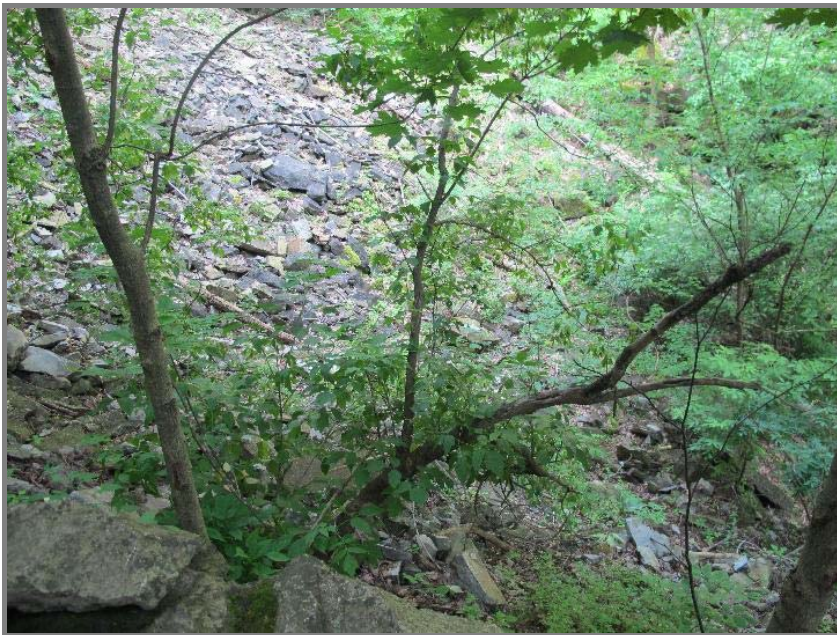
9:12 AM. Matt said that the piping here was placed beneath stone and mortar. Seep water was conducted away from the path to daylight on the other side of the path. "This was 1980s technology," he said. This is a photo looking towards "the other side of the path."

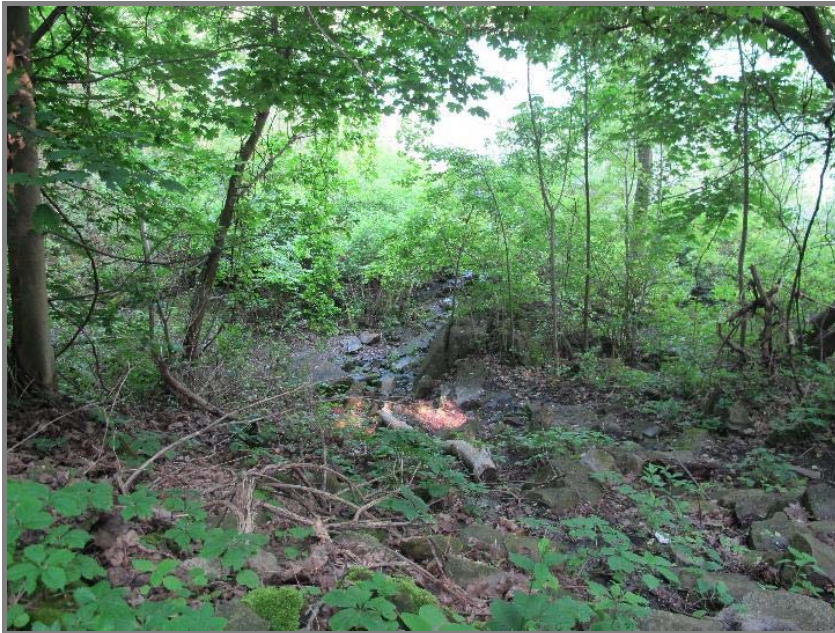
9:24 AM. My notes don't align perfectly with the photos. My log book says, Seep #7A, dry. Woodchuck sighted. Seep 7 B & C talus-covered, no visible flow. Seep 7 D flowing. This seep has increased possibly from the last time, we commented.

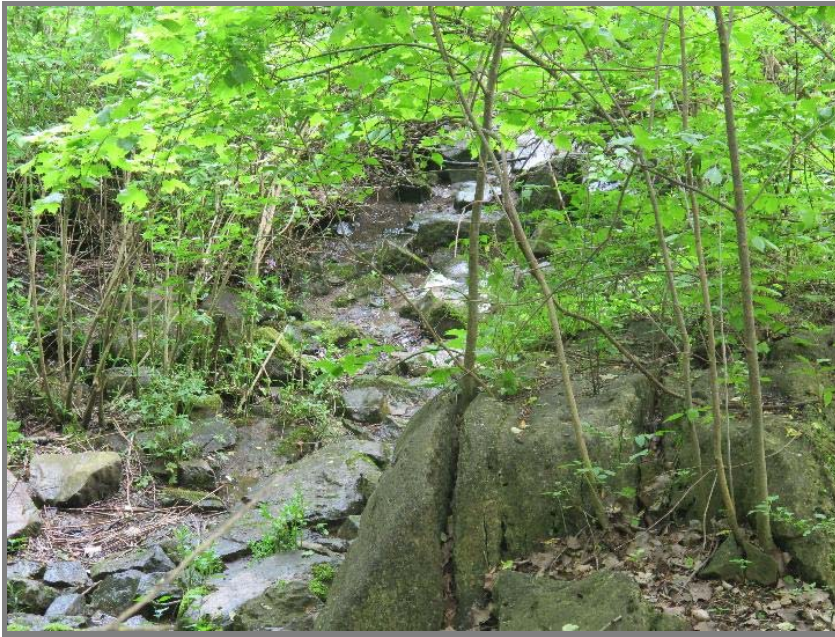
9:24 AM. This is the Irondequoit. The 7-series no visible flow at end, above the path, but flow is visible at the "beach." The "beach" location is Seep #8.

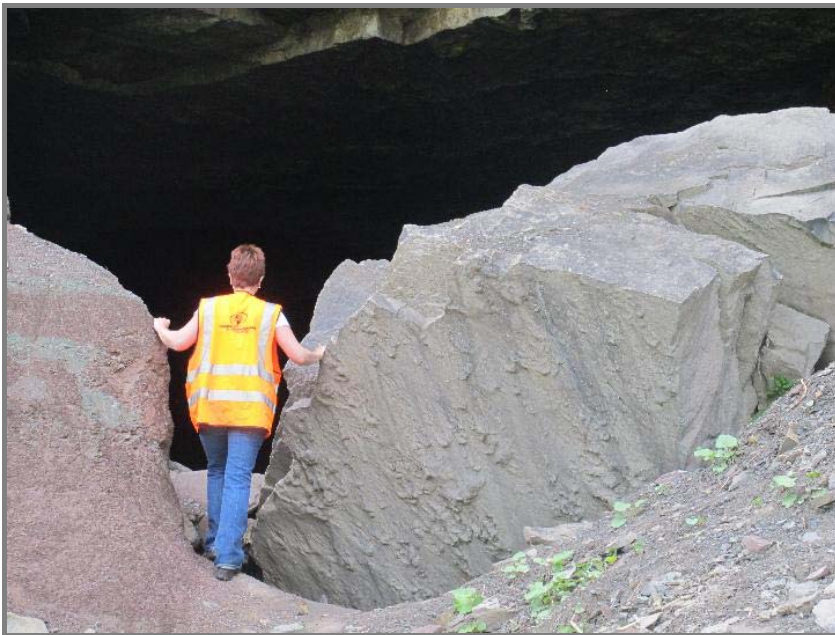
9:34 AM. Garfield Avenue Sewer. Seep # 21. We noted more fallen rx. than last visit. We walked into the cave. cool air flowing out; not too much smell.

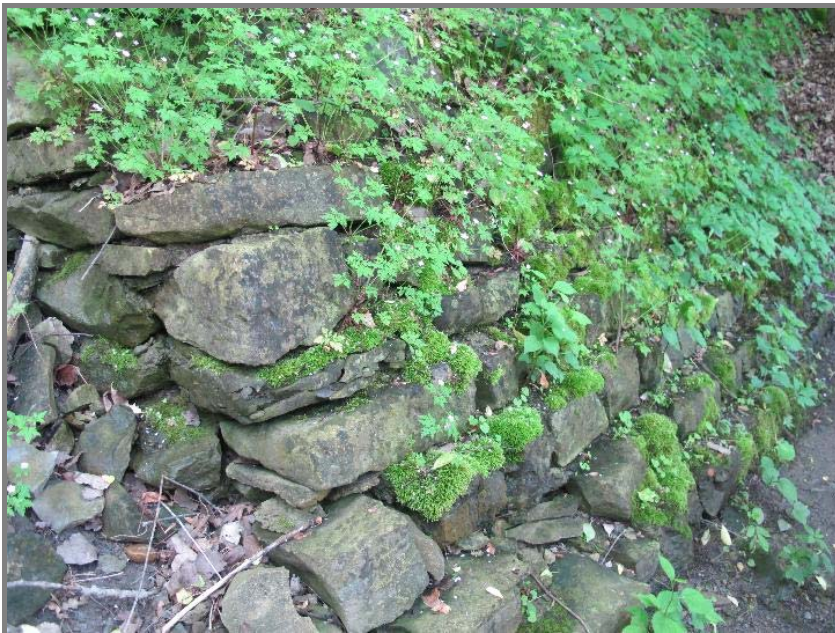
10:03 AM. Laid-up stone, a remnant of the narrow-gauge train that ran here many years ago. Seeps 11 A & B Inlet along the river bank at the laid-up stone.

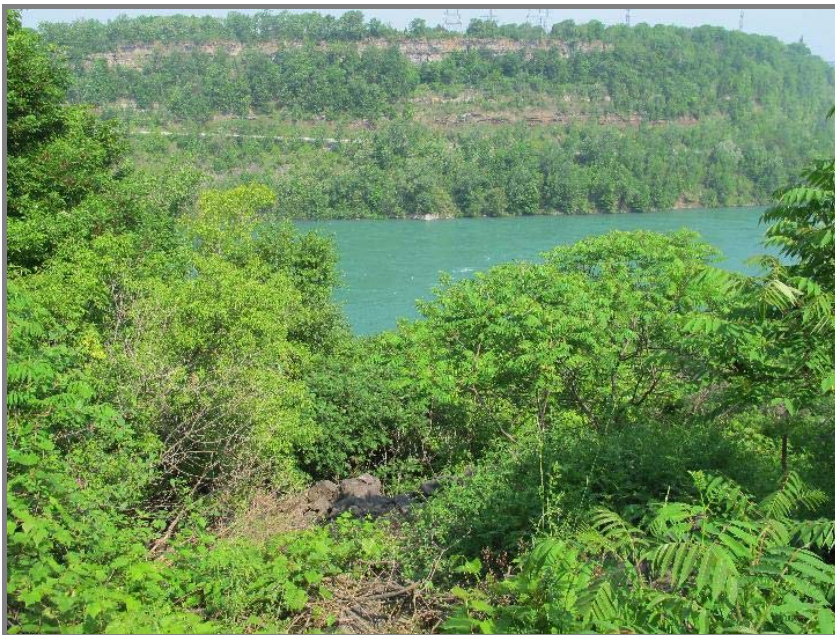
10:47 AM. Culvert 8 overlooking the river. Culvert 7 was obscured by overgrowth.

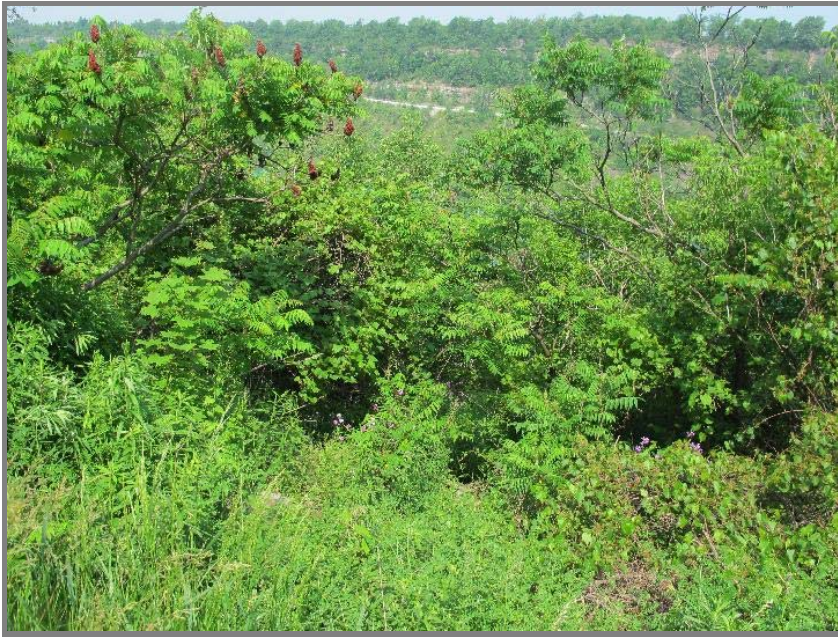
10:49 AM. Photo through sumac.
Seep 167, damp area at contact,
Lockport-Rochester.

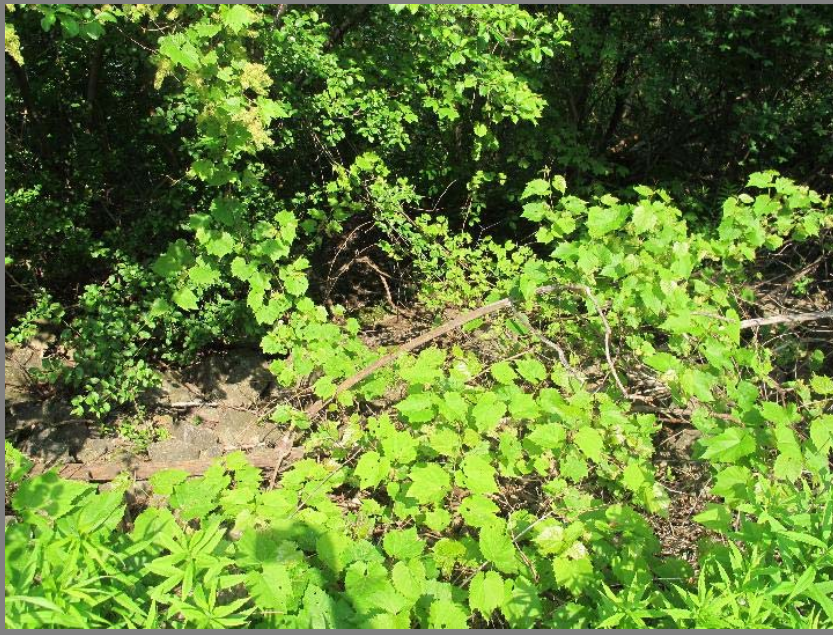
10:55 AM. Culvert 6, headwall barely visible. Seep 2. grate, basin pipe. Much growth, flow of water.

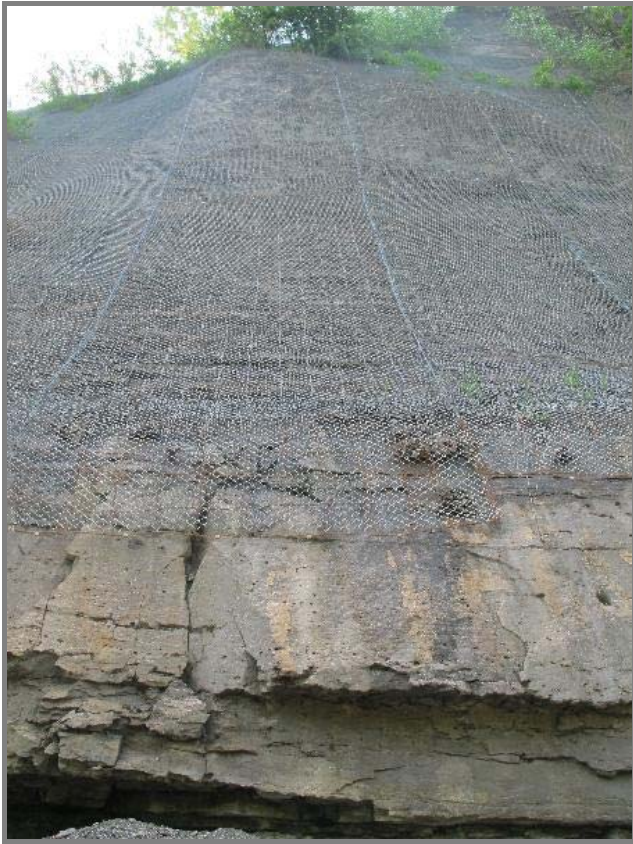
11:00 AM. Seep 17A, slightly moist, damp, color on rock.

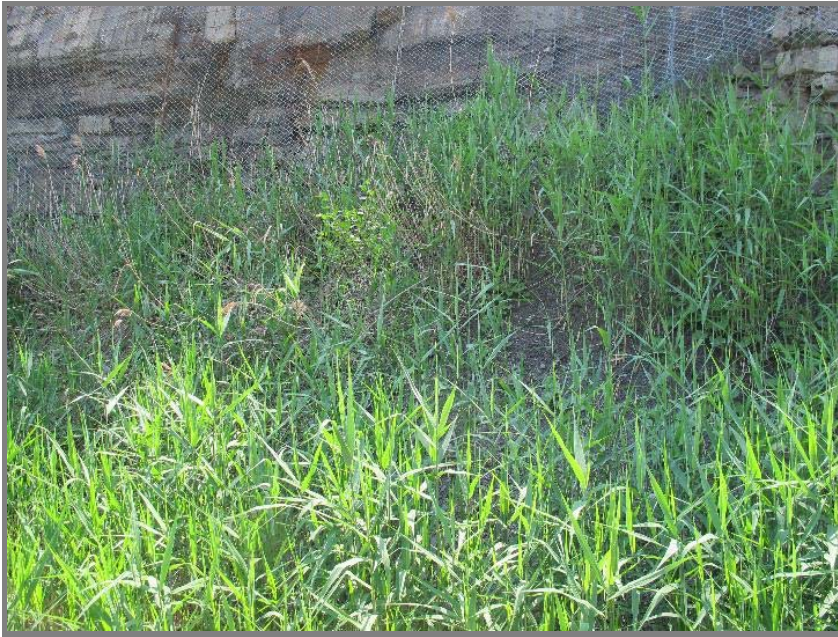
11:02 AM. Seep 3, flowing,
ditch, vegetation abundant.

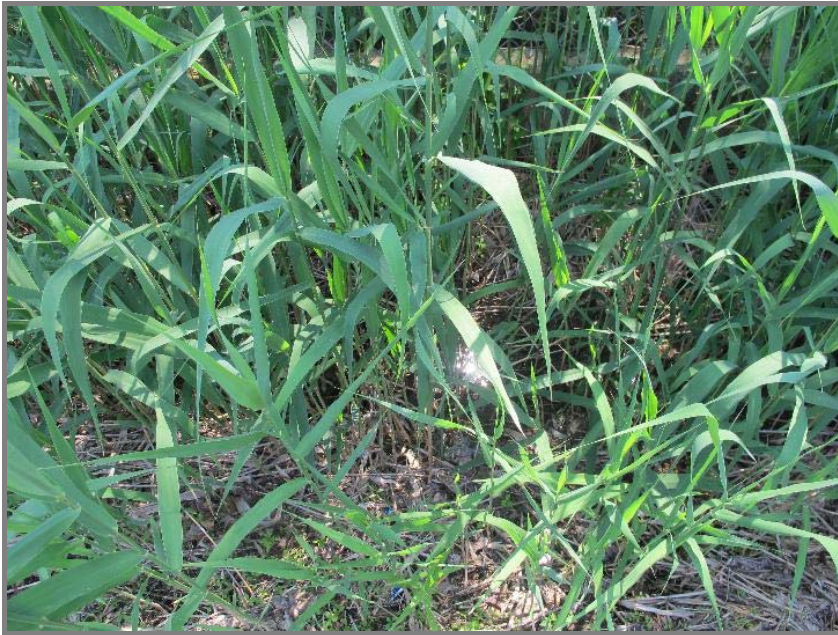
11:04 AM. Seep 3, flowing,
ditch, vegetation abundant.

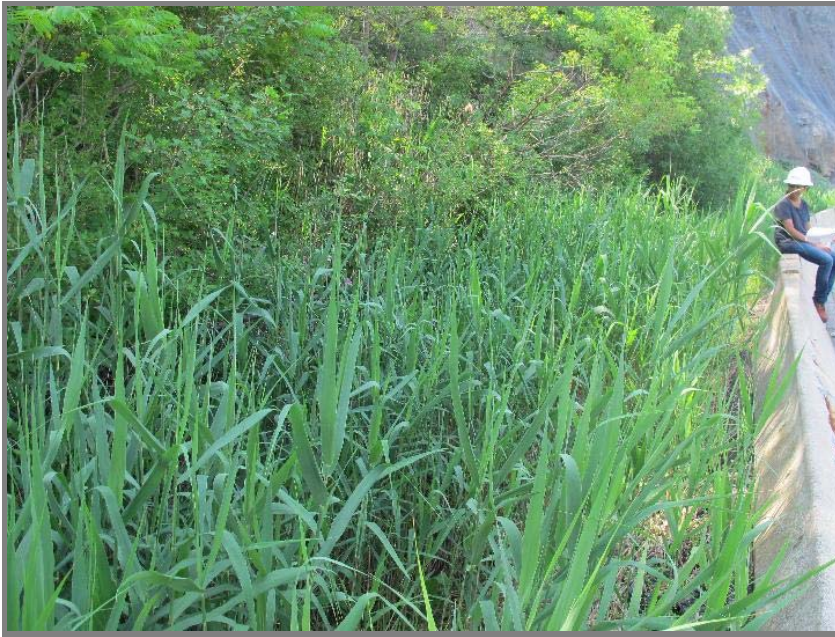
11:05 AM. My notes don't synch with the photos here. My notes say, Box culvert for bloody run. At inlet for culvert 5, Olutle culvert 5. Vegetation and flow. Bloody run concrete gutter.

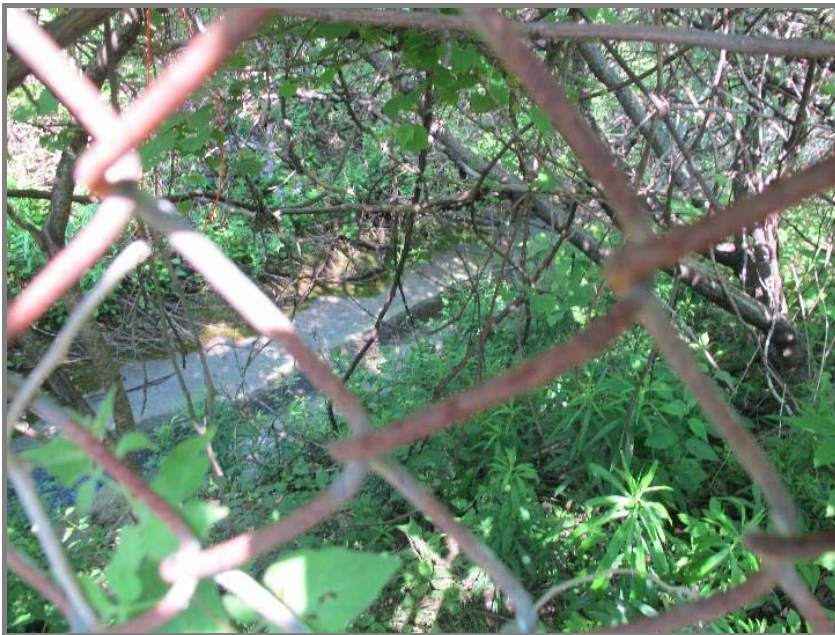
11:10 AM. Culvert #4 behind the chain-link fence. Couldn't find last time or this time.

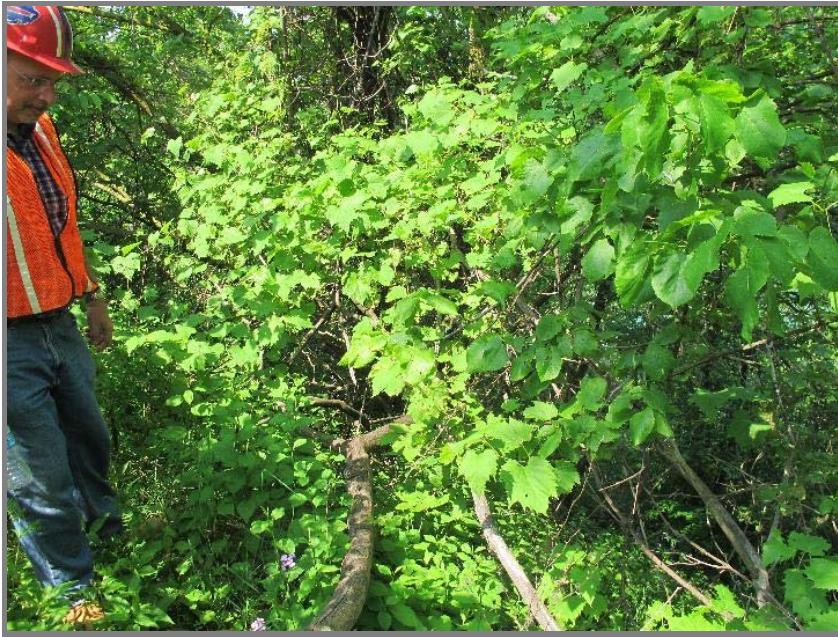
11:12 AM. Dry on cliff face side.

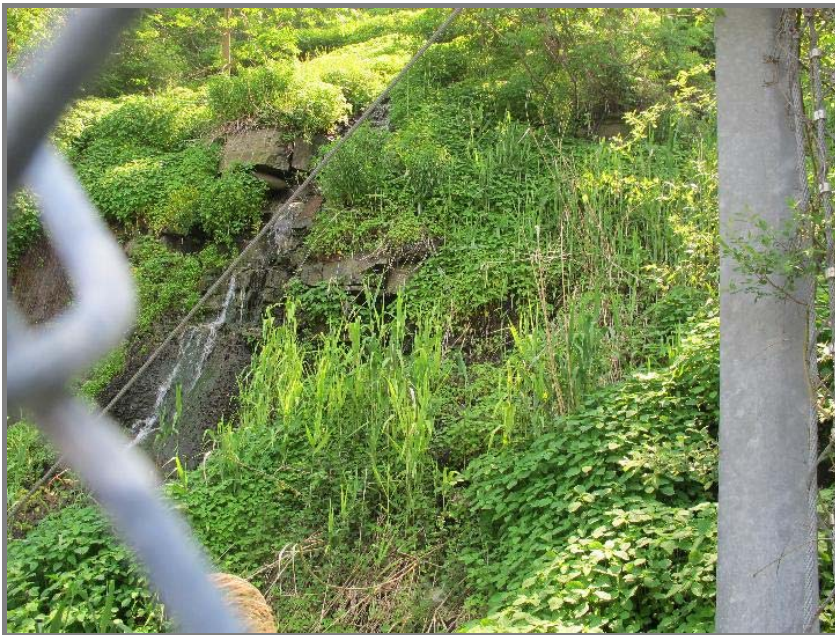
11:18 AM. Seep # 4. "Like a typical waterfall." There's a basin here and a culvert.

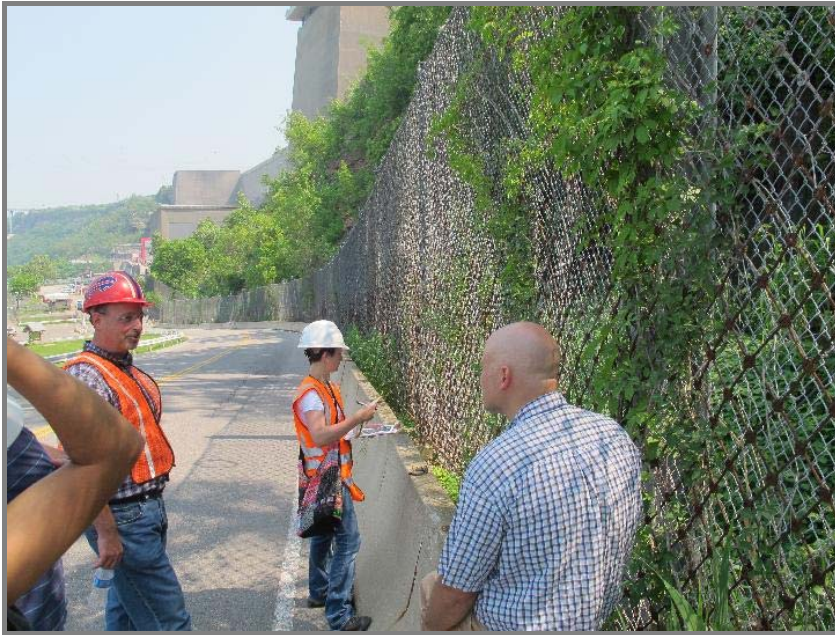
11:18 AM. Seep 20, damp.

Culvert 2, outlet obscured.

Seep # 19, flowing at base,
damp wall.

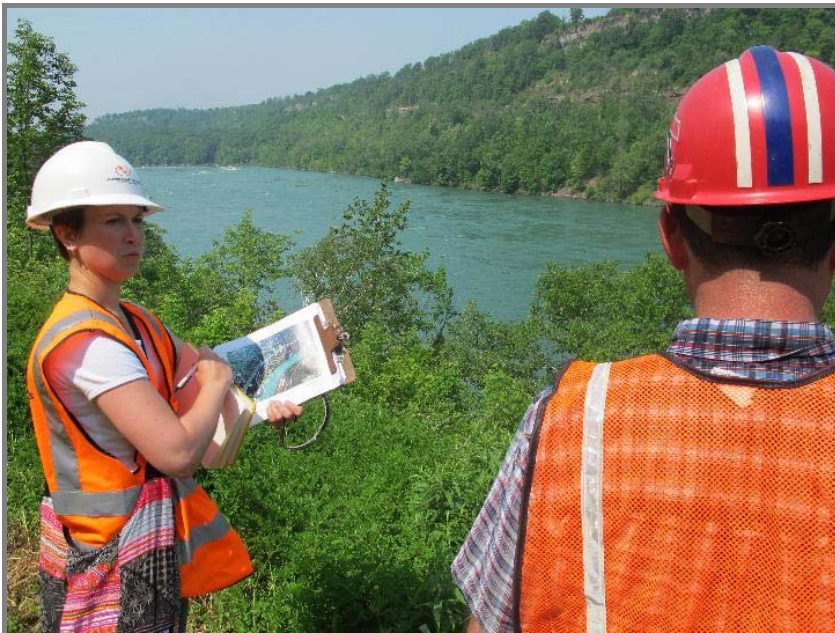
11:24 AM. Seep 15, Culvert 1,
steady flow.
