## **PRELIMINARY ASSESSMENT / SITE INSPECTION**

Former Guterl Specialty Steel Corporation  
Lockport, New York

U.S. Army Corps Of Engineers  
Buffalo District  
1776 Niagara Street  
Buffalo, NY 14207  
04/13/01

**FUSRAP - GUTERL SPECIALTY STEEL CORPORATION, LOCKPORT, NY**  
**STRUCTURAL INSPECTION**  
**EXCISED BUILDINGS NUMBERS 1-6, 8, 9, and 35**

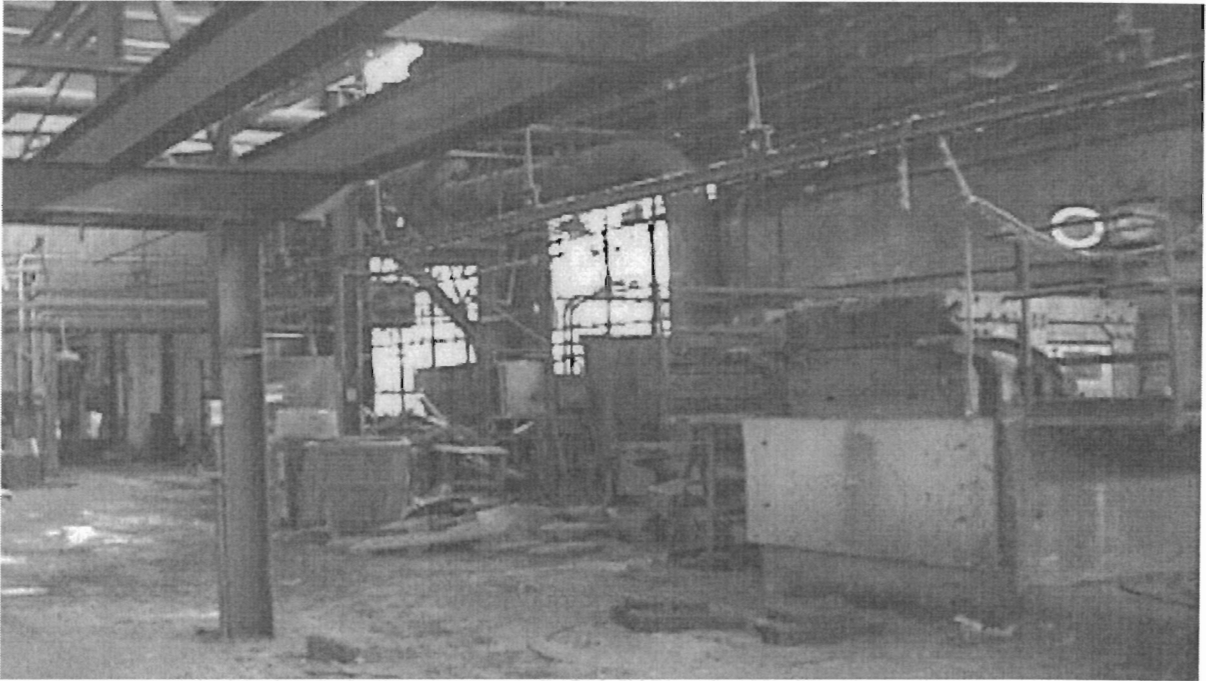
2.4.5 Observations: Massive holes are present in the corrugated sheet metal roof. See Photograph 1. More corrosion seems present in this building than in Building 1. Most metal rolling/mill buildings produce incredible amounts of heat, which in turn produces moderate to heavy amounts of condensation. This condensation can, in turn, produce substantial amounts of corrosion. This building may have experienced this phenomenon. Years of exposure to the elements may also attribute to the corrosion witnessed. Although the corrosion in Building 2 is higher than in the other excised buildings, it does not appear to be detrimental to the structural stability of Building 2. See Photographs 2-7.

**Photograph 1 - Building 2 - East Interior Wall Center Section**

2.4.6 Specific Conclusions/Recommendations: No significant structural distresses present in Building Number 2.

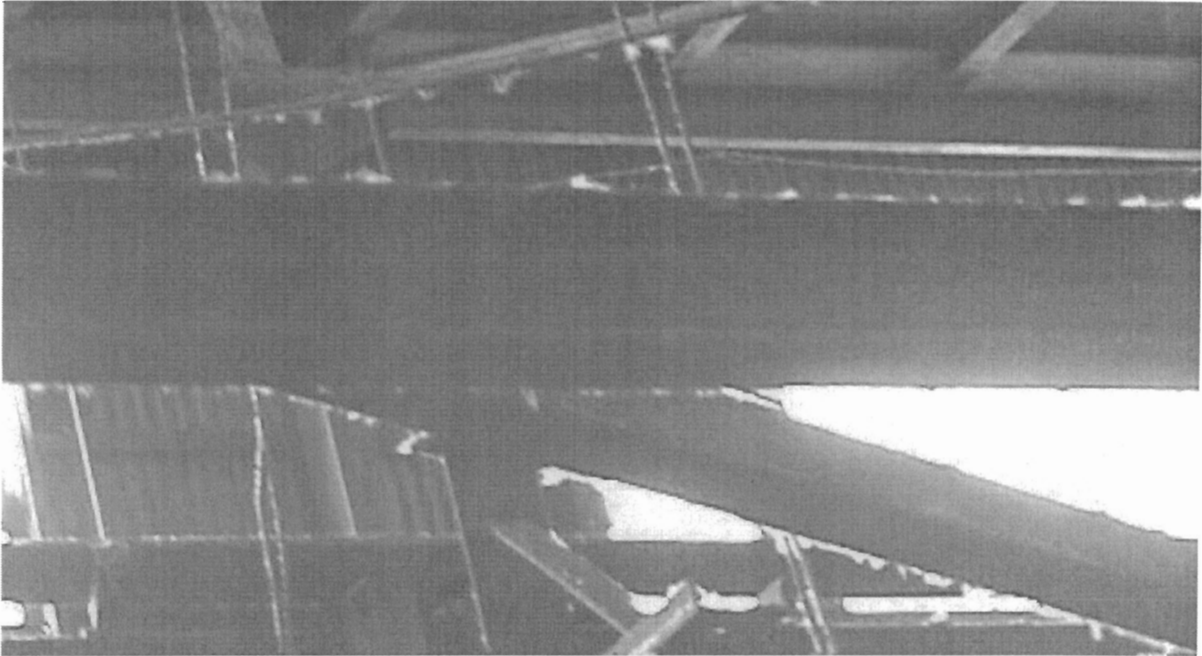
**Photograph 2 - Building 2 - East Interior Wall Connection & Roof**

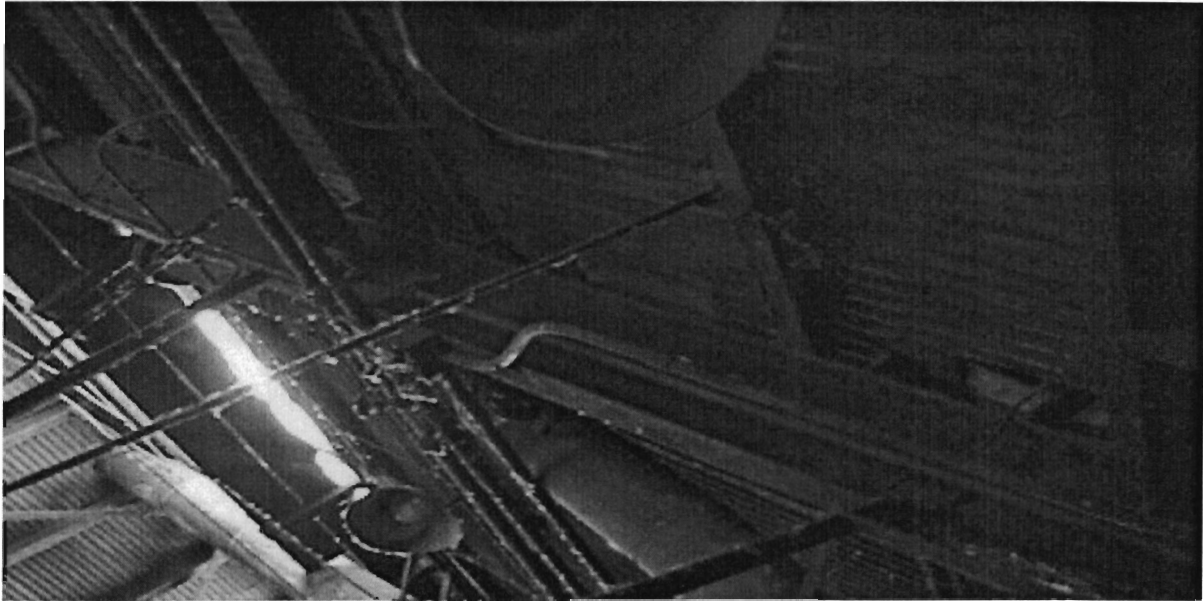
Photograph 3 - Building 2 - Roof

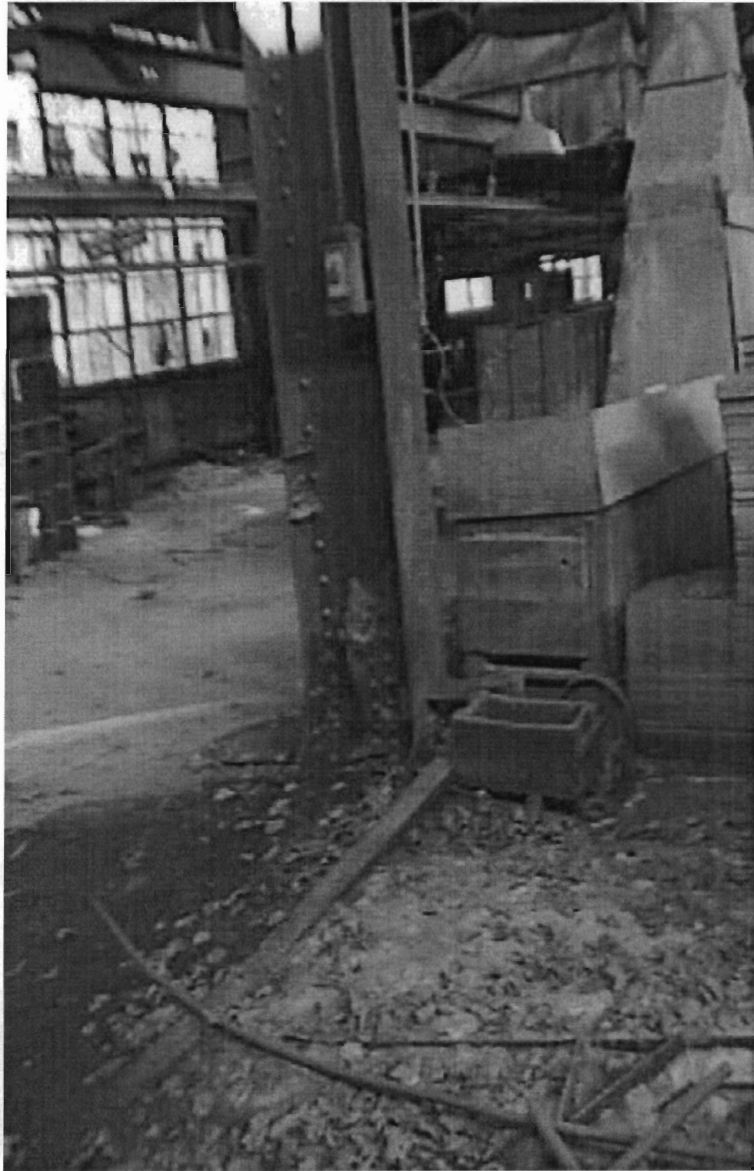
Photograph 5 - Building 2 - Typical Built-up Column

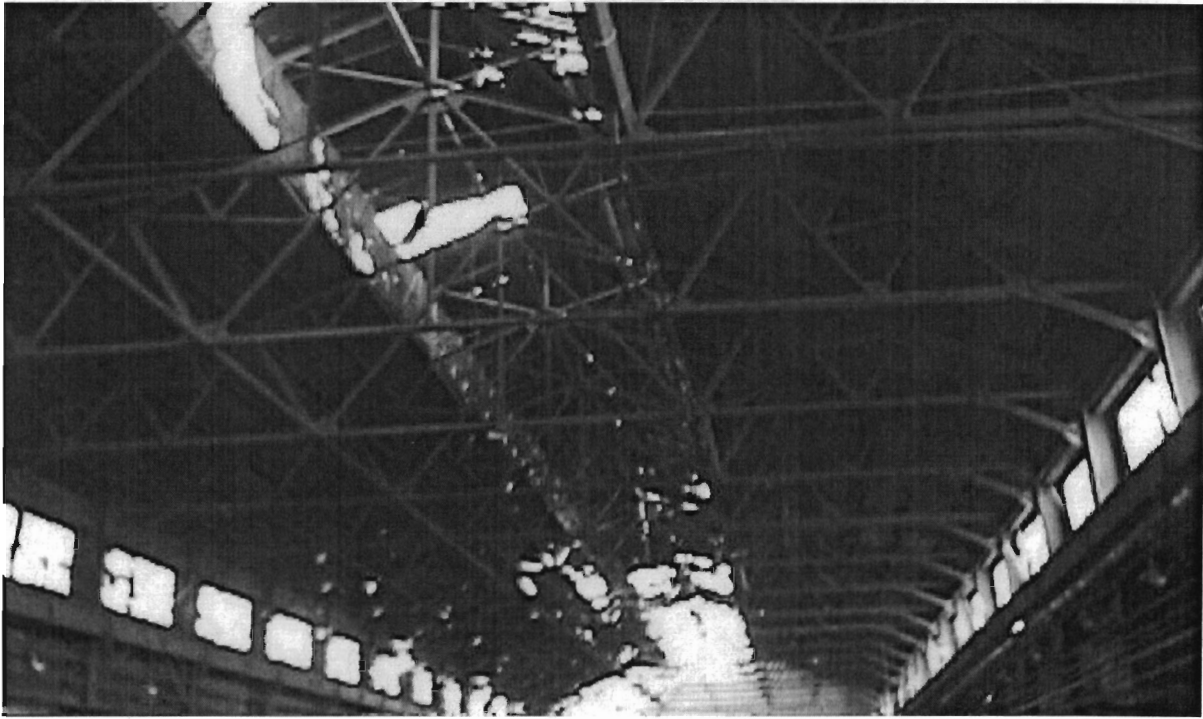
Photograph 6 - Building 2 - Typical Roof openings

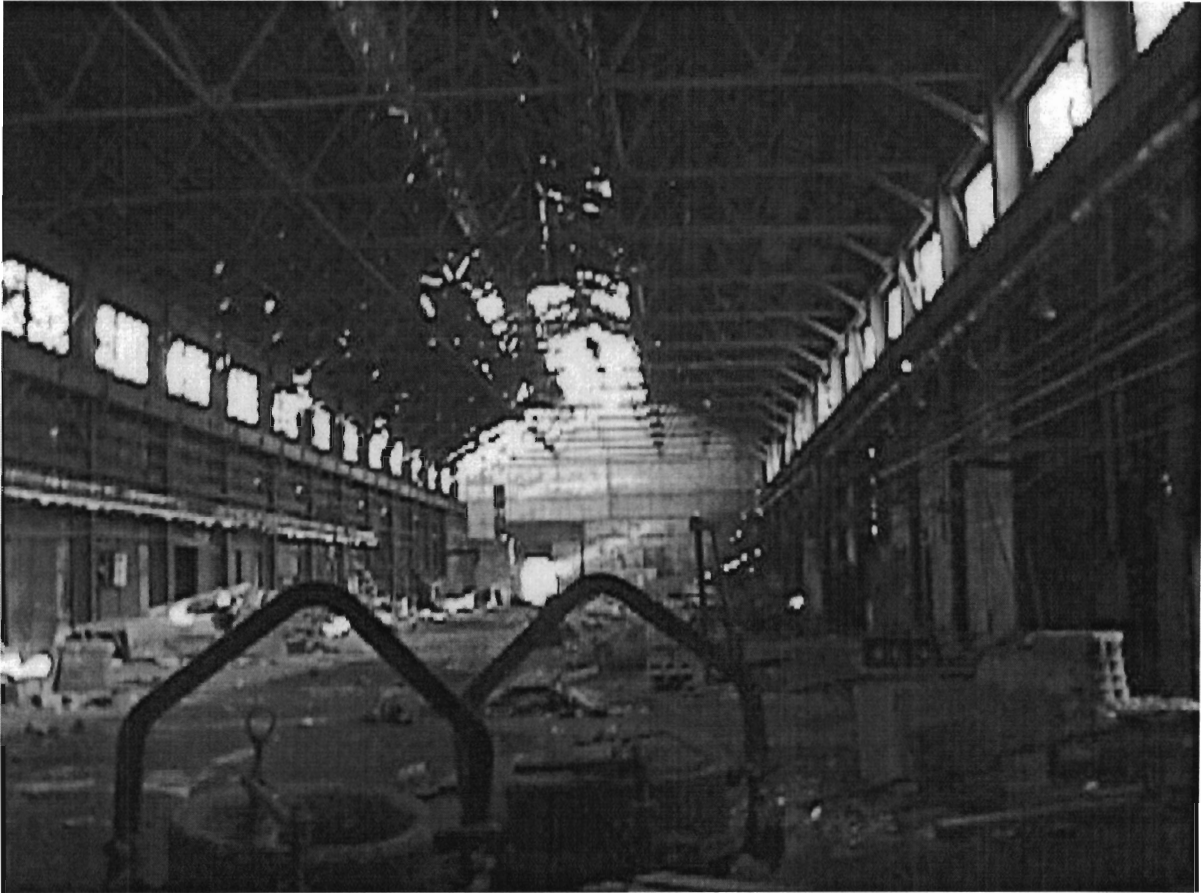
Photograph 7 - Building 2 - Overall Building View facing north

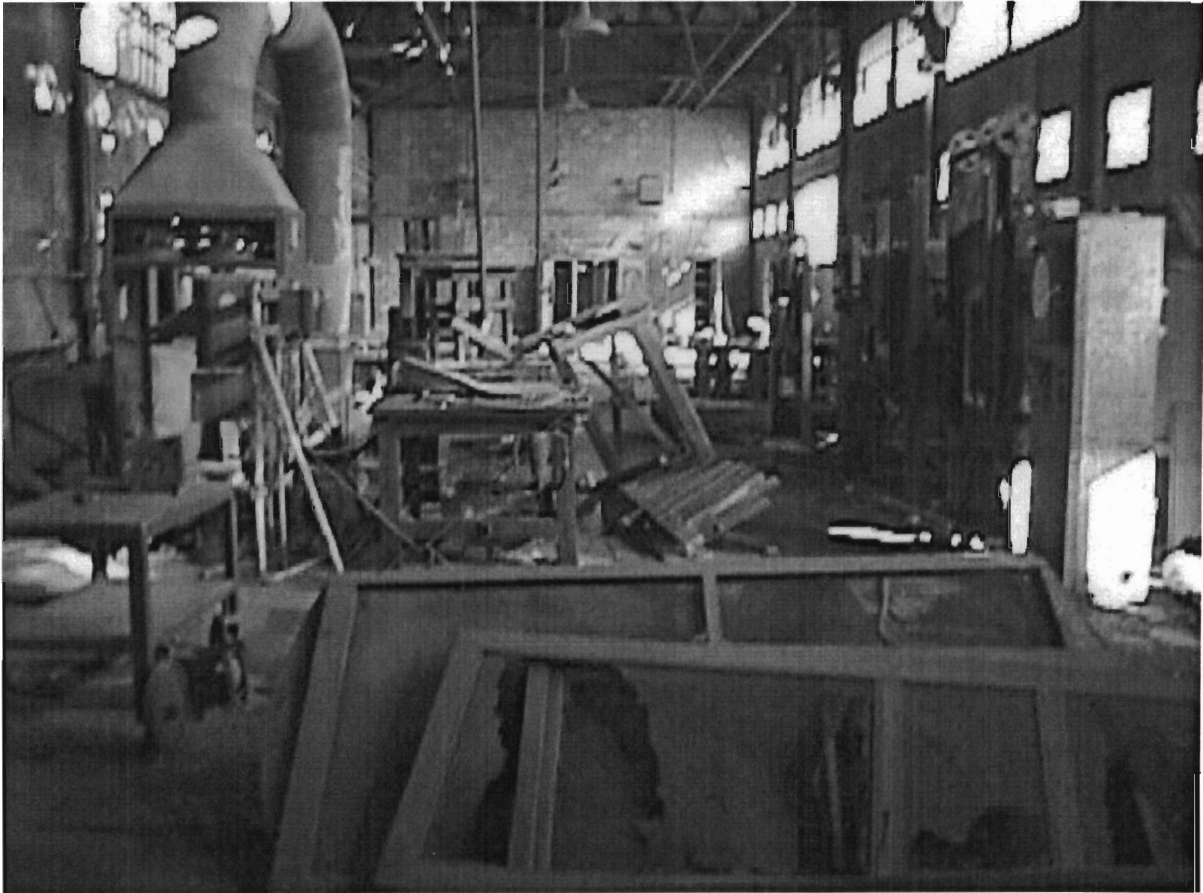
Photograph 9 - Building 1 - Center Room facing north

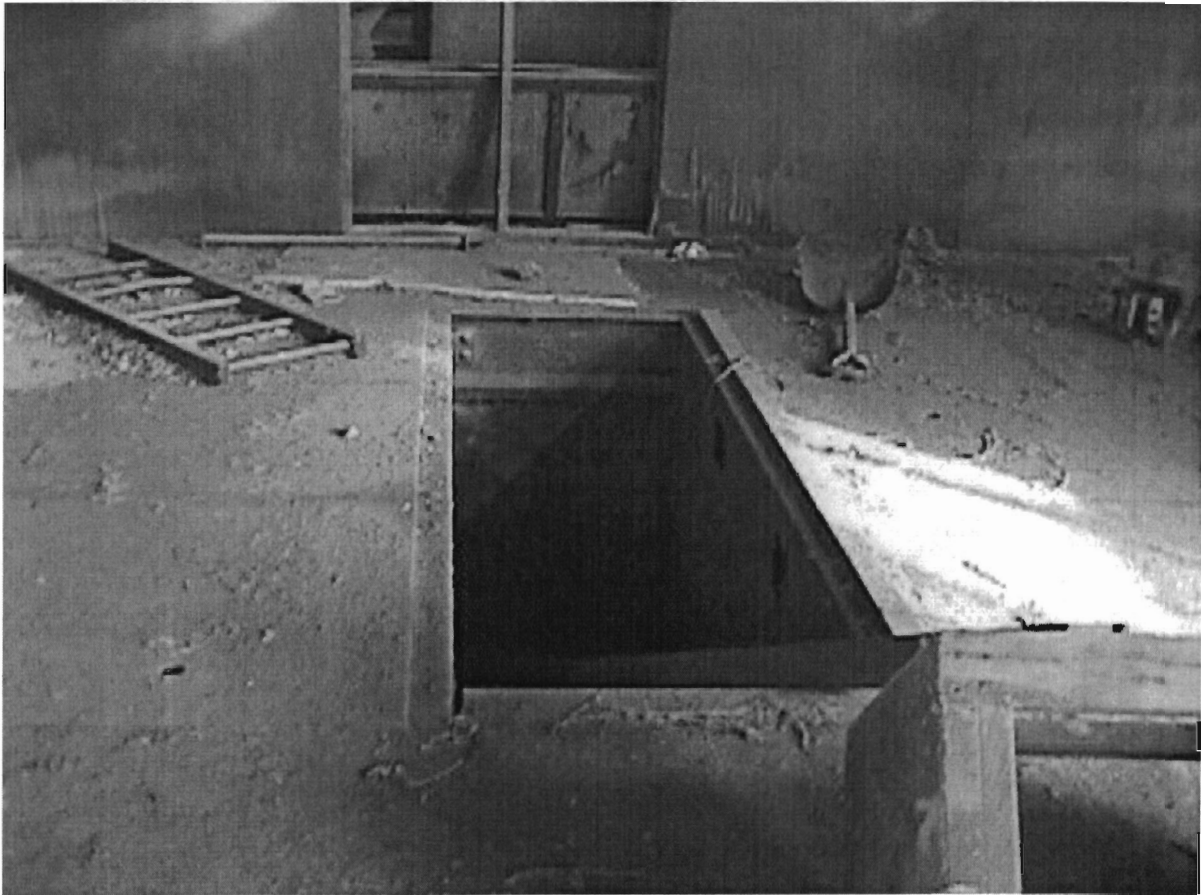
Photograph 10 - Building 1 - South Room facing north  
Note access down to pit or trench

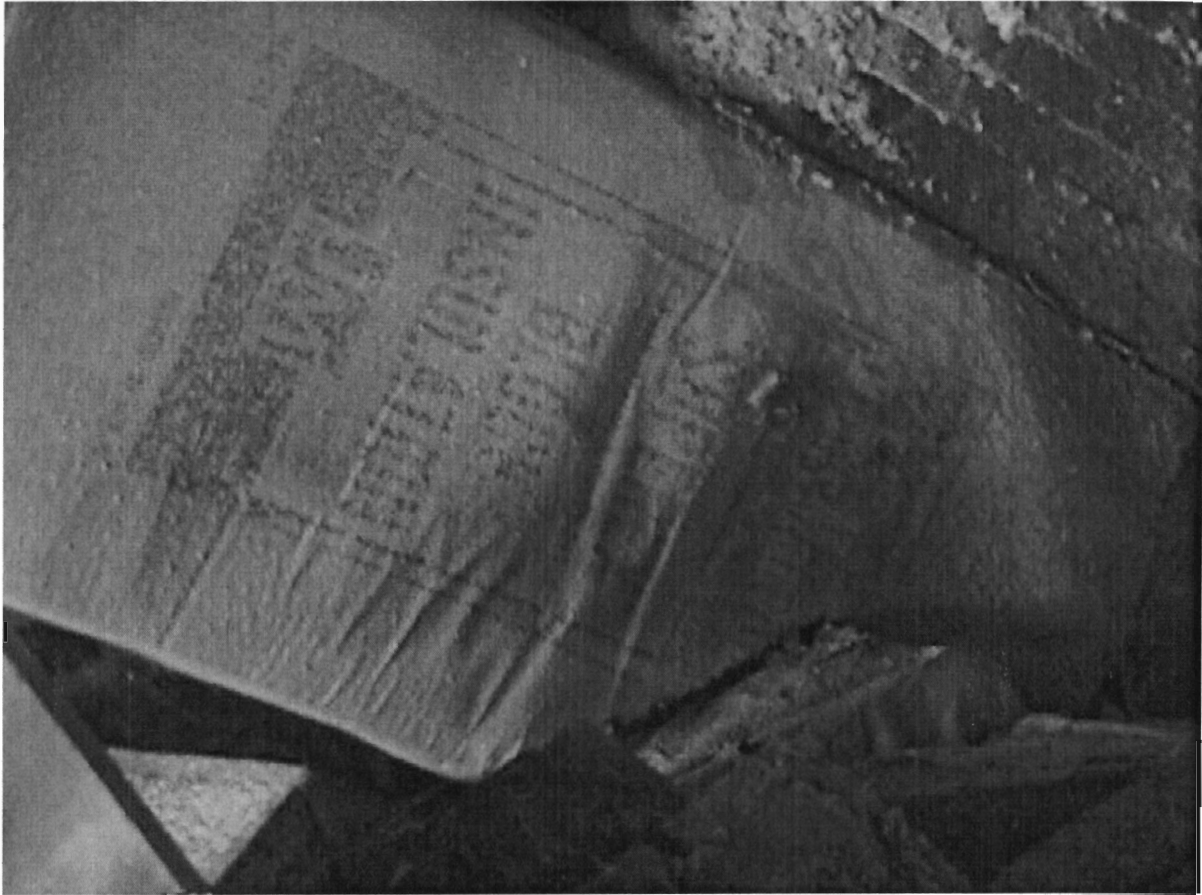
Photograph 11 - Building 1 - Insulation Close-up in Work Room

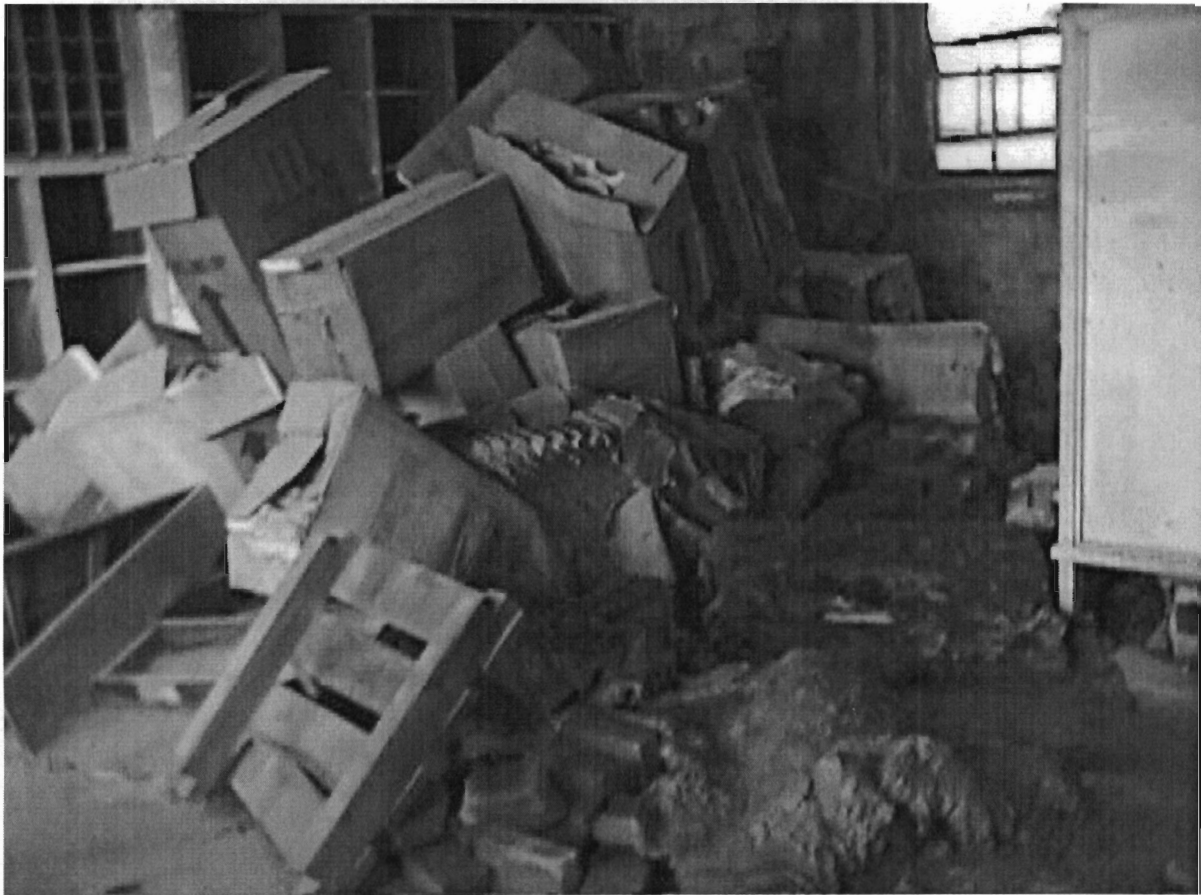
Photograph 12 - Building 1 - Work Room Insulation Stockpile

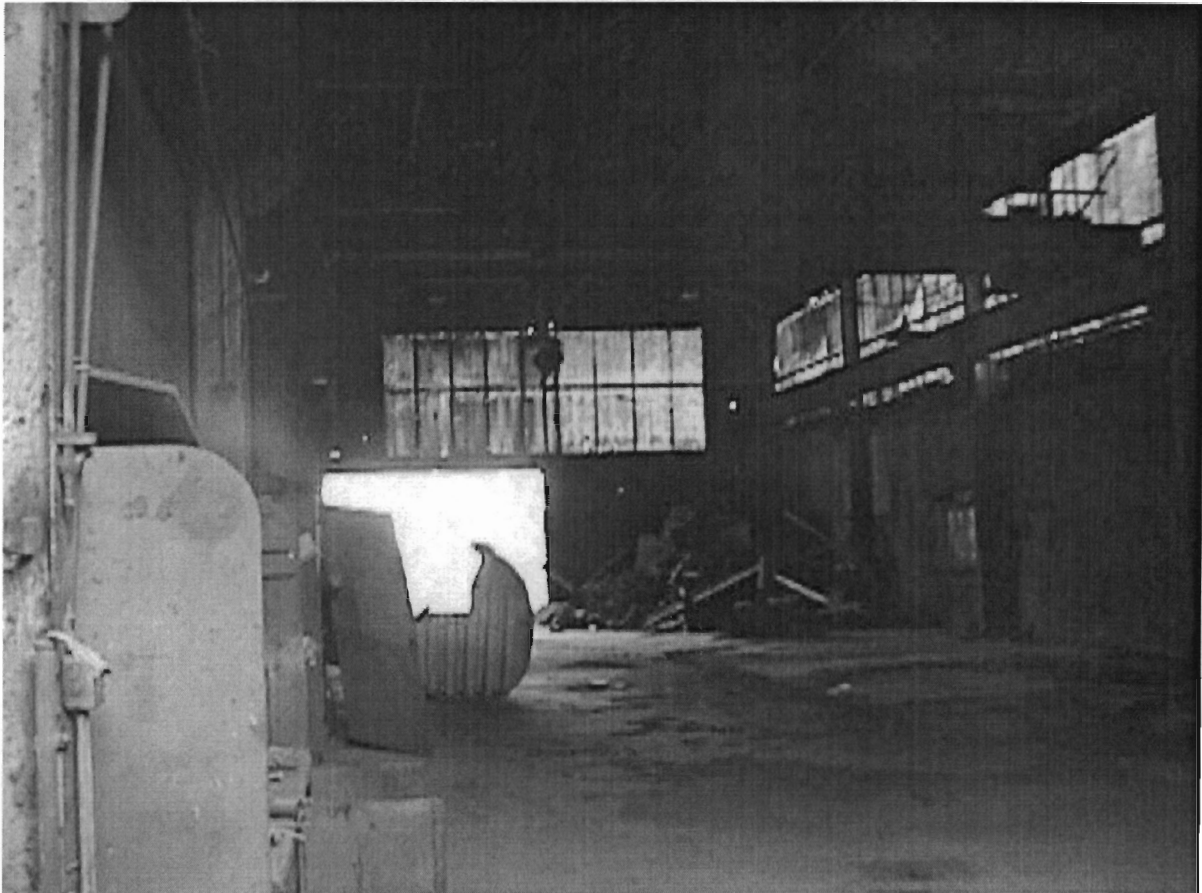
2.9.5 Observations: Although some minor water damage is present in both the exterior mortar and brick near the northeast corner of the building, no deficiencies can be found. The interior also is very good condition. See Photograph 13.

Photograph 13 - Building 35 - facing north

2.9.6 Specific Conclusions/Recommendations: No significant structural deficiencies are present. Access to this building should not be limited solely due to structural and non-structural deficiencies.

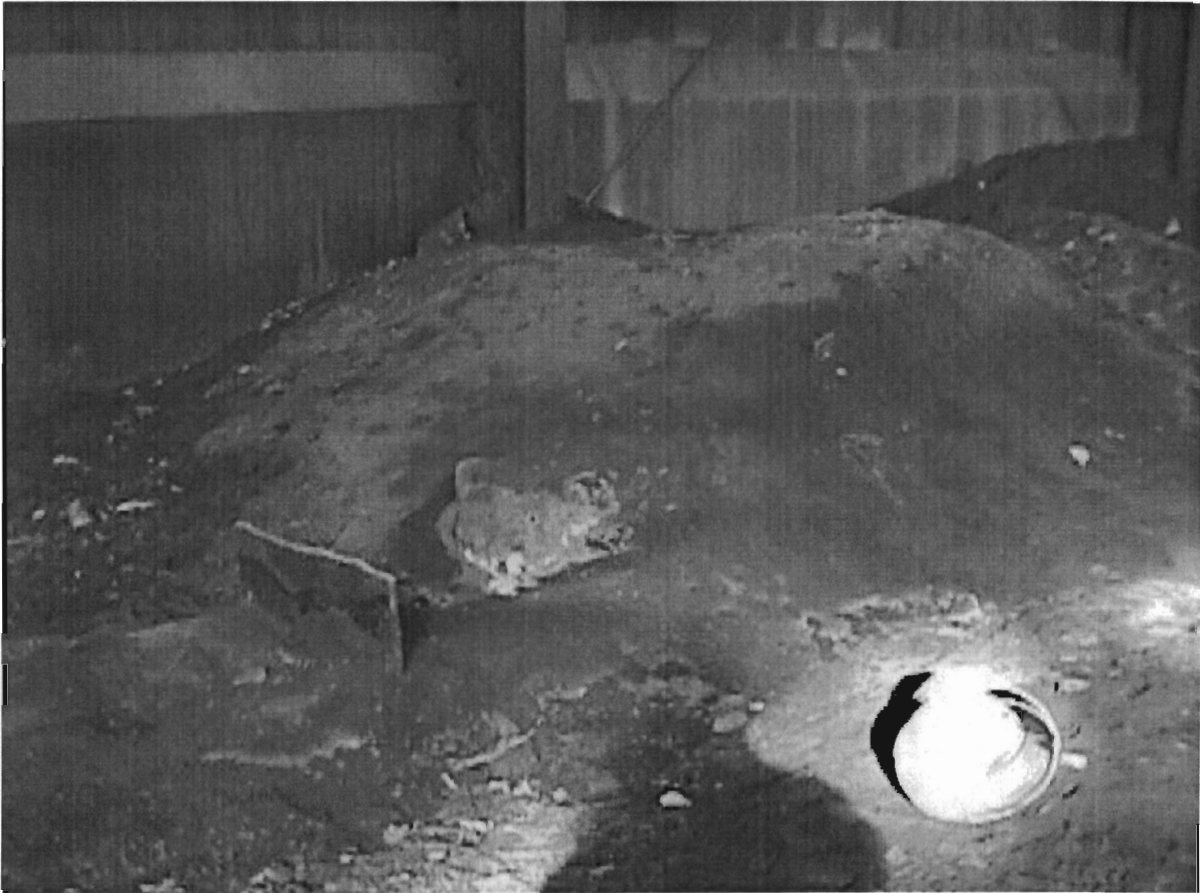
Photograph 14 - Building 3 - North Section - East Wall near  
Building 8 - Post rolling debris/waste?

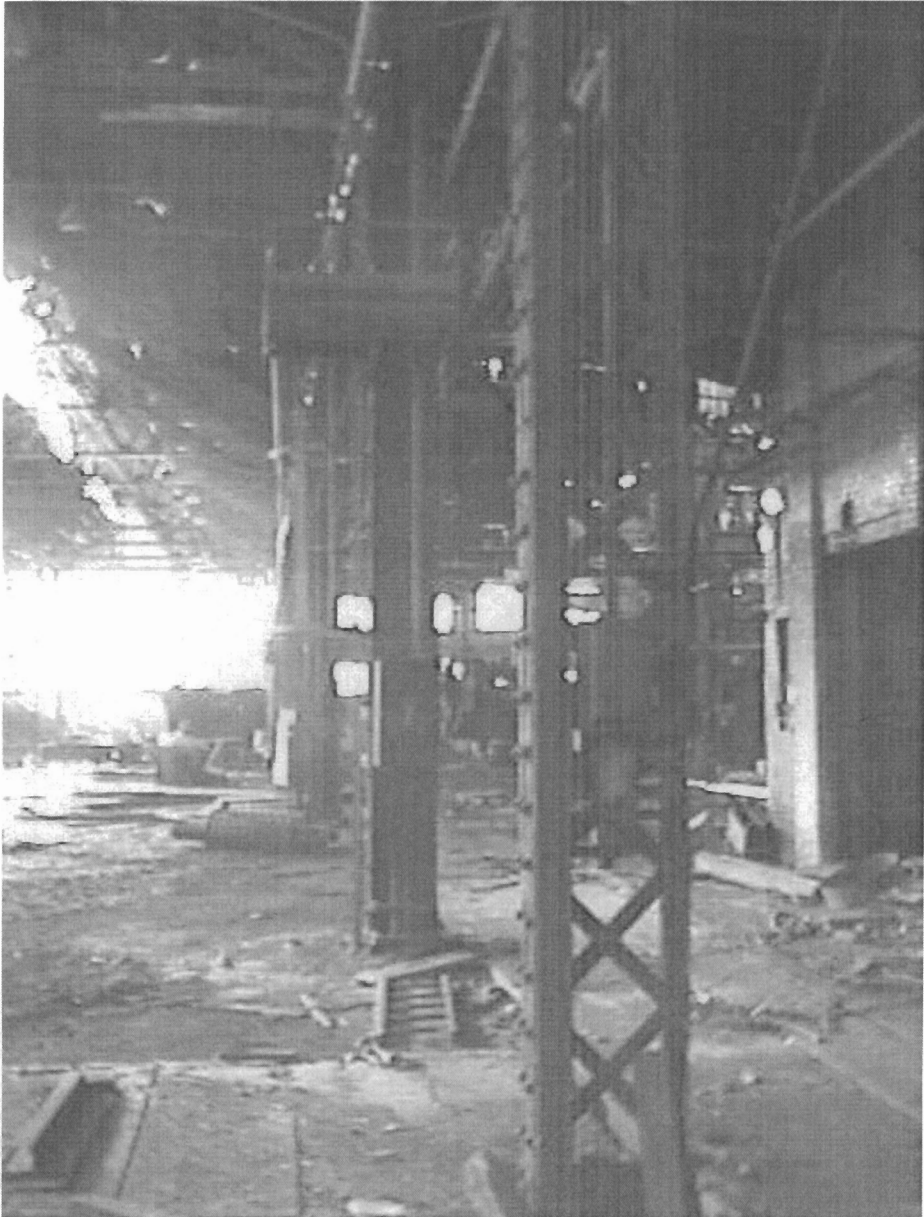
2.8.5 Observations: Most of this area was "roped off" with Danger Radioactive signs and no entrance to this area was made during this inspection. Although the eastern side of these buildings was inspected along the interface with Building Number 3 See Photograph 15. Although some corrosion exists on the original columns and later installed columns that support the roof, this corrosion does not threaten the stability of the columns or the roof trusses they support. Several areas also have uneven walking surface. It appears as though heavy vehicles have caused the sub-based material to compress and have caused ruts on the laid brick floor. Caused should be exercised near Building Numbers 6 & 8.

Photograph 15 - Buildings 6 & 8 - Typical Built-up Columns along Building 3 interface - facing south - Note furnace in background

2.8.6 Specific Conclusions/Recommendations: A more detailed structural inspection, with the correct PPE and HP supervision, is required for both these buildings if more information is desired.

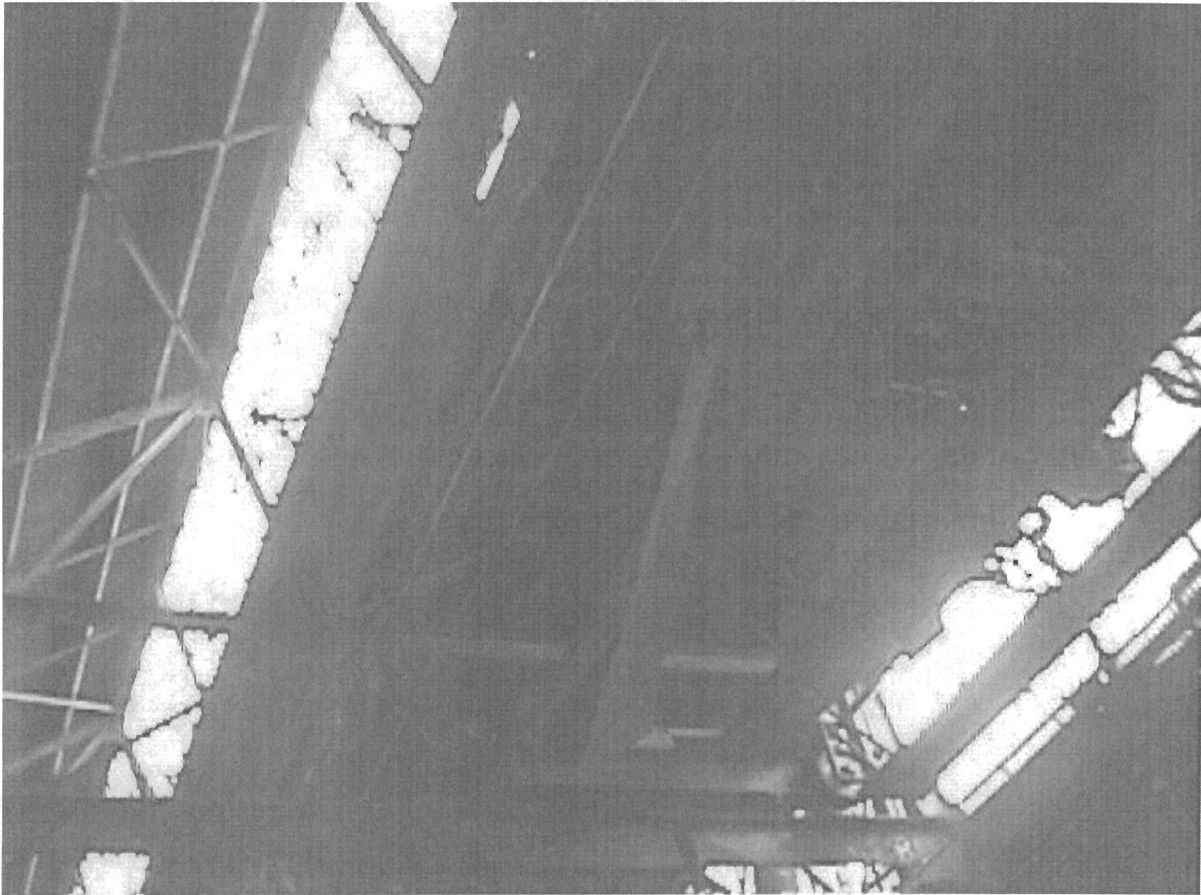
2.6.5 Observations: Some very small holes openings in the roof. Potential for falling pieces of roofing presents a non-structural hazard. See Photographs 16-21. Some coating or material seems to be peeling off the roof. The structural impacts from the loss of this material is unknown. (Could this be fire insulation?) The potential health impacts are also unknown.

Photograph 16 - Buildings 4 & 9 - Typical roof trusses, vents, and roof openings

2.6.6 Specific Conclusions/Recommendations: No significant structural deficiencies are present. Access to this building should not be limited solely due to structural and non-structural deficiencies.

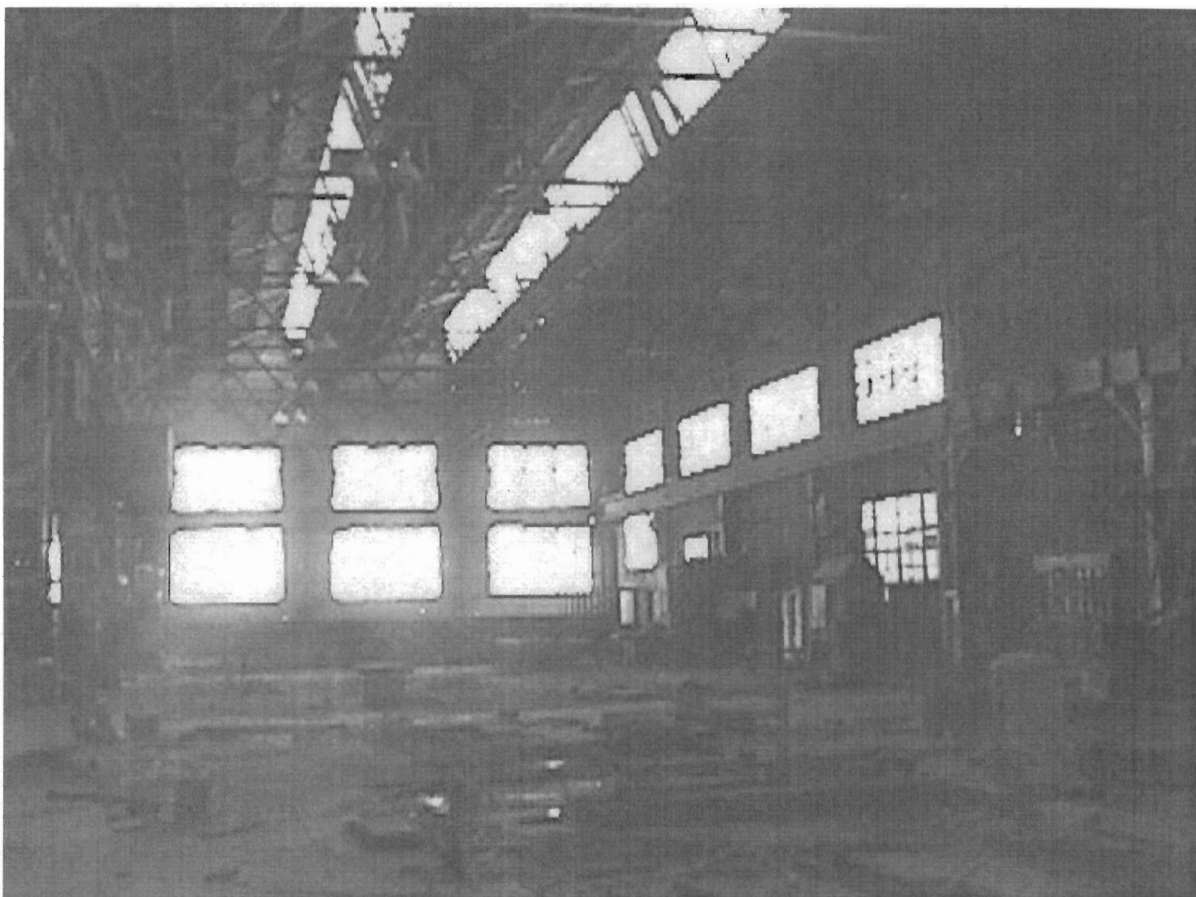
Photograph 18 - Buildings 4 & 9 - Facing north at Loading Dock Area

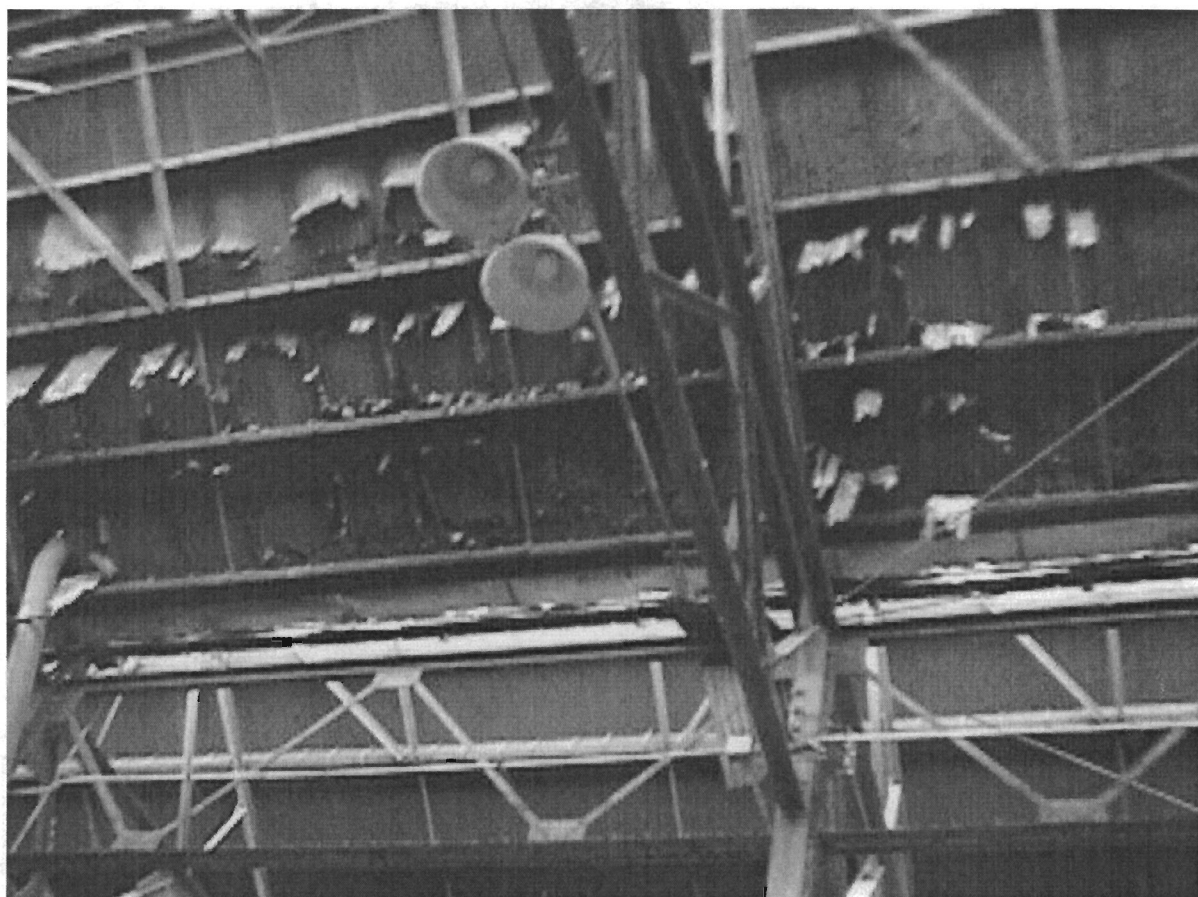
Photograph 19 - Buildings 4 & 9 - Typical peeling of roof material

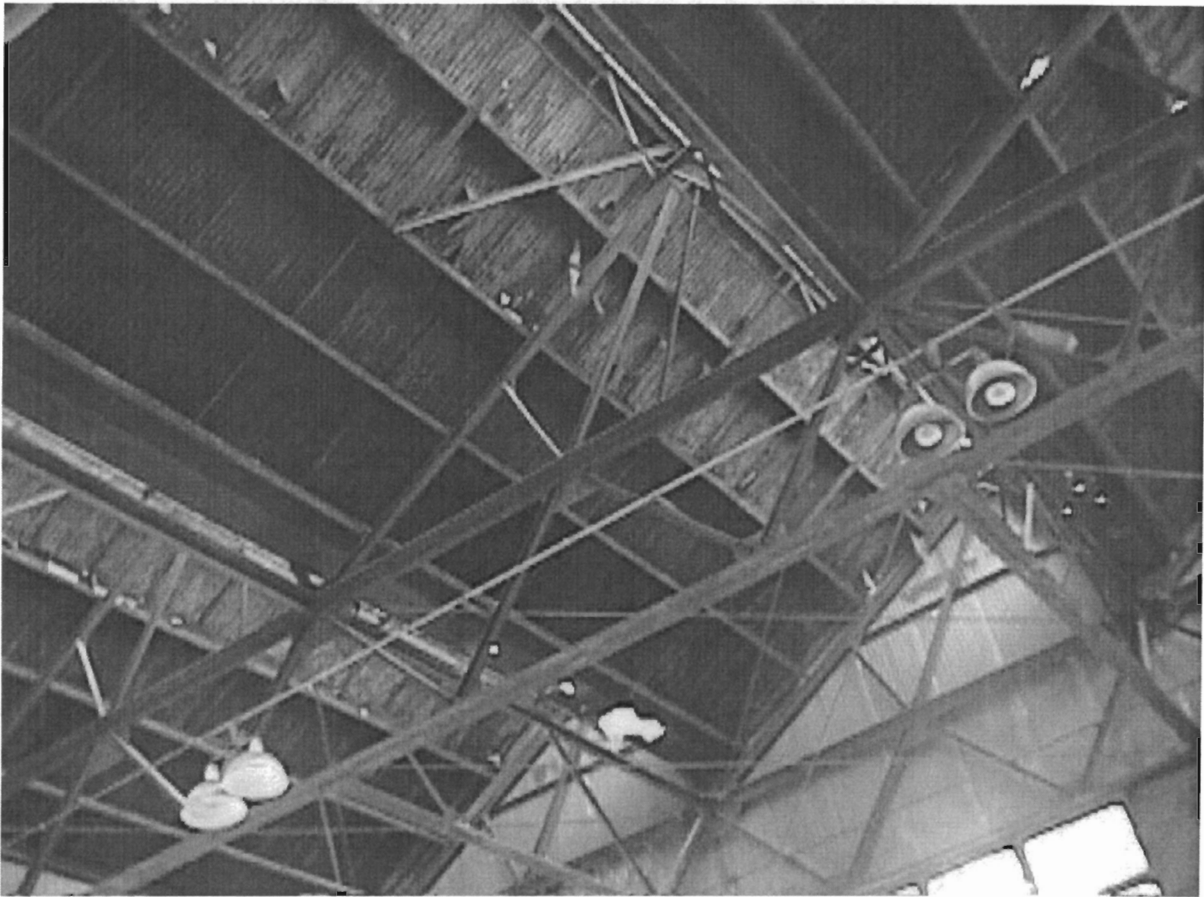
Photograph 20 - Buildings 4 & 9 - Typical peeling of roof material

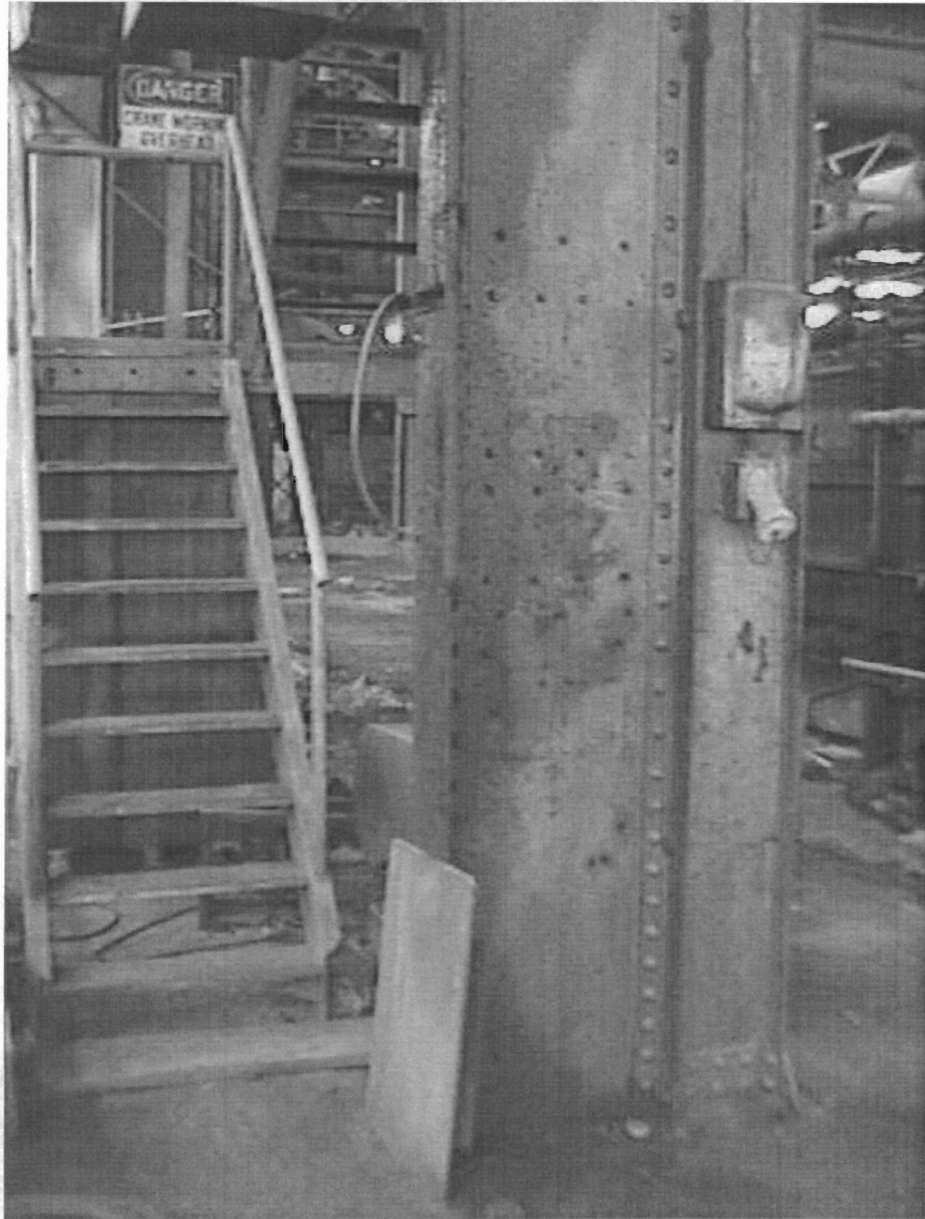
Photograph 21 - Building 4 & 9 - Typical Built-up  
Column

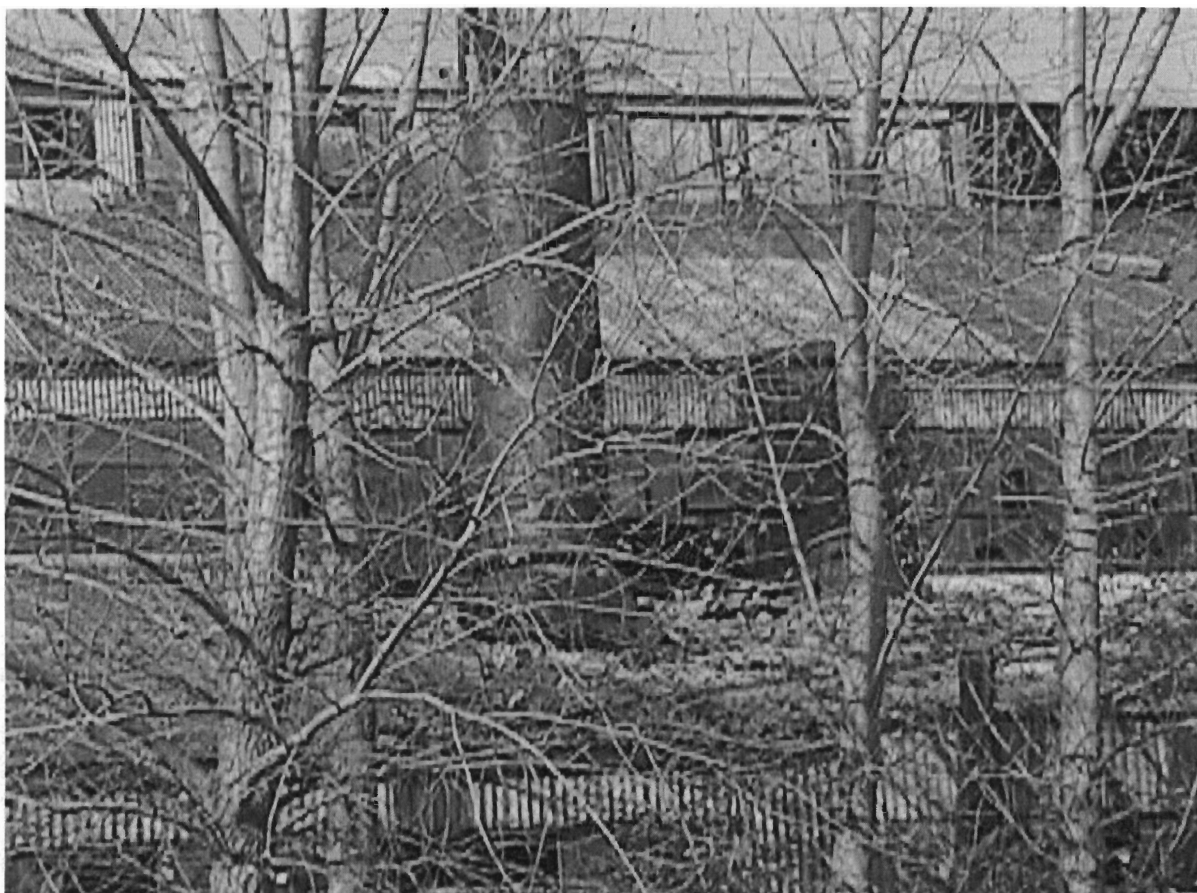
2.5.5 Observations: Some small holes openings in the roof. Potential for falling pieces of roofing presents a non-structural hazard. Some unknown fluorescent yellow material seems to be deposited at the end of the remnants of some type of production area. See Photograph 14. Several trenches are present and they are uncovered or are covered but have simple plywood spanning over them. Care should be taken in and around all trenches. No exploration was made of these trenches during this inspection. The smokestack above the south section of Building 3 has deteriorated. Some of the insulation brick is beginning to crumble and is another falling hazard.

Photograph 22 - Building 3 - South Smokestack Deterioration

significant structural distresses present in Building Number 3. Recommend roping off the exterior south east area of this building until the smokestack is brought down.
