# ENGINEERING INVESTIGATIONS AT **INACTIVE HAZARDOUS WASTE SITES** IN THE STATE OF NEW YORK

## PRELIMINARY SITE ASSESSMENT Volume 1

**Union Carbide Corporation Carbon Products Division Site** Site Number 932035 Town of Niagara, Niagara County

## **April 1995**

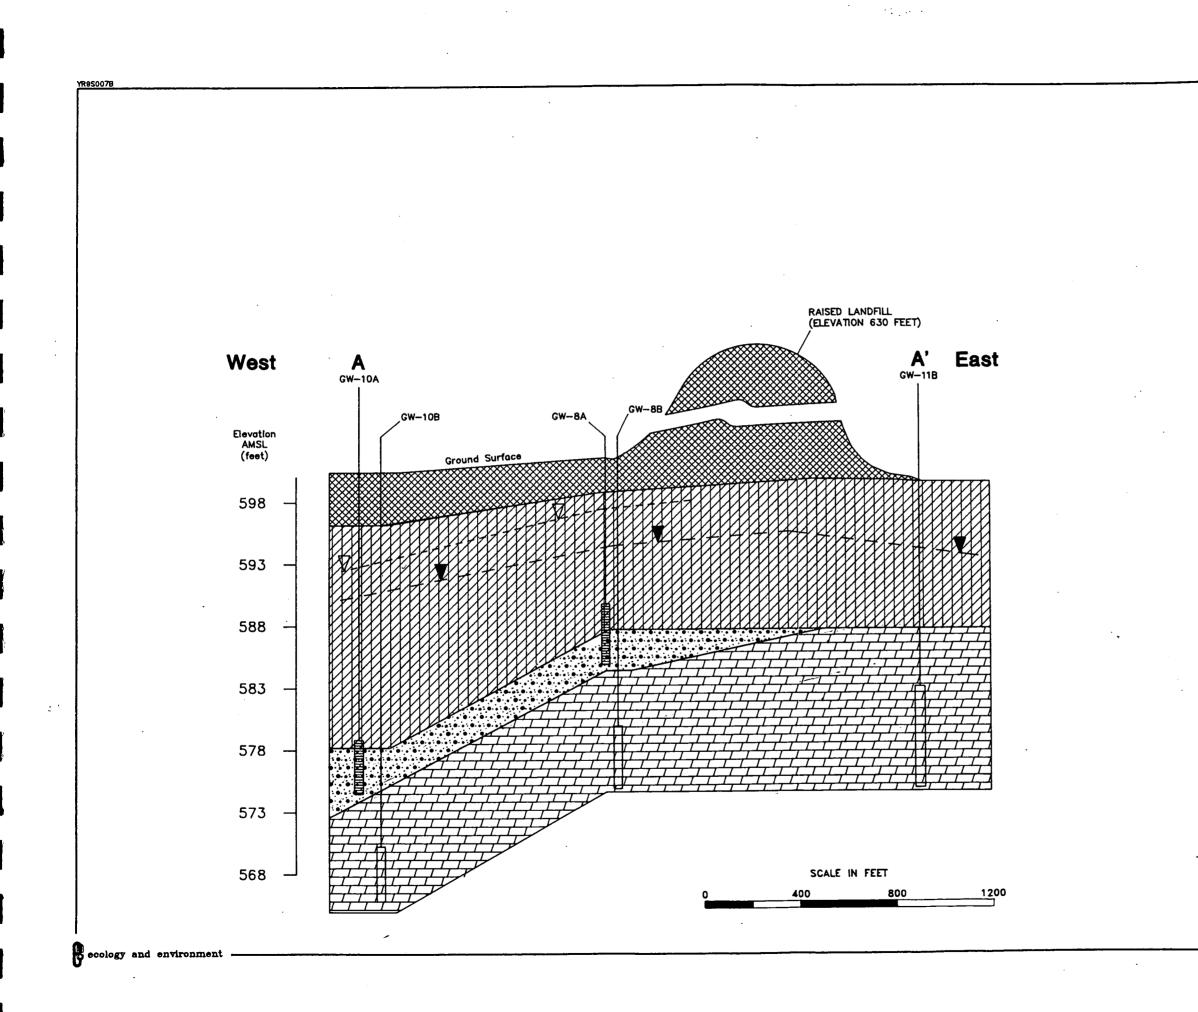
# Figure 3-4

The geology beneath the Union Carbide site consists of a relatively thin overburden cover above fractured dolostone bedrock. The overburden at the site ranges from approximately 7 to 26 feet thick, excluding the raised landfill which is approximately 30 feet above the surrounding grade. The overburden generally thickens away from the top of bedrock high under the landfill. It is relatively thick (over 30 feet) west of the site property at well MW-3B, and it is thinnest (less than 15 feet) on the eastern edge of the site property at BW-5 and MW-3. Since the site is relatively level, the general westward thickening of overburden across the site is caused by a corresponding generally westward dip of the top of bedrock layer beneath the site (see Figures 3-2 and 3-3).

GEOLOGIC CROSS-SECTION A-A' UNION CARBIDE SITE
