New York State Department of Environmental Conservation Division of Solid and Hazardous Materials, Region 9

MEMORANDUM

UCAR Graf Tech Closed Landfill Inspection

June 2, 2010

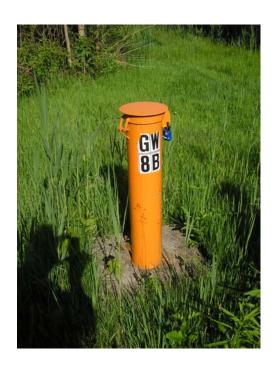
MW.typ.JPG UCAR - Graf Tech 052710

We drove around the landfill and walked to some of the monitoring wells which were not accessible by vehicle. In general, the monitoring wells were well taken care of, with recent painting, new weather-resistant locks, and sturdy identification markers. The only noted problem was the lack of surface seals on a few of the wells, including BW-1, BW-5, BW-6, and MW-2. It is unclear whether the seals were broken and just removed some time in the past, or were buried under soil when closure grading took place. Mr. Bucci will check these wells out and provide surface seals within the next couple of weeks. He will send me photographic documentation of the work.
