New York State Department of Environmental Conservation

INSPECTION REPORT

Site Number: 9320635

Site Name: GrafTech International Holdings Inc.

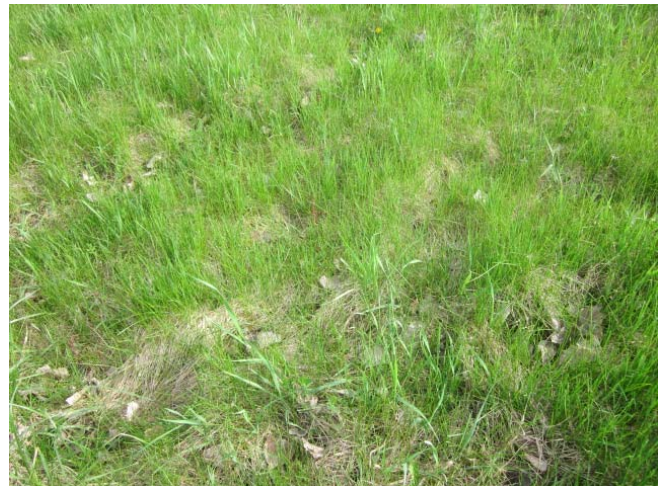
Cap Vegetation

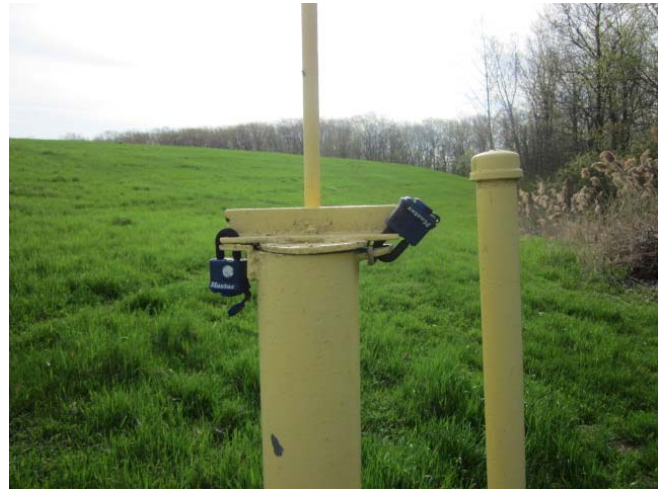
Double Locks

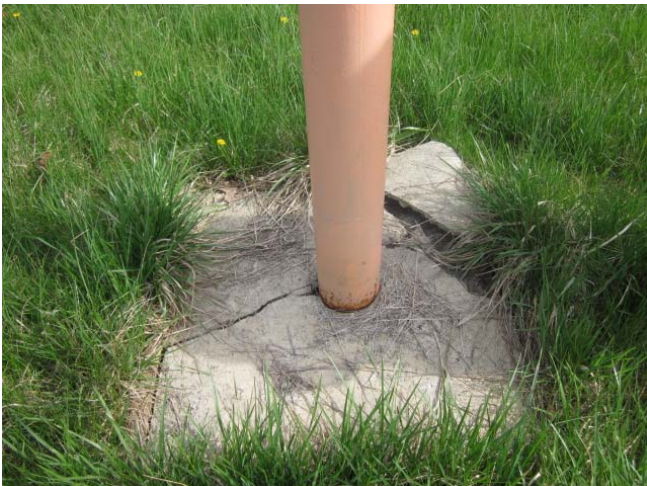
-The 16.5 acre inactive landfill was found in good condition. The vegetation was relatively short, uniformly dense and healthy. There were no signs of significant irregularities such as settling or standing water. The perimeter cap-toe interface was also inspected. There were no signs of erosion rivulets or leachate breakouts. All the monitoring wells were in very good condition, e.g., caps, locks, paint, identification and concrete surface seals. The exception was monitoring well GW-7B where the concrete surface seal was cracked. Mr. Bucci said that this would be repaired.

GW-7B Cracked Surface Seal'
GrafTech 050313

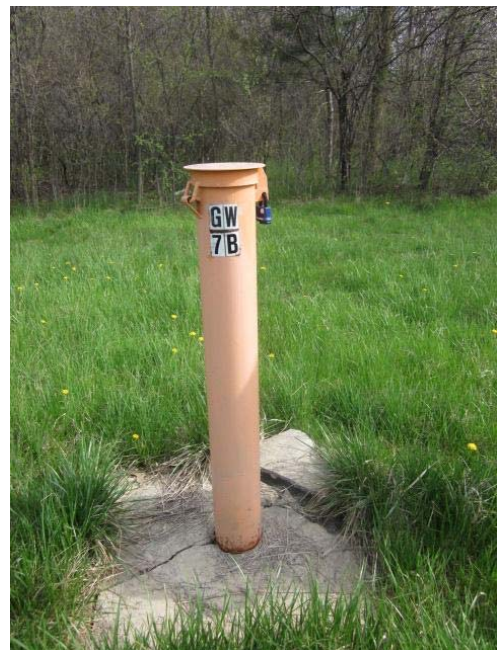
GW-7B Cracked Surface Seal
Page 2

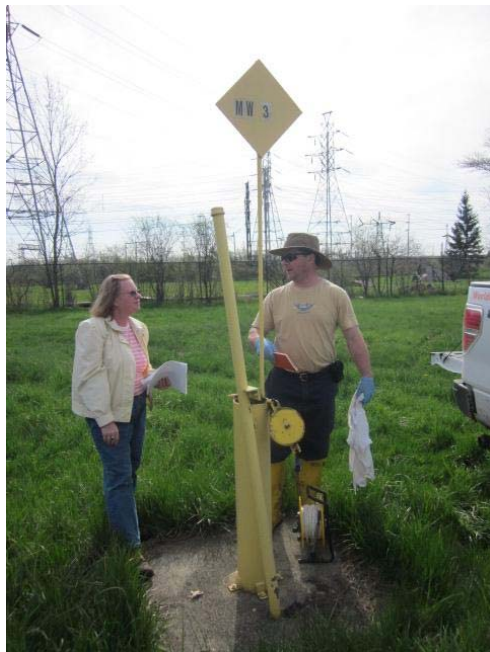
Sampling Review

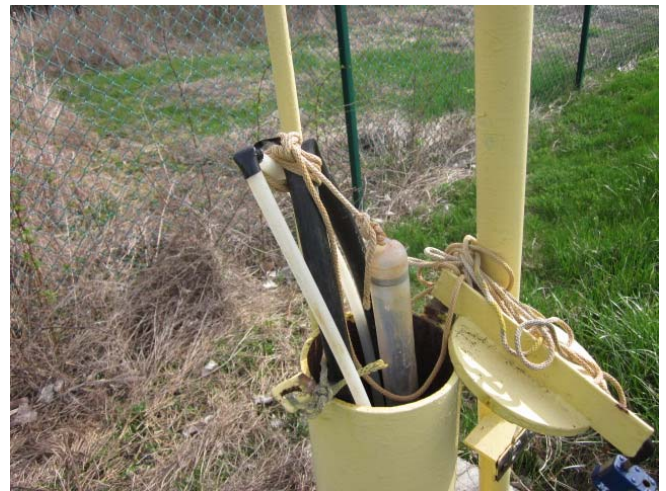
Typ. Bailer

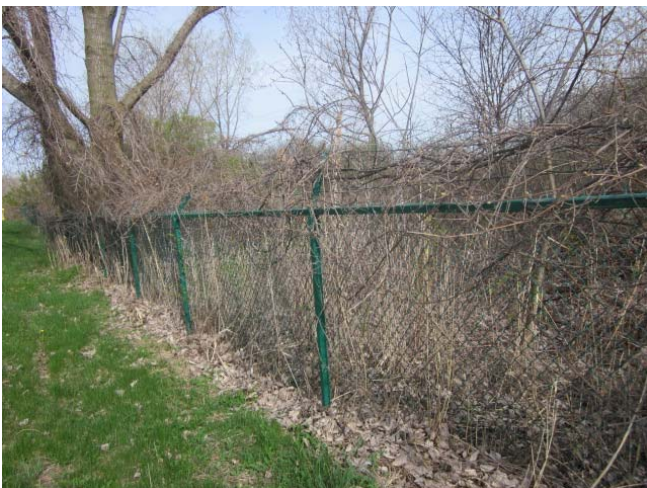
-Security is "tight" and is provided by a perimeter chain link fence and a locked main gate. There were no breaches in the fence material and it is in good condition.

Typ. Fenceline

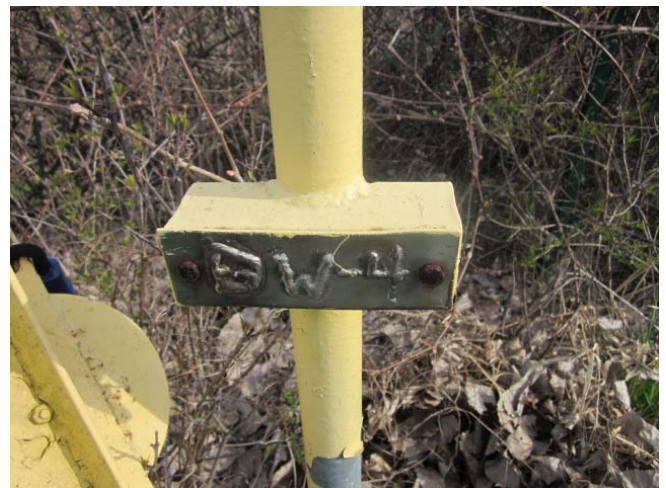
Well Identification
