# NEW YORK STATE DEPARTMENT OF ENVIRONMENTAL CONSERVATION

## DAILY INSPECTION REPORT

**Facility:** Vanchlor Company, Inc. (Vanchlor) Landfill  
600 Mill Street, City of Lockport, Niagara County, NY 14094  
DEC Site # 932039  
EPA ID – NYD991290529

**Date:** December 19, 2018 (11:30 – 13:00)

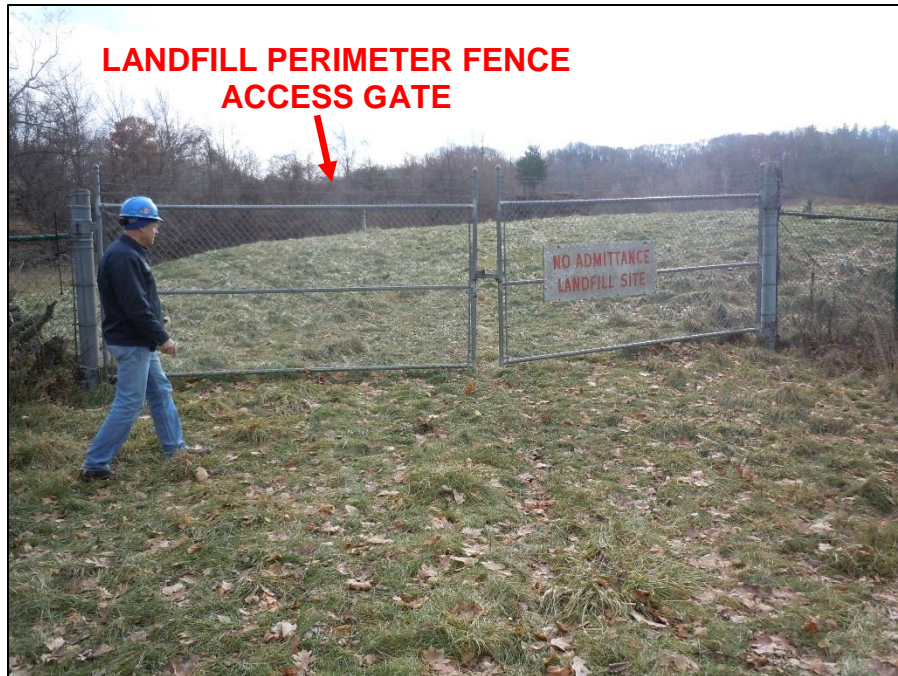
Southeastward view of access gate at north end of landfill.

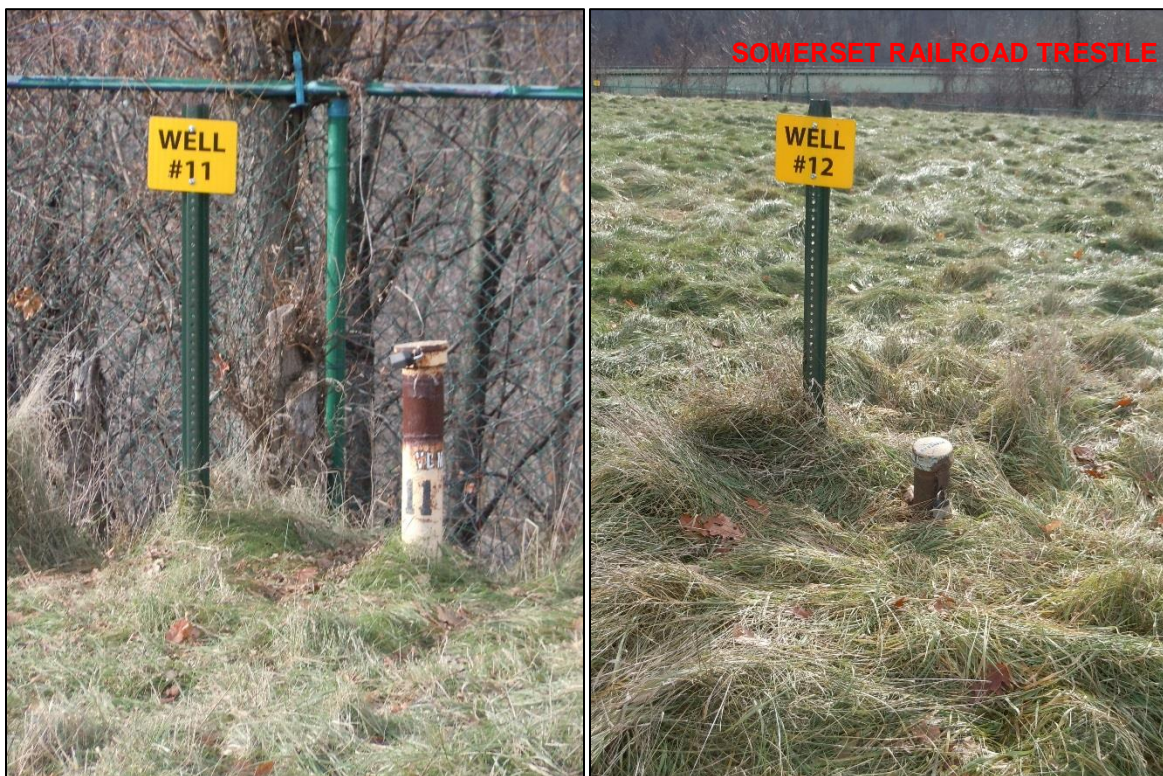
Views of monitoring wells VDM-11 and VDM-12.

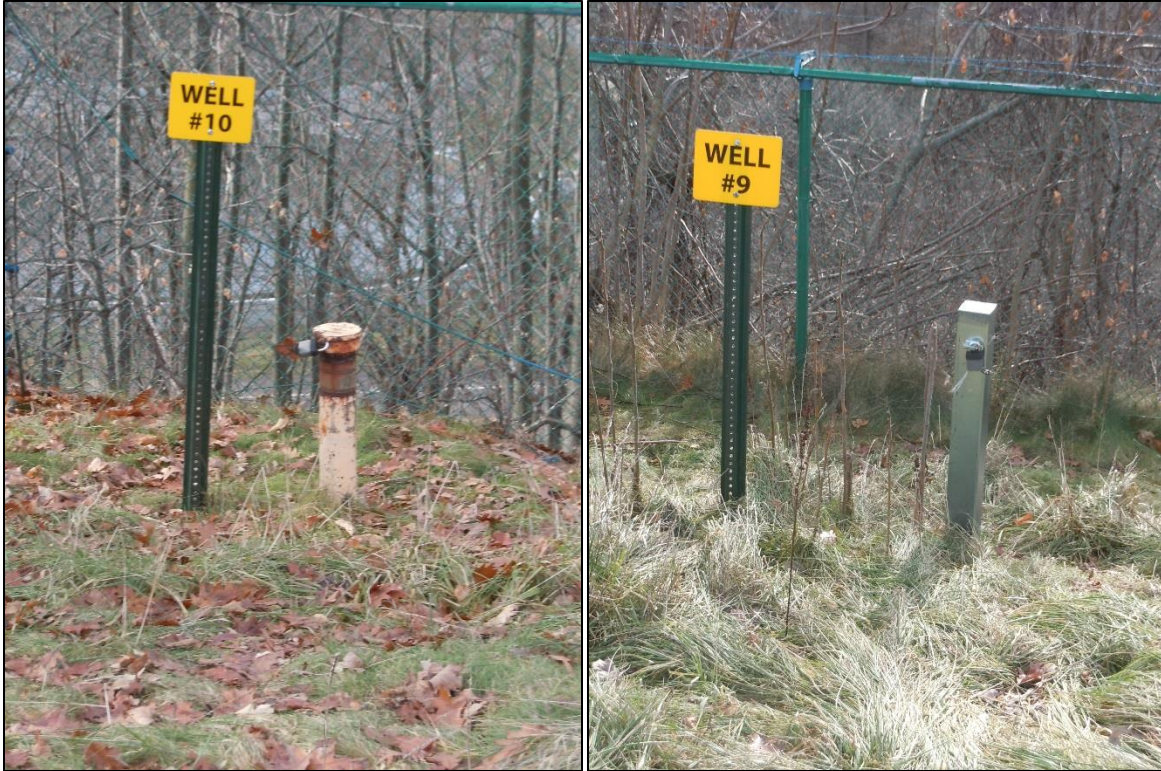
Views of monitoring wells VDM-10 and VDM-9R.

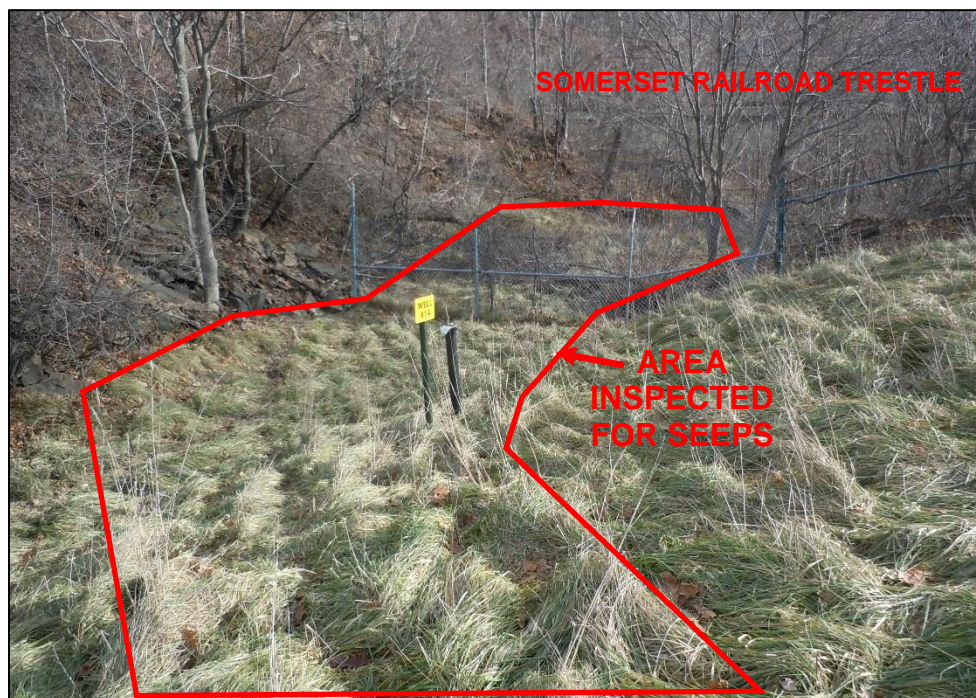
We then inspected the area downslope of the interceptor trench and southeast of well VDM-14 for evidence of leachate seeps. Most of the leafy vegetation had dropped their leaves, which permitted good viewing through the standing vegetation outside the landfill. We also checked the area outside the perimeter fence for about 100 feet downslope toward the railroad trestle. We did not find any visible seeps, discoloration, or signs of distressed vegetation.

Southeastward view (downslope) near monitoring well VDM-14 showing area inspected for leachate seeps.

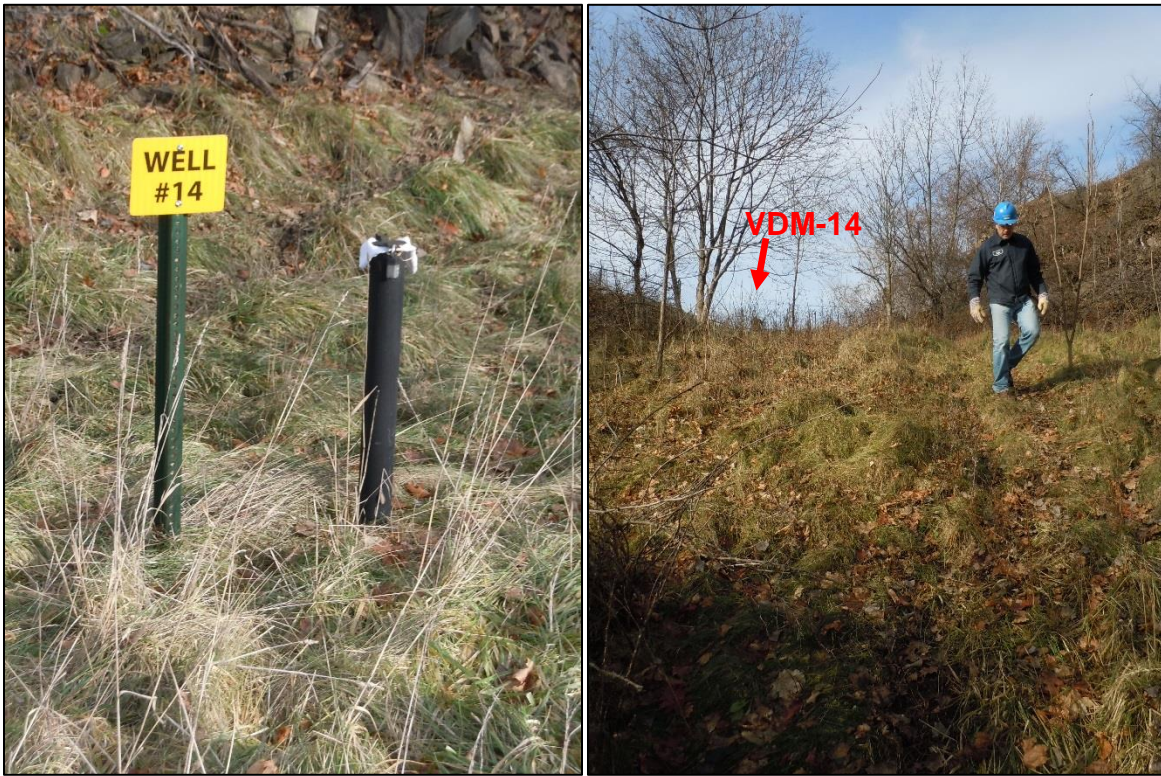
Closeup view of monitoring well VDM-14 (right) and view upslope toward VDM-14 (left).

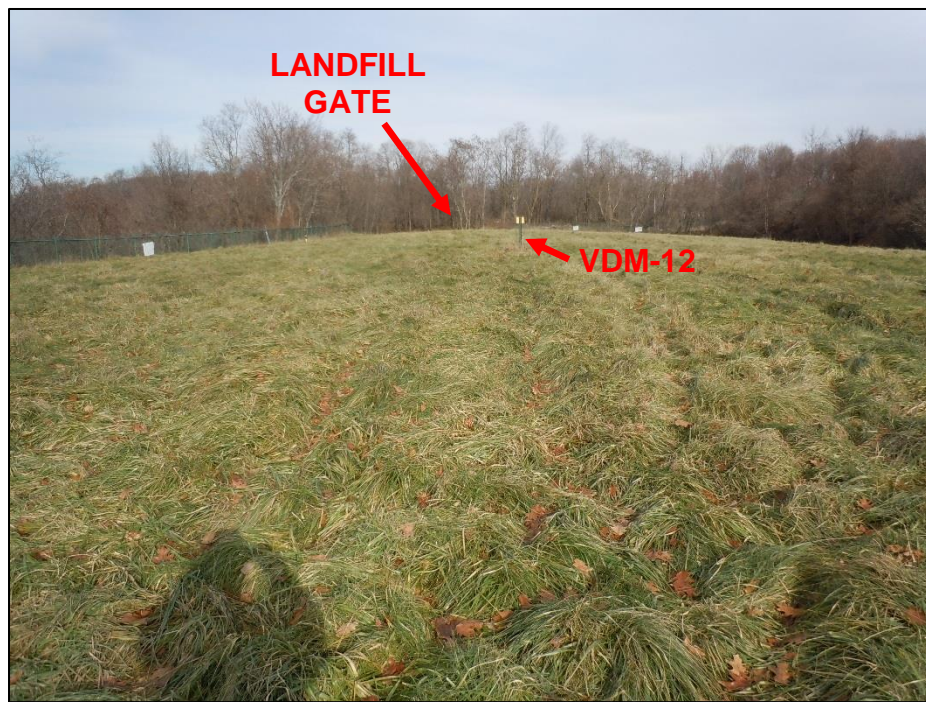
Northward view from southern end of landfill (near VDM-9R) toward gate.
