SITE INSPECTION REPORT

Facility: Vanchlor Company, Inc. (Vanchlor) Landfill
600 Mill Street, City of Lockport, Niagara County, NY 14094
DEC Site # 932039
EPA ID – NYD991290529

Date: September 3, 2020 (08:30 – 10:45)

Work Performed: 2020 Annual Groundwater Sampling and Landfill Inspection Event

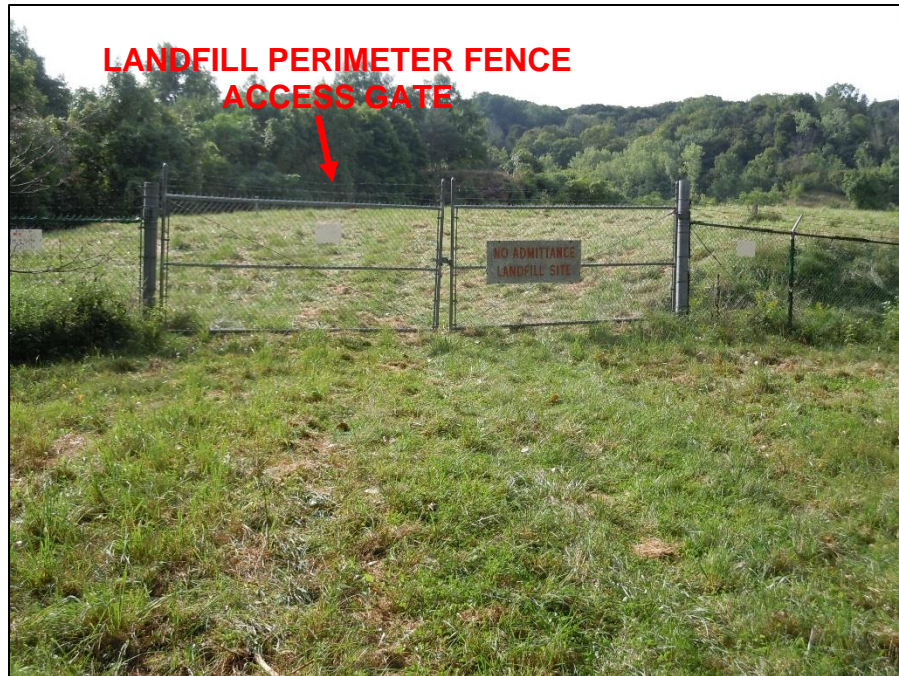
Southeastward view of access gate at north end of landfill.

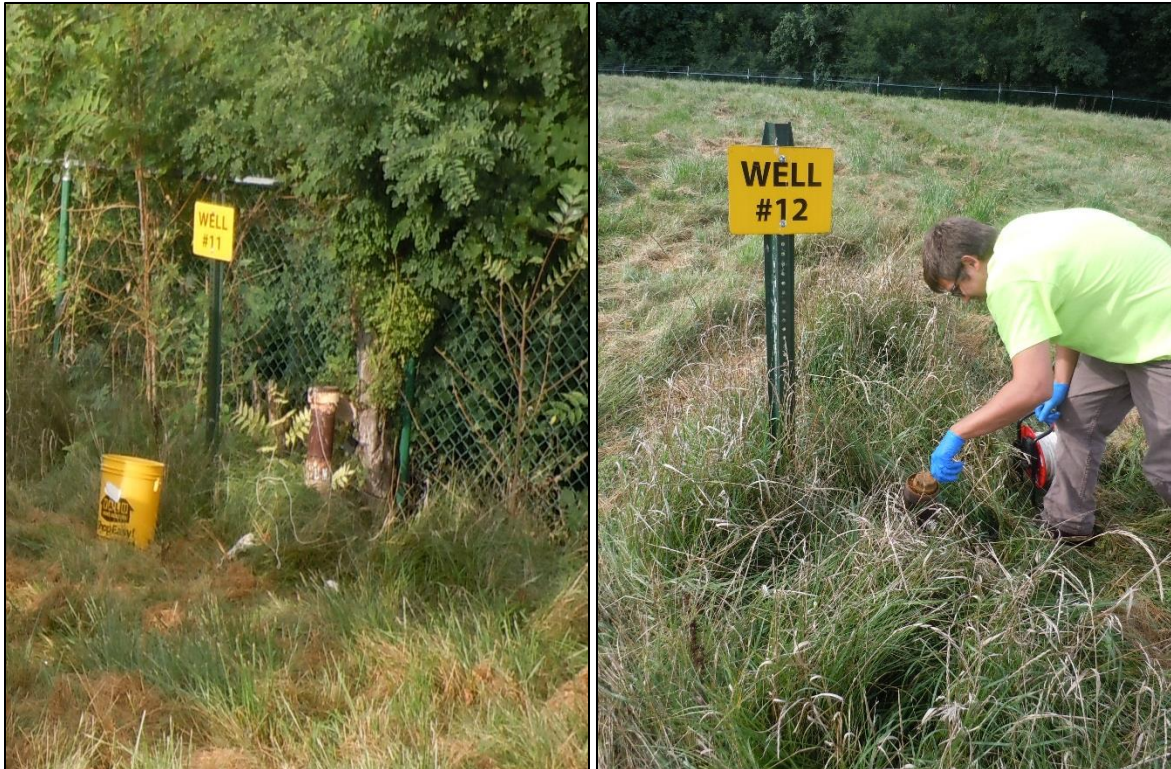
10, VDM-11, and VDM-14R) and one offsite, upgradient location (D-55) using dedicated HDPE bailers in accordance with the *Vanchlor Landfill Groundwater Monitoring Plan* (Appendix E of the SMP); well VDM-12, located in the center of the landfill, was dry and could not be sampled (see attached map). The dry conditions found in well VDM-12 are normal and provide a good indication that the cap is preventing infiltration, because prior to landfill capping VDM-12 had sufficient water to allow for sample collection. Wells VDM-9R, -10, -11, -14R, and D-55 will be purged today (many purge to dryness, or near dryness), allowed to recover overnight, and will be sampled tomorrow. A surface water sample will also be collected tomorrow from Eighteen Mile Creek downstream from the southern end of the landfill, but upstream of the City of Lockport Wastewater treatment plant SPDES discharge point.

Views of monitoring wells VDM-11 and VDM-12.

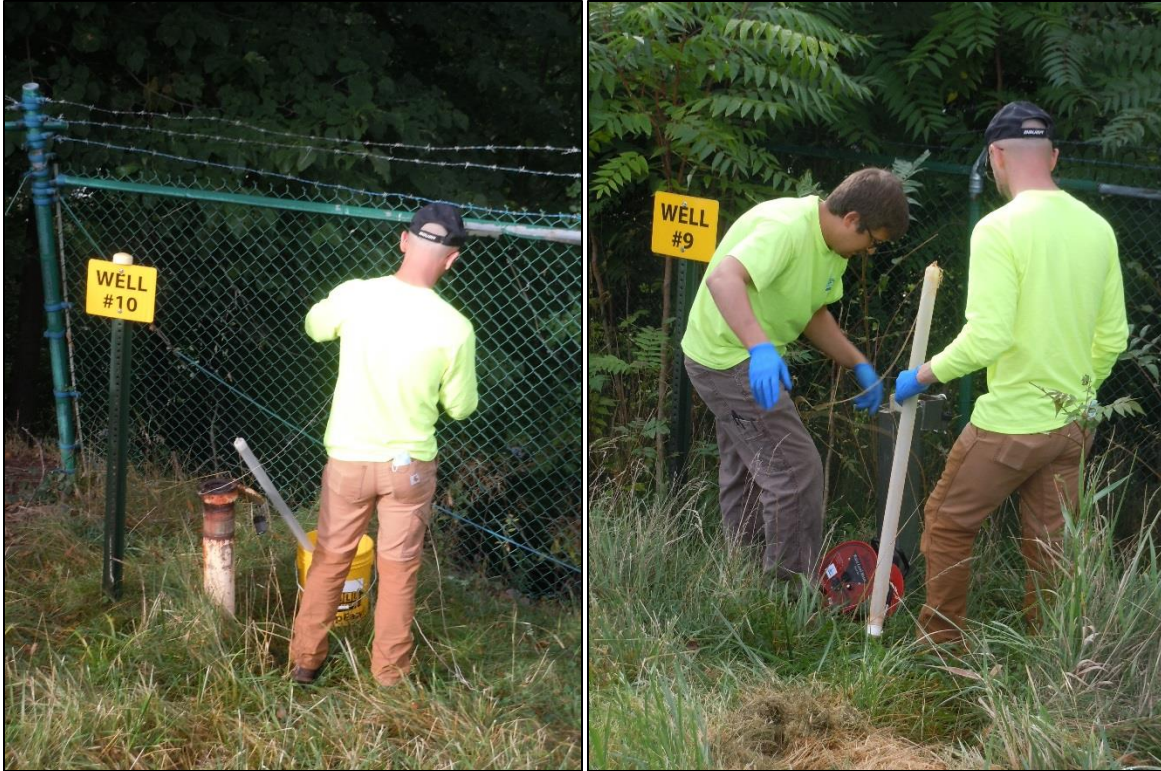
Views of monitoring wells VDM-10 and VDM-9R.

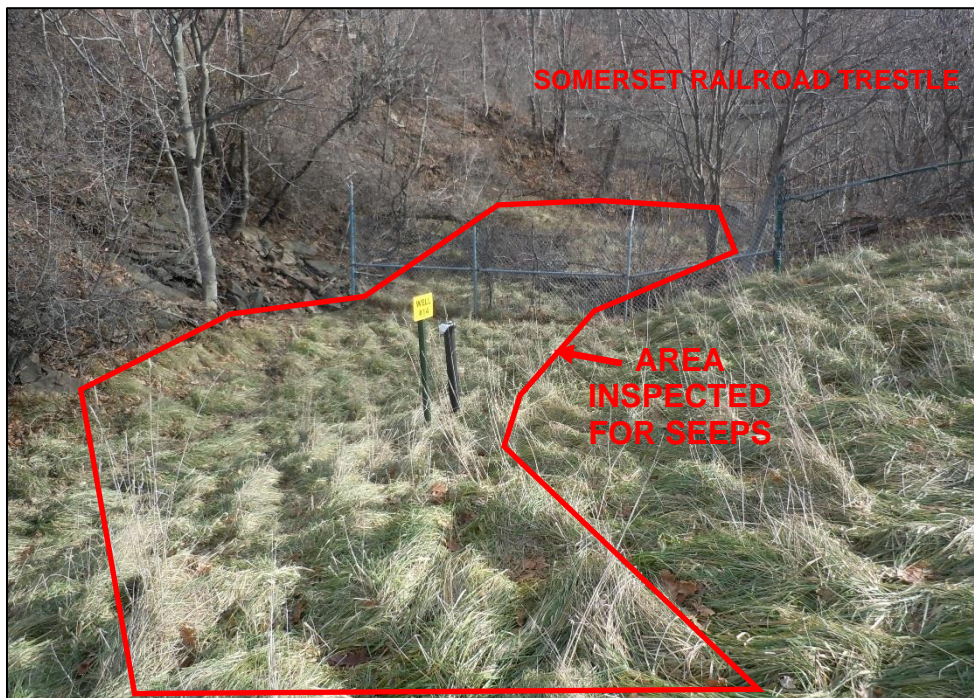
Southeastward view (downslope) near monitoring well VDM-14R showing area inspected for leachate seeps (Note: this photo was taken in December 2018).

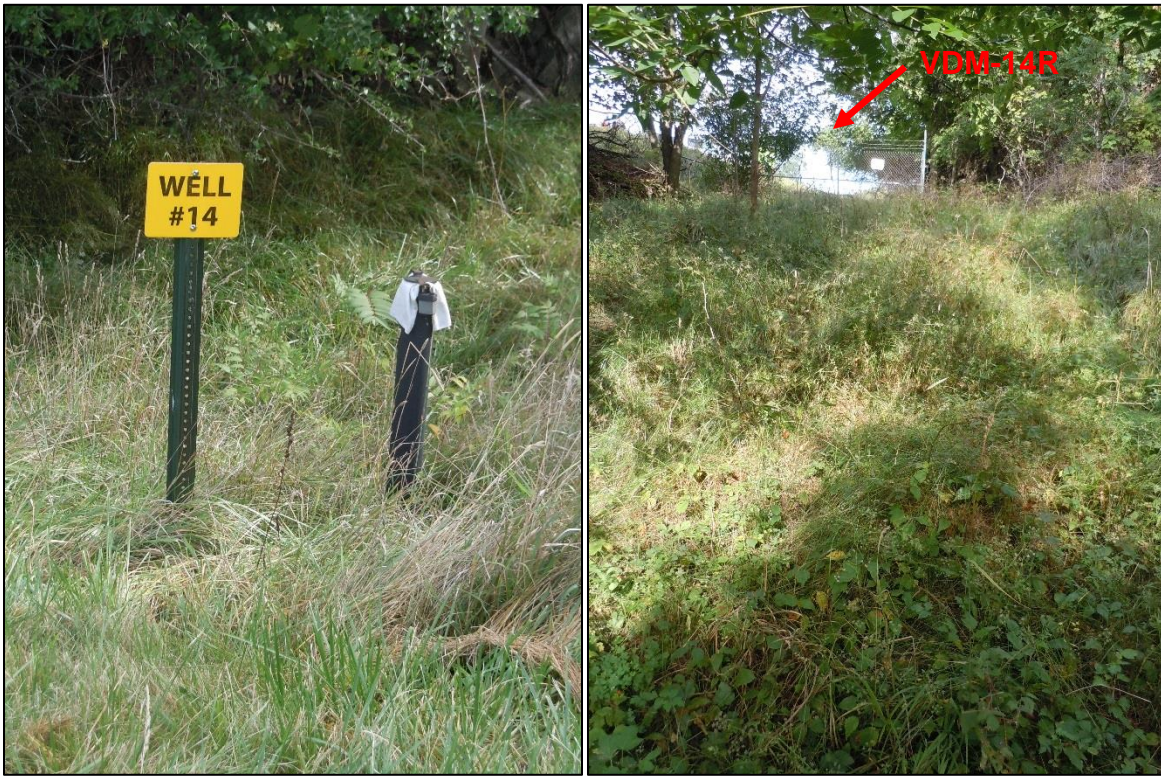
Closeup view of monitoring well VDM-14R (left) and a view from outside the landfill upslope toward VDM-14R (right) showing no signs of seeps.

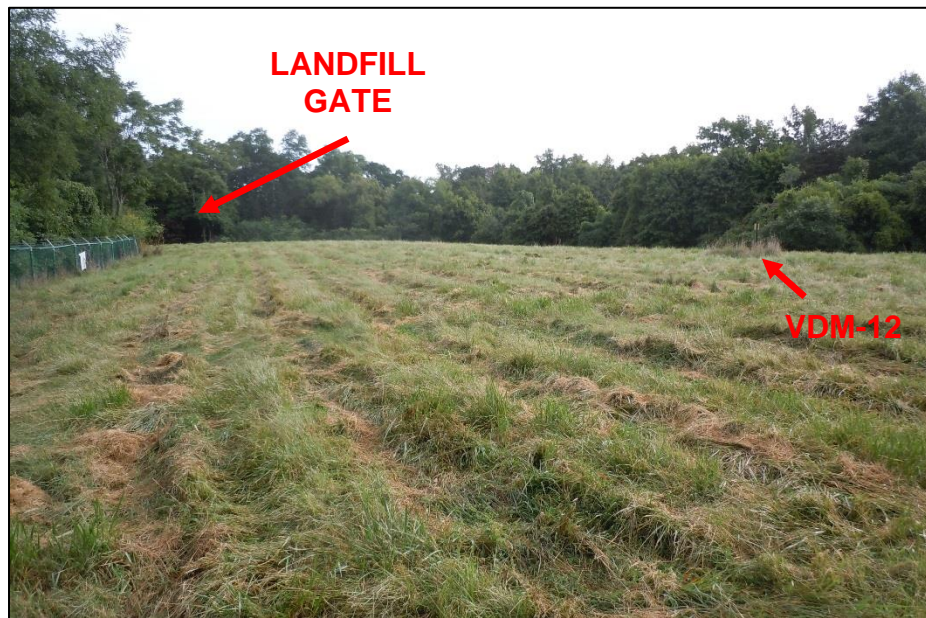
Northward view from southern end of landfill (near VDM-10) toward gate.

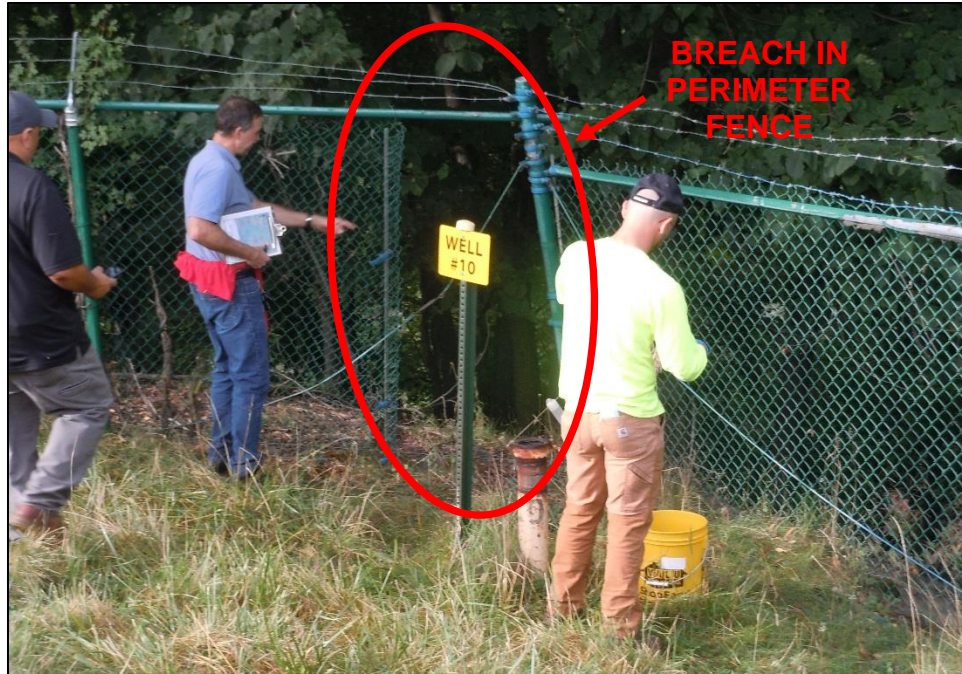
A small breach in the perimeter fence was noted on the south side of the landfill near well VDM-10. Vandals had broken brackets that connected the chain-link fence to a fence post and peeled a small section of the fence back. Jim Wrazen said he had walked the site about 2 weeks ago and did not notice the fence breach. Brian Law said Vanchlor would repair the fence.

Breach in southern landfill perimeter fenceline near well VDM-10.

Action Item: Vanchlor to repair the breached fence line near well VDM-10.

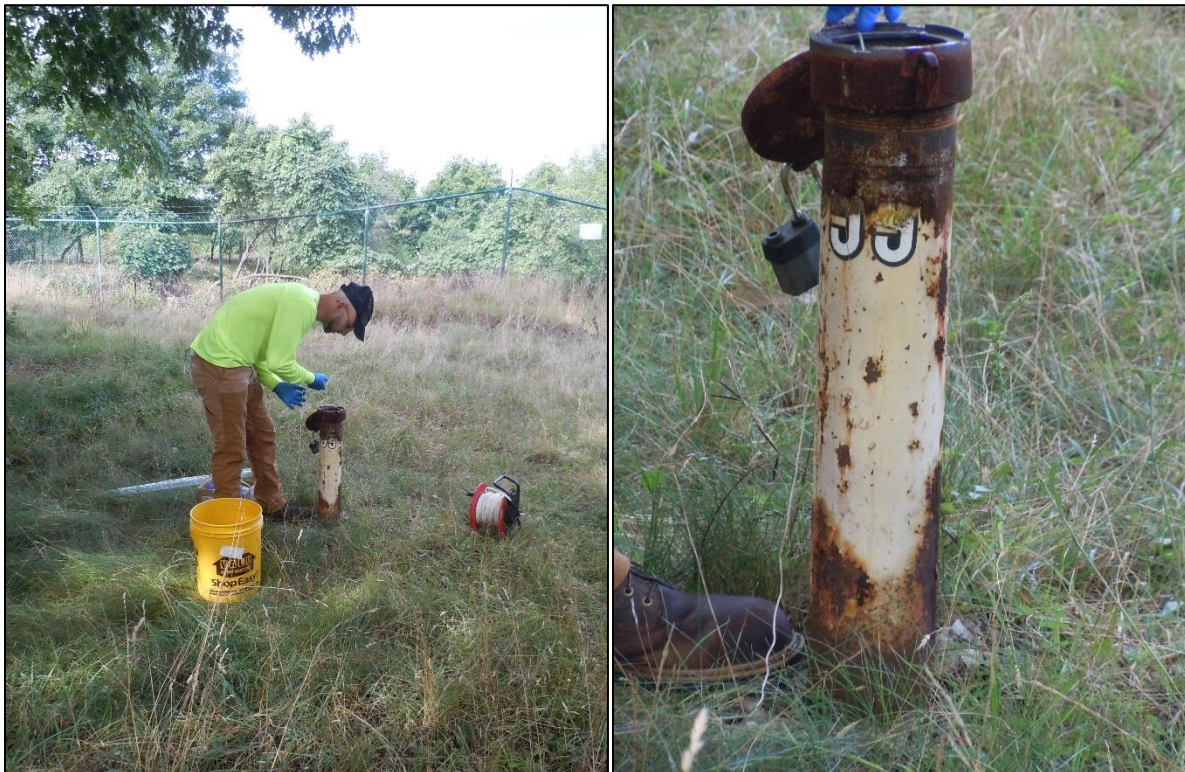
Views of upgradient monitoring well D-55. Top of protective casing was repaired.
