SITE INSPECTION REPORT

Facility: Vanchlor Company, Inc. (Vanchlor) Landfill
600 Mill Street, City of Lockport, Niagara County, NY 14094
DEC Site # 932039
EPA ID – NYD991290529

Work Performed: 2023 Annual Groundwater Sampling and Landfill Inspection Event

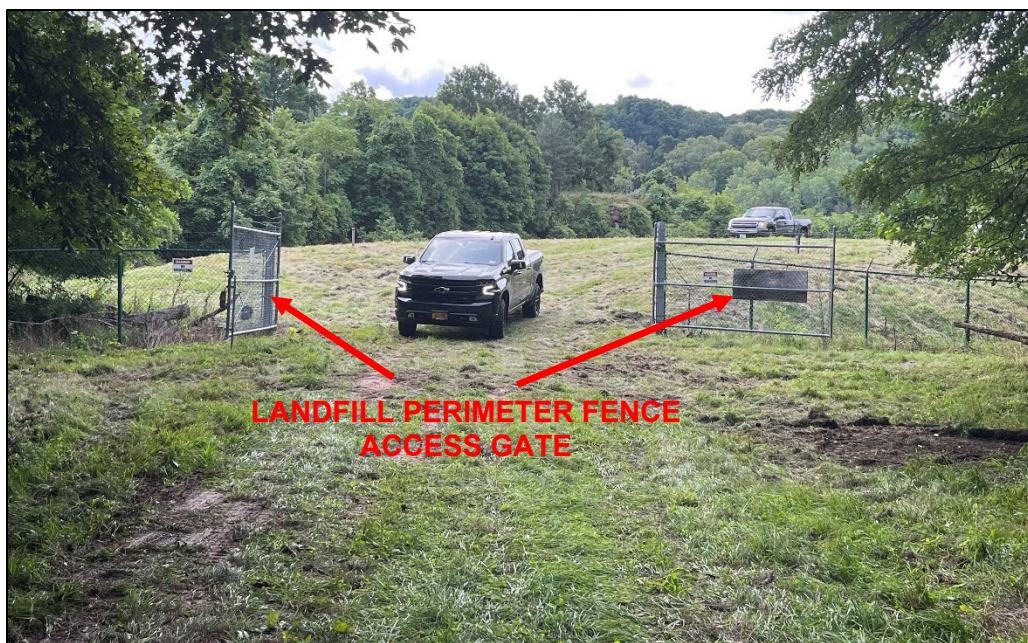
Southeastward view of perimeter fence access gate at north end of landfill. Note grassy, mowed landfill cap and “NO TRESPASSING” signs posted on perimeter fence.

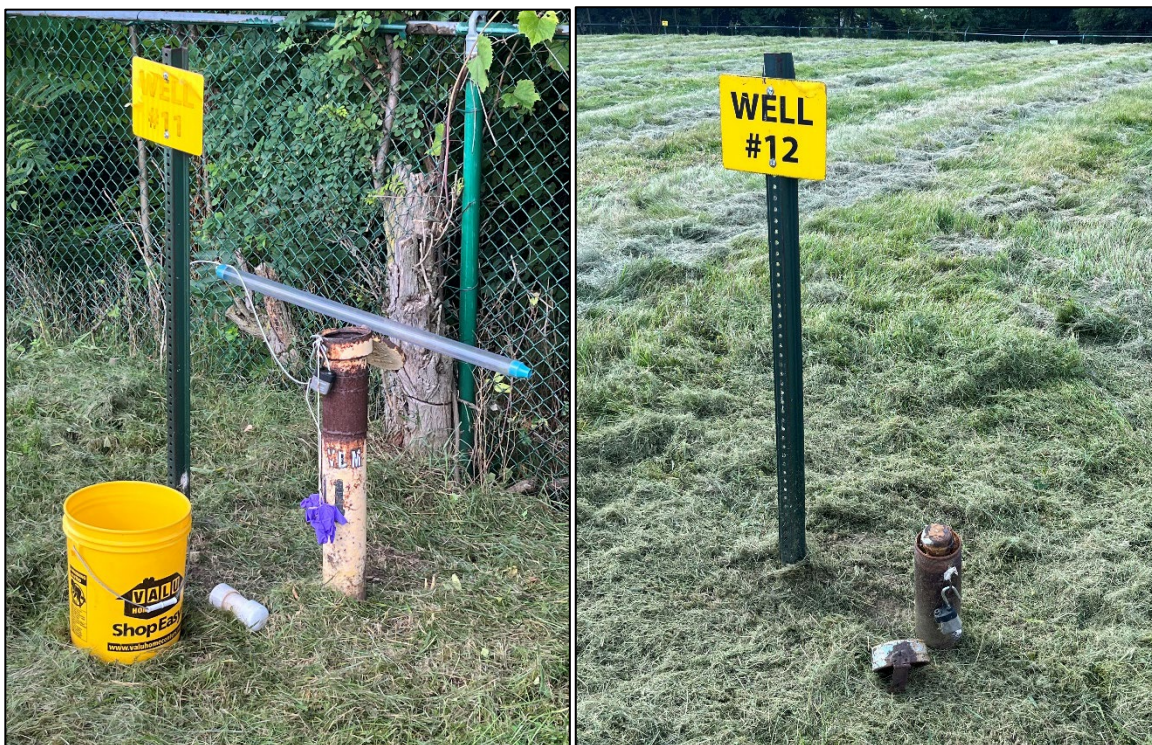
Views of monitoring wells VDM-11 and VDM-12. Note dedicated bailer used for purging/sampling on VDM-11.

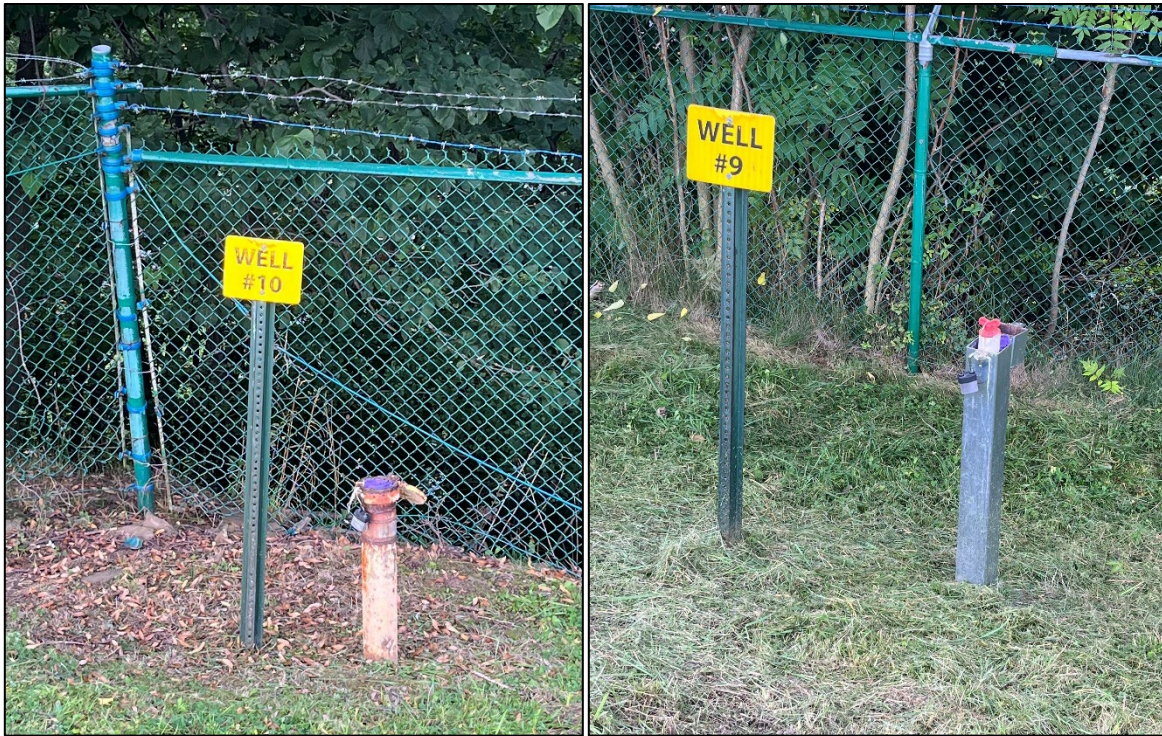
Views of monitoring wells VDM-10 and VDM-9R.

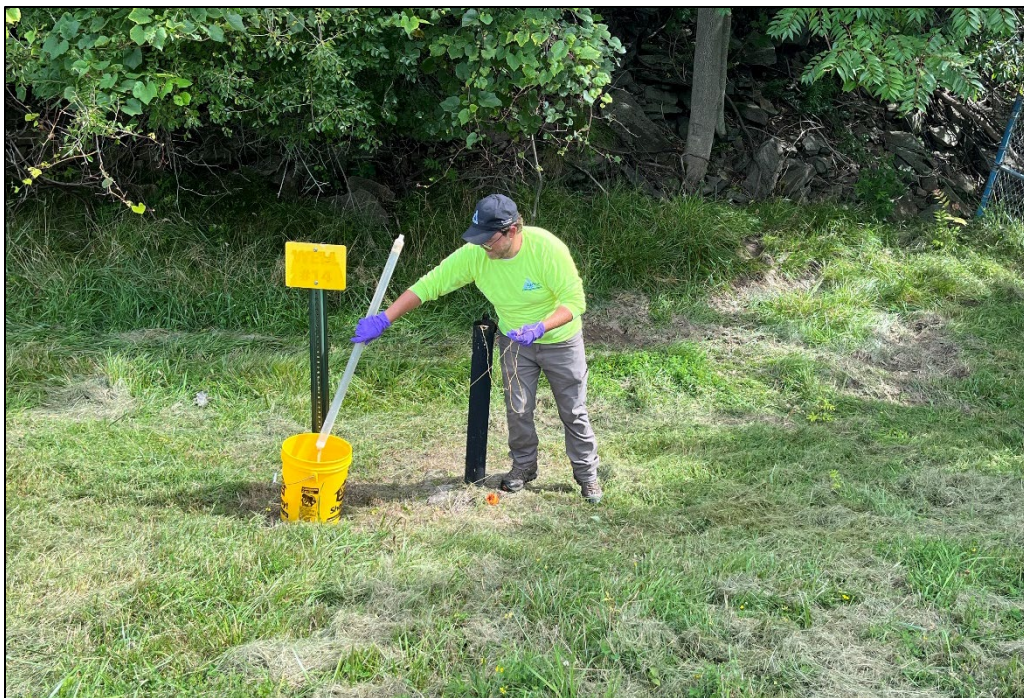
View of monitoring well VDM-14R during purging with dedicated bailer.

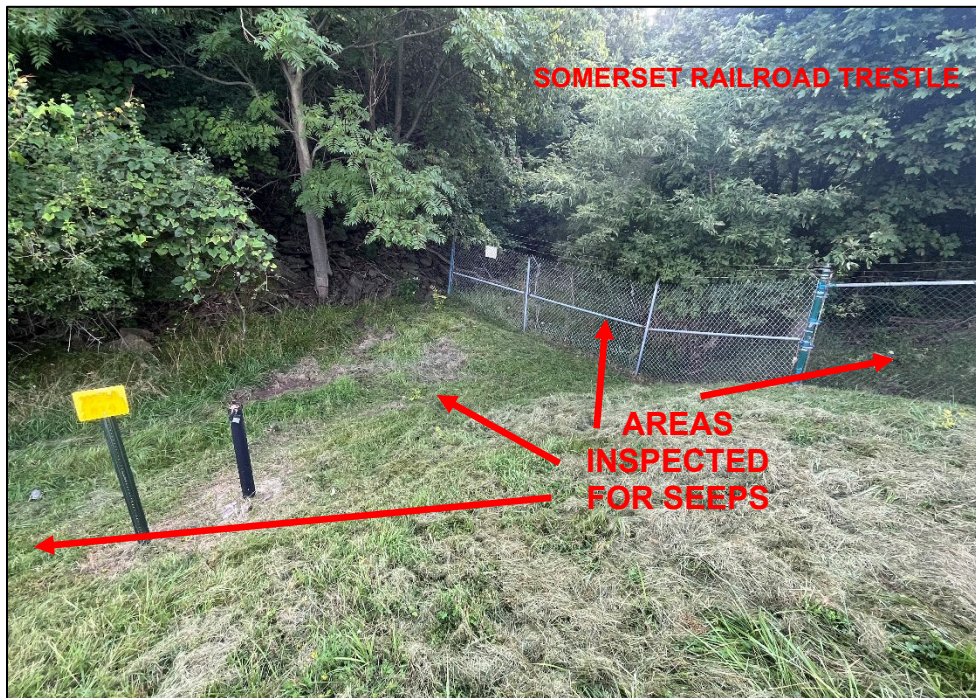
No standing water or leachate seeps were observed on the landfill or along its perimeter inside the fenceline. I inspected the area downslope of the interceptor trench and southeast of well VDM-14R for evidence of leachate seeps and did not find any visible seeps, discoloration, or signs of distressed vegetation. No breaches were noted in the perimeter fence surrounding the landfill. Vanchlor had repaired the small gap in the perimeter chain-link fence southeast of well VDM-14R identified during the August 2022 landfill inspection.

Southeastward view (downslope) near monitoring well VDM-14R showing areas inspected for leachate seeps.

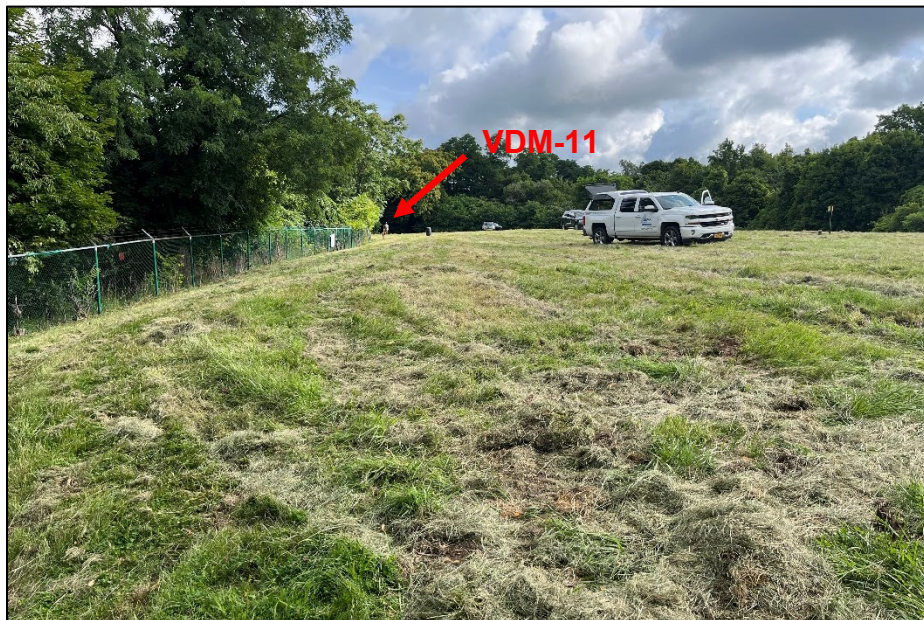
A northward view of the west side of the landfill taken from near VDM-10.

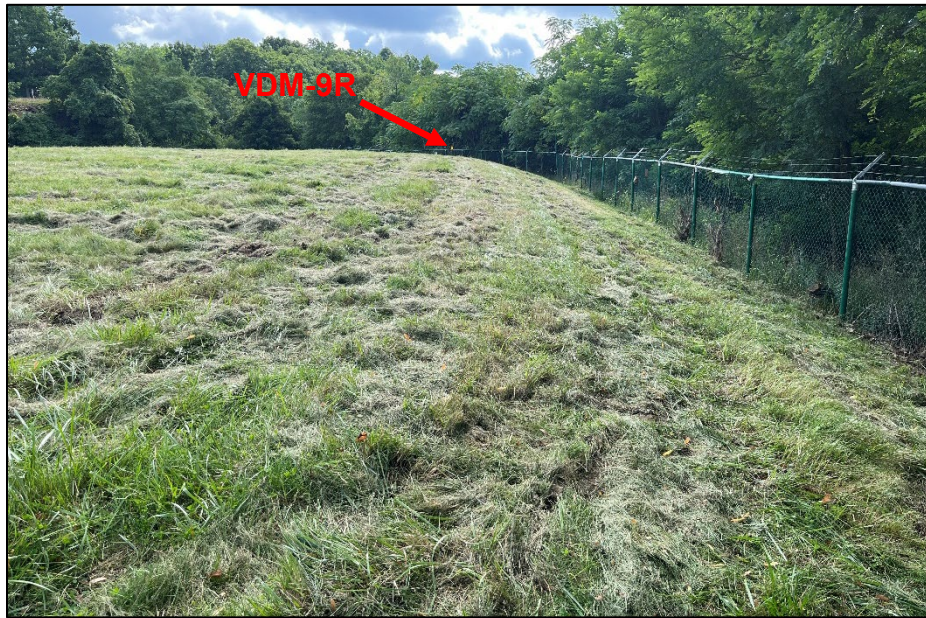
An eastward view of the south side of the landfill taken from near VDM-10.

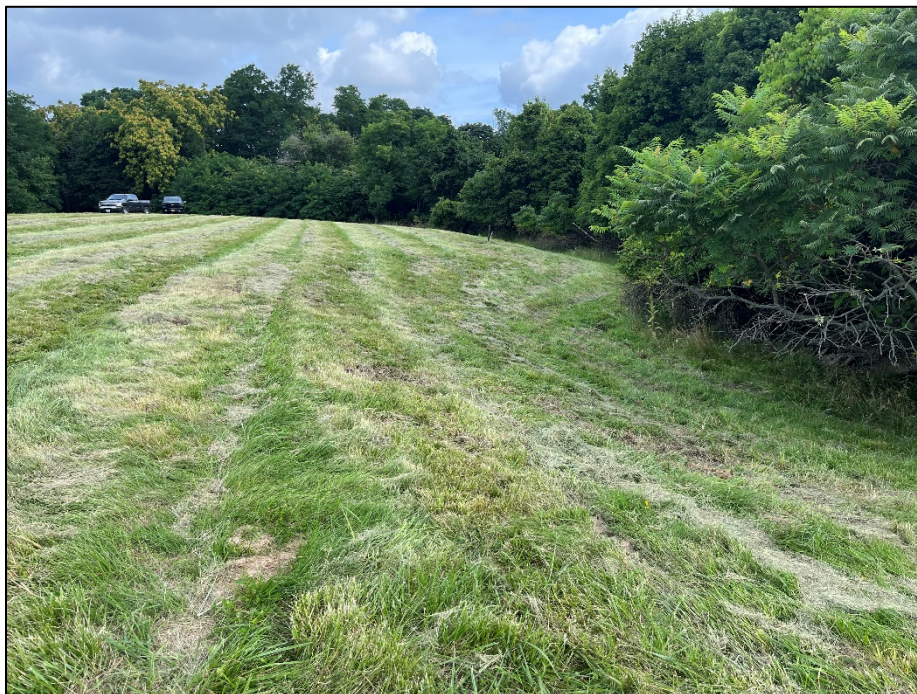
A northward view of the east side of the landfill.

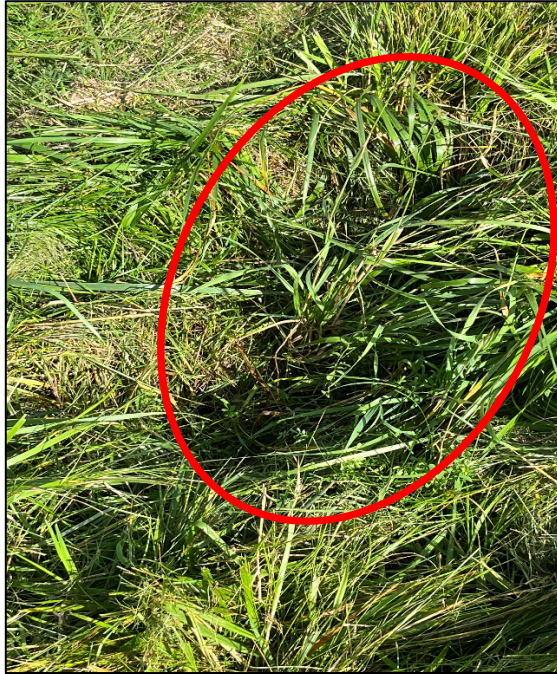
The landfill had been mowed recently and the grassy vegetative cover was well established with no bare spots. Brian Law noted a small depressional area (maybe 2 feet in diameter by 6 inches deep; still grassy) about 50 feet northeast of well VDM-12. Brian indicated that Vanchlor would repair this depression by filling it with topsoil.

Small depression northeast of well VDM-12 observed during the landfill inspection. Brian Law (Vanchlor) said they would repair the depression by filling it with topsoil

Action Item: Vanchlor to repair the small depressional area northeast of VDM-12 with topsoil.

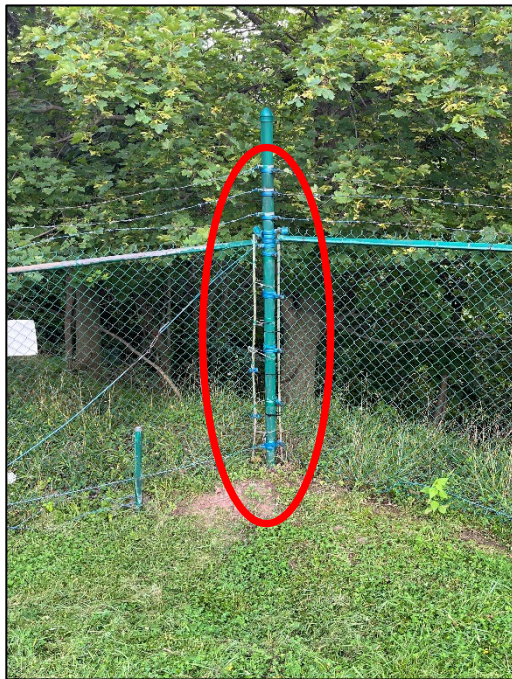
Repaired small gap in the perimeter chain-link fence southeast of well VDM-14R (identified during the August 2022 landfill inspection).

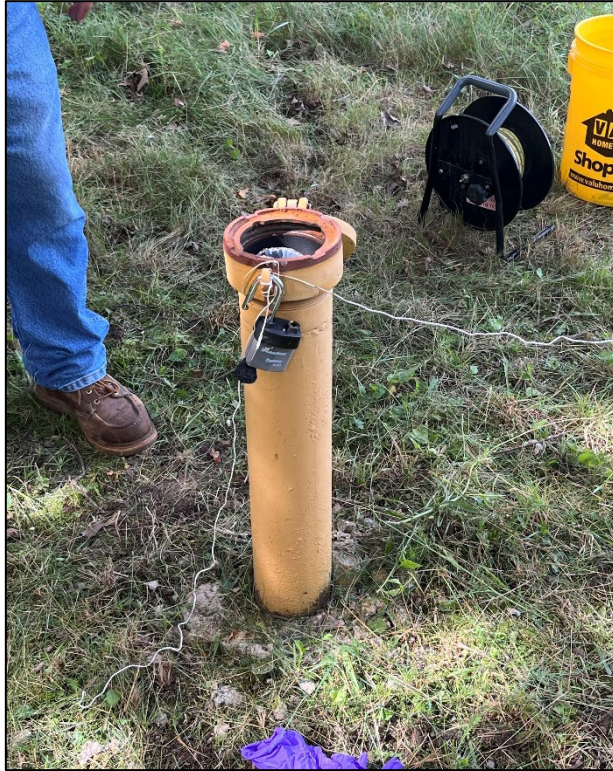
View of upgradient monitoring well D-55, located outside the east side of the landfill perimeter fence.

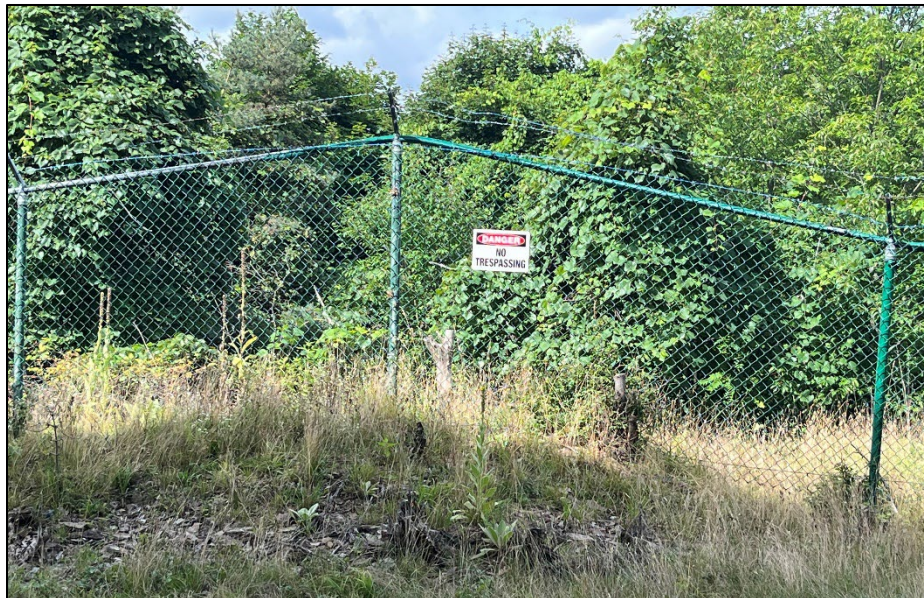
A westward view of the landfill perimeter fence near upgradient monitoring well D-55 showing typical “NO TRESPASSING” signage posted around the landfill perimeter.

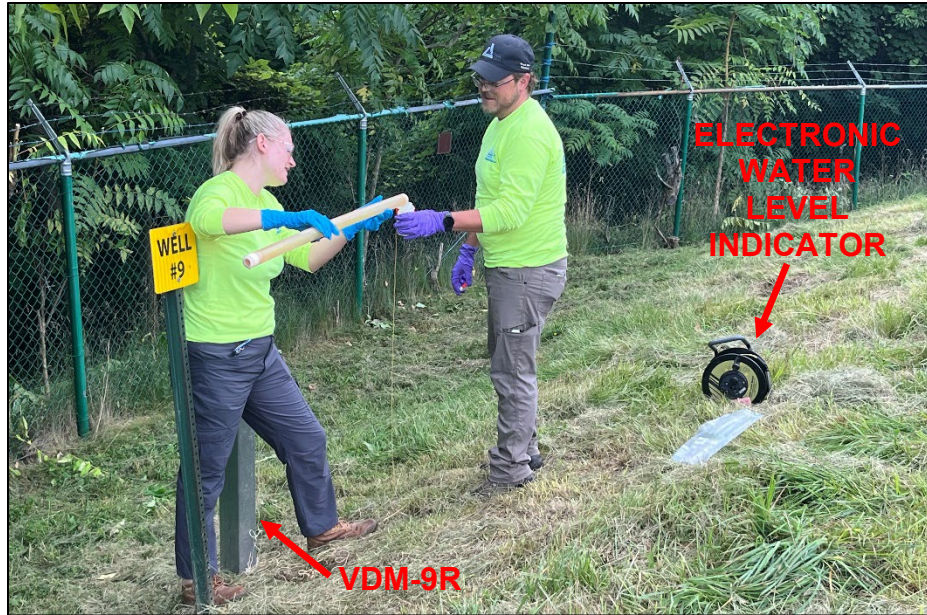
Groundwater sample collection at well VDM-9R.

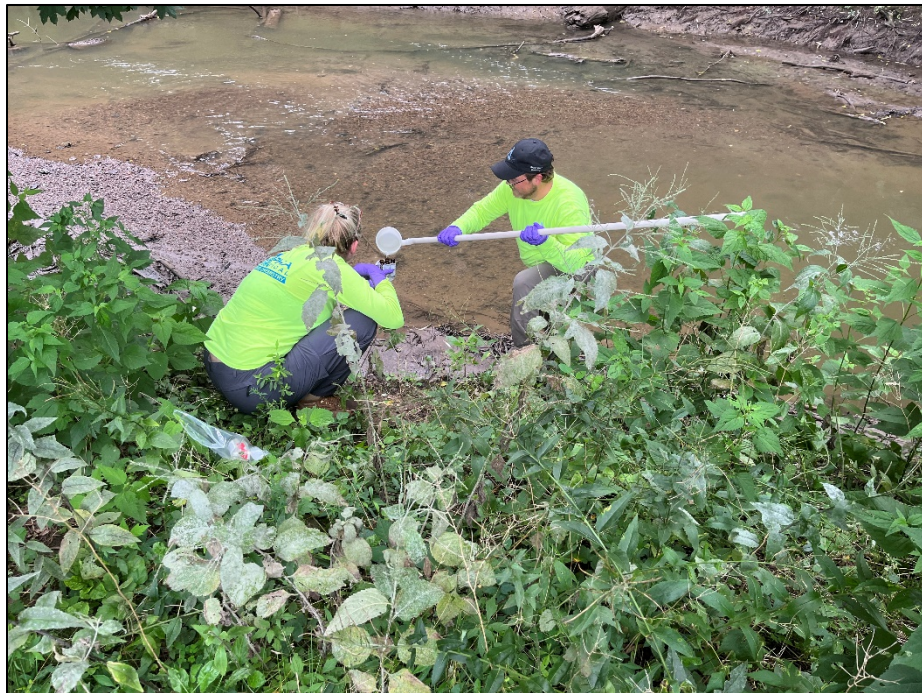
Surface water sample collection from Eighteen Mile Creek using a dipper pole.
