SITE INSPECTION REPORT

Site Name: Frontier Chemical Pendleton

Site Number: 932043

Inspection Date: 4/1/2026

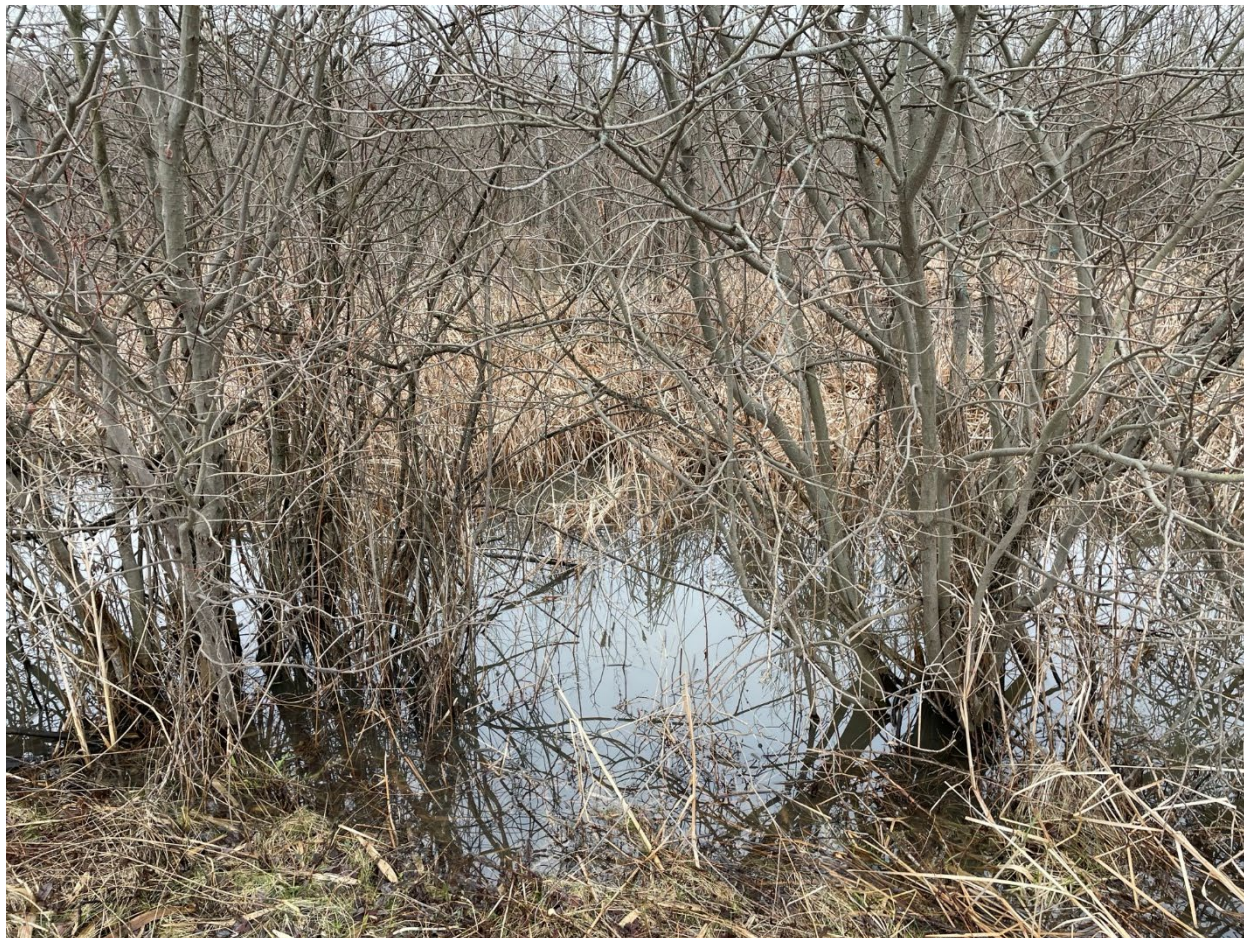
Wetlands west/northwest of Quarry Lake.

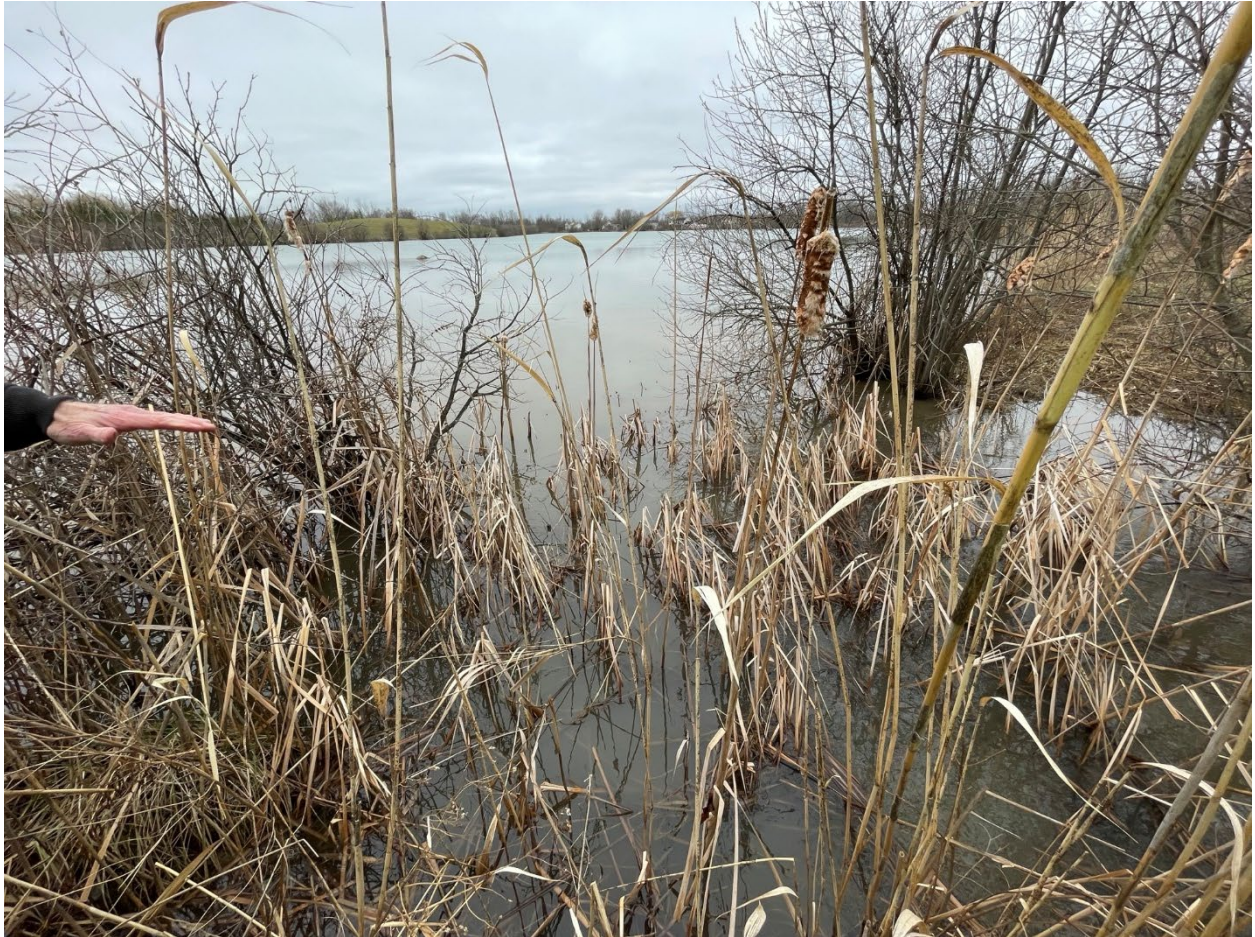
- NYSDEC onsite 10:00 AM to 11:00 AM for semiannual inspection.
- Glynn surveyed water level of Quarry Lake with Topcon AT-FG and inspected weir. Glynn Group unaware of remedial significance of surveying water level of Quarry Lake, it was an item on original inspection checklist after remedial action was completed, per Jesse. Overflow weir was observed to be flooded and water flowing into lake. Per Glynn Group, weir was simply geotechnical fabric and stone laid down in that area during remedial action completion.

Weir conditions, view facing south.

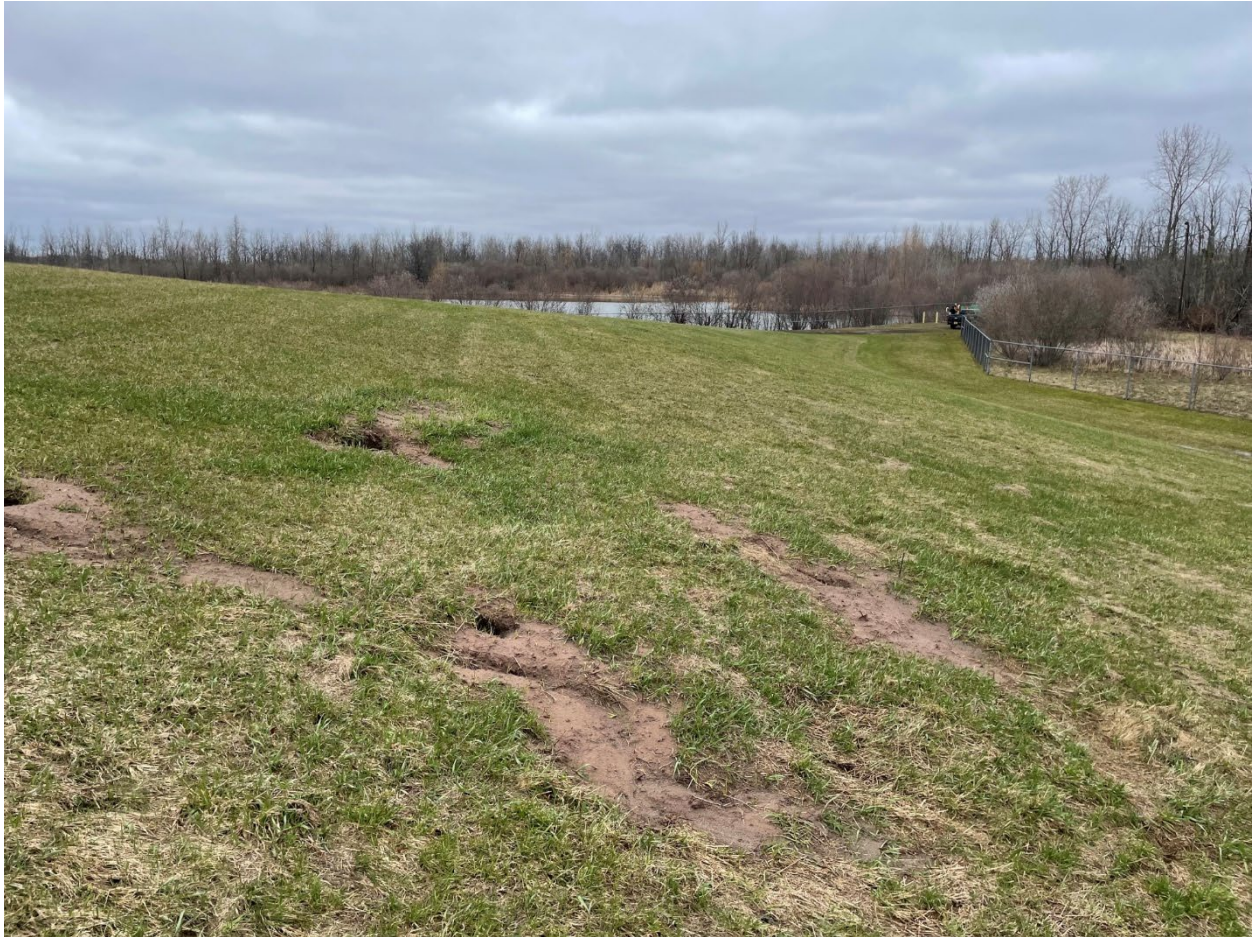
- Ruts in driveway along western to northwestern site perimeter. Several animal borrow holes were observed in eastern/northeastern landfill capped area and will need to be backfilled.

Animal Burrows in landfill cap.

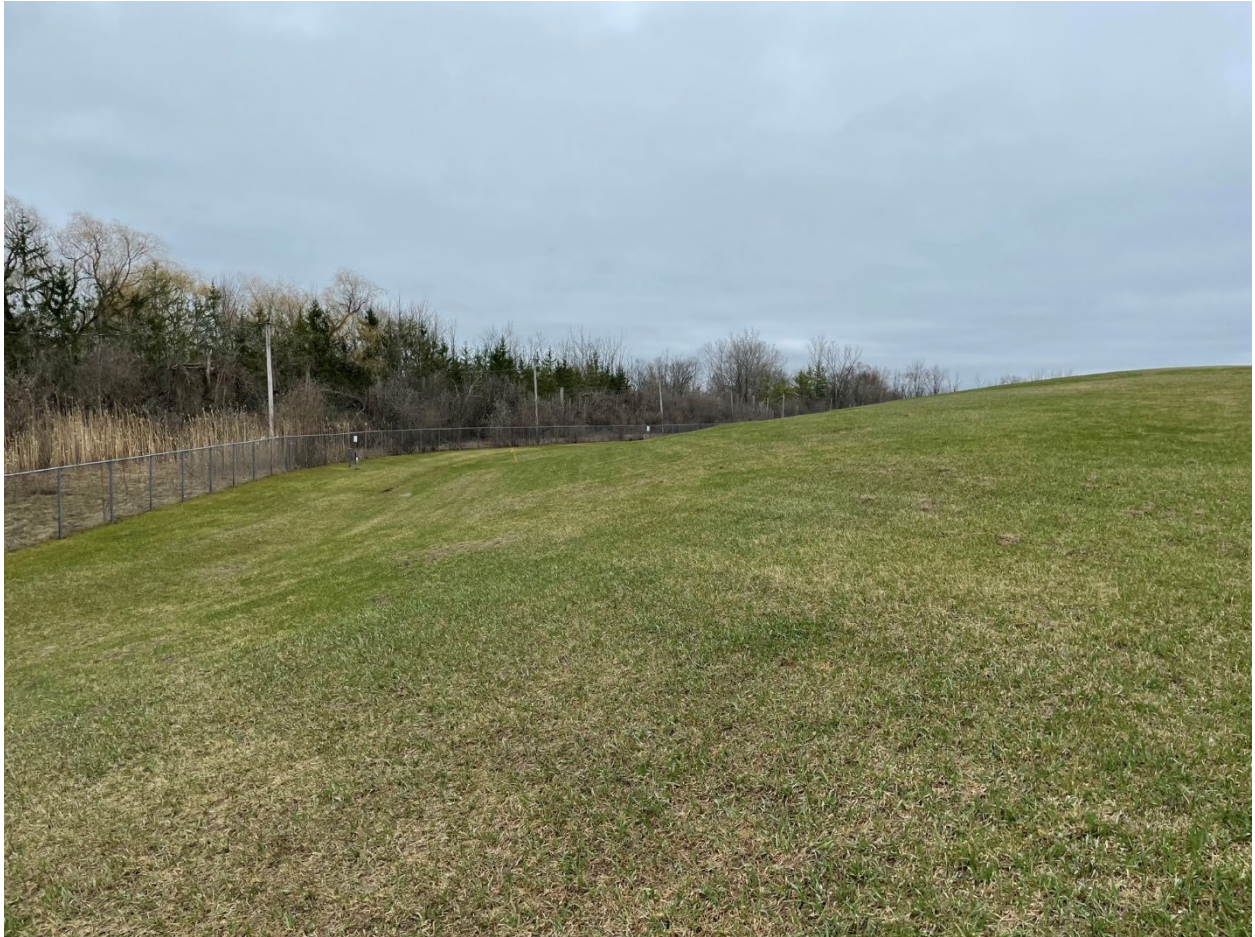
Landfill cap conditions, view facing southwest.

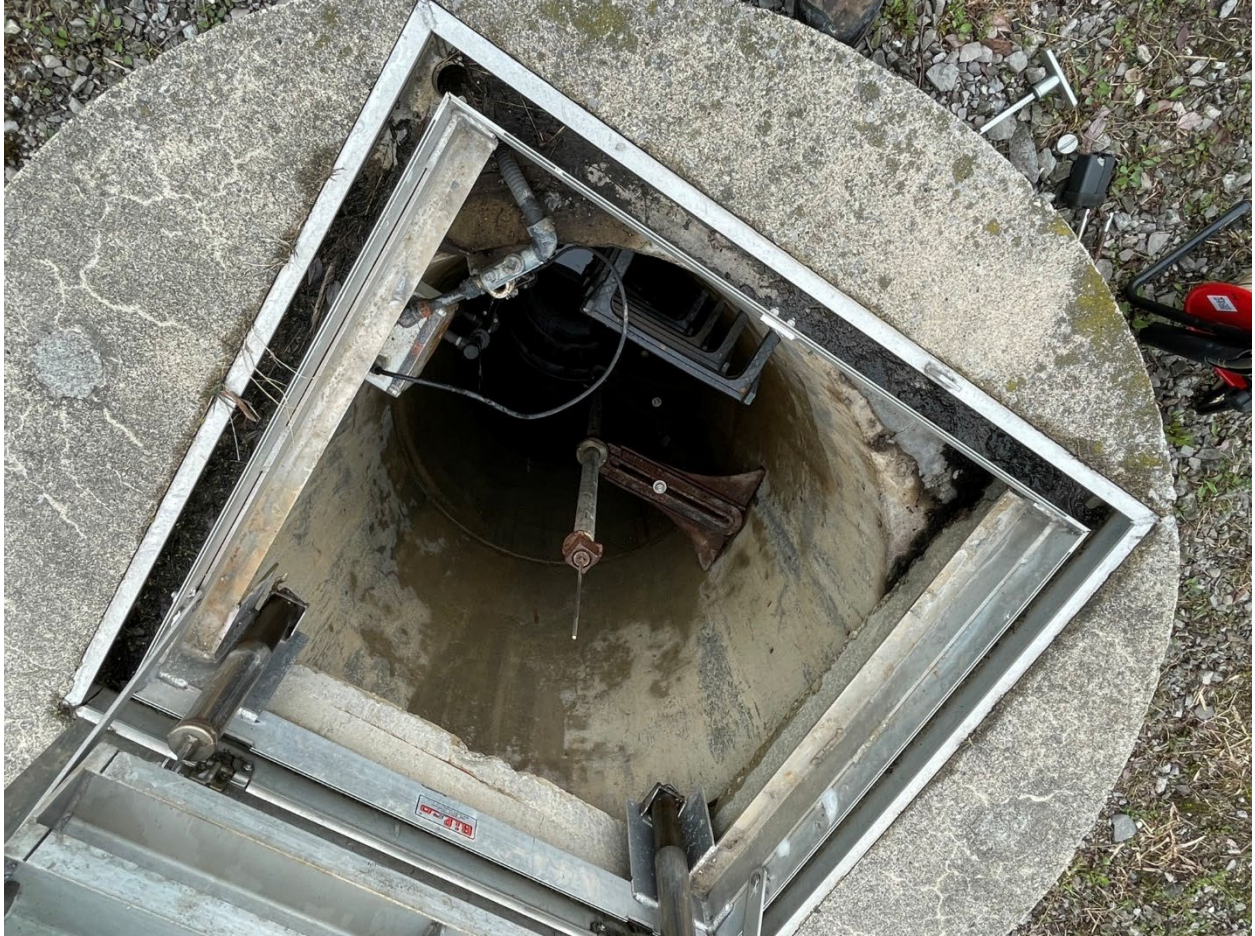
- Sevenson pumping collection system for influent and effluent sampling. NYSDEC informed them of ongoing requirement to include disposal records of treatment system carbon tanks. If carbon is treated as non-hazardous solid waste, applicable testing records must be provided in annual Periodic Review Reports.

Groundwater collection system sump vault.

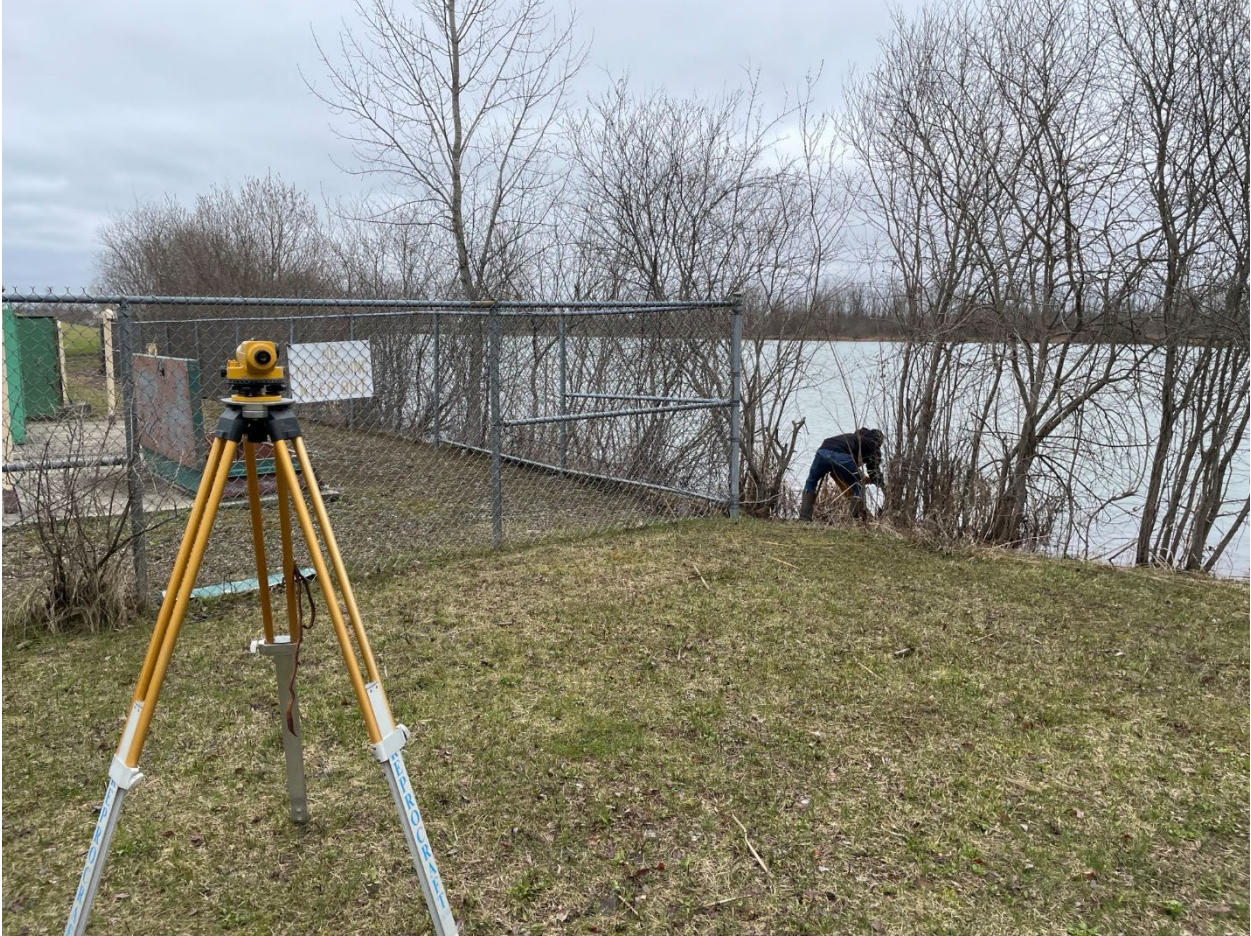
Glynn survey setup.

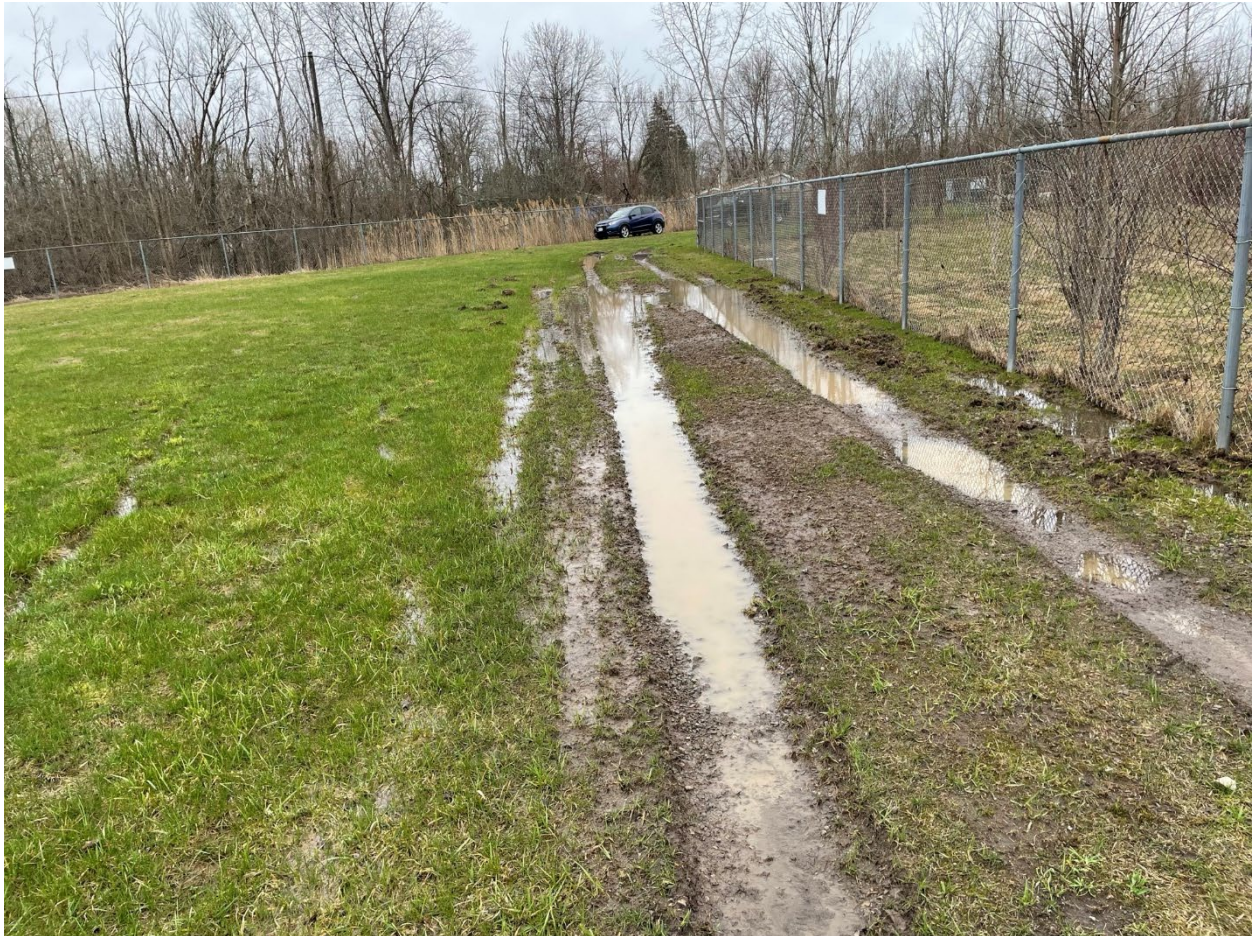
Vehicle ruts, view facing south.

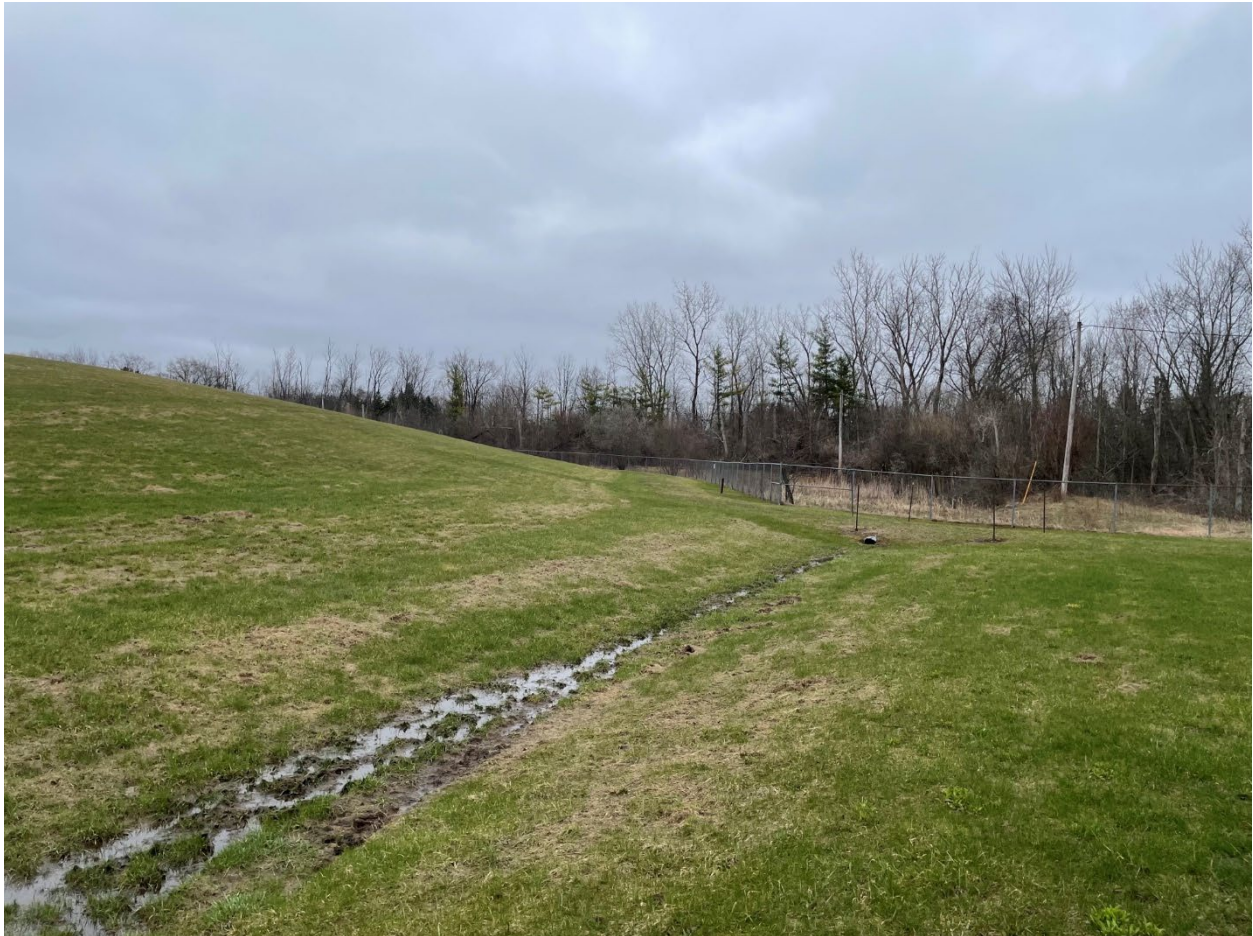
Landfill cap conditions, view facing south/southeast.
