Division of Environmental Remediation

Site: Olin Industrial Welding Site

Phase: Management

Site No.: 932050

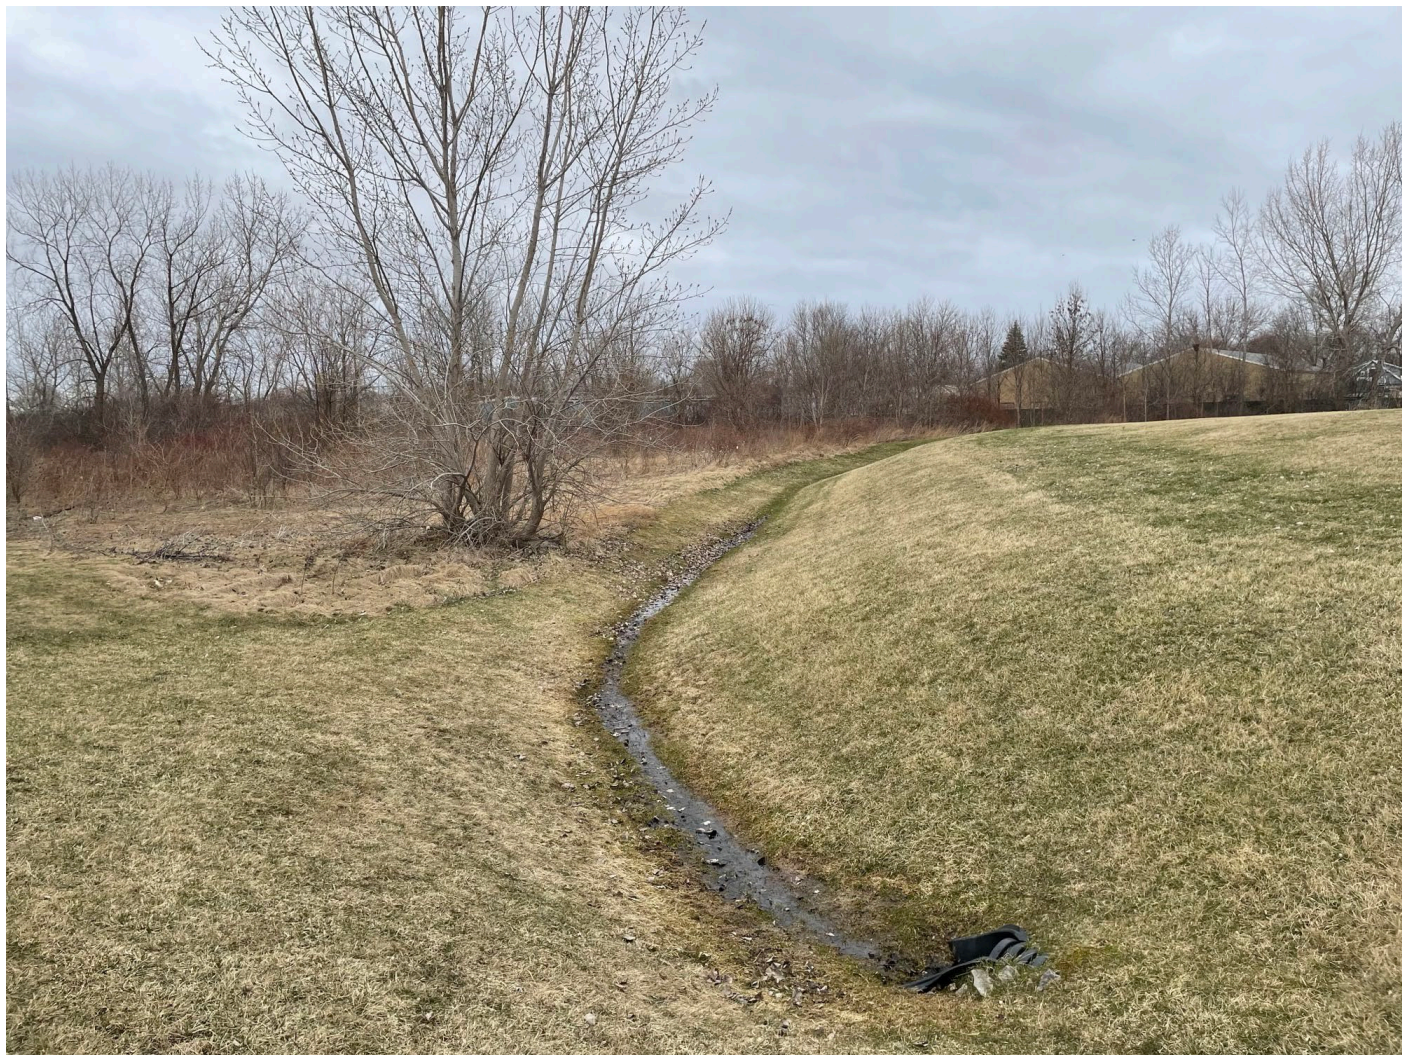
- Fencing, leachate control recovery system (LCRS) flow meters, piping, sump, and vegetative cover in good shape, no deficiencies noted. Some standing water in perimeter drainage ditch but no evidence of erosion or settlement. All catch basins, monitoring wells and LCRS cleanout found to be in acceptable conditions. Piezometer P-1R hinge would not shut, should be noted on inspection form. NYSDEC requested annual mowing occur after Aug 15, Severson noted.

OU-2 vegetative cover/drainage ditch with a small amount of standing water. View looking NW.

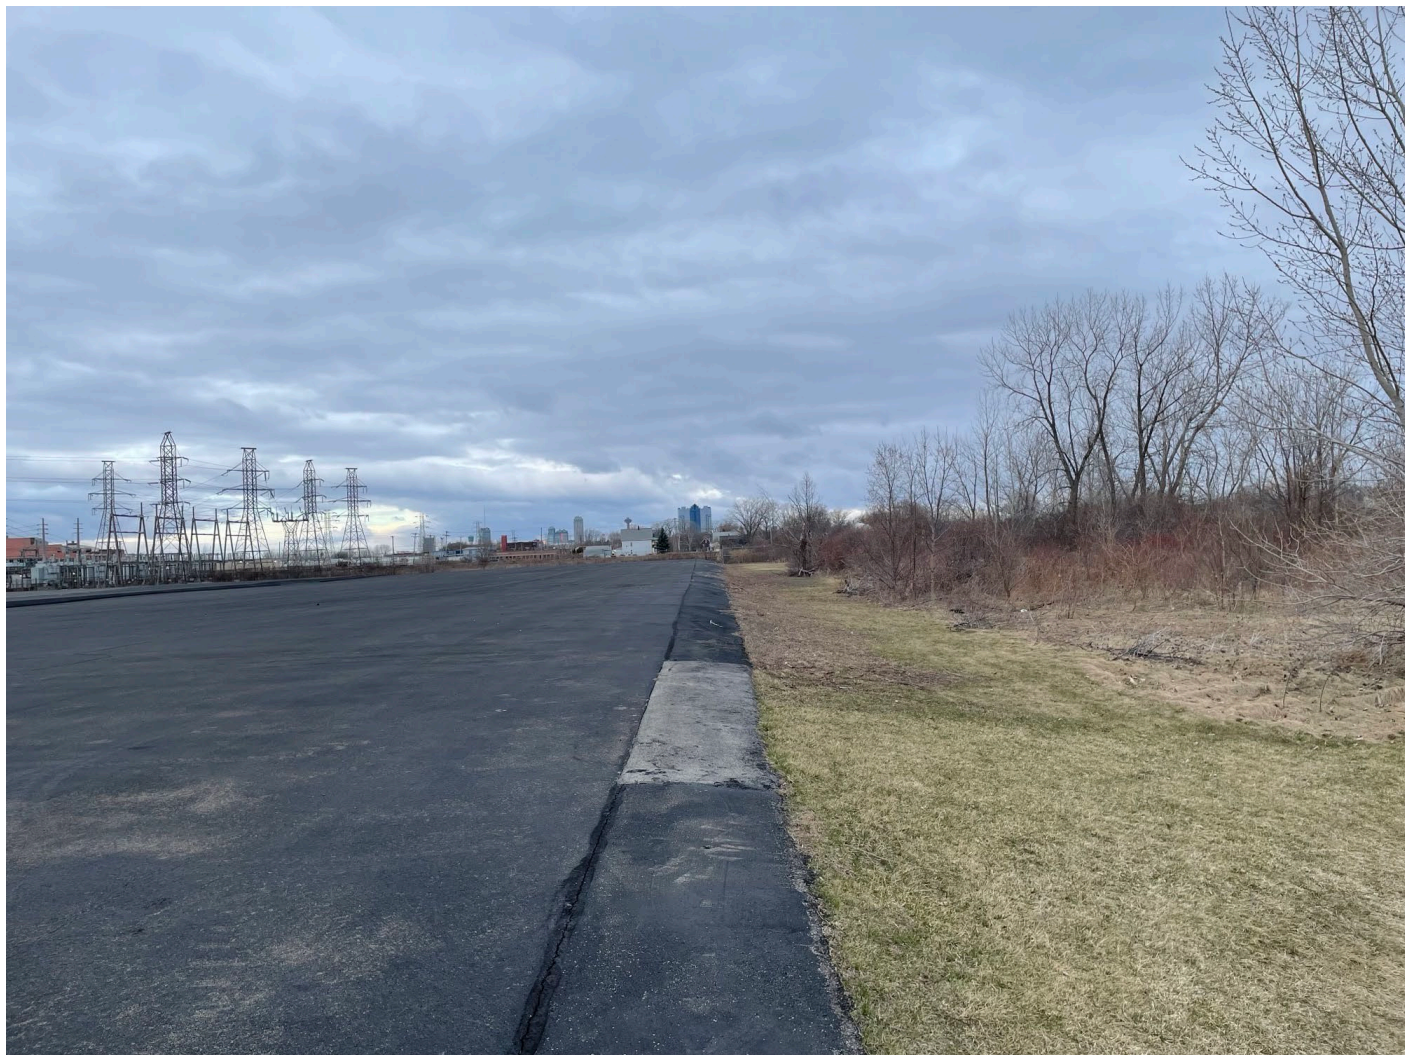
Asphalt/Vegetative cover. View looking W.

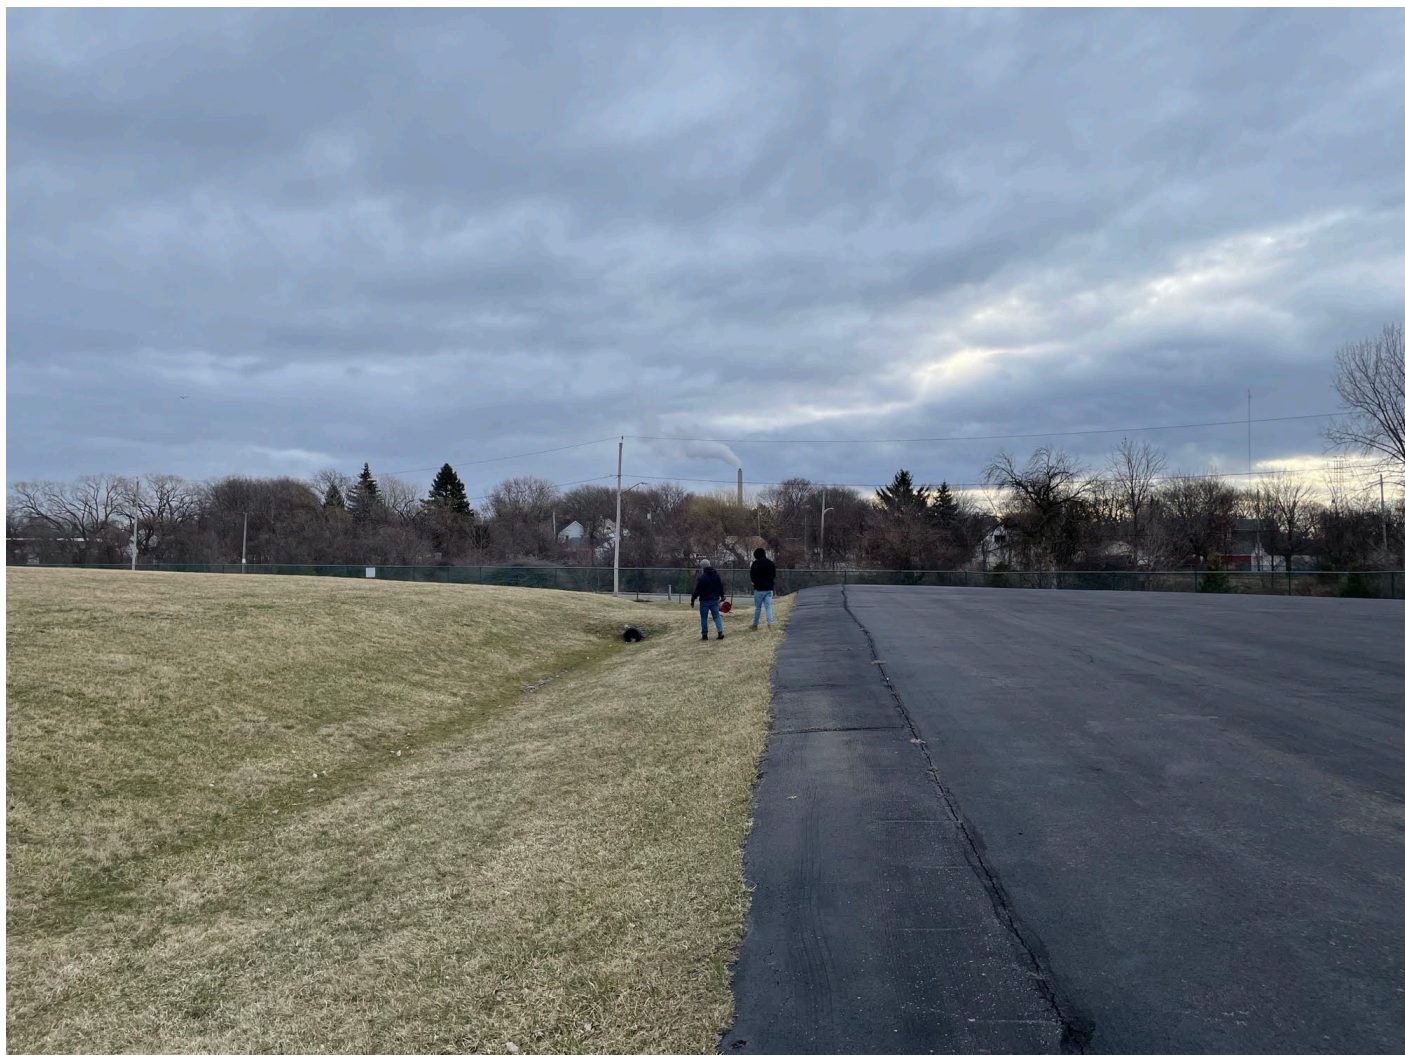
Asphalt/Vegetative cover. View looking E.

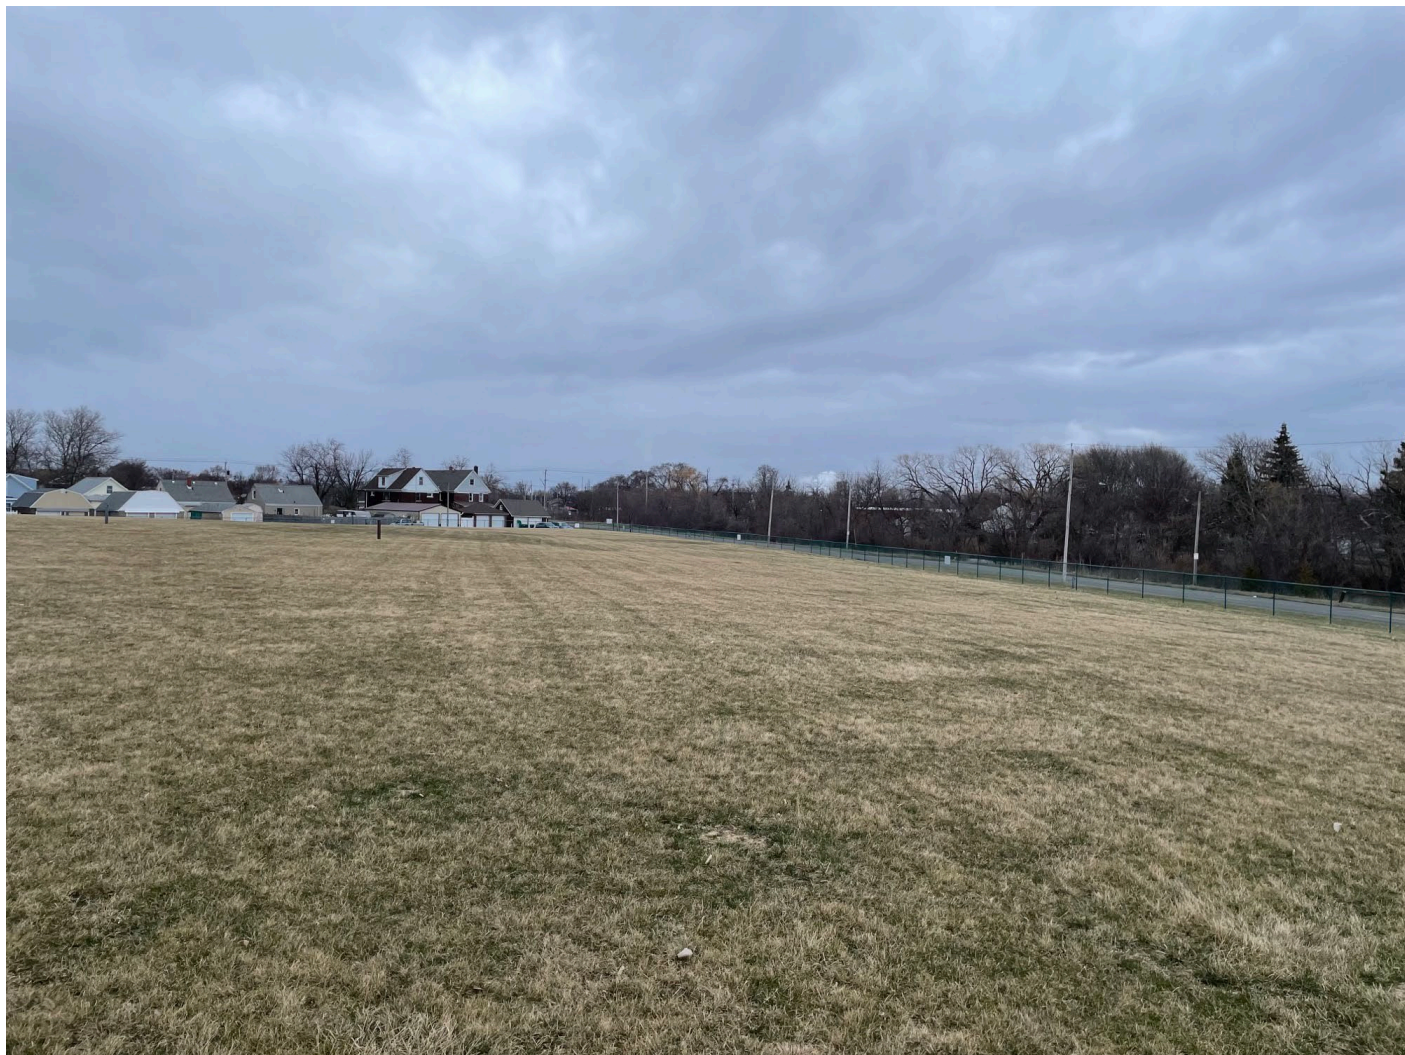
Vegetative cover/OU-2 view looking N.

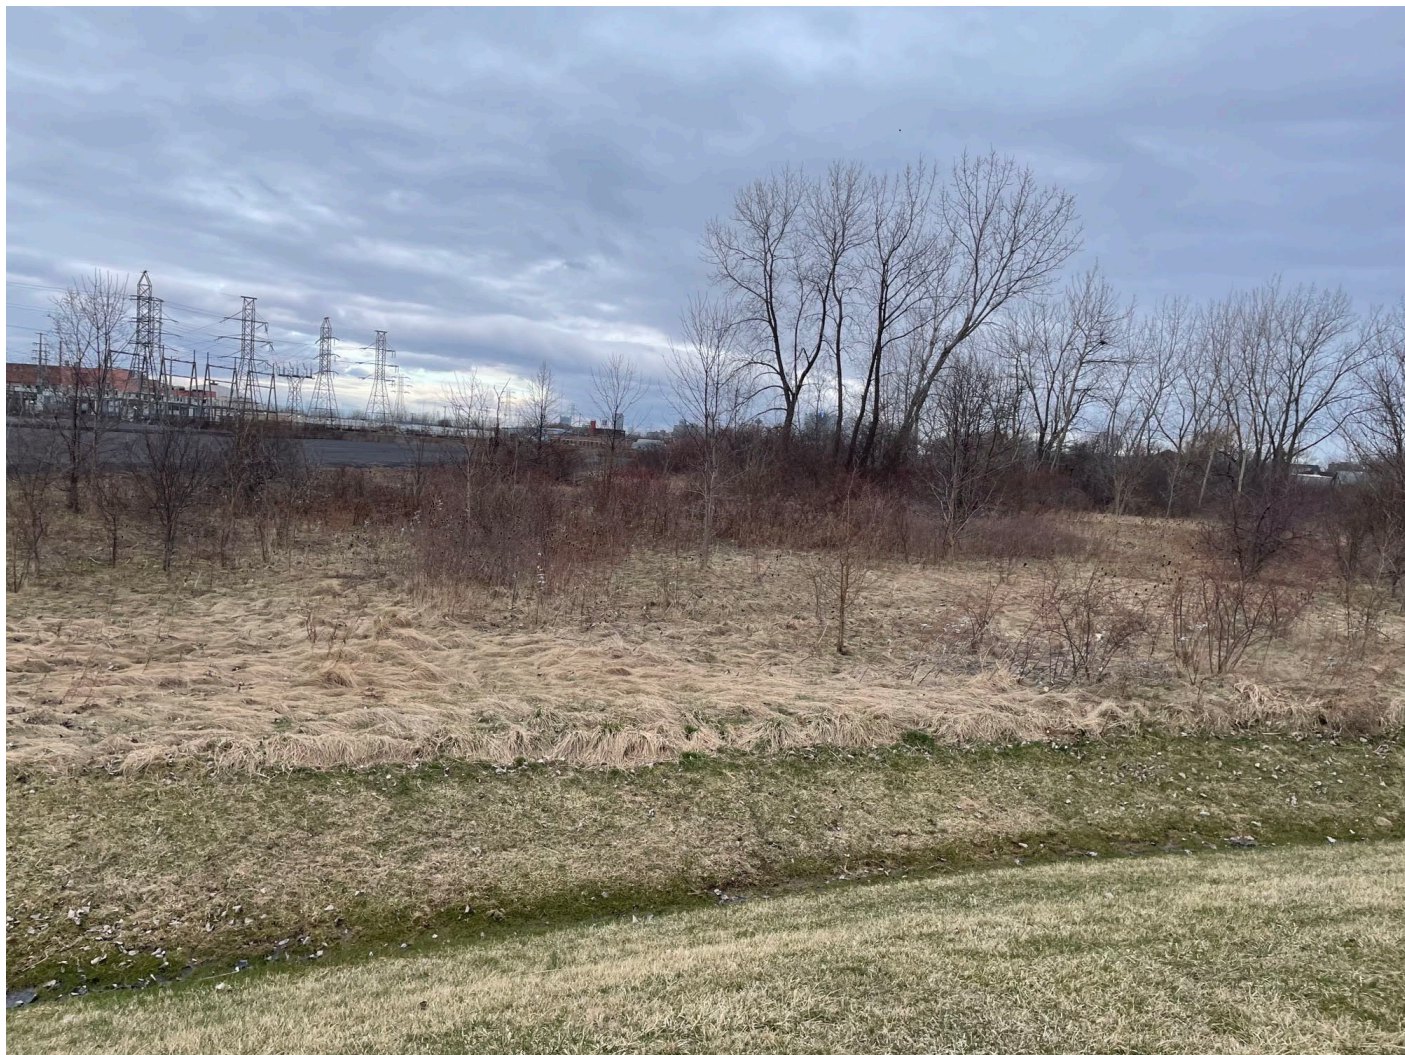
Wooded area outside of cover system. View facing W.

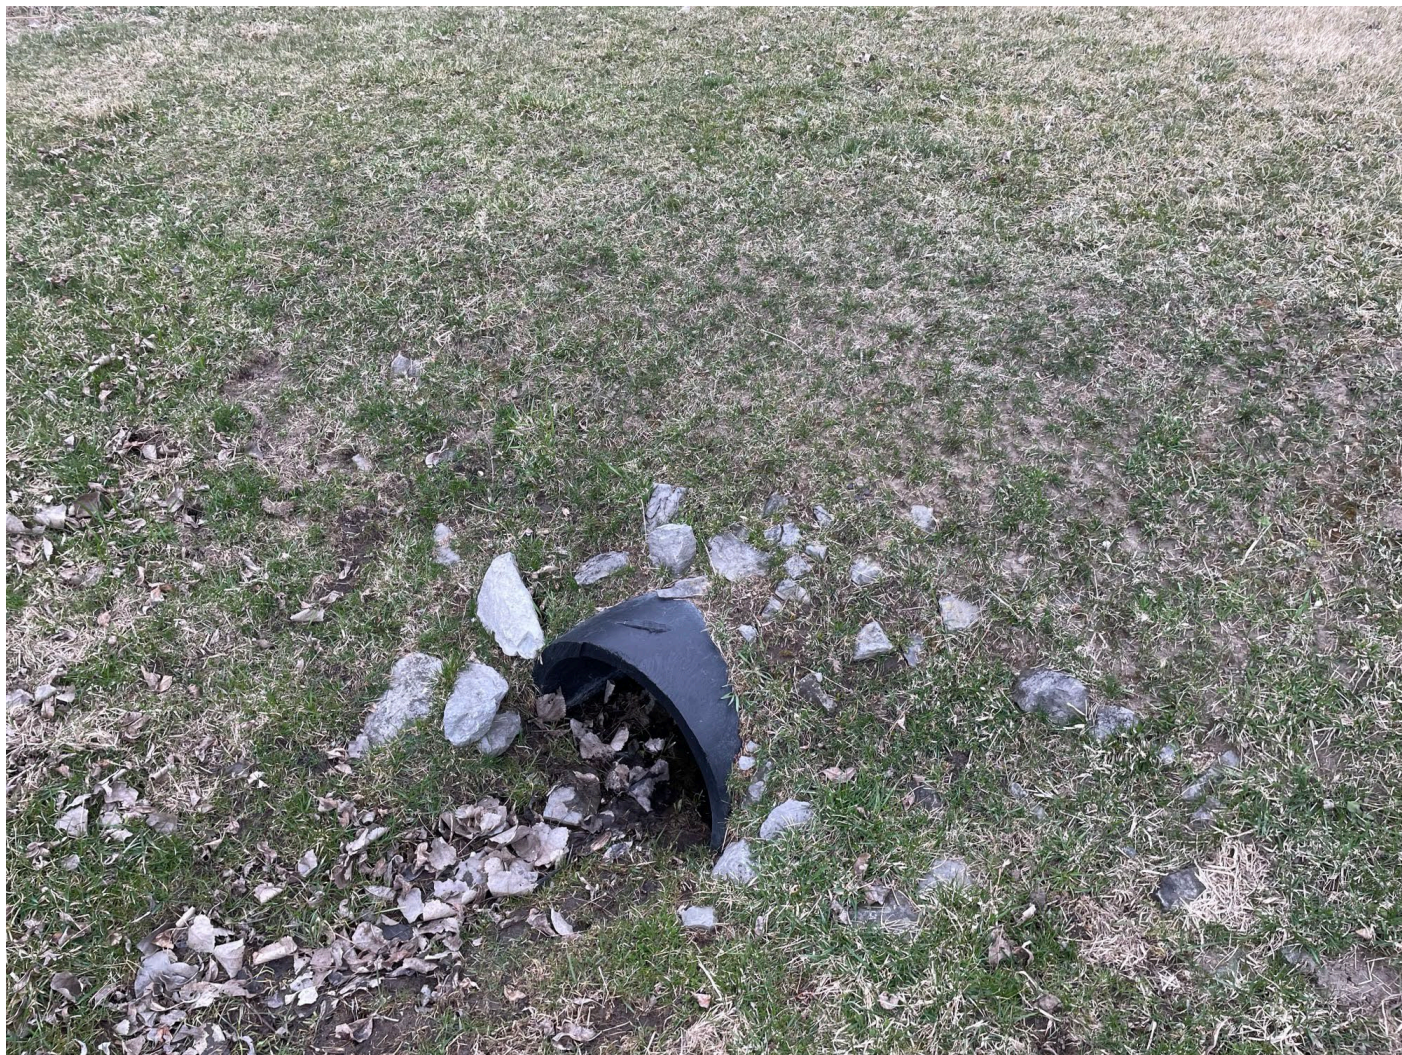
Culvert/Riprap.

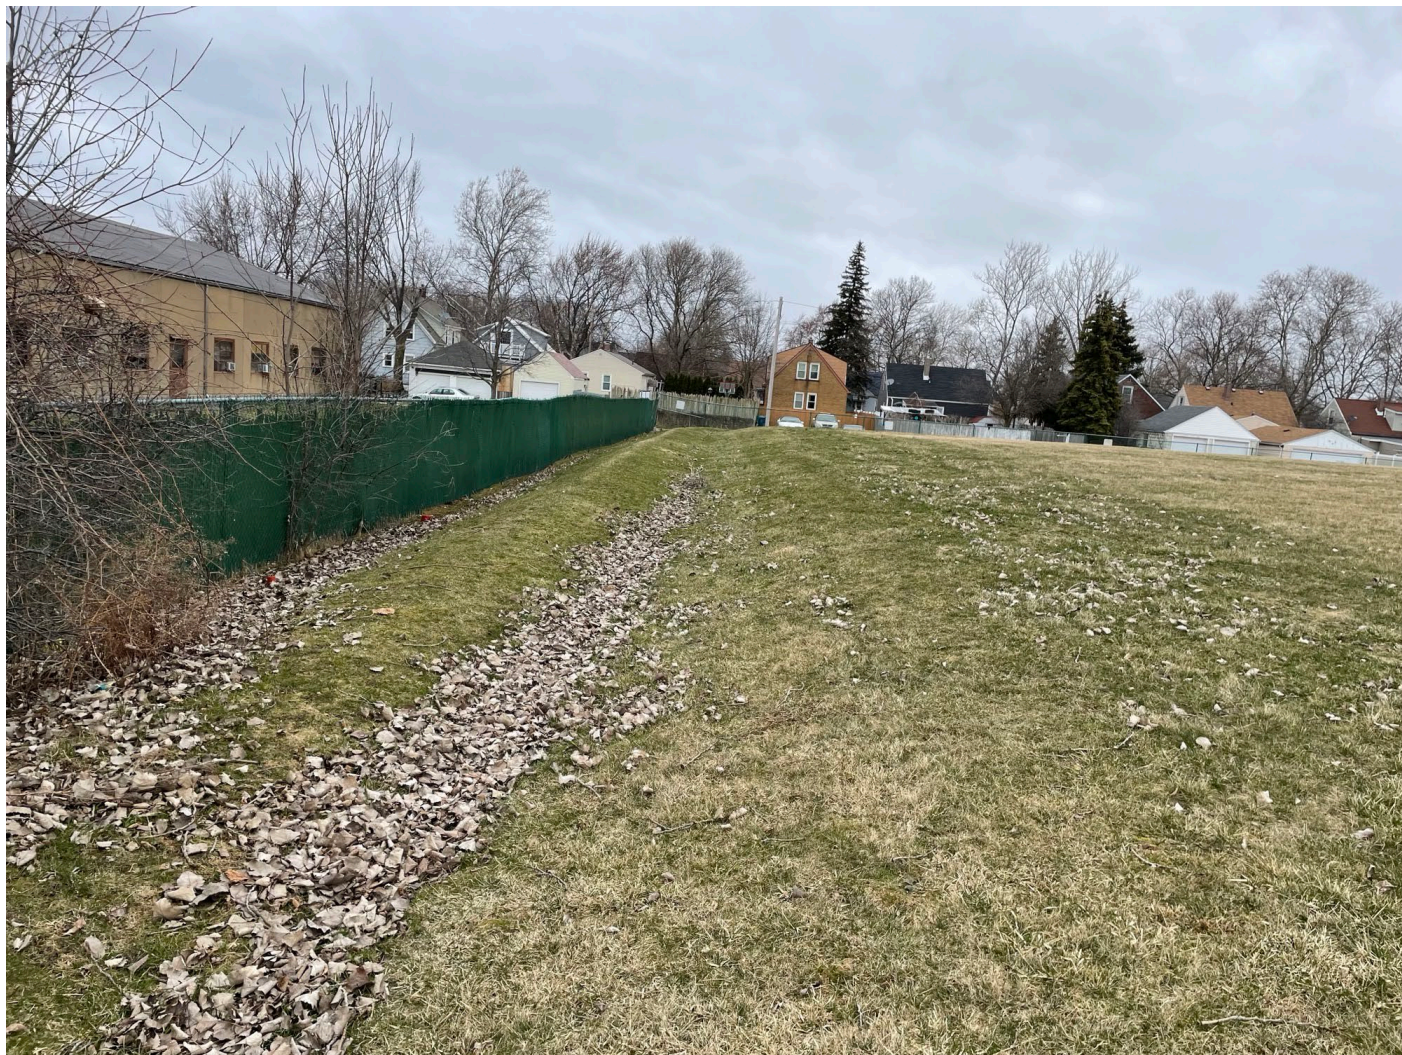
Drainage ditch/vegetative cover OU-2 view facing N.

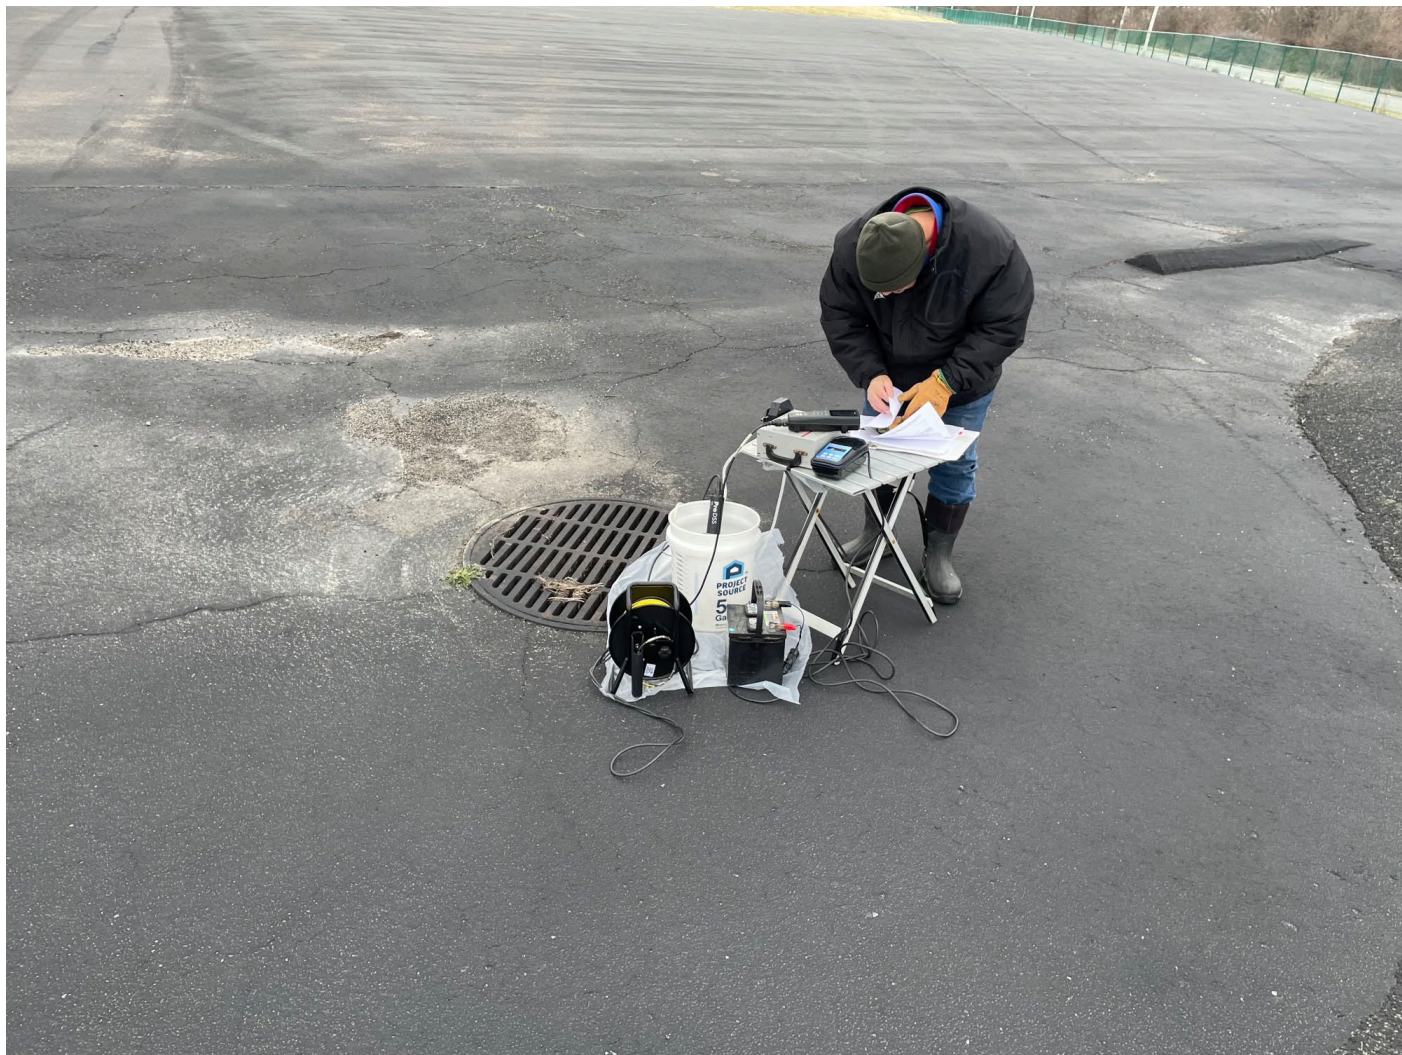
Olin sampling SD-1.

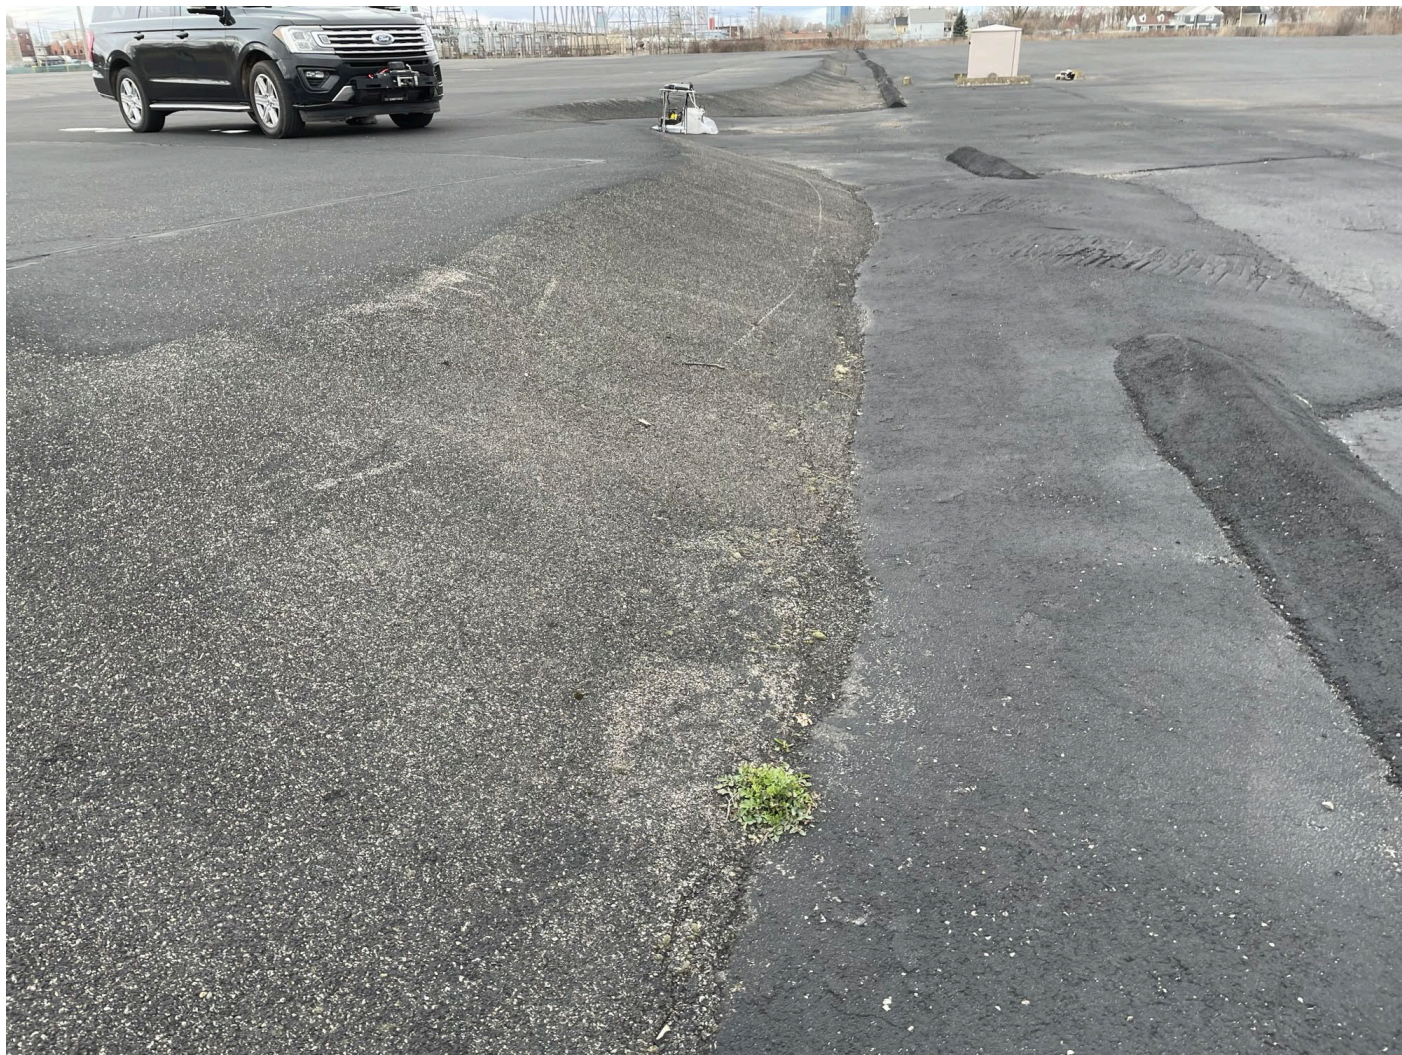
- Asphalt cover in good shape, 1 instance of vegetation growth through cover was noted. No further action needed at this time. All manholes, culverts, drop inlets in acceptable conditions. Only 1 of 3 outfalls/headwall was visible from opposite side of Gill Creek and appeared to be in good condition.

Asphalt cover with minor vegetation growth through cracks.

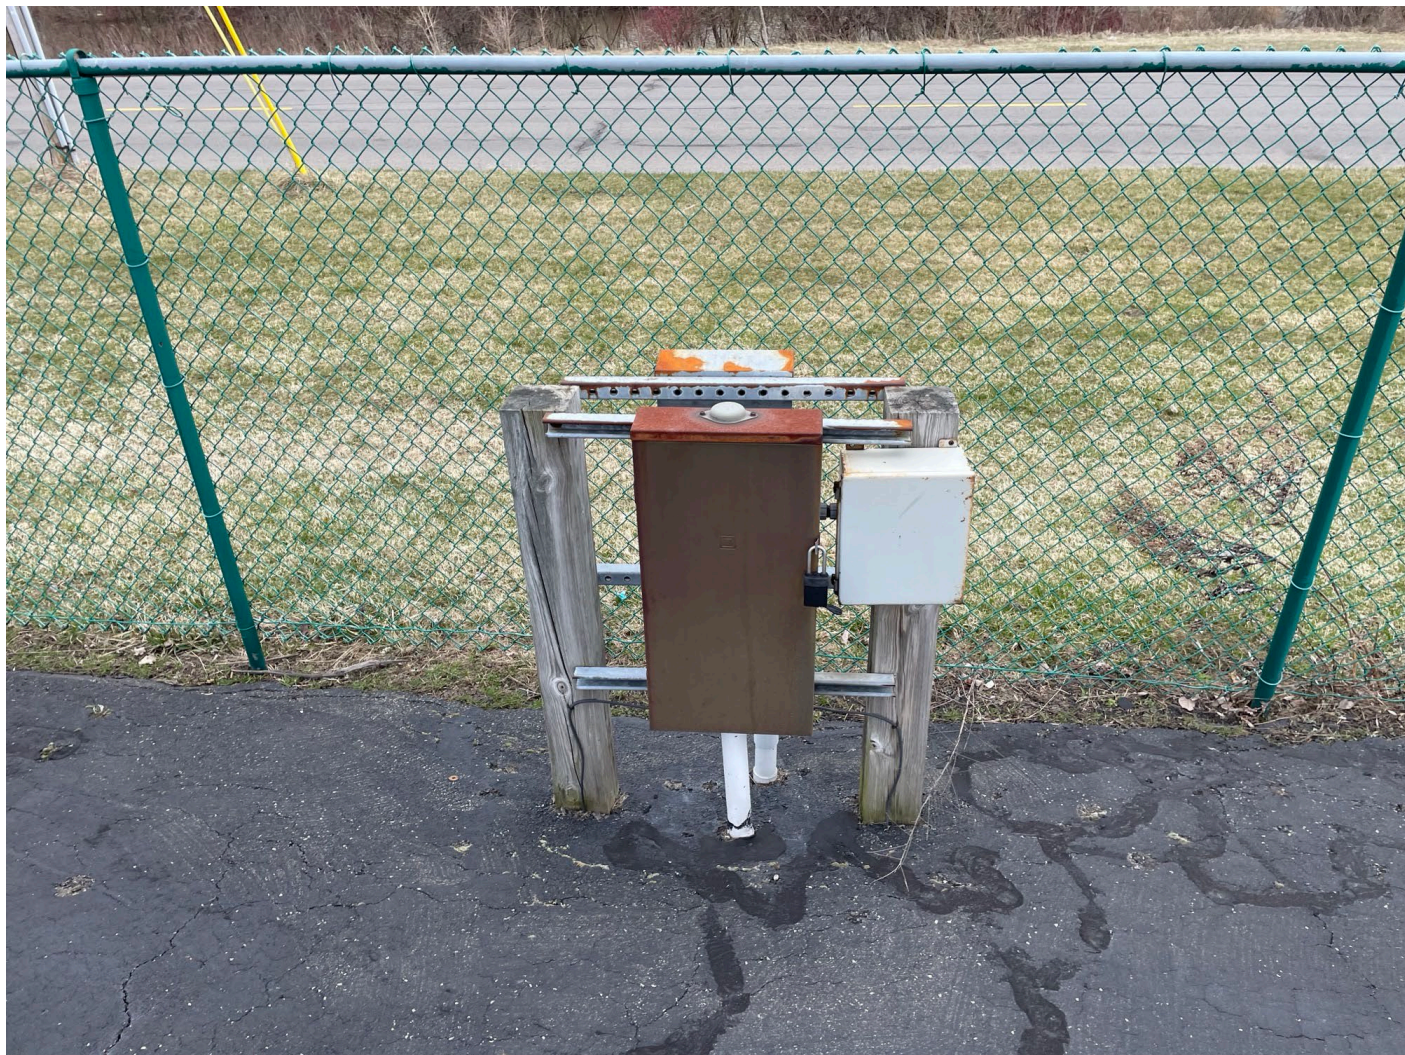
Electric panel/control box for LCRS.

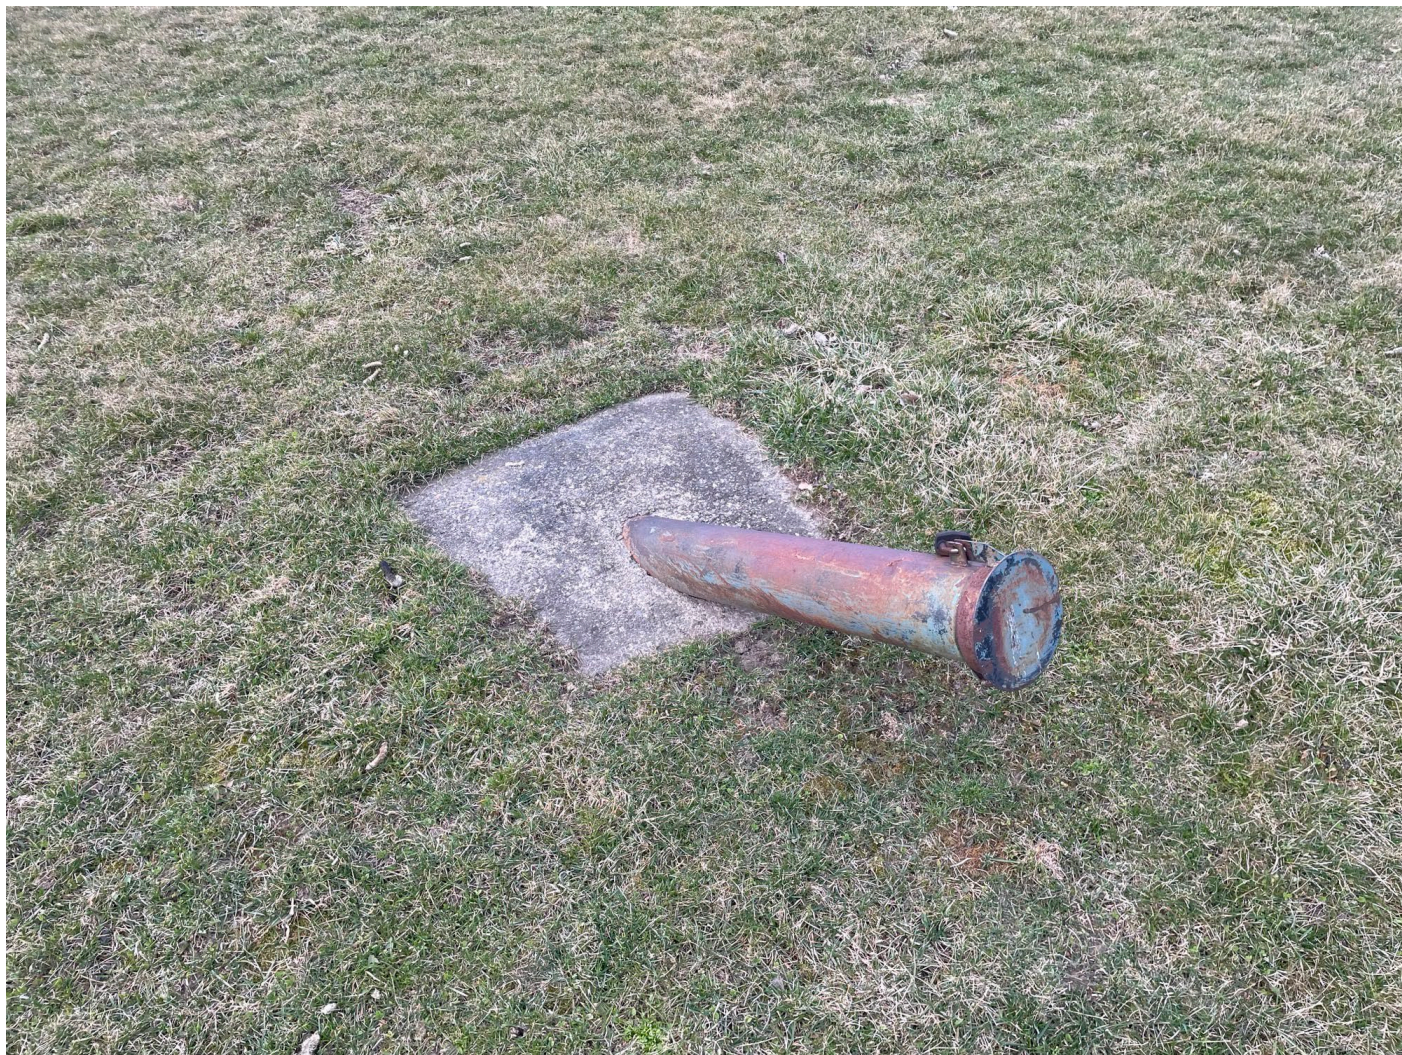
LCRS cleanout pipe.

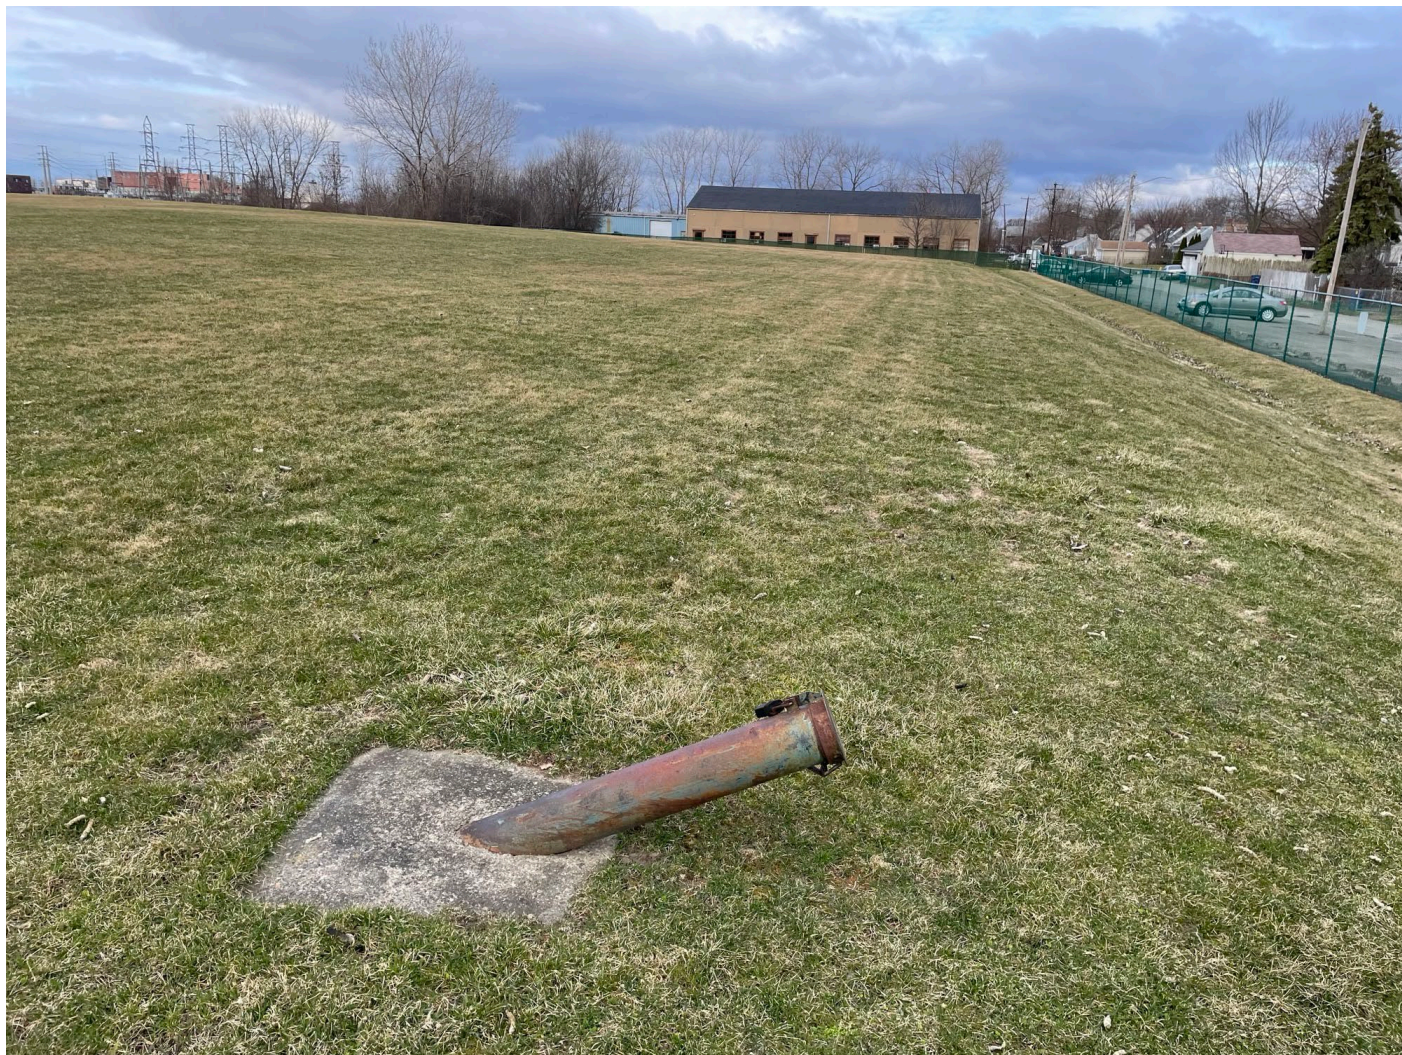
LCRS cleanout pipe/northern vegetative cover facing W.

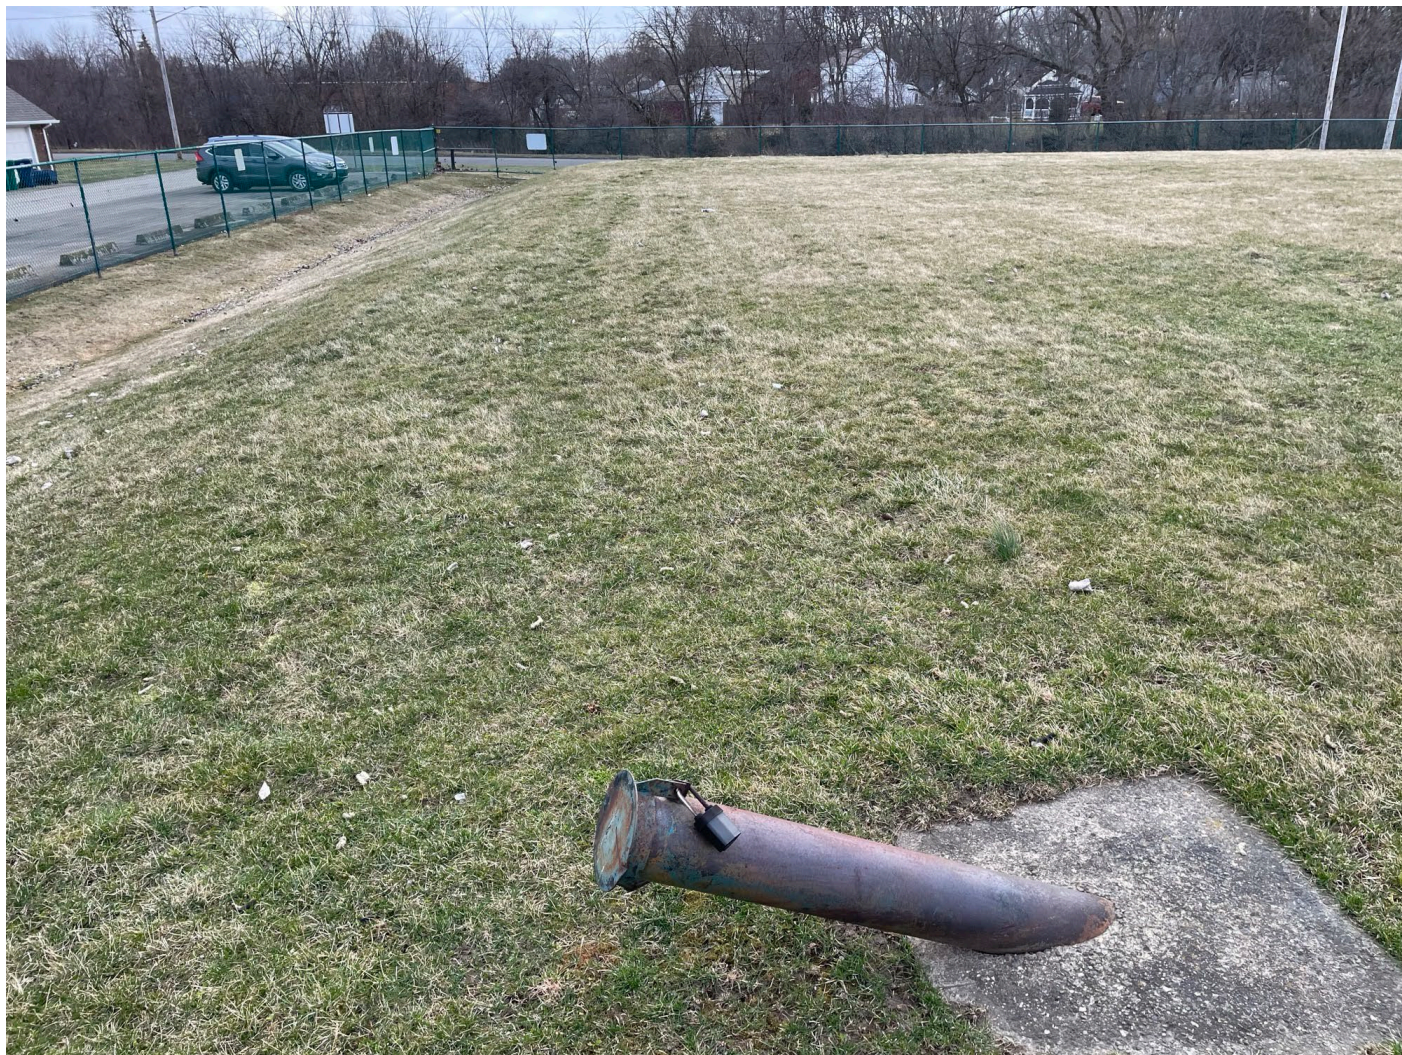
LCRS cleanout pipe/northern vegetative cover facing E.

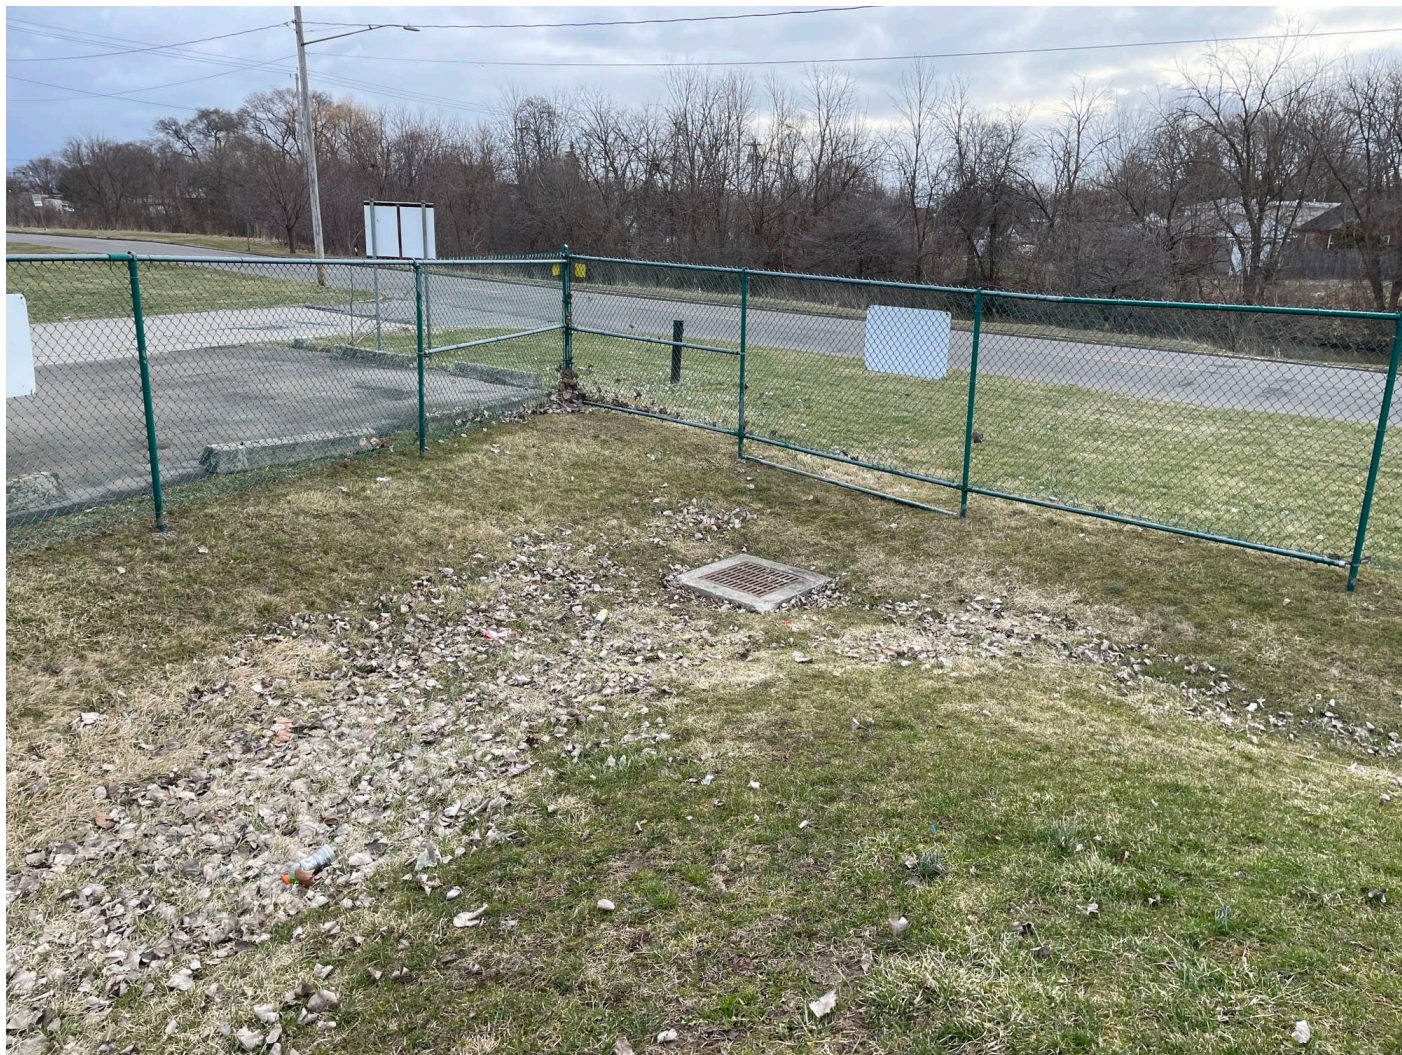
Catch Basin in NE corner.

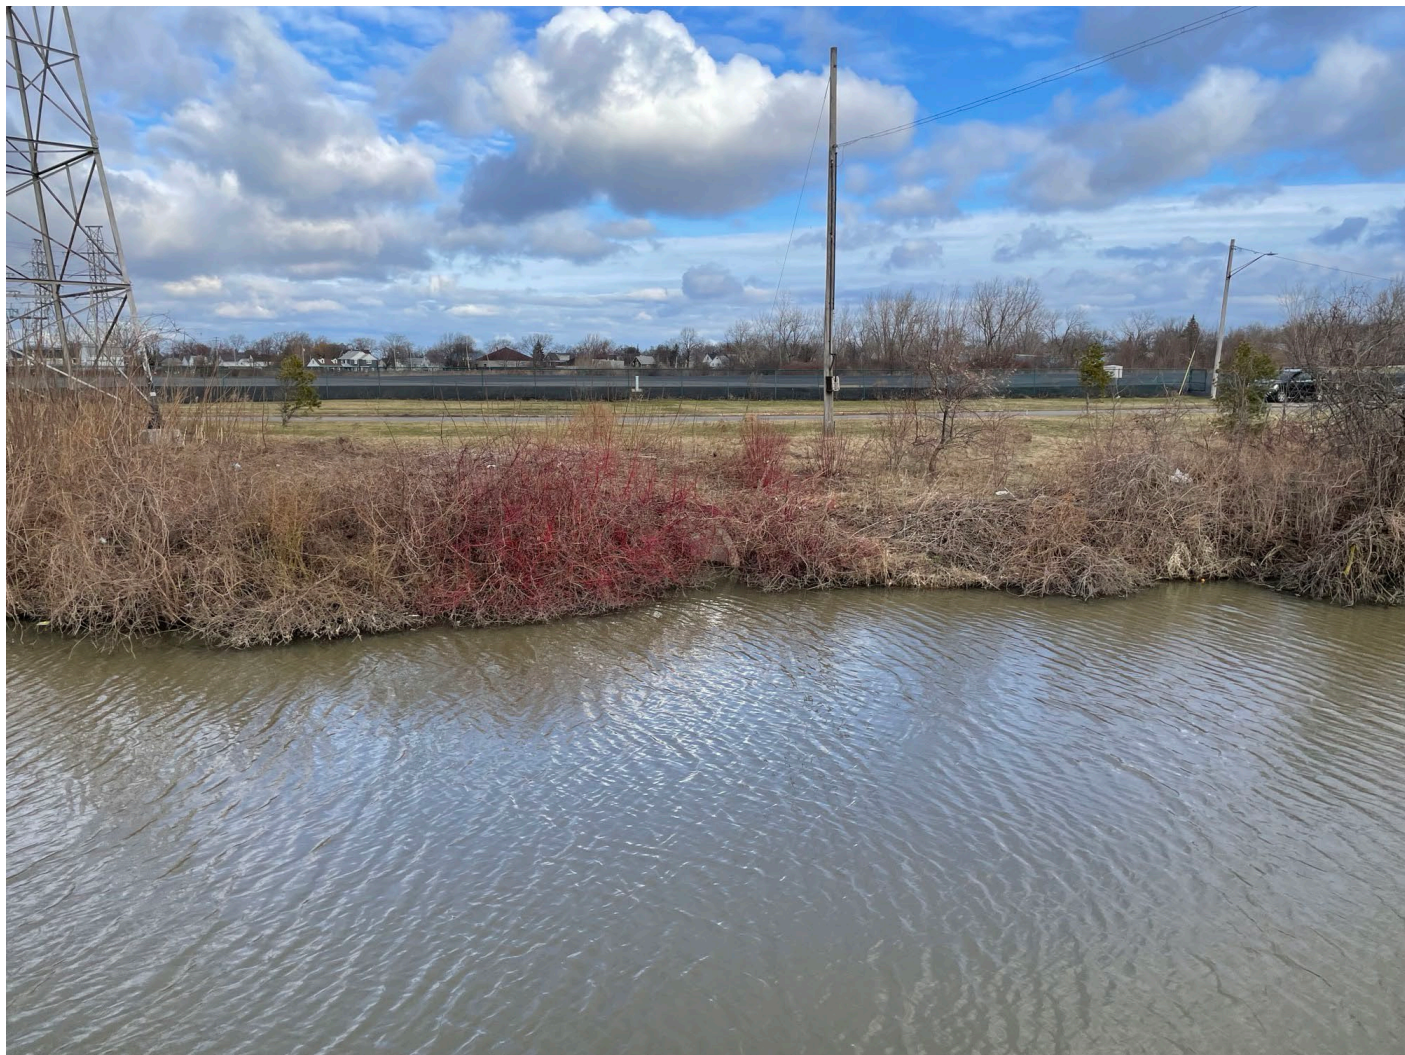
Gill Creek/OU-1.
