Division of Environmental Remediation

Site: Olin Industrial Welding Site

Phase: Management

Site No.: 932050

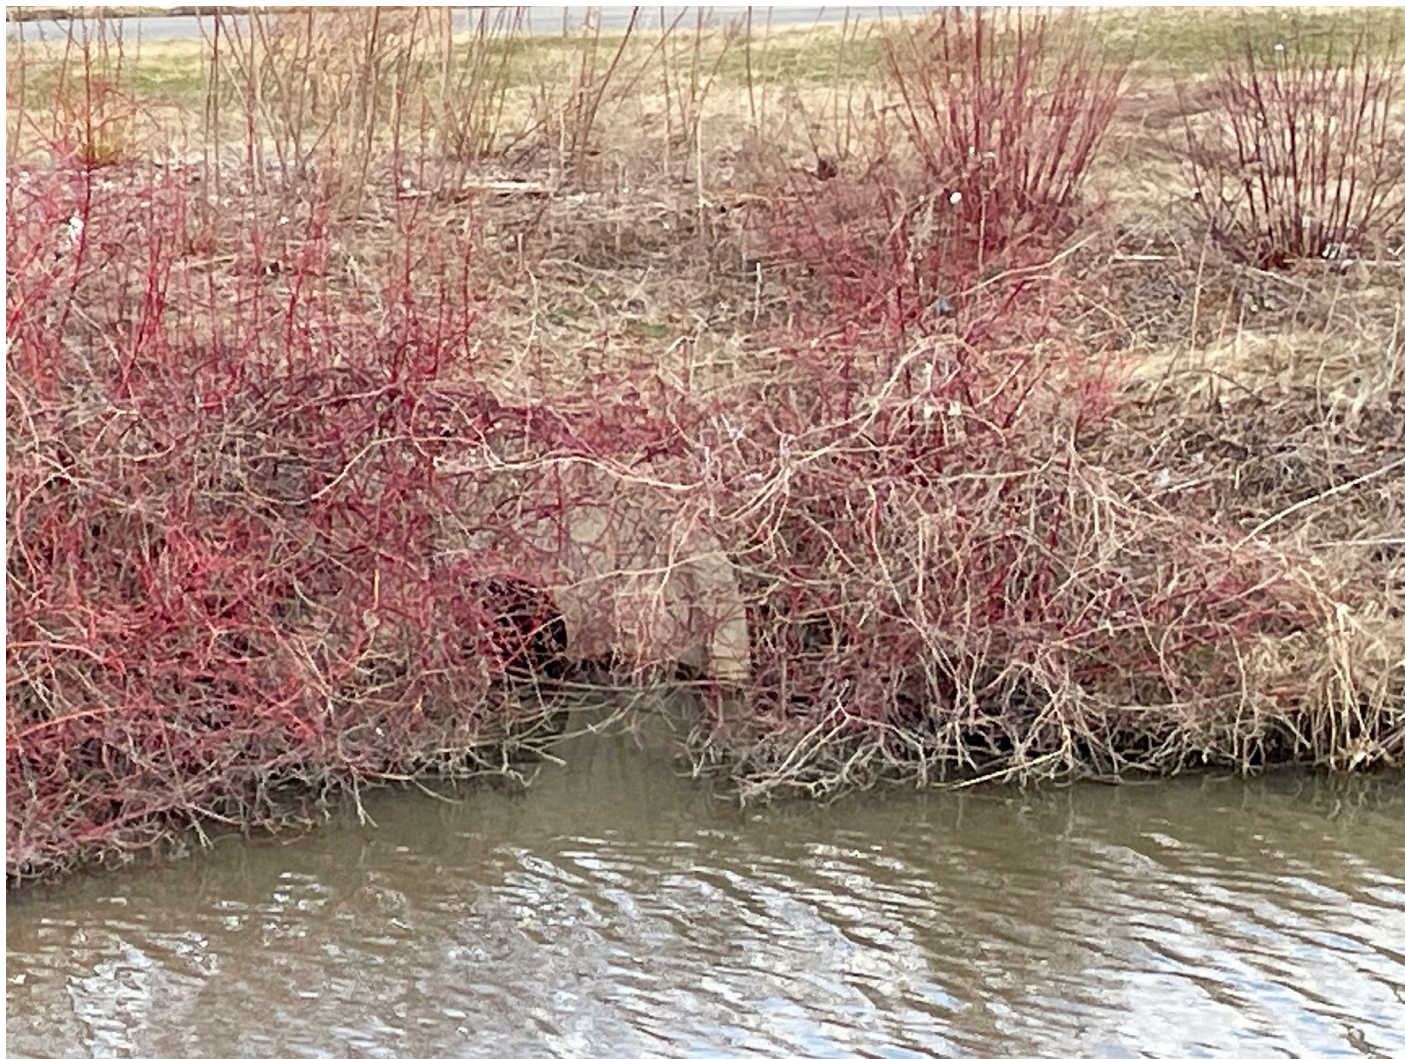
Outfall/headwall at Gill Creek/OU-1. Only 1 of 3 outfalls was observed on this date.

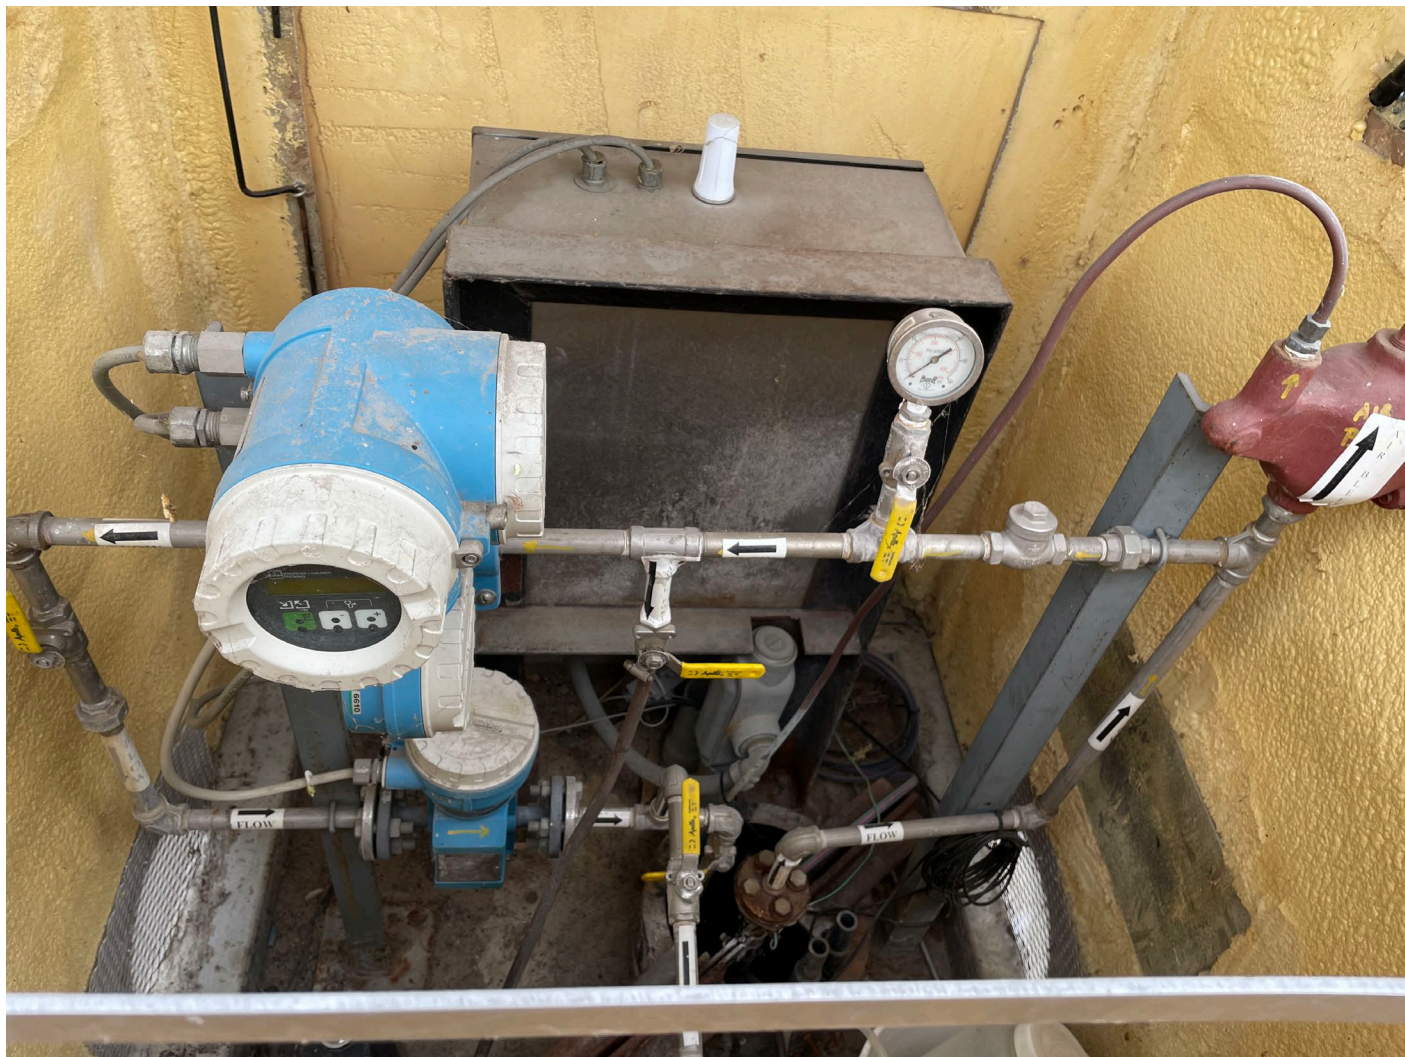
LCRS sumps/piping/flow meter.

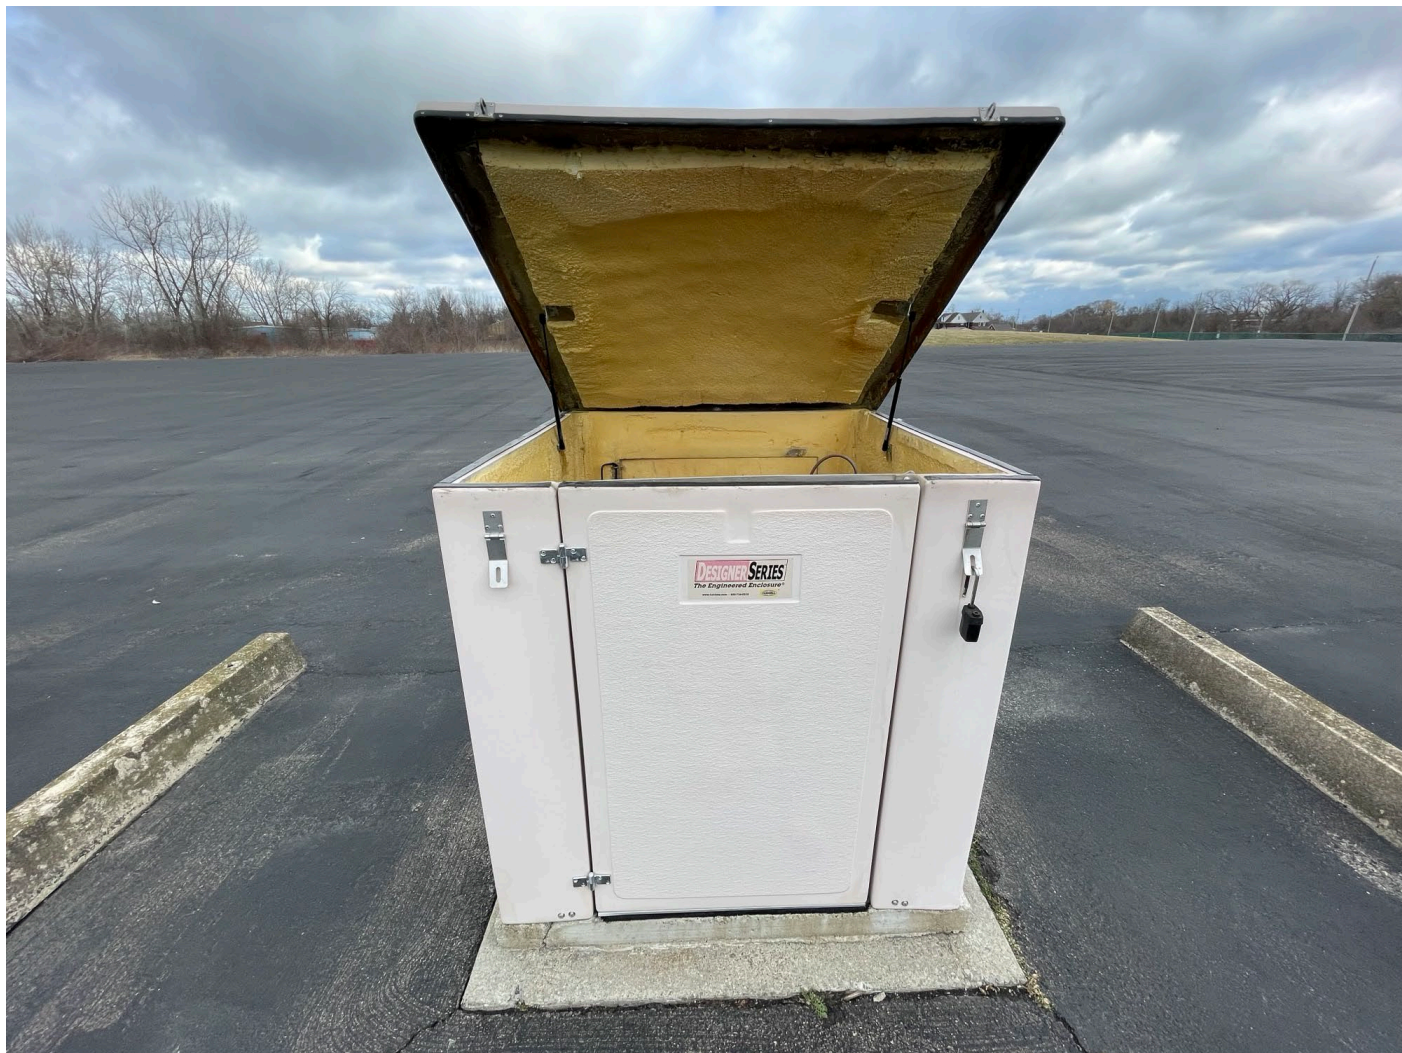
LCRS containment box.

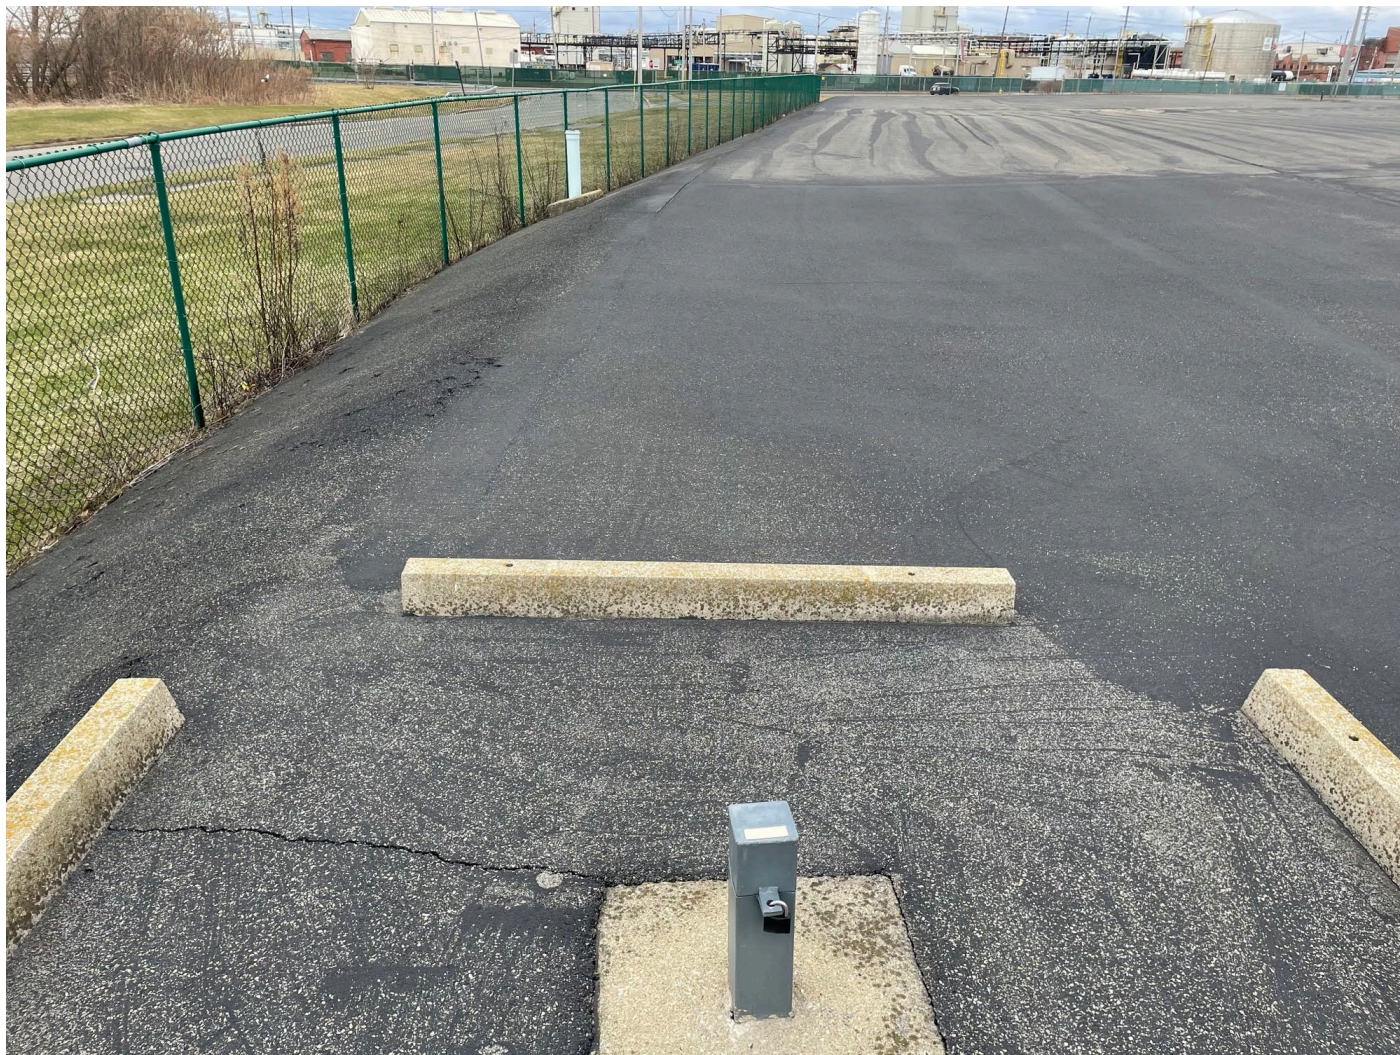
- PRMW-1, PRMW-2 additional standpipe need to be identified on site figure. One unidentified monitoring well was observed in poor condition in NE portion of site between Gill Creek and Veterans Drive.

PRMW-1/unidentified standpipe.

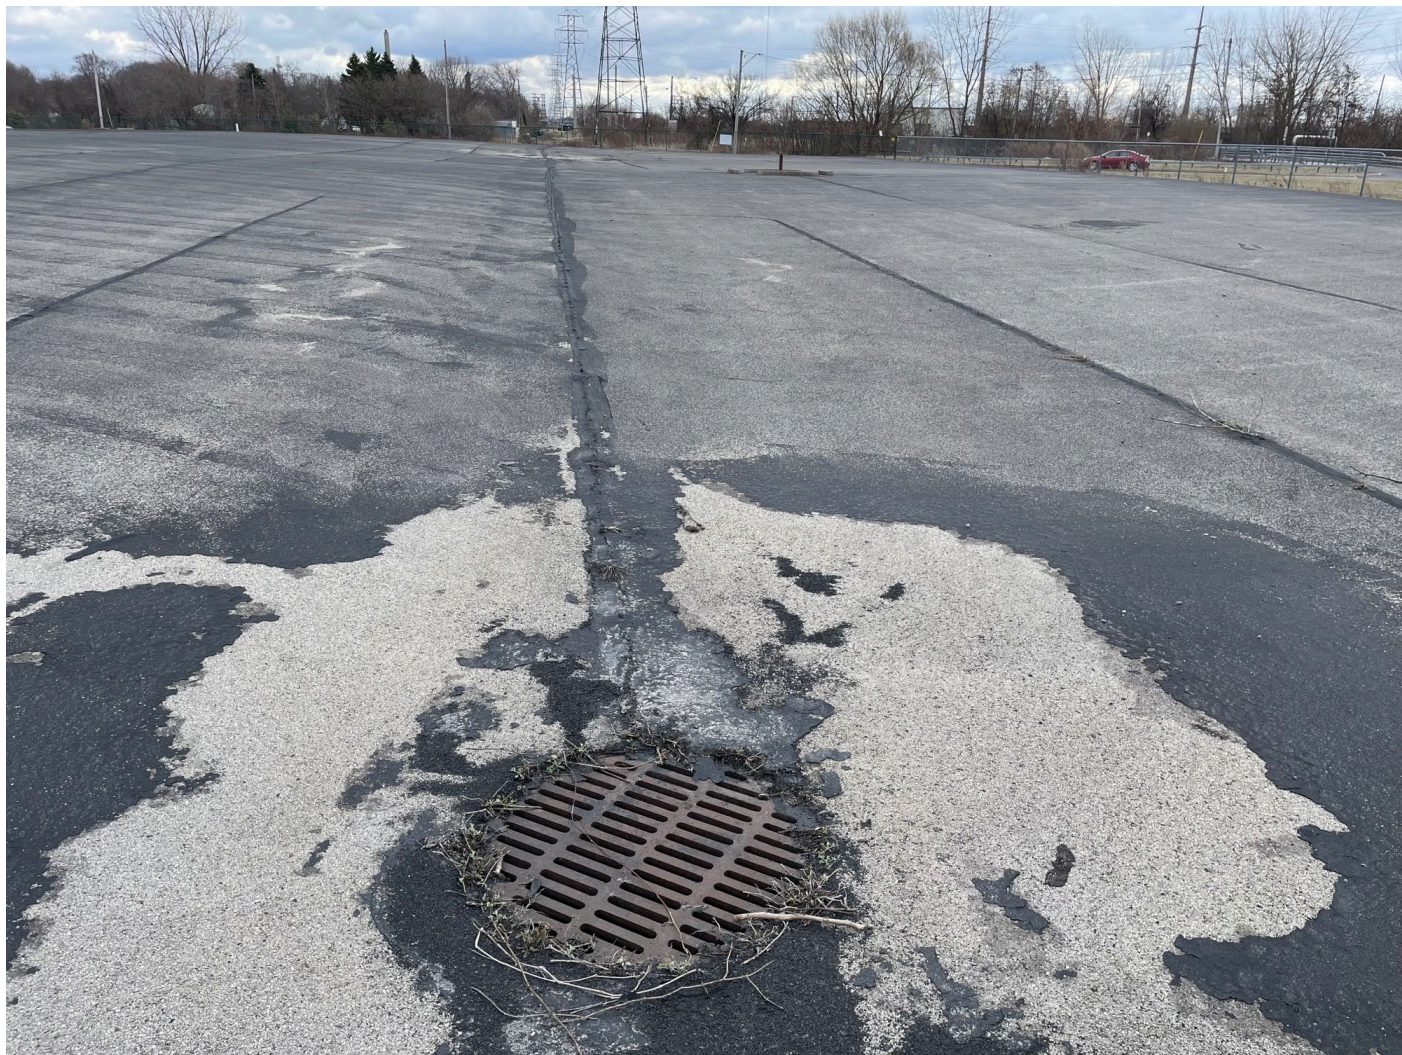
Drop inlet, typical.

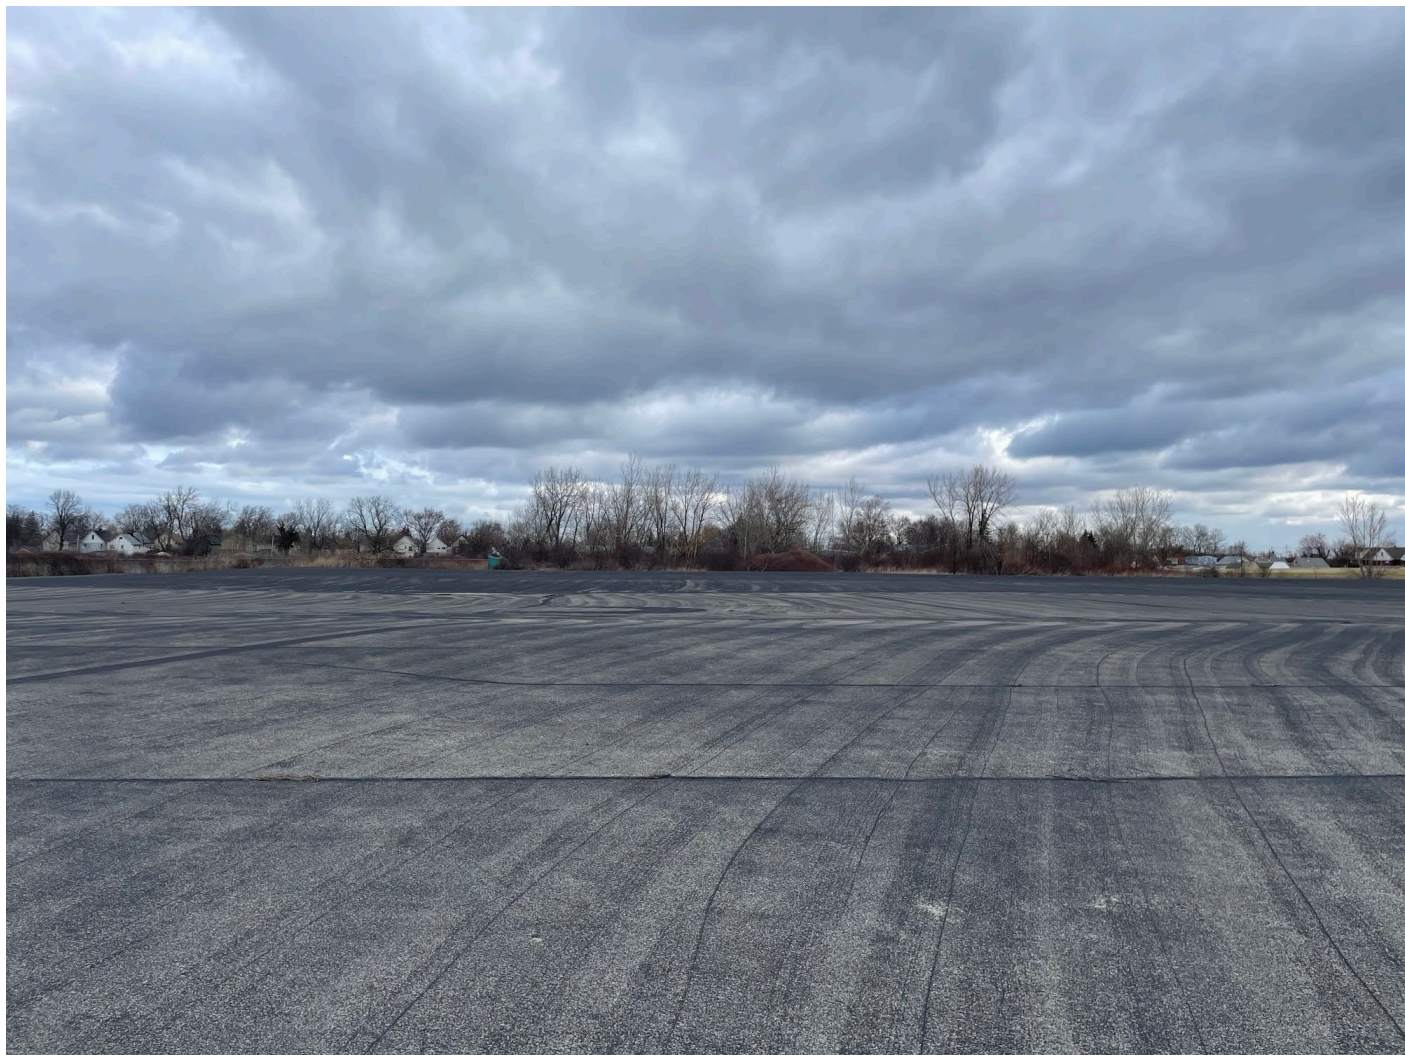
Asphalt cover facing N.

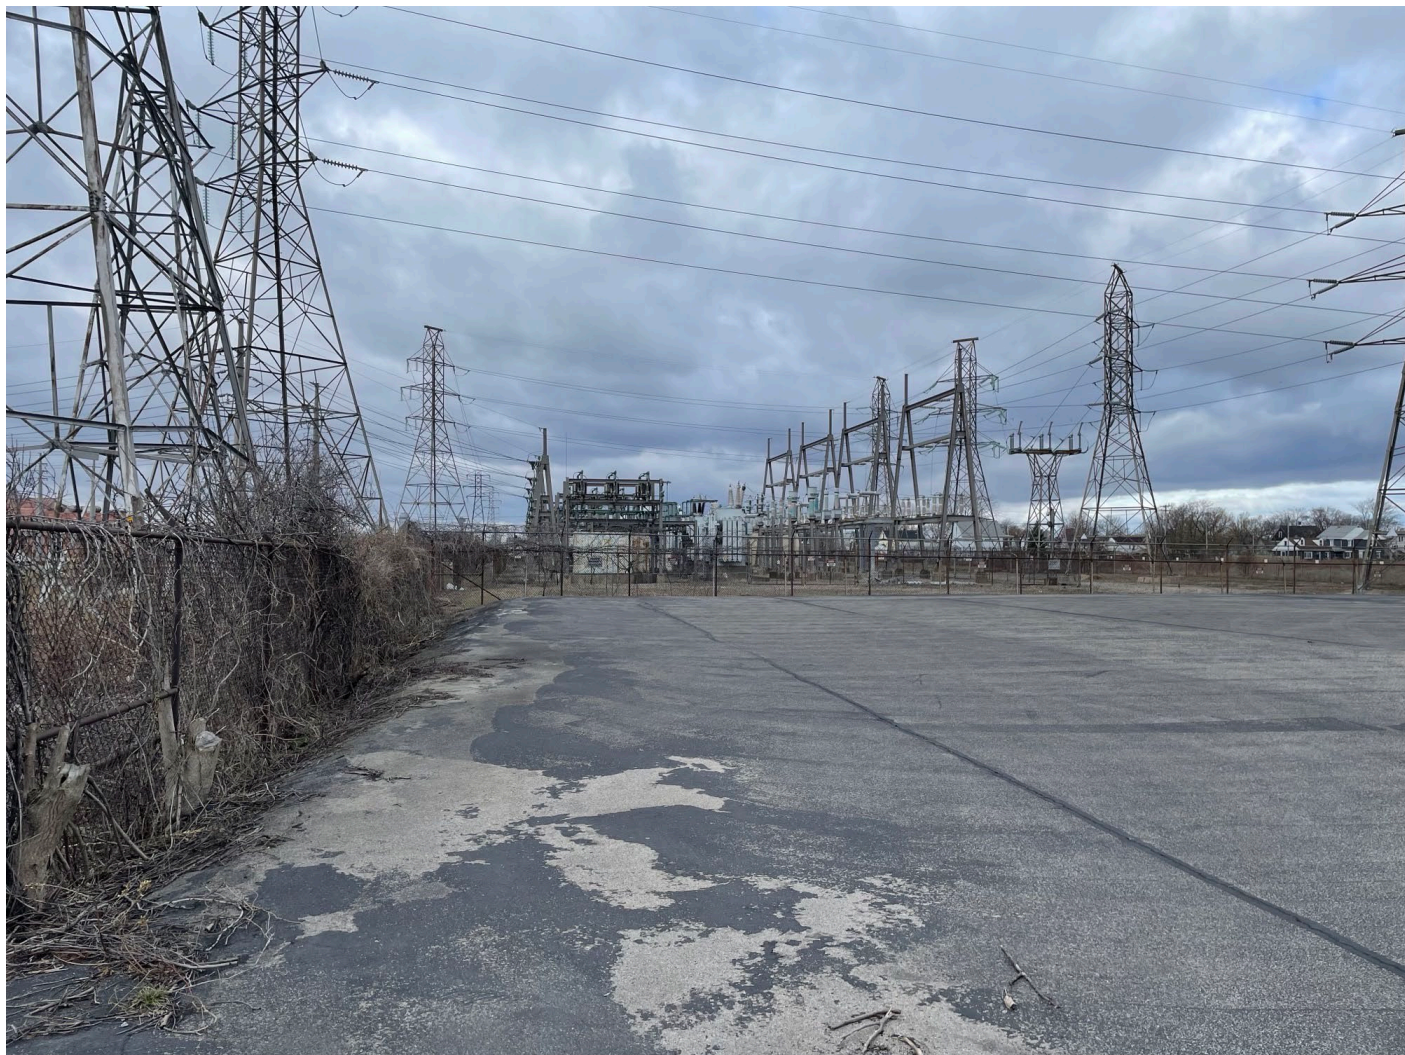
Asphalt cover facing W.

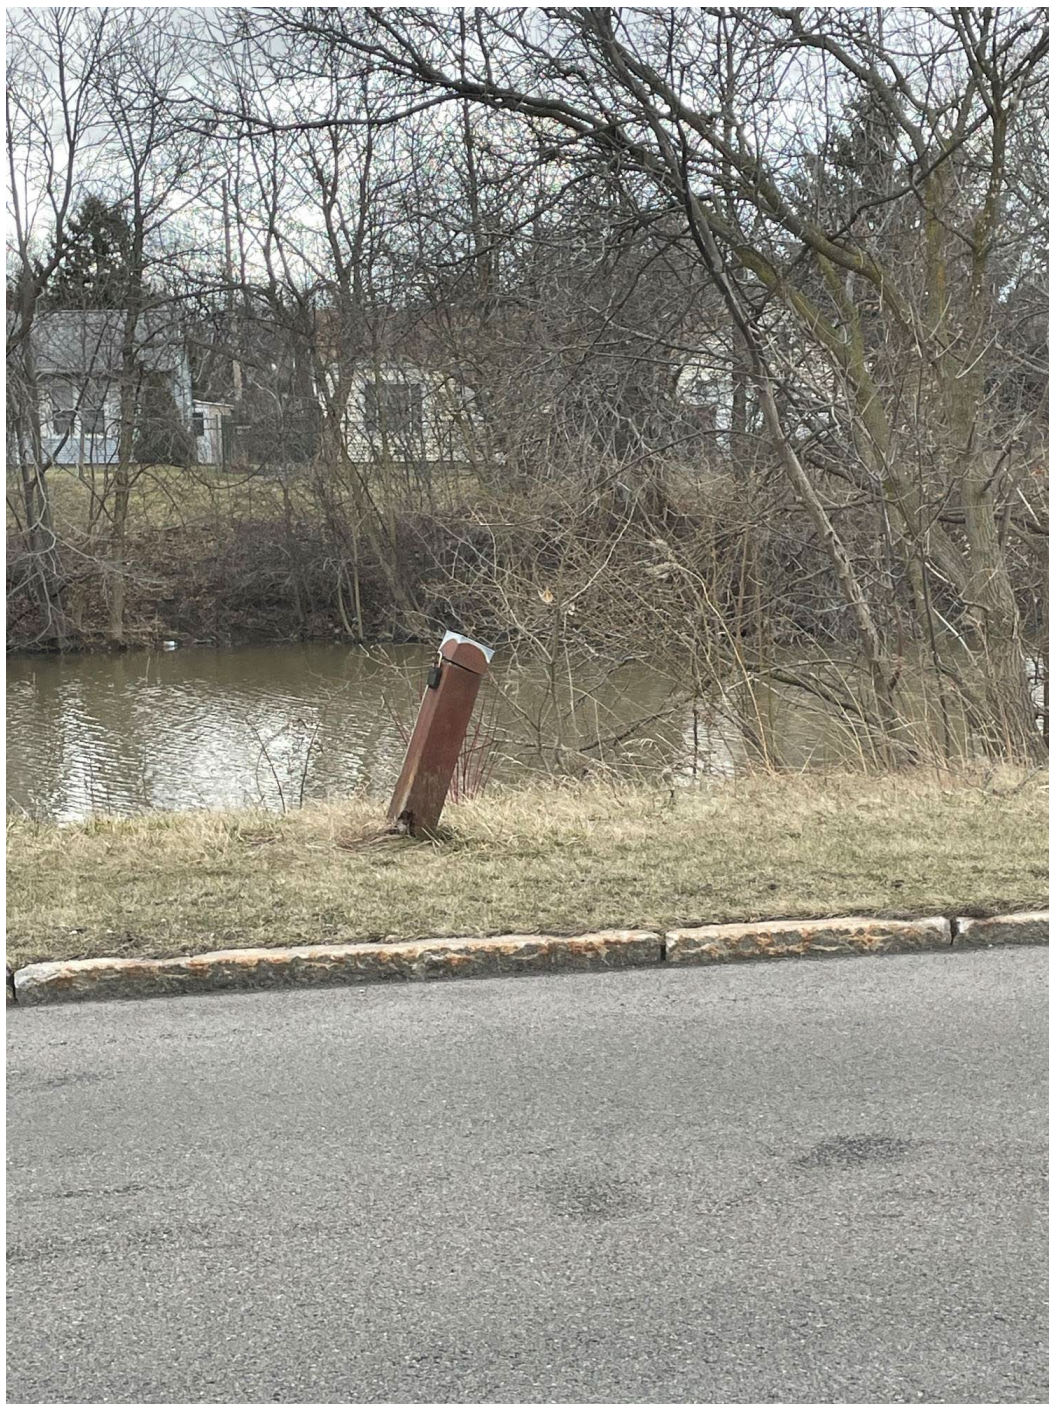
Unidentified well between Veterans Dr. and Gill Creek.
