MEMORANDUM

SUBJECT: Olin Chemicals, Buffalo Ave. Facility, Niagara Falls, New York
EPA ID No. NYD002123461
RCRA Facility Operation and Maintenance
Groundwater Monitoring/Corrective Action Inspection Report

DATE: June 2, 2008

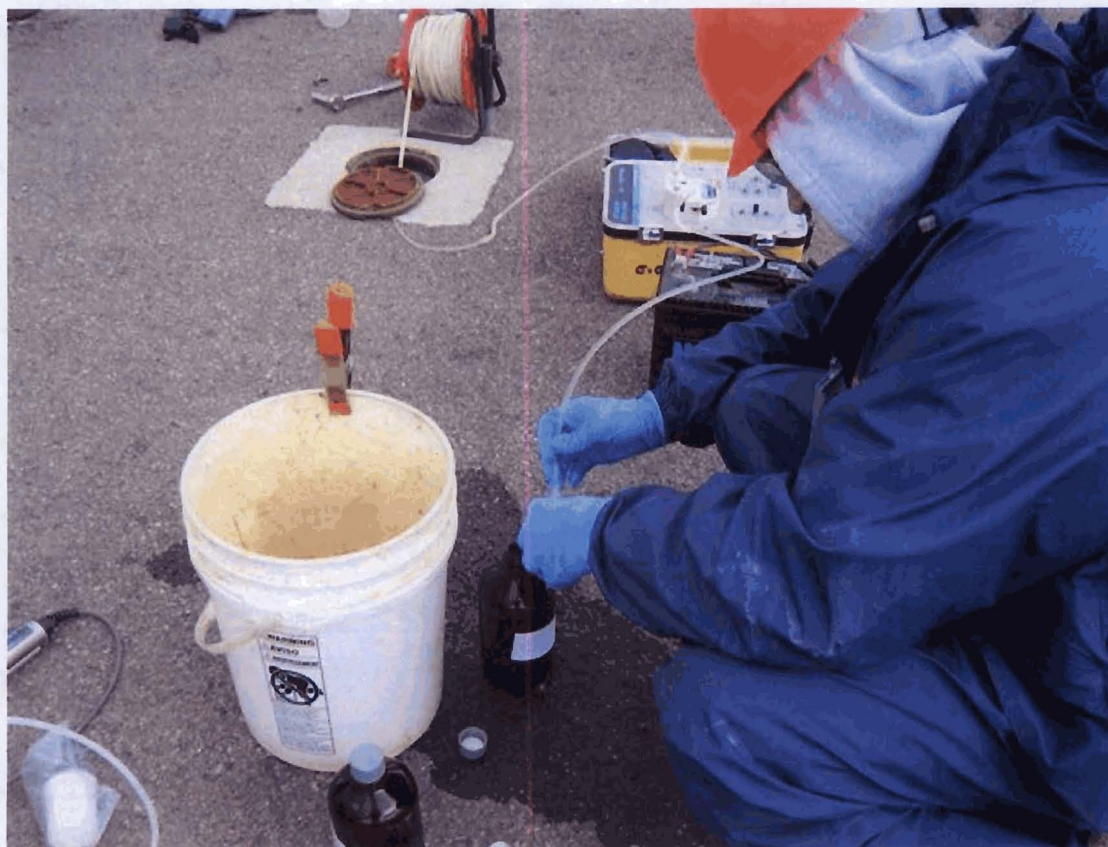
Figure 1

temperature, conductivity, turbidity, oxidation-reduction potential, and dissolved oxygen. Both wells stabilized fairly quickly and samples were collected by disconnecting the discharge tube from the in-line cell and redirecting flow to the sample containers [Figure 1]. Well purging and sampling protocols were satisfactory.

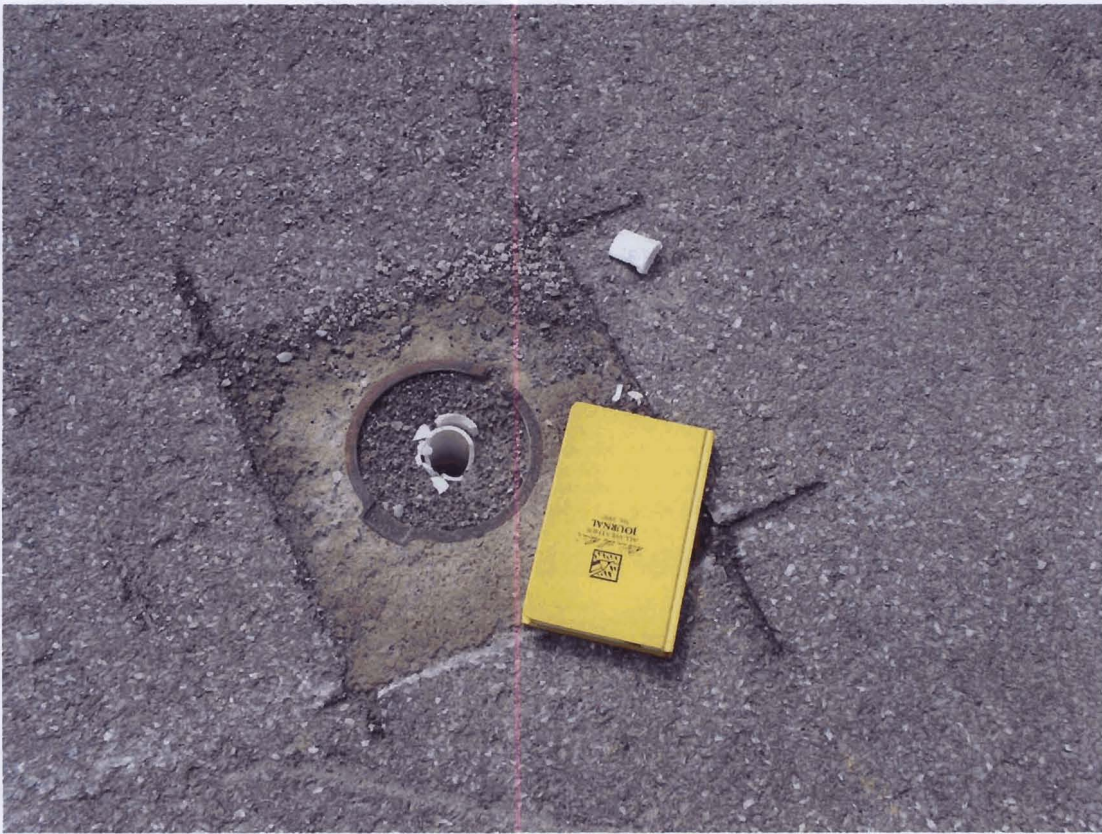
Figure 2

Several maintenance issues were noted regarding monitoring wells. First, a number of wells located along Gill Creek (e.g., PR-6 and PR-13, among others) had well covers that were missing bolts and were thus not properly secured. Second, several wells lacked legible identification labels. And third, two piezometers had their tops sheared off and were effectively open conduits from the surface to the aquifer. Both of these damaged piezometers were unlabeled but one is located next to well PR-8 and is believed to be PN-6A [Figure 2]. The second is located next to well PR-9 and is believed to be PN-7A.

2. All wells and piezometers should have permanent, legible identification labels. A stamped or engraved dog tag affixed to the well cap or an ID number engraved or written with a weld bead on the cap are effective, permanent labels.
3. Temporary plugs should be installed as soon as possible to prevent contaminant infiltration in the two sheared off piezometers until more permanent repairs can be implemented [Note: an email regarding this issue was sent to Mike Bellotti, Olin's project manager for this site, so that the piezometers could be plugged in a timely manner].

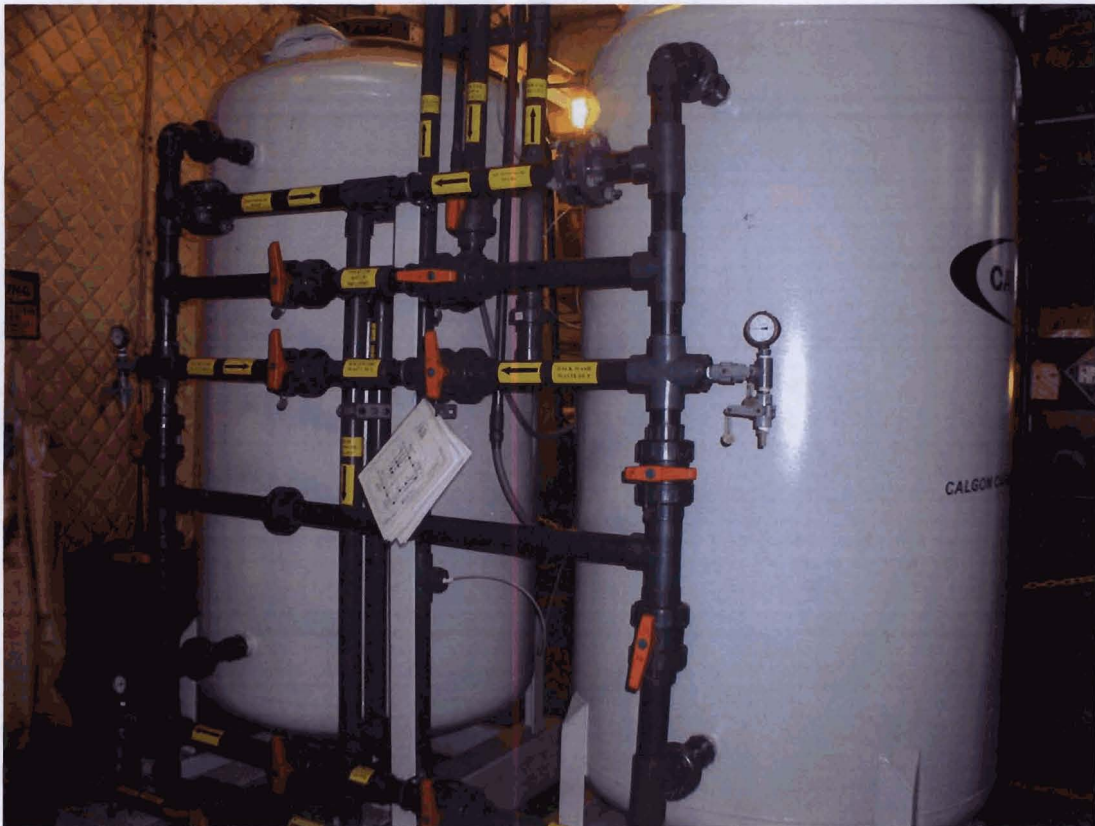
Figure 3

Following an exceedance of contaminant loading in their permitted sewer discharges, Olin installed a new carbon polisher [Figure 3] to their groundwater treatment system to prevent a recurrence. Mr. Sebring discussed operation of the polisher and I inspected the daily log sheet for operation of the treatment system. The daily log was up-to-date and complete.
