ENGINEERING INVESTIGATIONS AT INACTIVE HAZARDOUS WASTE SITES IN THE STATE OF NEW YORK

PRELIMINARY SITE ASSESSMENT Volume 1

Roblin Steel Site
Site Number 932059
City of North Tonawanda, Niagara County

February 1995

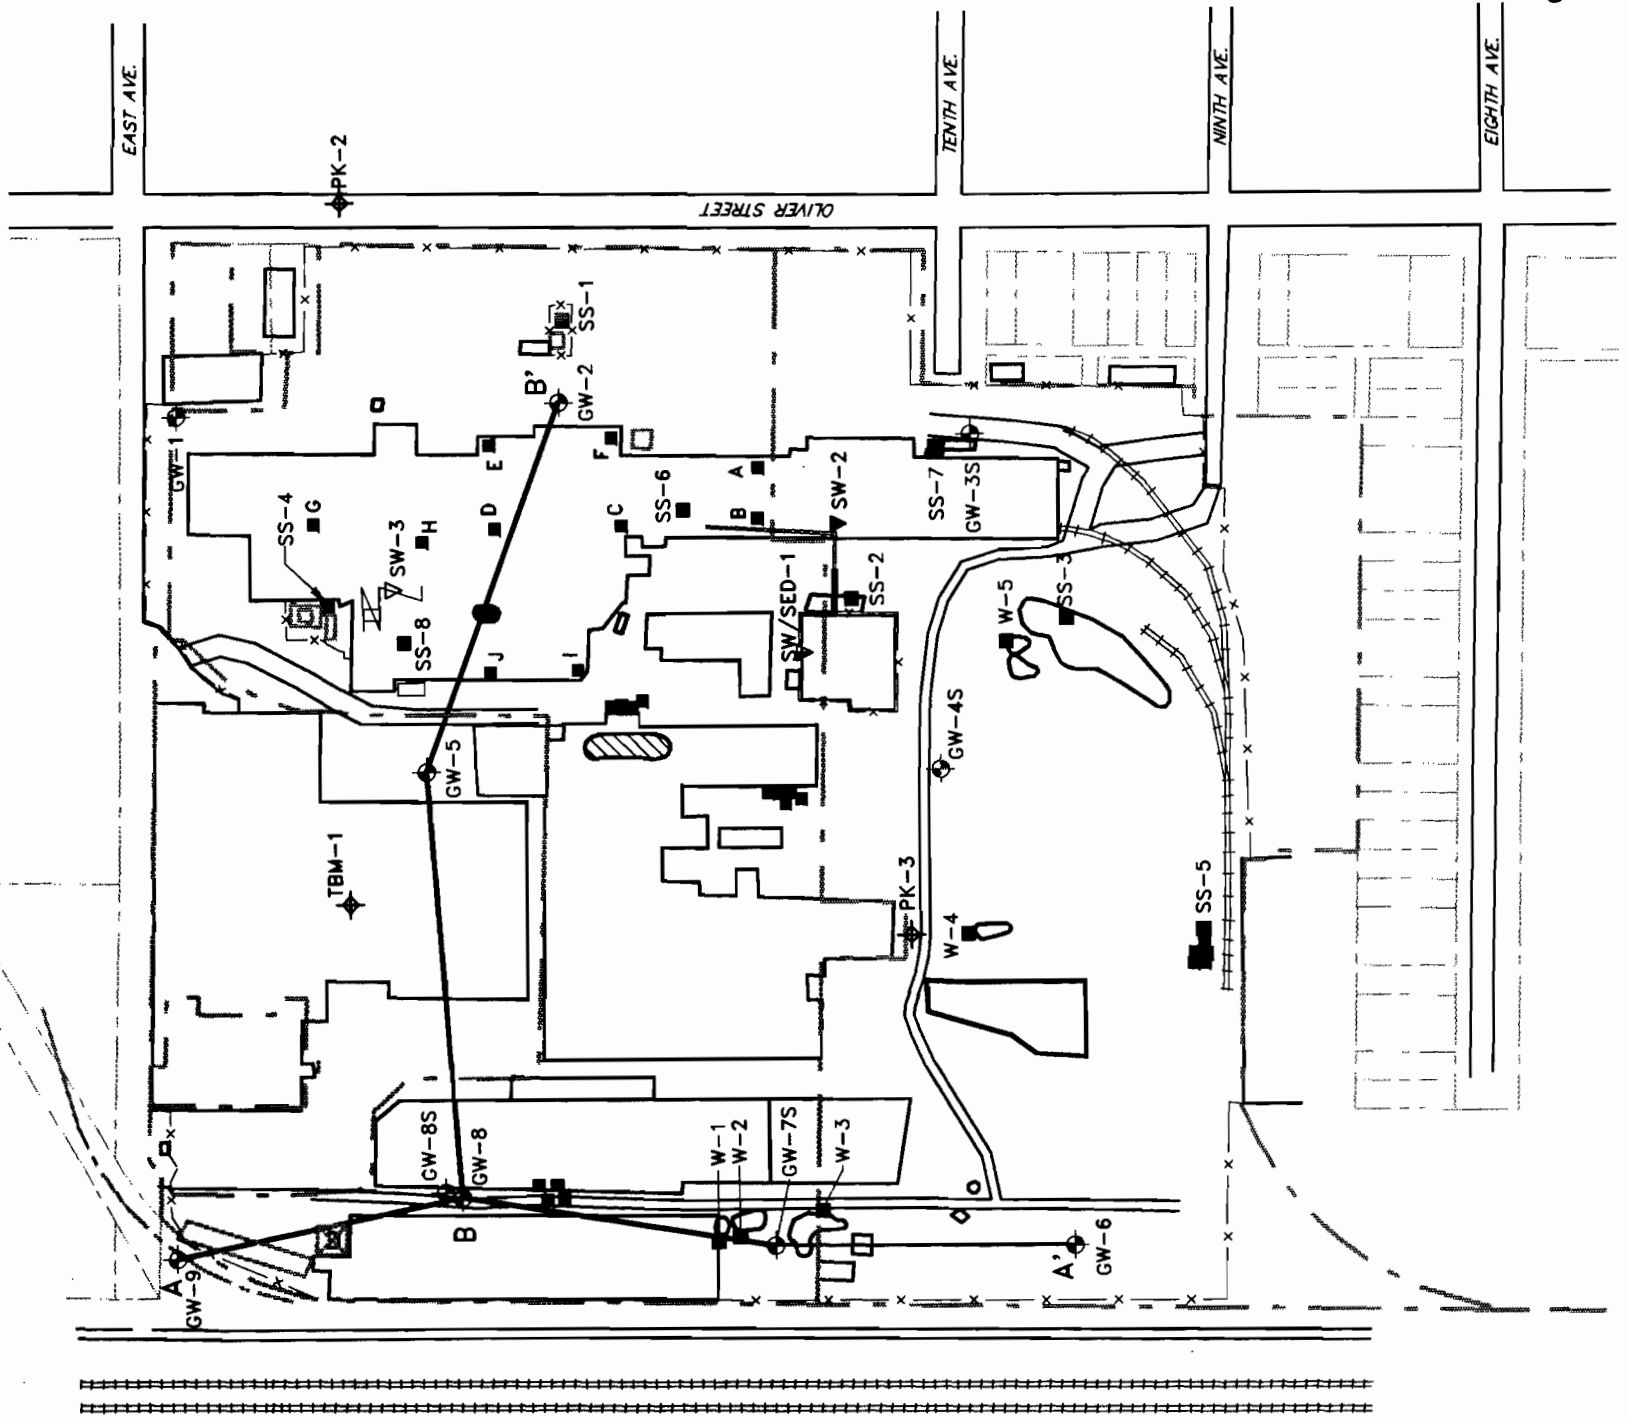
Figure 3-1 SAMPLE LOCATION MAP ROBLIN STEEL

SW-1 and SW-3 were submitted for Target Compound List (TCL) organic and inorganic analyses. Sample SW-2 consisted of oil and sludge from a cement-lined trough in the rolling mill building (see Figure 3-1). The trough contained trash and debris, including engine and machine parts, and less than 1 foot of water. The sample was collected from an approximately 3-inch-thick layer of oil and sludge that was floating on the water. Sample SW-2 was analyzed for hazardous waste characteristics, including reactivity (total sulfide and cyanide), corrosivity (pH), and ignitability (flash point); PCBs in liquid; petroleum products; and toxicity characteristic leaching procedure (TCLP) volatile and semivolatile compounds and metals. One matrix spike/matrix spike duplicate (MS/MSD) sample set and one trip blank were analyzed with these samples for QA/QC purposes.

On October 26, 1993, a drum inventory was performed in the rolling mill and wire mill buildings. Drums were identified in 10 locations (see Figure 3-1). A total of 60 55-gallon drums and 14 smaller drums and containers were found (see Table 3-19).
