> Re: Reconstruction of Slurry Wall Cap and North Embankment Slope Pine and Tuscarora Remediation Site Niagara Falls, New York

Reconstruction of Slurry Wall Cap and North Embankment Slope Pine and Tuscarora Remediation Site Niagara Falls, New York

## SLOPE STABILITY RECONSTRUCTION OF SLURRY WALL CAP AND NORTH EMBANKMENT SLOPE PINE AND TUSCARORA REMEDIATION SITE NIAGARA FALLS, NEW YORK

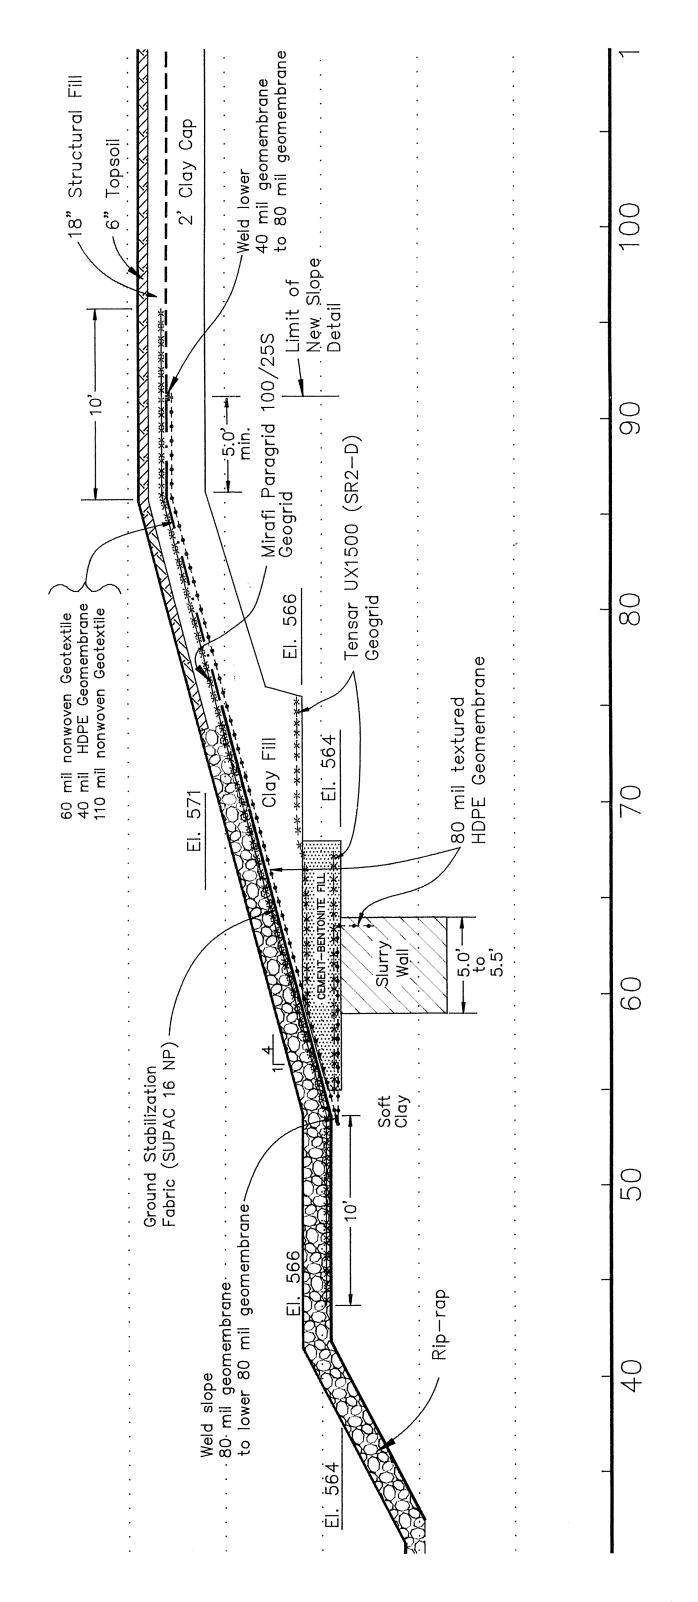
The following construction procedure is recommended for reconstruction of the slurry wall cap and the north embankment slope of the Pine and Tuscarora Remediation Site. This area experienced a slope stability problem two days after the 2-foot clay cap was constructed over the slurry wall. Measurements have shown that the slurry wall has widened from the 3-foot constructed (and design) width to approximately 5 to 5.5 feet. Probing has shown that the slurry wall is intact, with the soil-bentonite backfill slumping as the embankment slope between the slurry wall and the adjacent creek channel moved laterally (due to the imposed pressure of the slurry wall and construction equipment operating adjacent to and over the slurry wall). The redesign of this area calls for a flattened 4:1 slope (versus an original 2:1 design slope) plus a reduced height of slurry wall (approximately 6 feet versus 10 feet). A cement-bentonite fill layer, 2 feet thick, is to be poured over the existing slurry wall to provide a stronger material that can bridge over the 5- to 5.5-foot-wide slurry wall, but still be somewhat pliable so that it may strain with the embankment without developing large cracks. A detailed cross section of the redesign is shown on the attached Figure 1. Details for the construction procedure are presented below.

- 1. Excavate below the existing grade to elevation 564 as shown on the attached Figure 1. The excavation should extend from 5 feet south of the slurry wall to the point where the 4:1 embankment slope (beneath the 18-inch-thick rip-rap zone) crosses elevation 564. Typically, this will be approximately 9 to 10 feet north of the channel side of the existing (widened) slurry wall. This excavation should be made with light equipment (equivalent to a Komatsu Model PC80 backhoe) located on the remediation site (south) side of the excavation area. Widening or reshaping of the existing bench and use of mats for spreading the equipment loads will likely be required.

- Place the remainder of the cement-bentonite fill to elevation 565.7.
- 6. Place a second Tensar UX1500 (SR2-D) geogrid layer over the cement-bentonite fill surface from the northern edge of the slurry wall (see Figure 1) and extend it all the way back to the southern edge of the excavation at elevation 566. Where the geogrid is over the cement-bentonite fill, place an additional 4 inches of cement-bentonite fill.

- 3. Shape the north embankment slope as shown on Figure 1 to provide for an 18-inch-thick rip-rap section with a bench at elevation 566, and then extending up slope at an inclination of 4:1. Place an 80-mil textured HDPE geomembrane liner on the shaped slope. Place a small triangle of clay fill over top of the double geomembrane liner system at the toe of the slope to create the fill subgrade to elevation 564.5. Weld the lower 40-mil geomembrane to the 80-mil geomembrane at least 5 feet south of the top of slope.

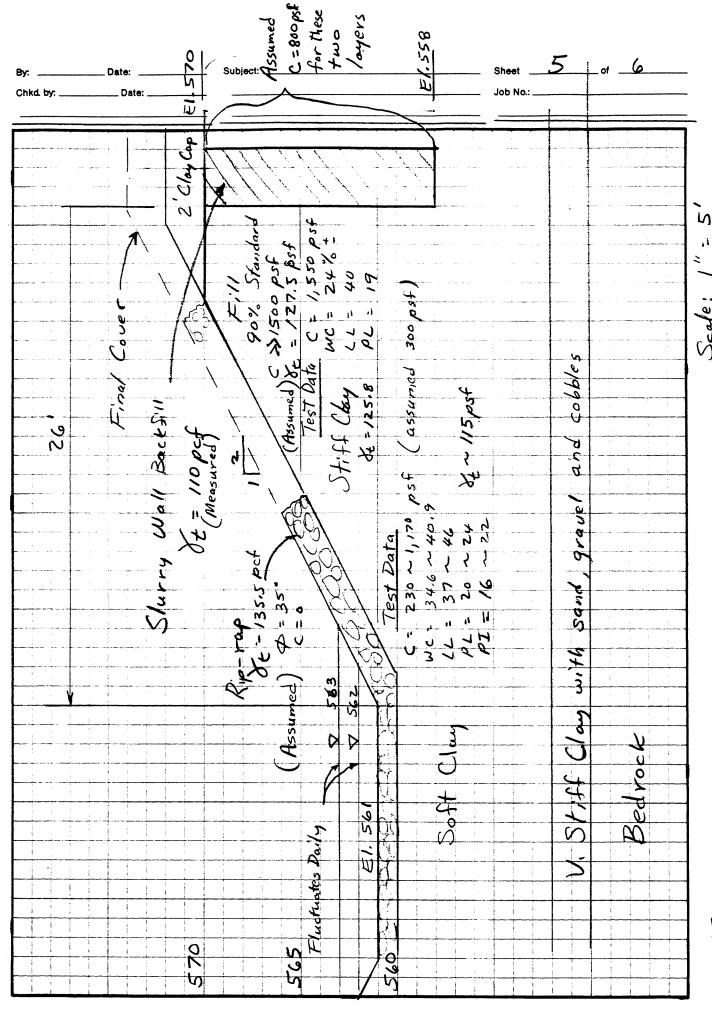
1 - Conditions At Failure

The slope stability for the north slope of the Pine and Tuscarora Site has been reanalyzed using field geometry for the existing conditions. Approximately two days after constructing the 2-foot clay cap over the slurry wall, settlement of the cap was observed together with a toe bulge in the middle of the channel. Also, longitudinal cracks along the edges of the slurry wall soon began to appear. After a few days, the toe bulge was observed to extend from about Station 1 to Station 3 of the new channel, and evidence of slumping and movement at the top of the 2-foot clay cap were apparent. It is obvious that the weight of the slurry wall backfill and the construction equipment used to place the clay cap had exceeded the shear strength of the underlying weak, soft clay layer below about elevation 561. Since there was evidence that movement was continuing at a very slow rate, Woodward-Clyde Consultants recommended that the top (approximately 6 feet) of the fill zone over the slurry wall be removed down to about elevation 565.5, forming a bench sloping from elevation 566 at the toe of excavation to 565 at the channel's edge. Removing the driving load of the fill from elevation 571 down to 565.5 (average) and the upper few feet of the slurry wall was judged to be adequate to mitigate the movement of the existing slope.

Attached are additional calculations used to reanalyze the slope conditions at the time of failure and also the recommended flattened 4:1 slope. Since the failure appears to have occurred by the lateral spreading of the 3-foot-wide slurry wall, a sliding wedge analysis was used to back-calculate the probable shear strength at the time of failure. Shown as "Case 1 - Conditions at Failure" on the attached calculations, the undrained shear strength, c, is estimated at the time of failure to have been approximately 285 psf. Since the slurry wall has spread by up to 2 to 2-1/2 feet, it is believed that the residual shear strength should be used for subsequent stability analyses.

92	By: Chkd. by:
Church Wall Barts!!	Date:
570 St = 110 pcf St 2 Chy Cap	E1 570
Rip-rap   1   3   1   1   2   1   2   1   2   1   2   1   2   2	Subject: H
sumed) C=0 (Assumed) &= 127 Test Date C=10	C=800pg for these two
560 EL. 561 Test Data de=125.8 PL = 19	/ohers
~ 40.9 21 ~ 46 ~ 24 2/~ 115 psf	EV.558
2-2-9/=10	_ Sh <del>ec</del> t _ Job No.:
U. Stiff Clay with sand, gravel and cobbles	6
	_ of
	6
Fig. 2 - Conditions At Failure (Du Analysis)

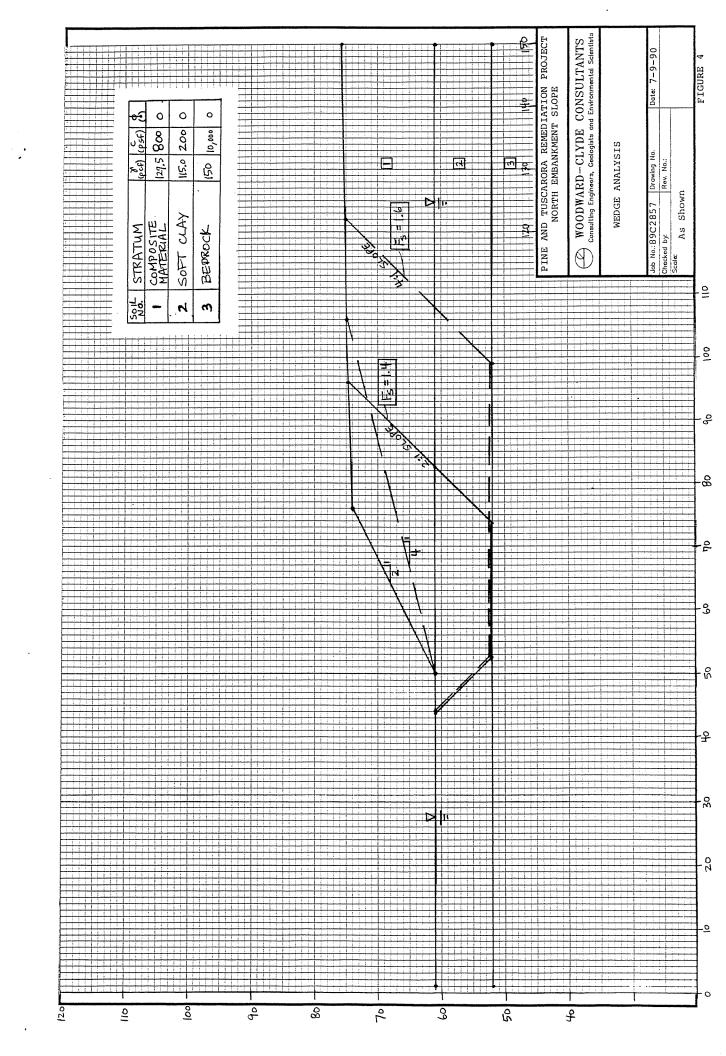
A wedge analysis (Figure 4) was also run using a computer slope stability program. This analysis yielded similar, but slightly higher, results compared to the circular failure mode for both the 2:1 and 4:1 slopes as summarized below.

Factor of	Safety
Slope	Circular Failure	Wedge Failure
2:1	1.2	1.4
4:1	1.5	1.6

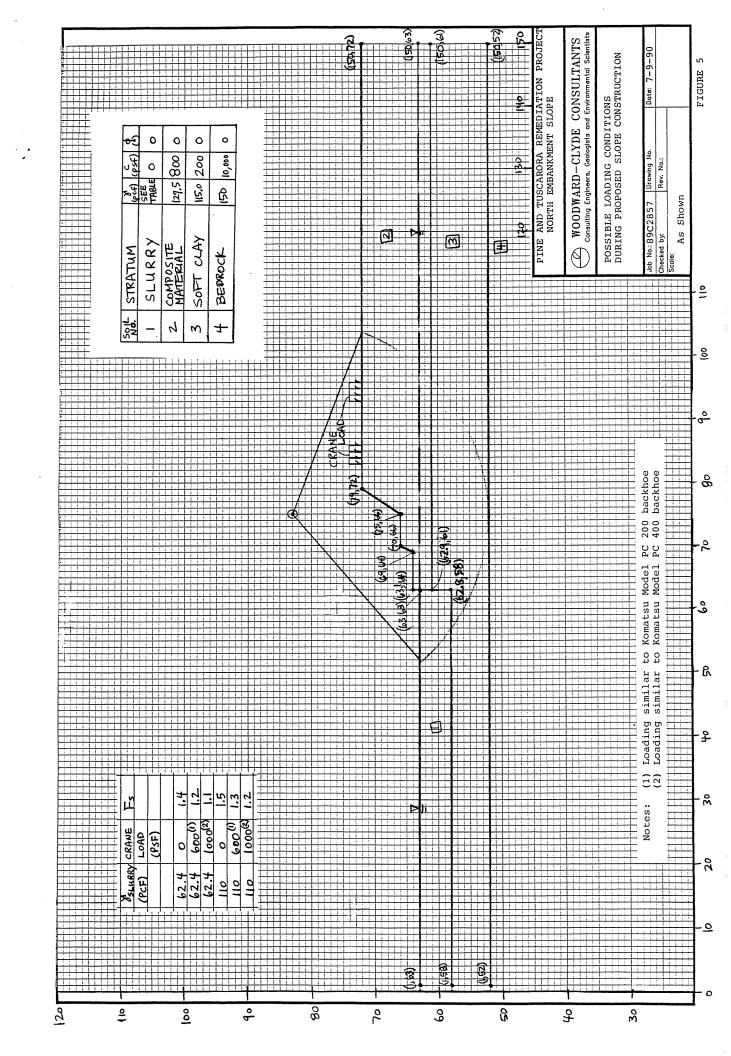
An analysis (Figure 5) was also conducted to determine the factor of safety for the construction condition when the 2 feet of material is to be excavated along the slurry wall in 50-foot segments. Assuming the existing steep slopes and a crane load of 1,000 psf, a factor of safety of 1.2 was estimated. Although this factor of safety is low, it is a short-term construction condition and the analysis parameters are believed to be very conservatively estimated. Thus, the true factor of safety is expected to be substantially higher than the calculated factor of safety of 1.2.

In summary, the slope stability analyses indicate that the flattened 4:1 slope will have an adequate design factor of safety. However, this is predicated on keeping construction equipment, other than light manually-guided equipment, off the top of the slurry wall.
