TOWN OF ROYALTON

SANITARY LANDFILL

FINAL CLOSURE REPORT

June, 1980

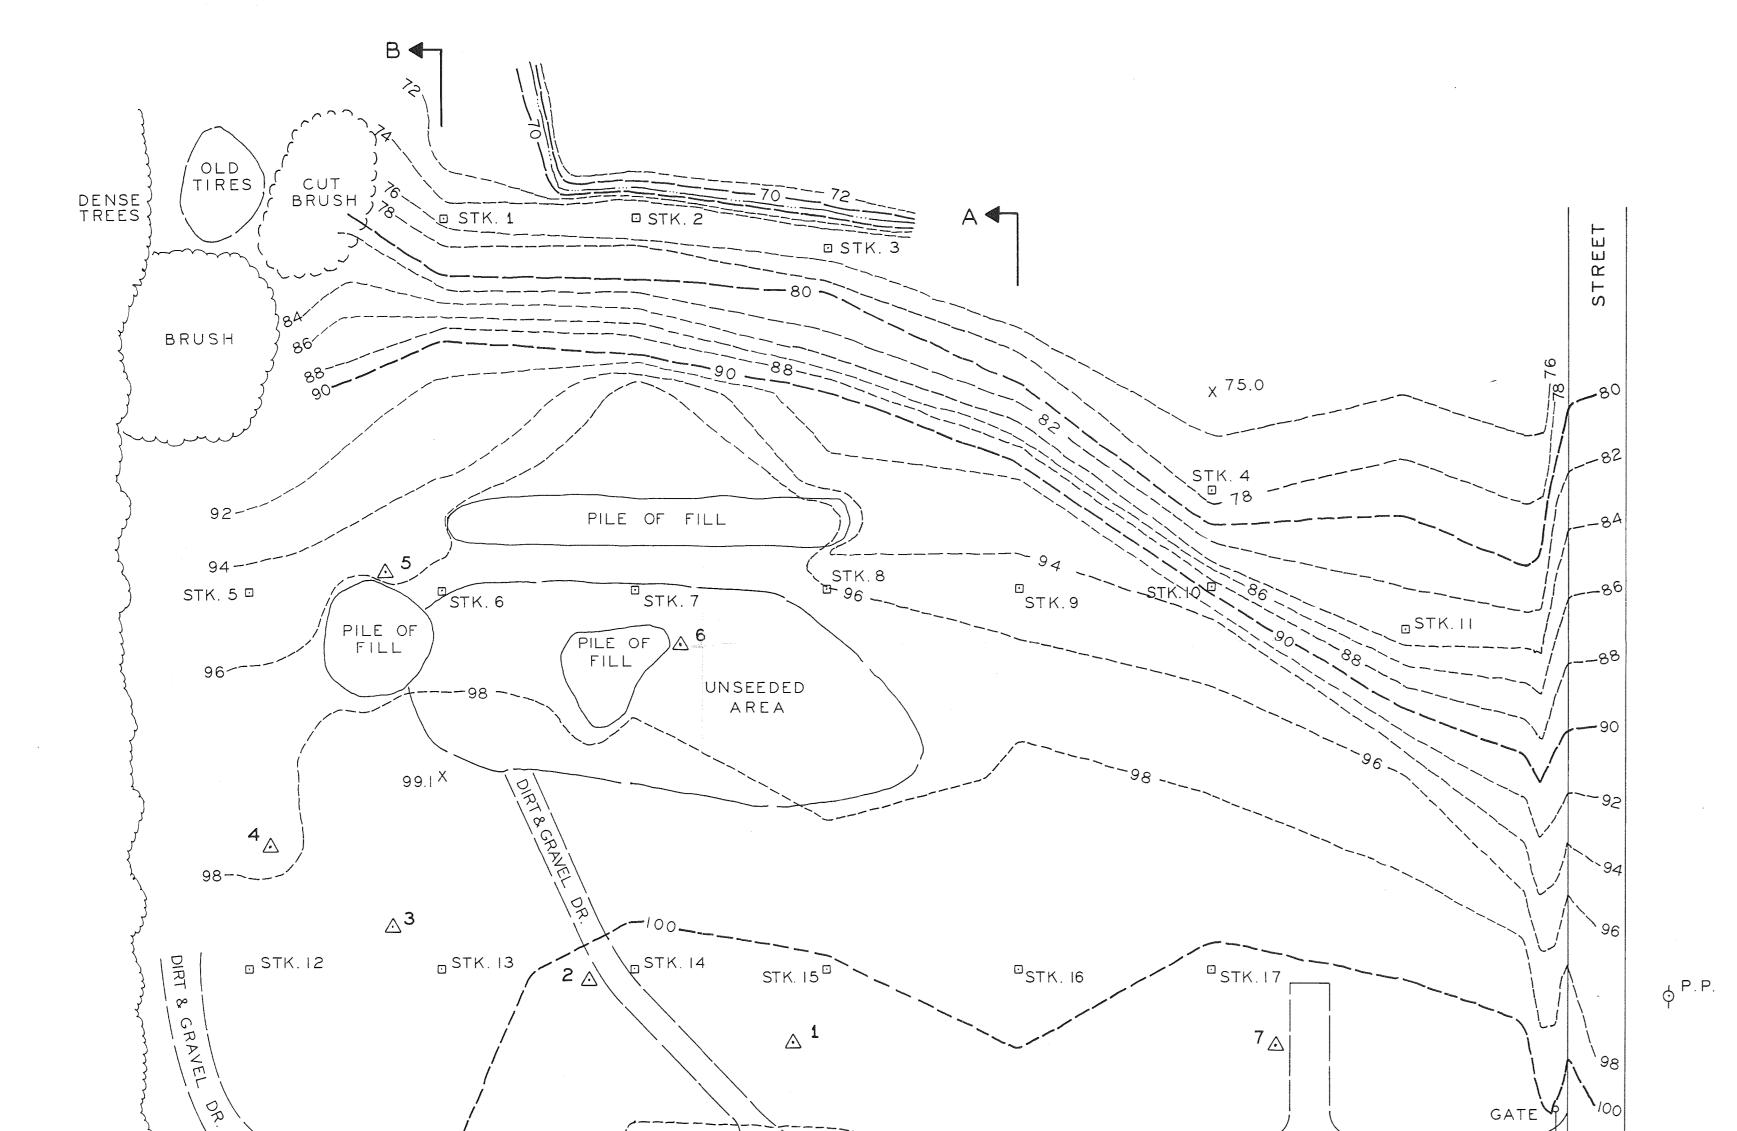
EXHIBIT 2

The site, as it exists, is shown in Exhibit 2. This Site Plan was developed as the result of site visits and survey field work as per discussions with the New York State Department of Environmental Conservation.

Exhibit 2 details the results of field investigations examining depth of cover at the site. As can be seen from this Exhibit, some areas do not have

a sufficient depth of cover over the landfill refuse. These areas are located generally in the most recently completed parts of the landfill. Numerous piles of cover material have been deposited at the site for covering purposes.

The general drainage pattern for the site is to the north. Within the site, some areas exist without proper grade and therefore pond water after a rainfall or snowmelt.

A few small leachate flows were found along the side slopes during field investigations. These generally were found to be dry and are indicative of improper cover or grading on top of the landfill, which allow surface water to enter the landfill and leach through the refuse.
