NYSEG TRANSIT STREET FORMER MGP SITE NAPL SEEP STUDY - NEW YORK STATE BARGE CANAL BASELINE SEEP LOCATIONS

FIGURE 1

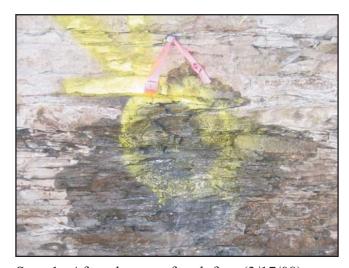
Seep 1: After cleanup of rock face (3/17/08).

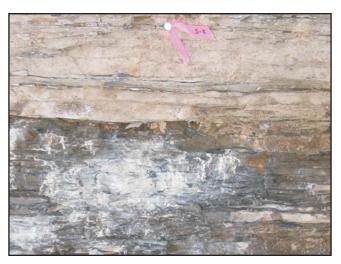
Seep 2: Image taken 3/17/08. Note black staining on rock face.

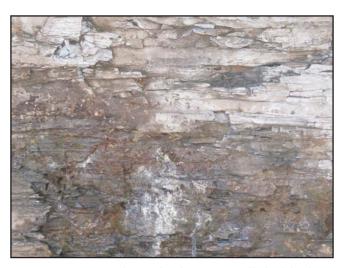
Seep 5: Image taken 3/17/08. Note slight black staining and white film.

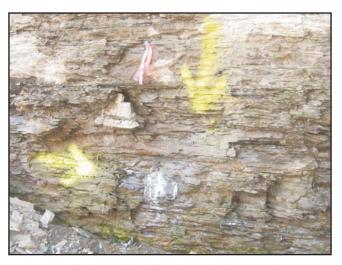
Seep 5: Slight white film developing and rust discoloration noted during inspection on 4/10/08.

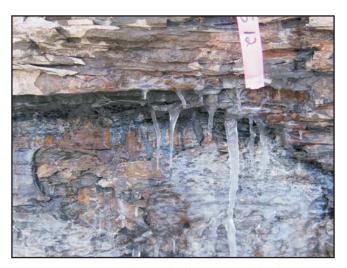
Seep 12: Image taken 3/17/08. Note black staining on rock face.

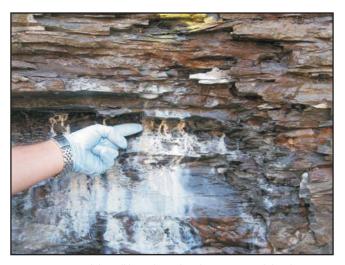
Seep 12: White film developing. Note black staining and tar globules. Image taken on 4/10/08.

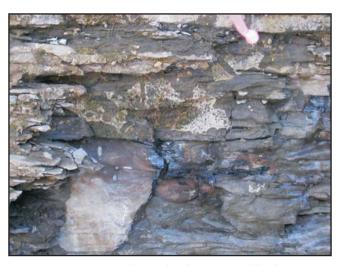
Seep 16: Image taken 3/17/08. Note black staining and slight sheen on rock face.

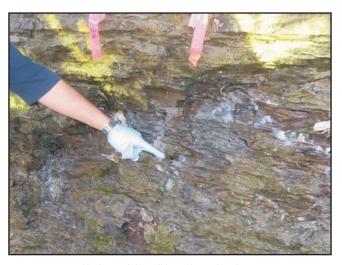
Seep 16: Slight white film developing. Note black staining and tar globules. Slight odor observed during inspection on 4/10/08.

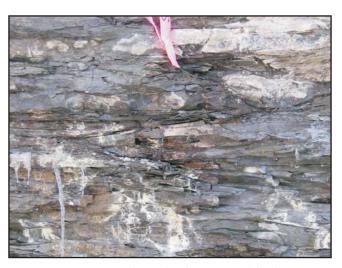
Seep 18: Image taken 3/17/08. Note black staining and white film on rock face.

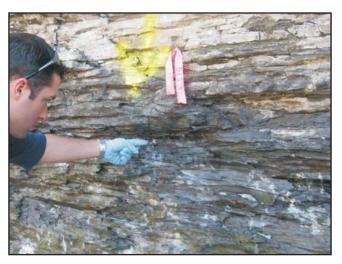
Seep 18: Slight white film developing, slight sheen observed. Note black staining. Image taken during inspection on 4/10/08.

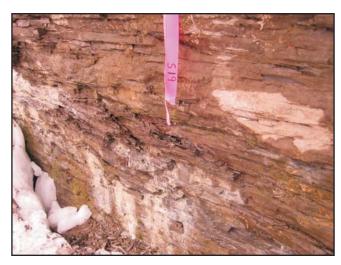
Seep 19: Image taken 3/17/08. Note black staining and white film on rock face. (Note: Rock face was not cleaned at this seep).

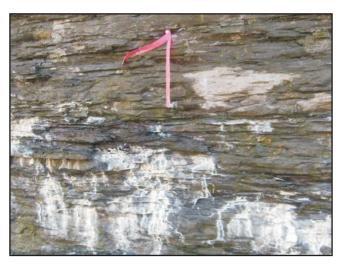
Seep 19: White film and black staining noted during inspection on 4/10/08.

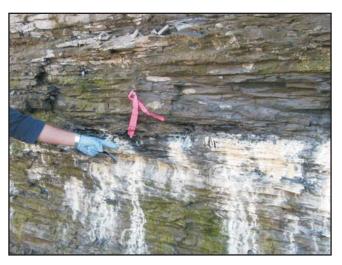
Seep 20: Black staining, tar globules, and odor during inspection on 4/10/08.

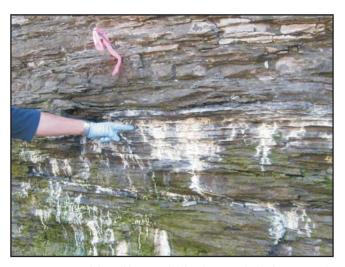
Seep 22: White film and black tar globules noted on rock face during inspection on 4/10/08.
