April 21, 2006

**Subject: Quarterly Groundwater Gauging Report
Booth Oil Site
North Tonawanda, New York
NYSDEC Site No. 9-32-100**

PHOTOGRAPH LOG

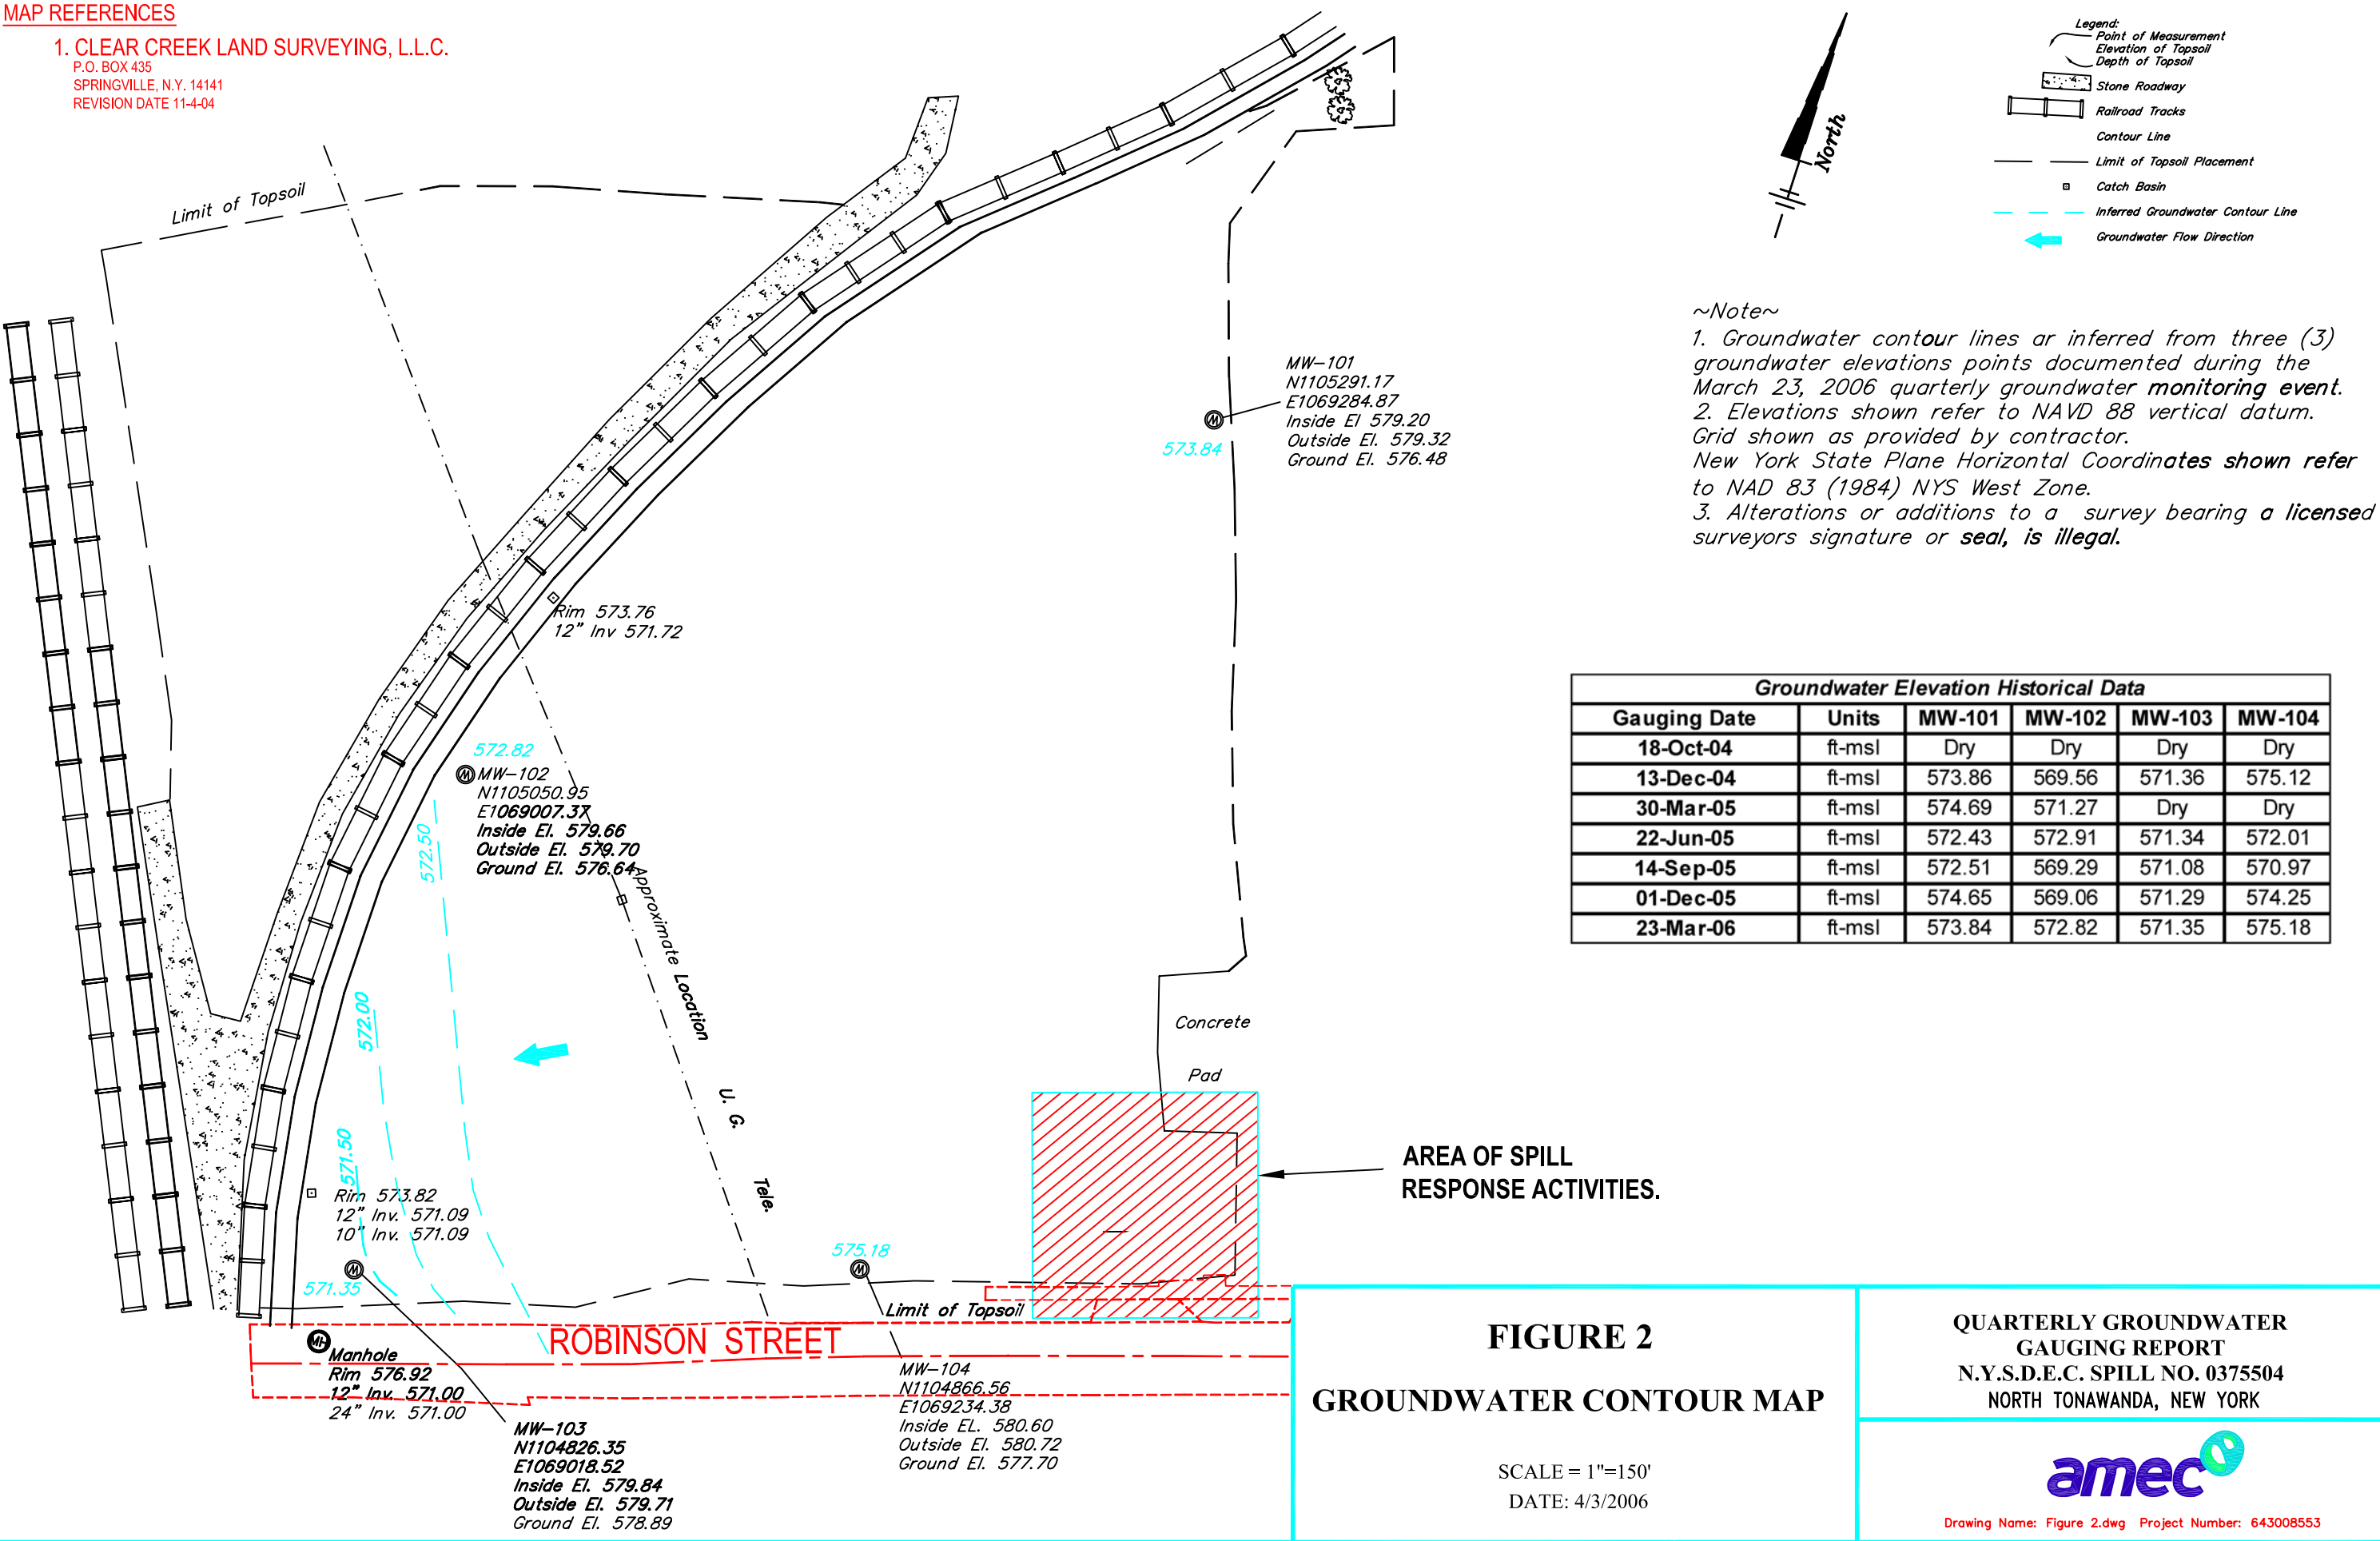
The depth-to-water results of the gauging event were utilized to develop a groundwater contour map (**Figure 2**). As illustrated on **Figure 2**, groundwater during the March 2006 monitoring event was projected to flow towards the west-southwest.

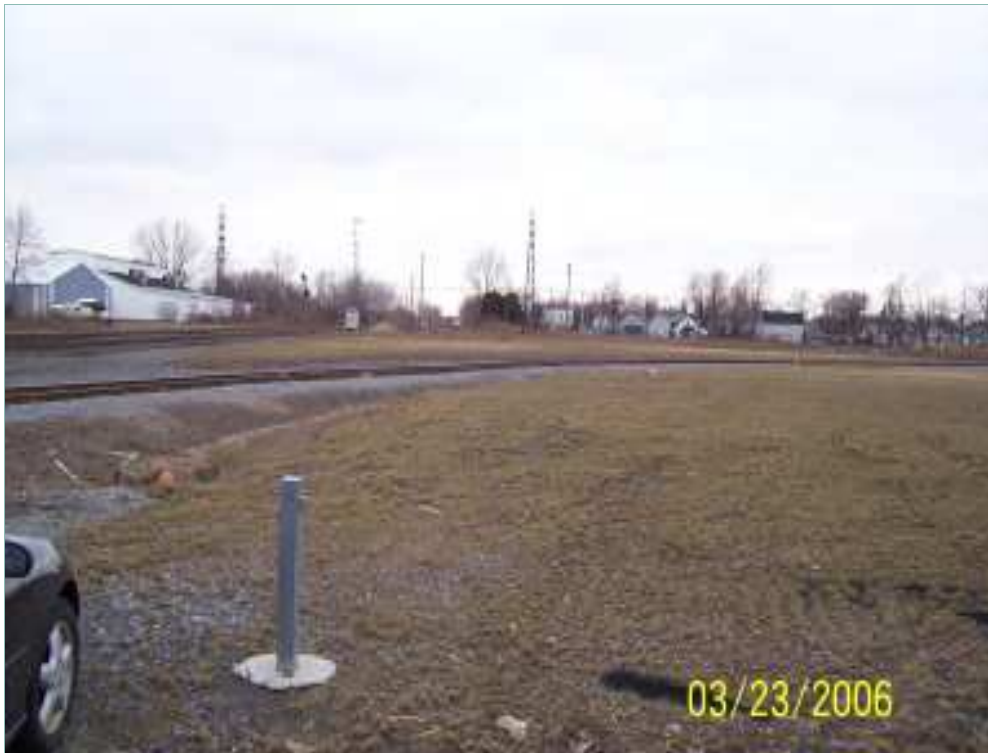
Photo # 1

Booth Oil Site, Facing Northwest

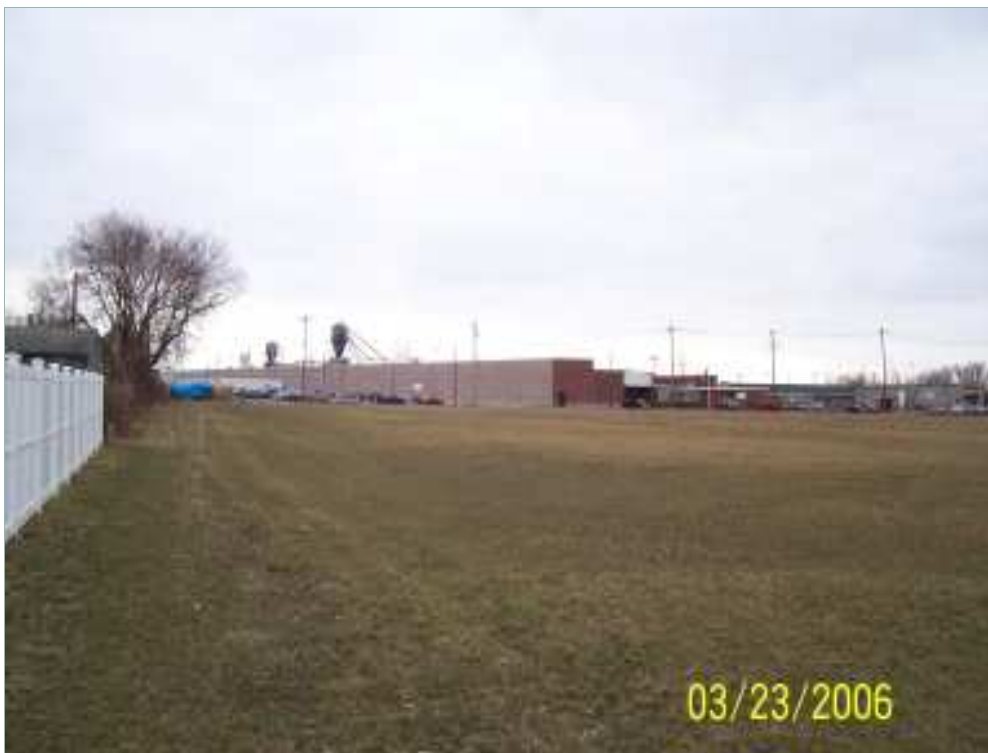
Photo # 2

Booth Oil Site, Facing South

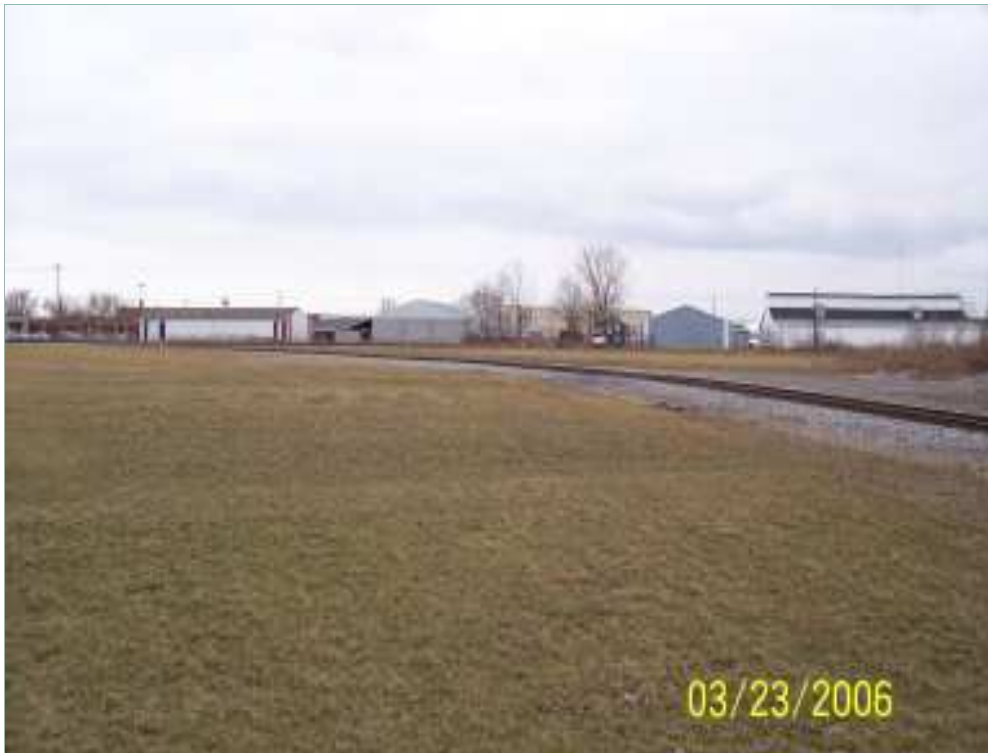
Photo # 3

Booth Oil Site, Facing West.

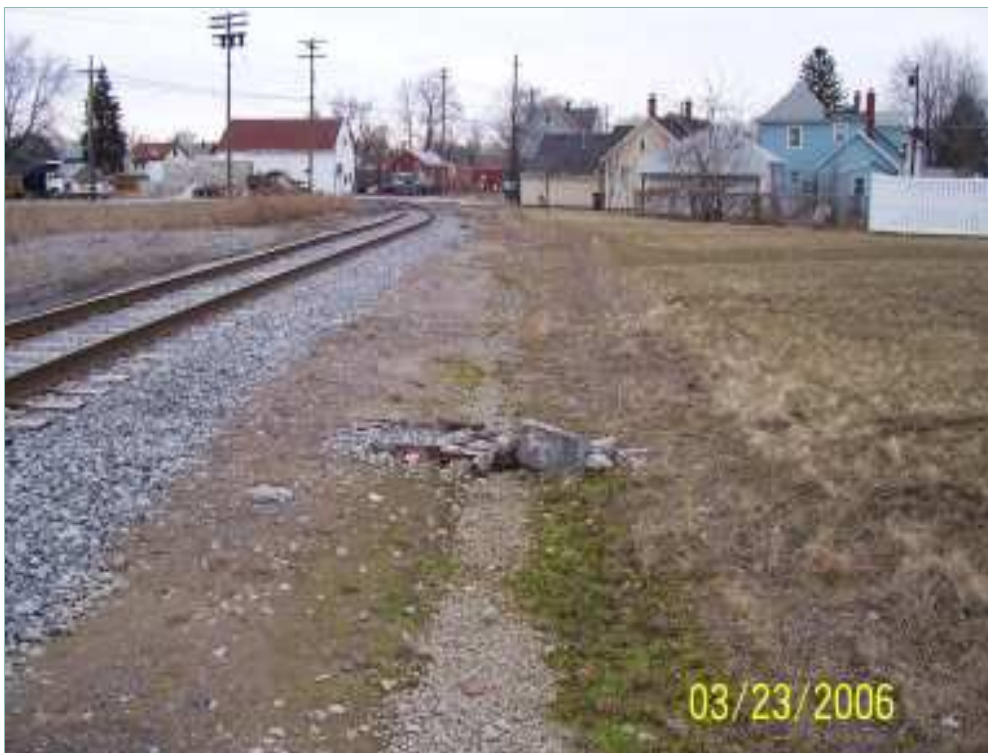
Photo # 4

The drainage ditches were generally unobstructed with minor erosion noted. The sediment control devices in the drainage ditches appear to be deteriorating and will be replaced prior to the next monitoring event.

View of Drainage Ditch Facing East.

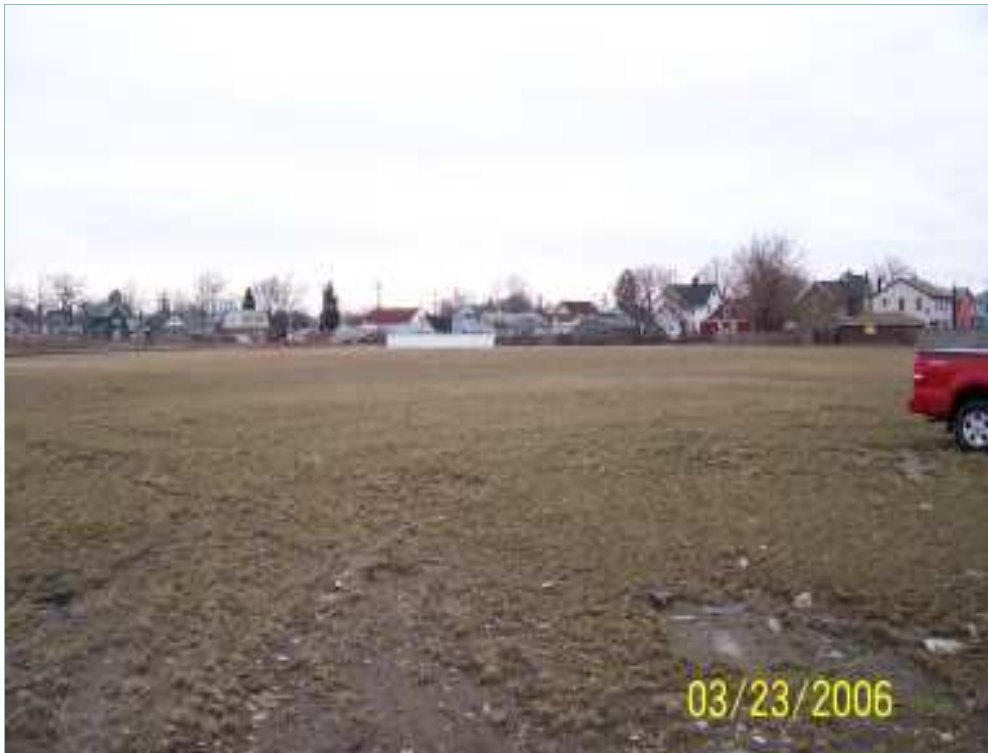
Photo # 5
View of the Site
Facing Northeast.

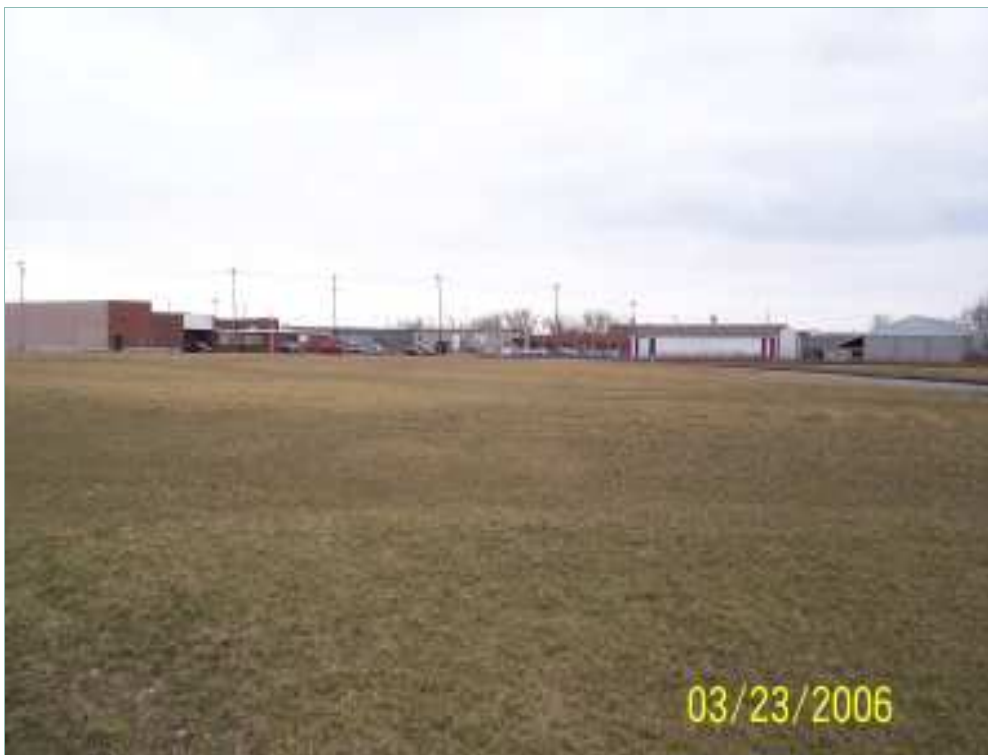
Photo # 6
View of the Site,
Facing Southwest.
