***2016, 2017, and 2018 Periodic Review Site Inspection Report
Site Management Periodic Review Report
Booth Oil Site
76 Robinson Street
North Tonawanda, New York
NYSDEC Site No. 9-32-100***

BOOTH OIL SITE
76 Robinson Street,
North Tonawanda, NY 14120

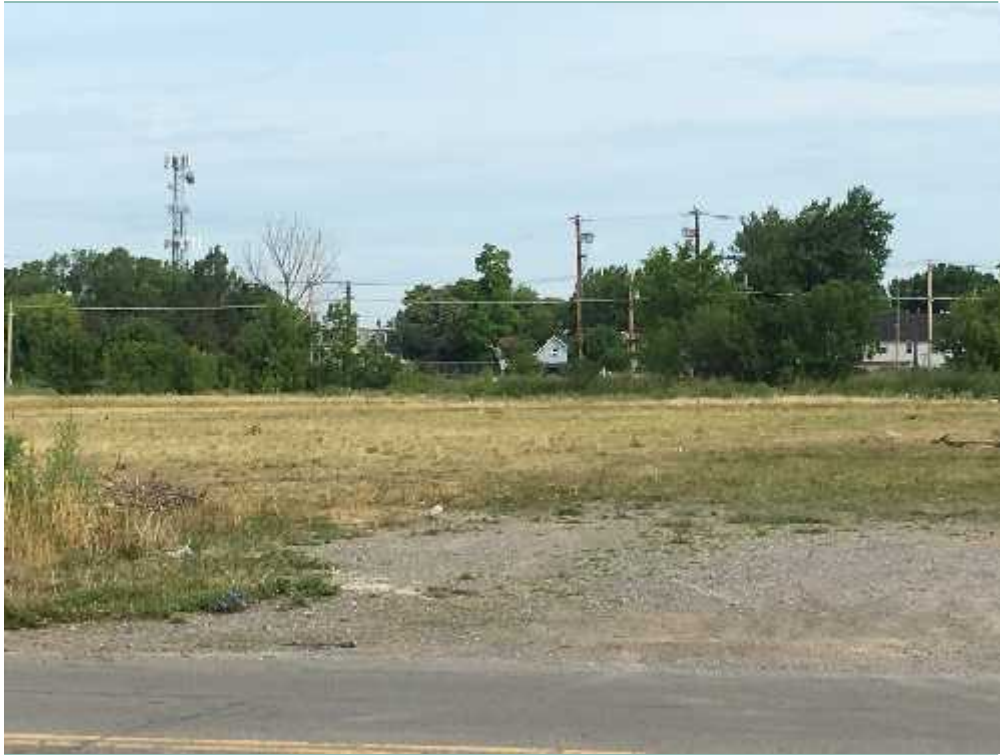
Photo 1

Facing north looking
across the site 7.28.16.

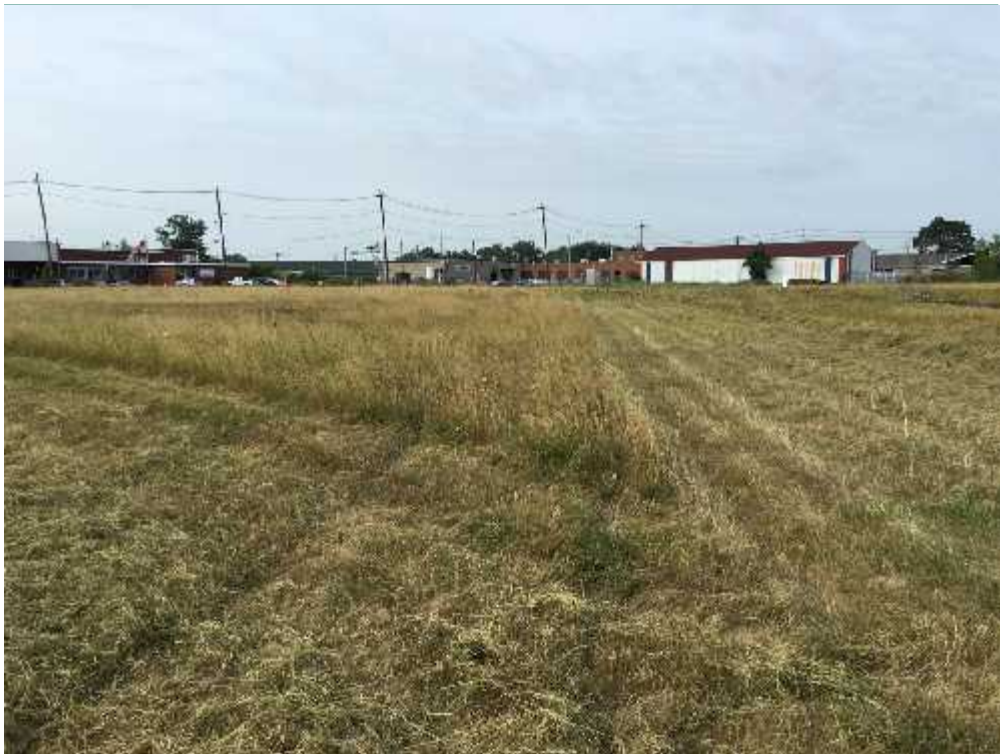
Photo 2

Looking east across the
site during maintenance
activities 7.28.16.

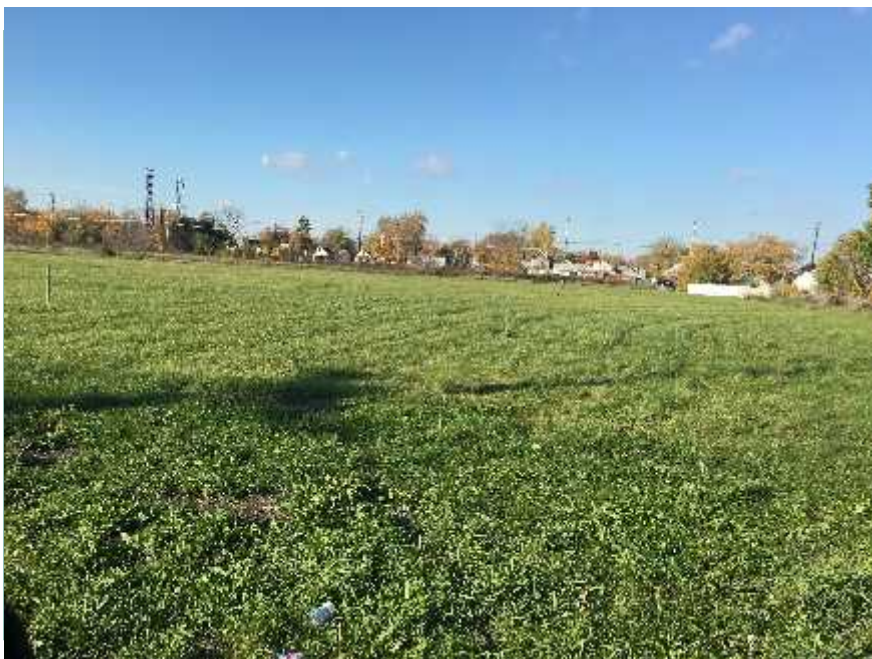
Photo 3

View across the site
Facing north 11.17.16.

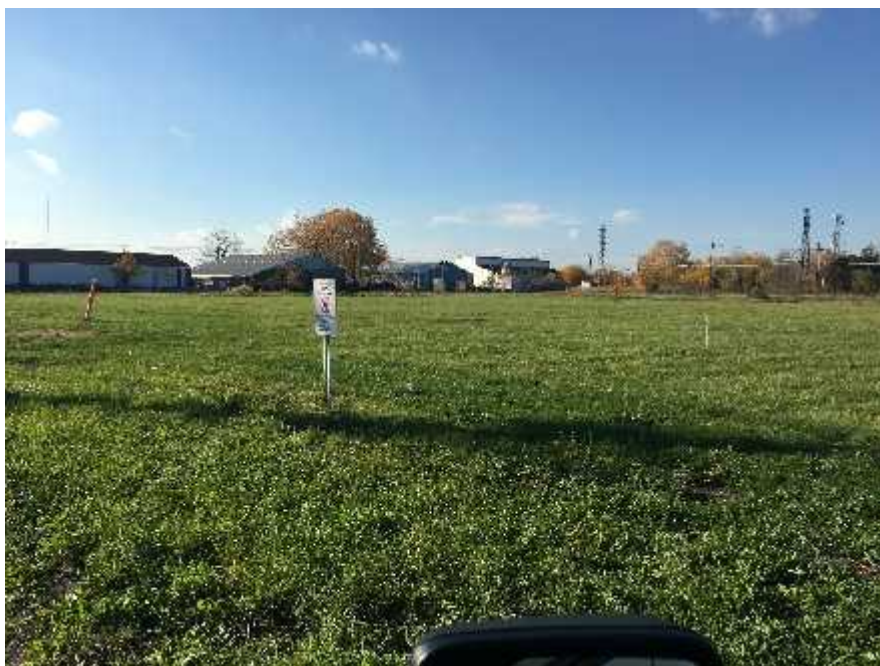
Photo 4

Facing north west
11.17.16.

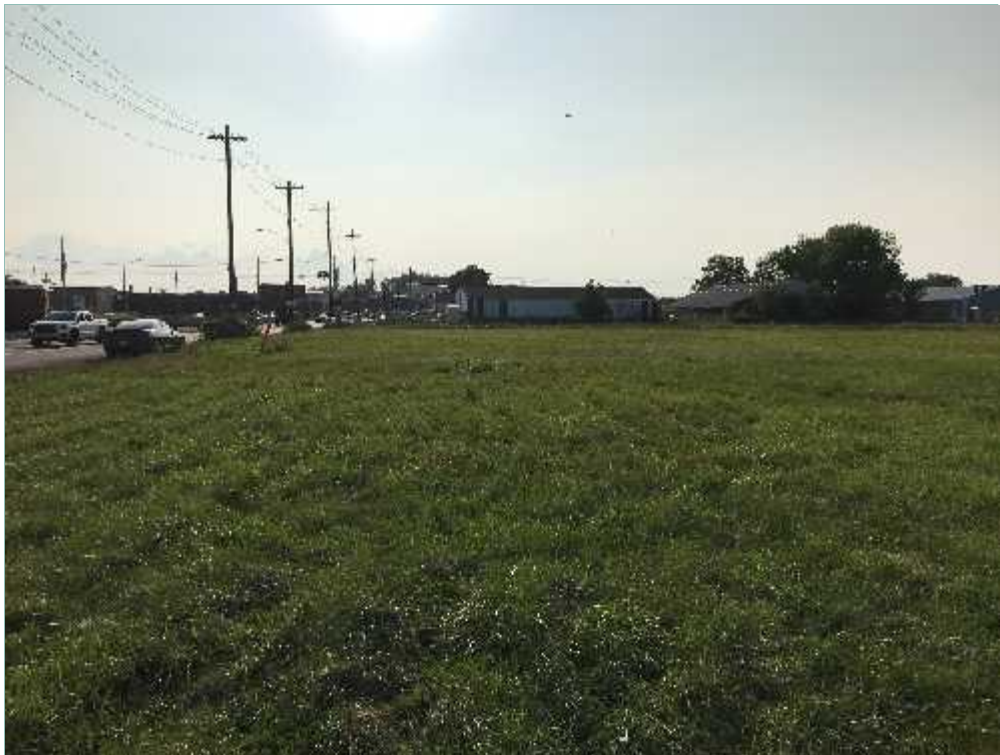
Photo 1

Facing west looking across the site.

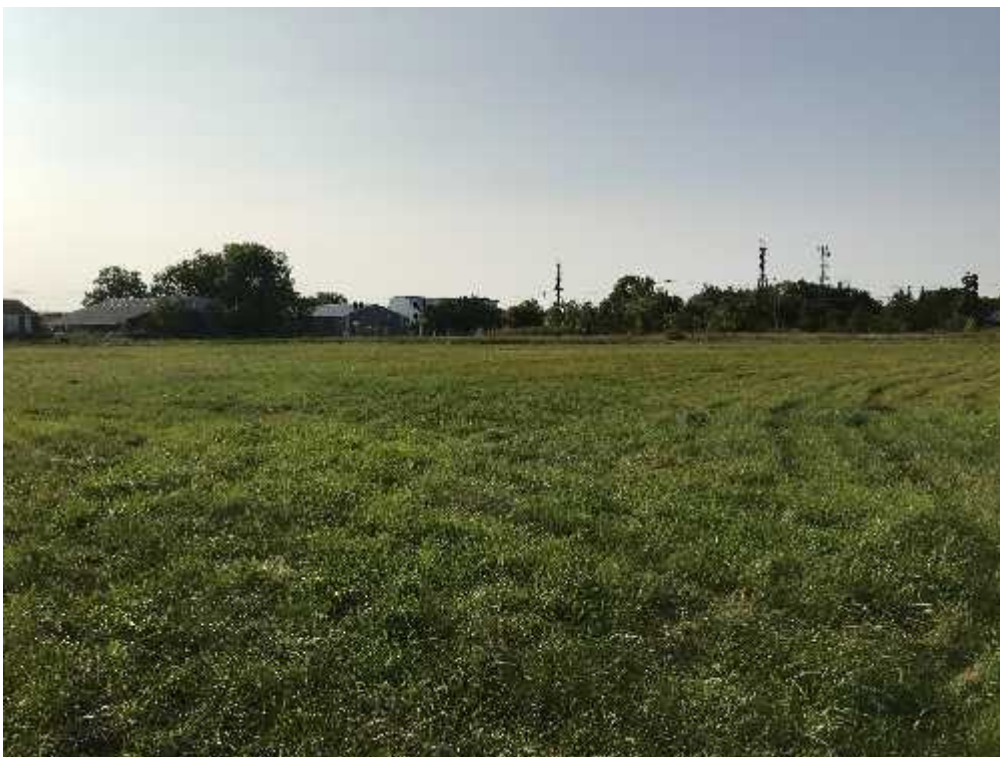
Photo 2

Looking north west across the site after maintenance activities.

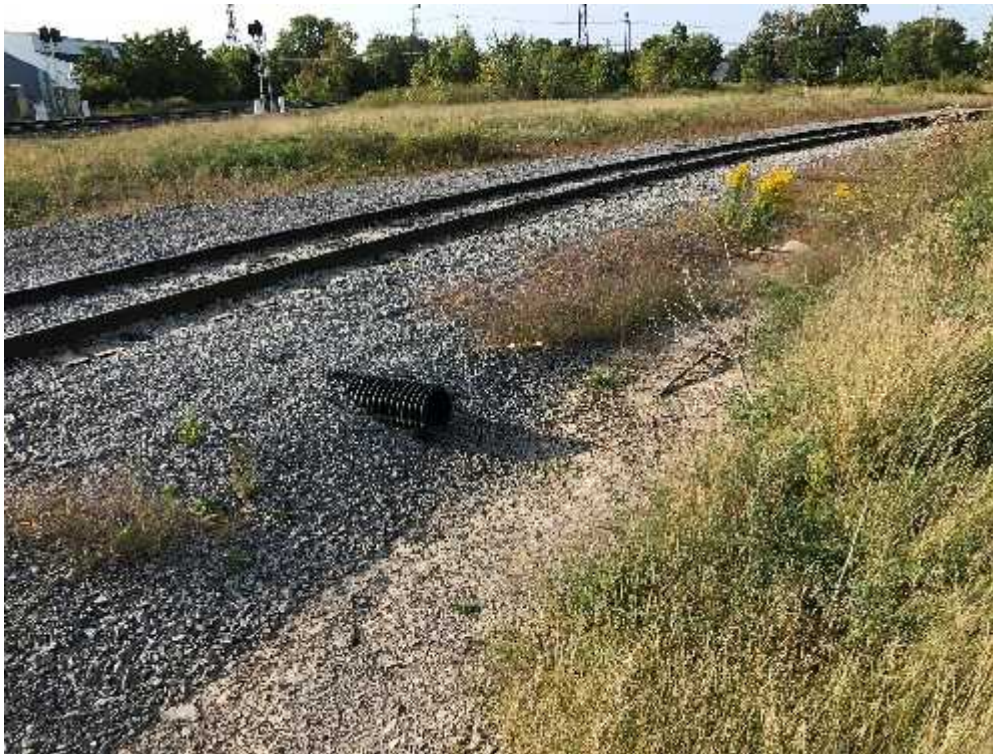
Photo 3

View of culvert pipe free of debris.

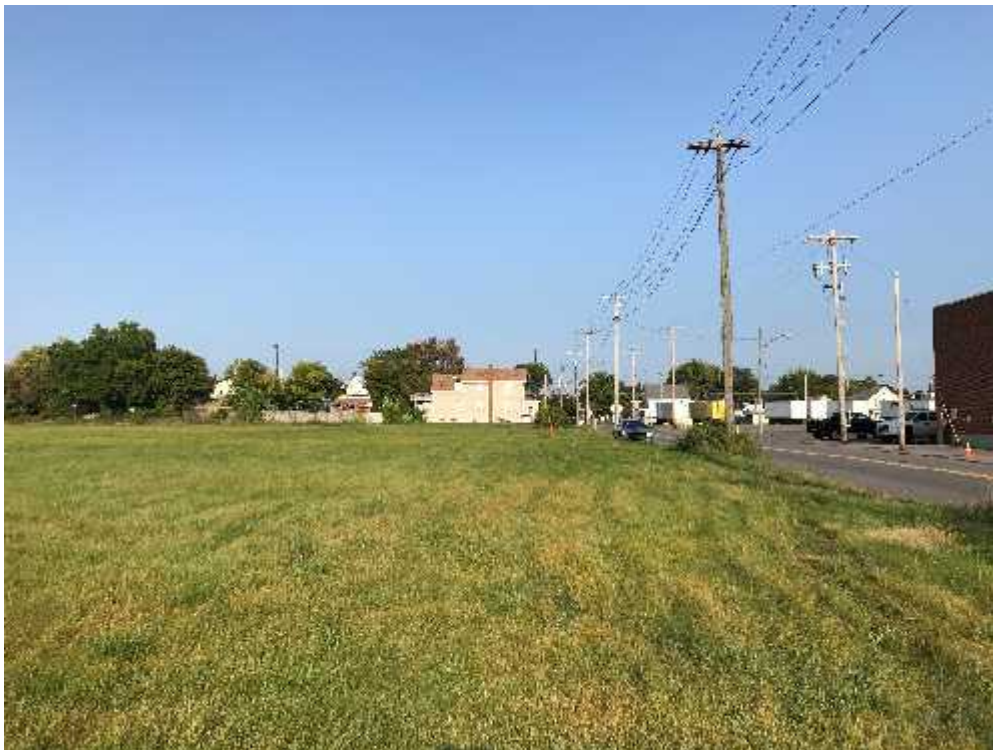
Photo 4

Facing east across the site.

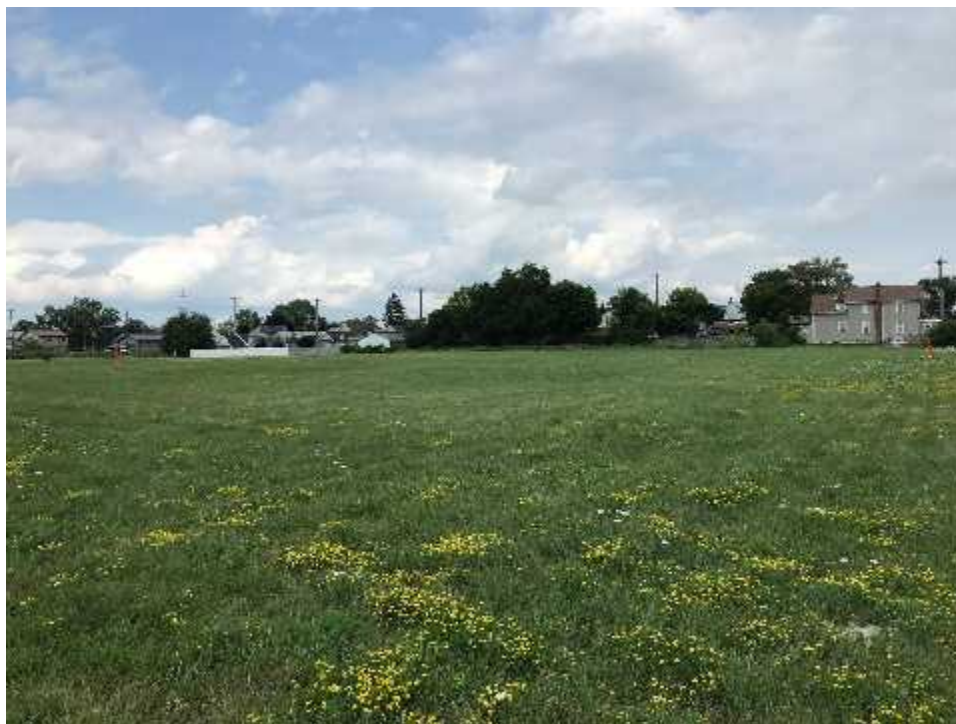
Photo 1

Facing east across the site.

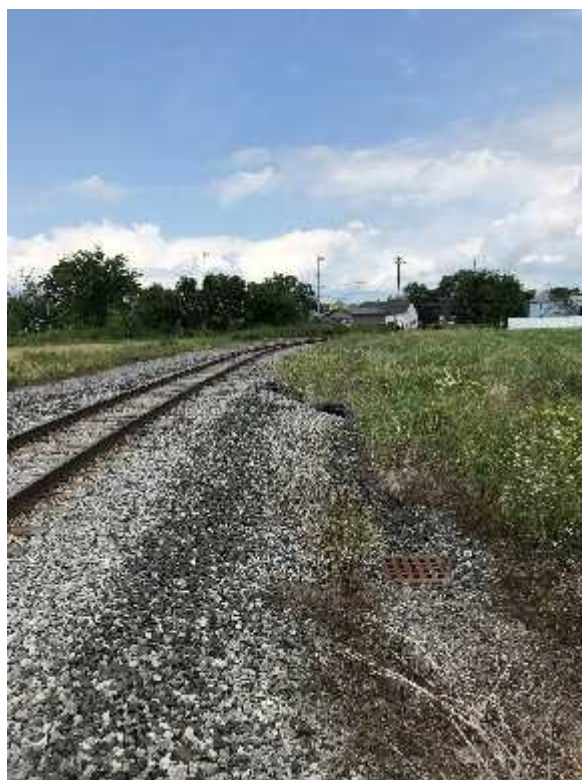
Photo 2

Photo showing drainage area free of debris.

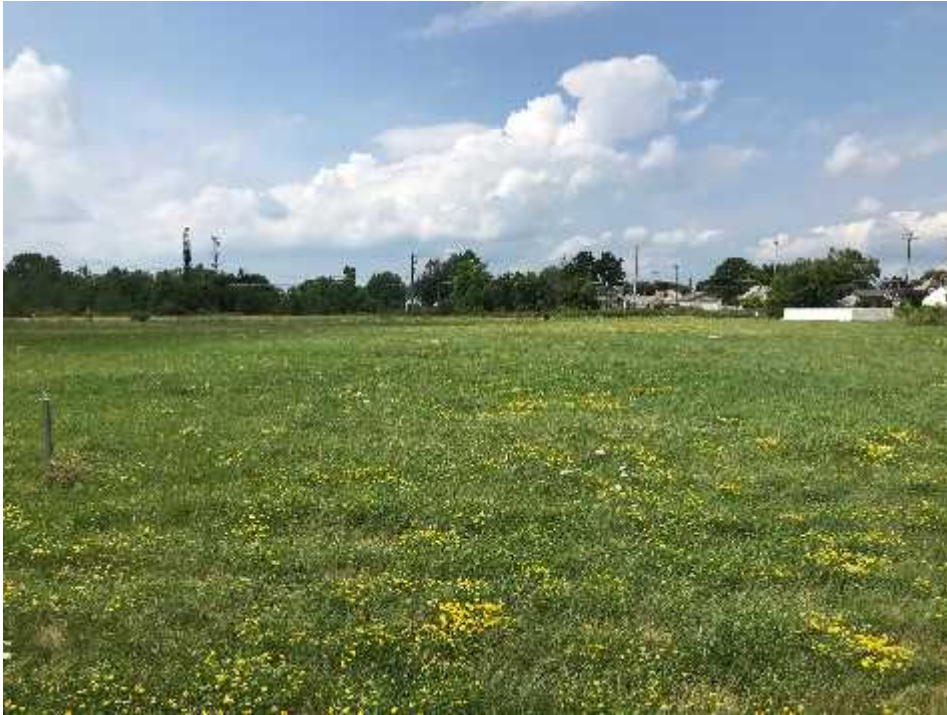
Photo 3

View facing north east.

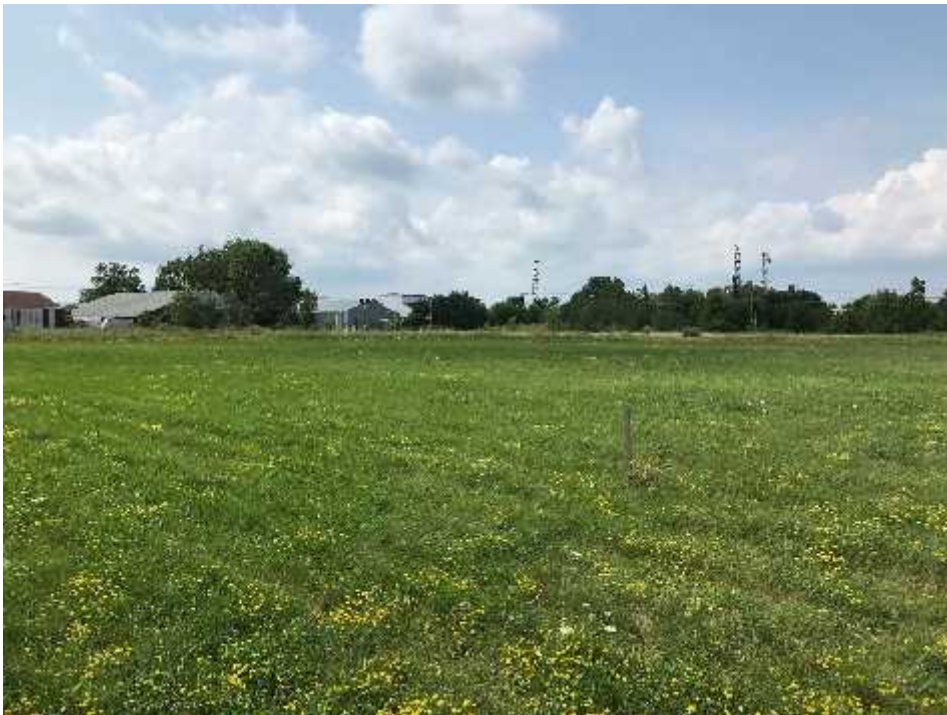
Photo 4

View facing north west.
