September 29, 2021

Subject: **2021 Periodic Review Report**
 Booth Oil Site
 76 Robinson Street
 North Tonawanda, New York
 NYSDEC Site No.: 932100

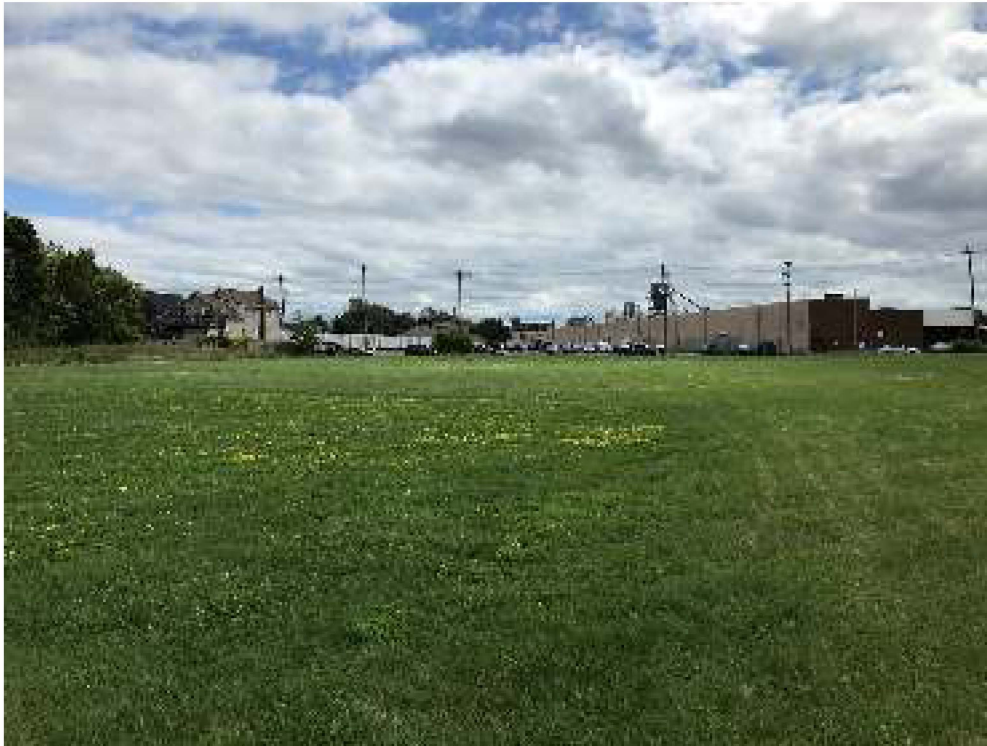
Photo 1

Facing south east across the site.

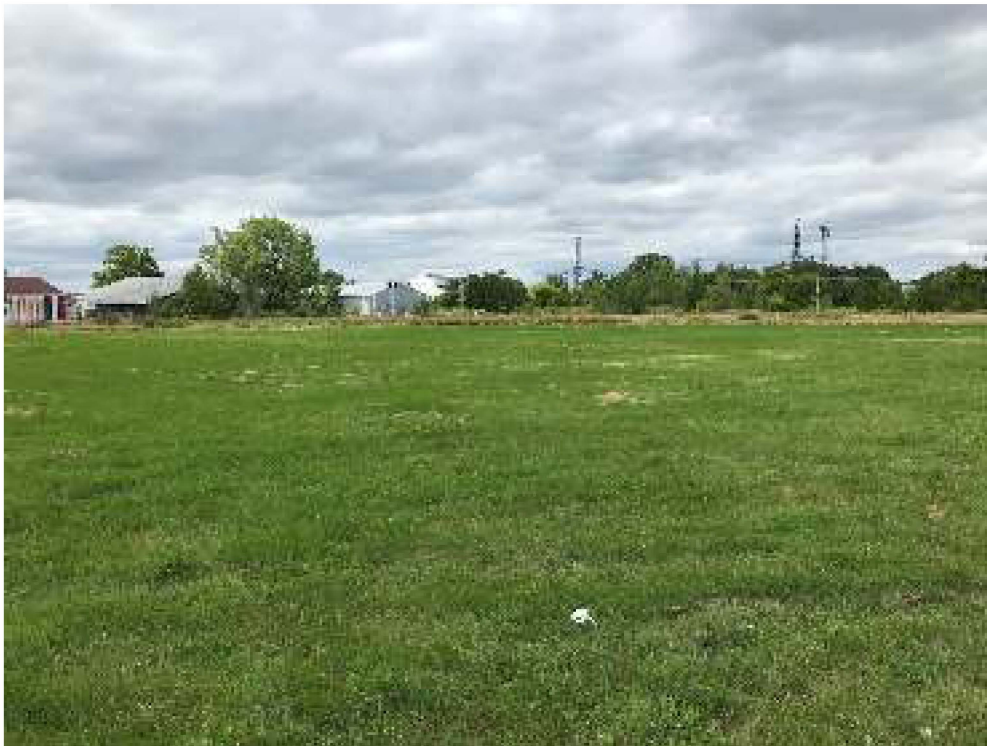
Photo 2

View of site looking north west.

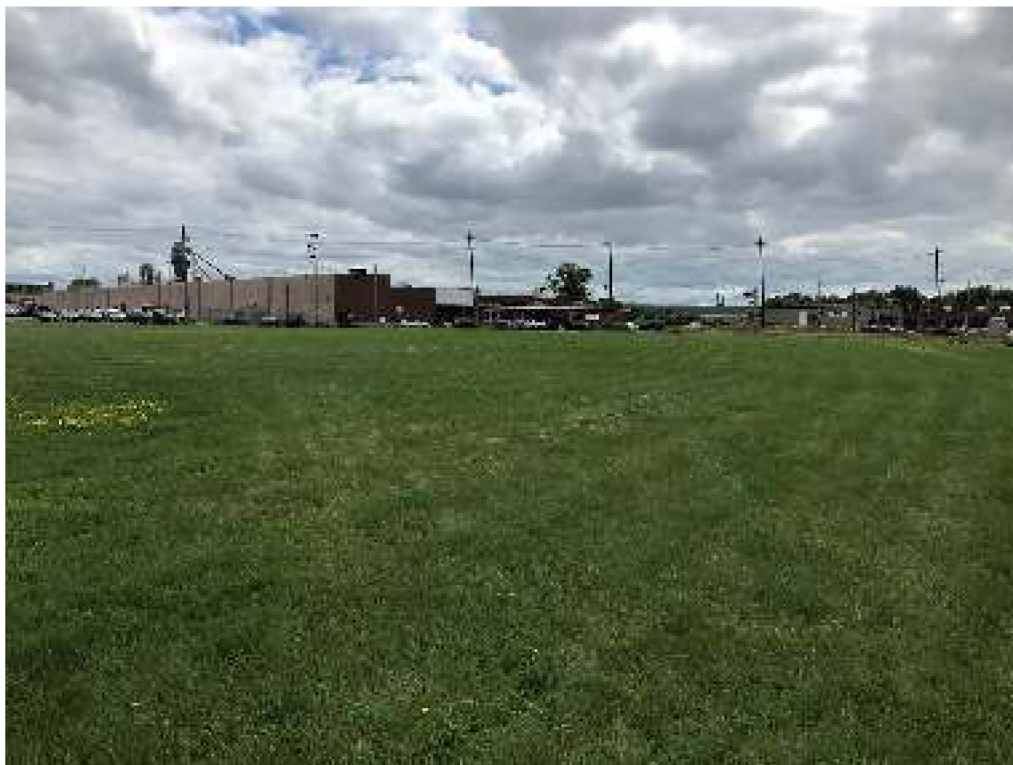
Photo 3

Looking across the site toward Robinson street.

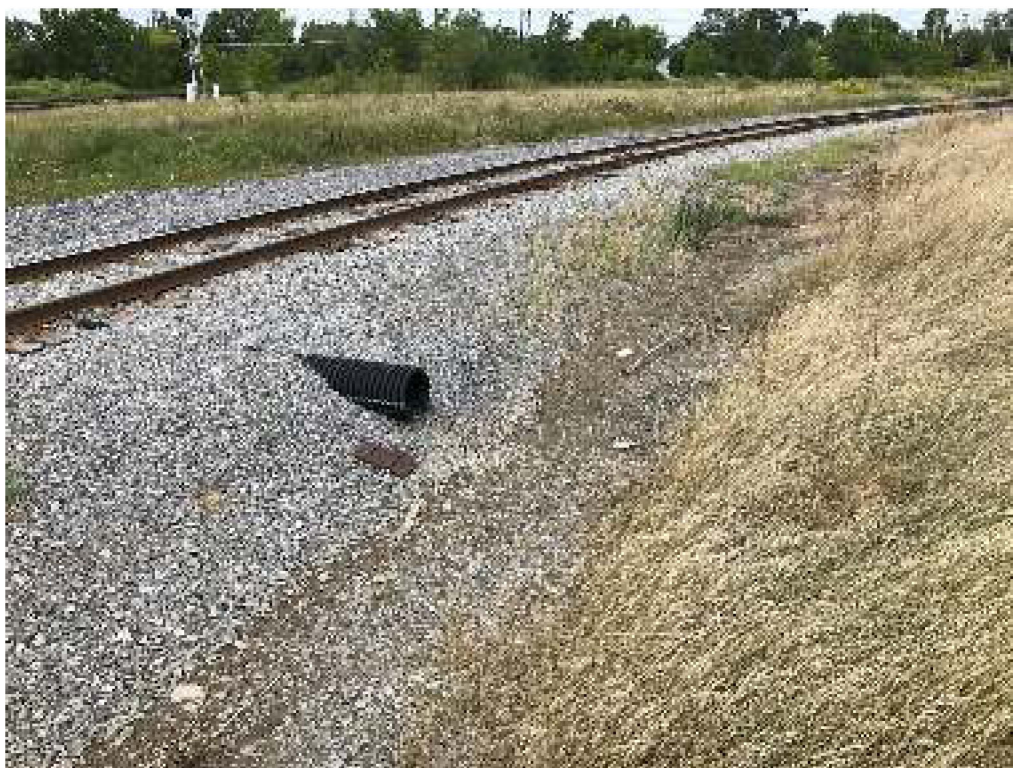
Photo 4

Photo showing north culvert pipe free of debris.

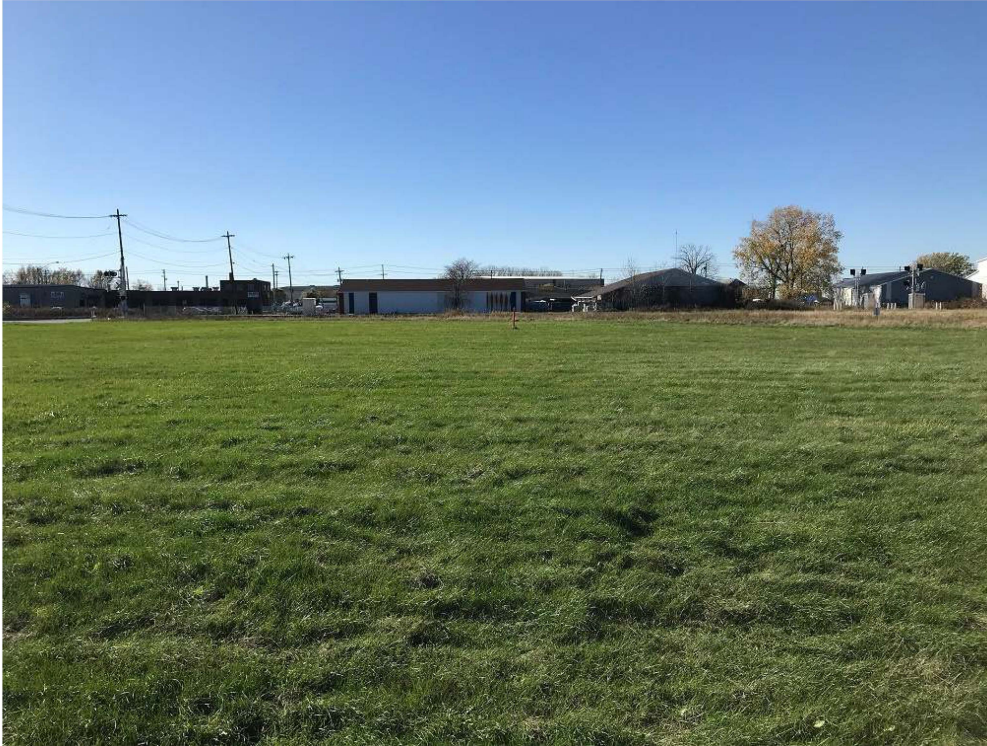
Photo 1

Facing south west across middle of site.

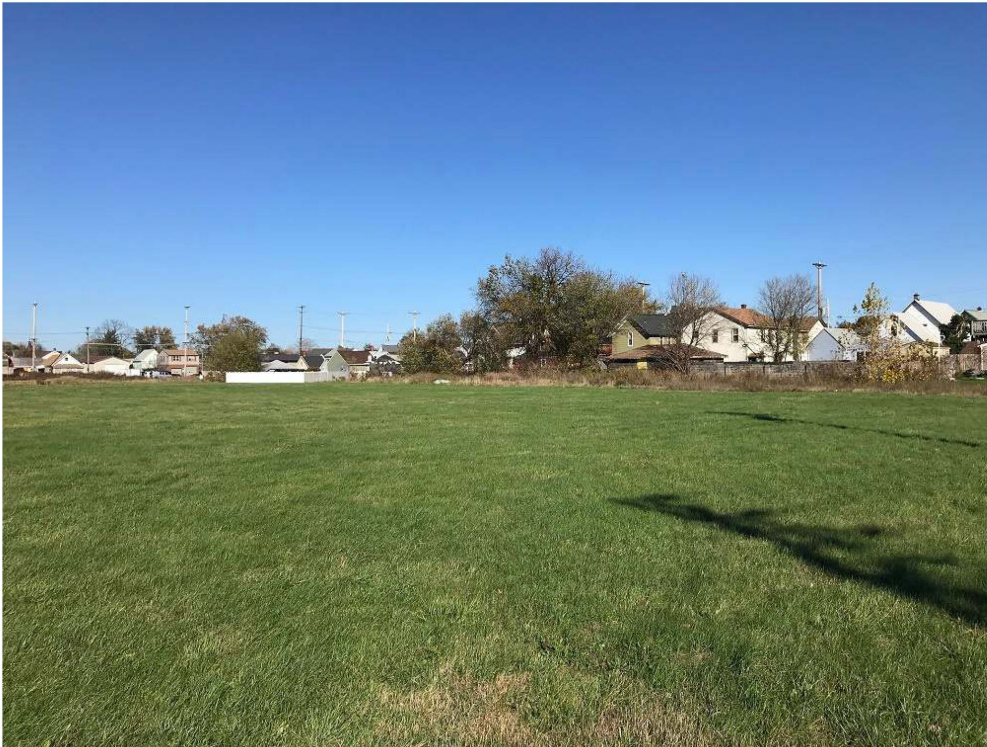
Photo 2

View of site facing north east.

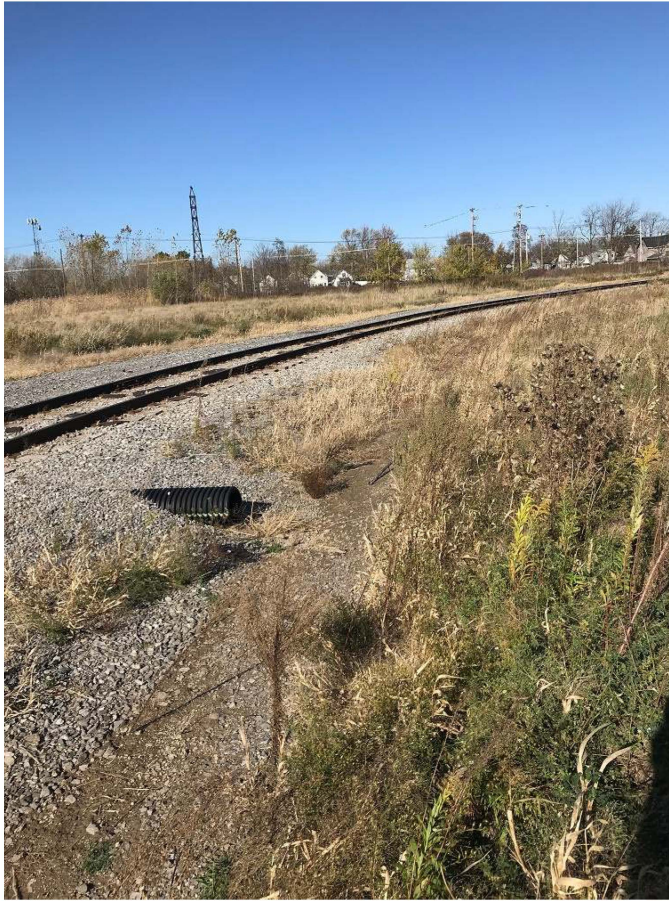
Photo 3

Photo showing clean area around the south western culvert pipe.

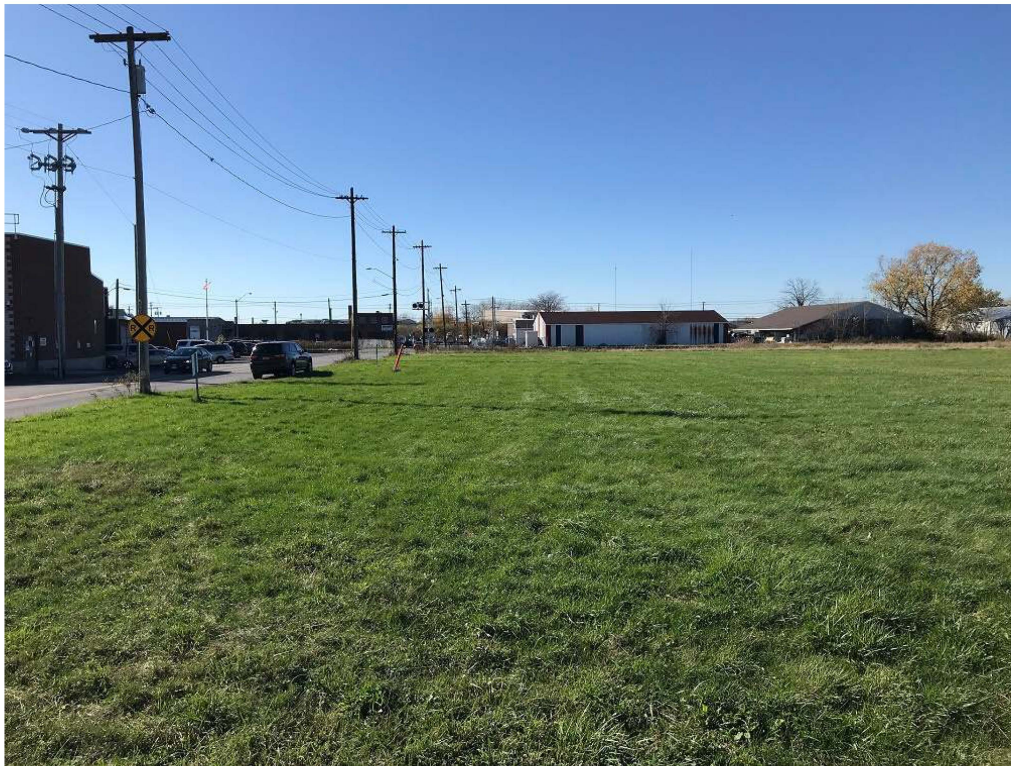
Photo 4

Facing west along Robinson Street.

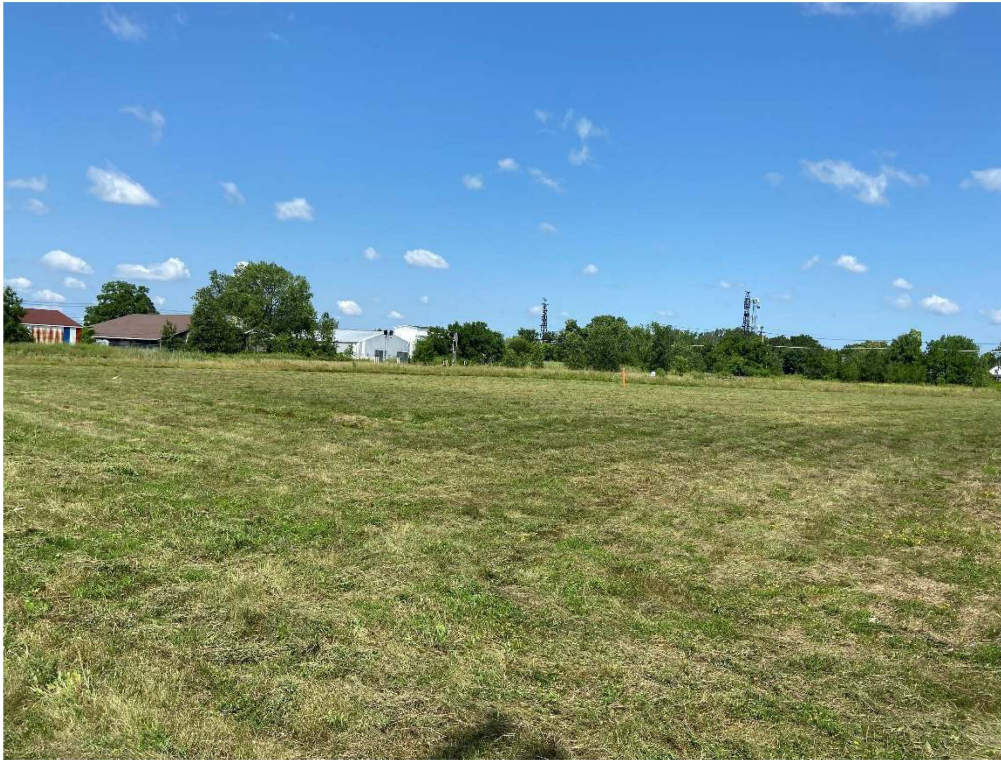
Photo 1

Facing north west across middle of site.

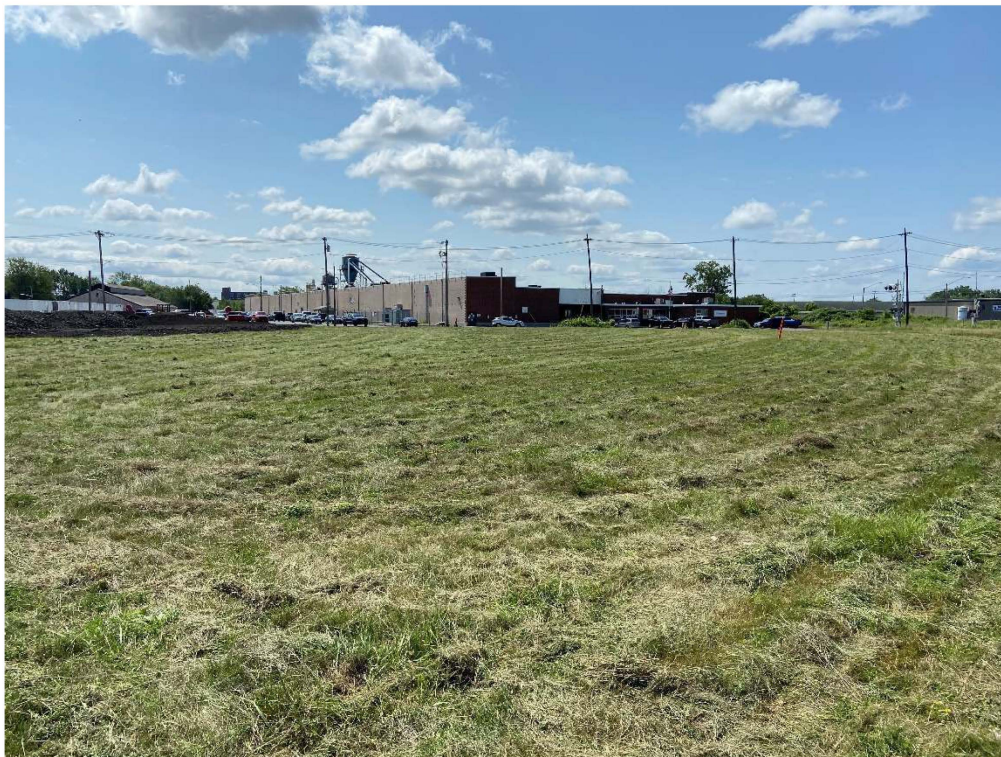
Photo 2

View of site facing south east.

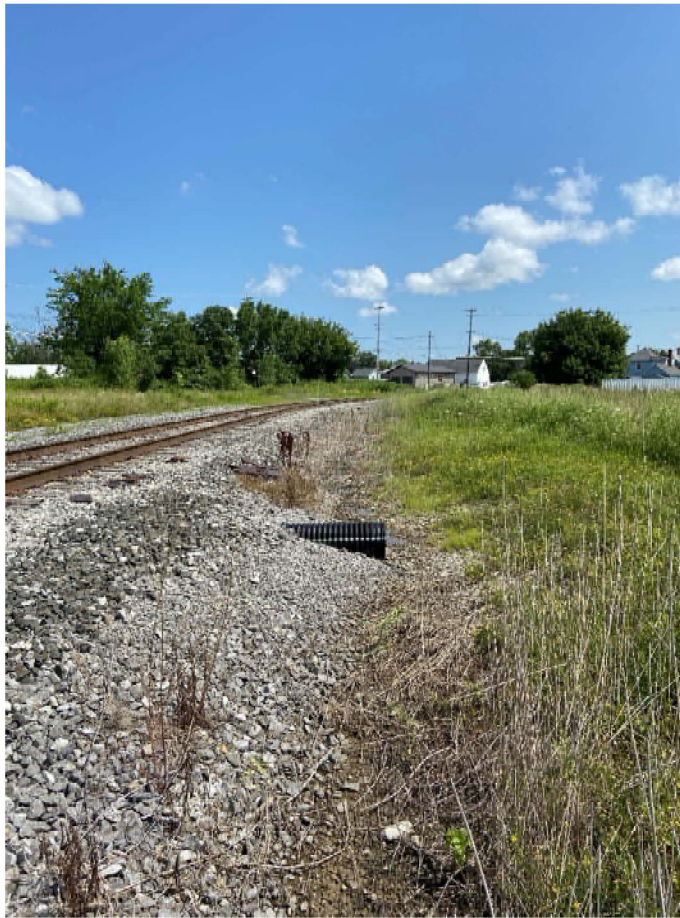
Photo 3

View of the north east site culvert pipe, free of debris.

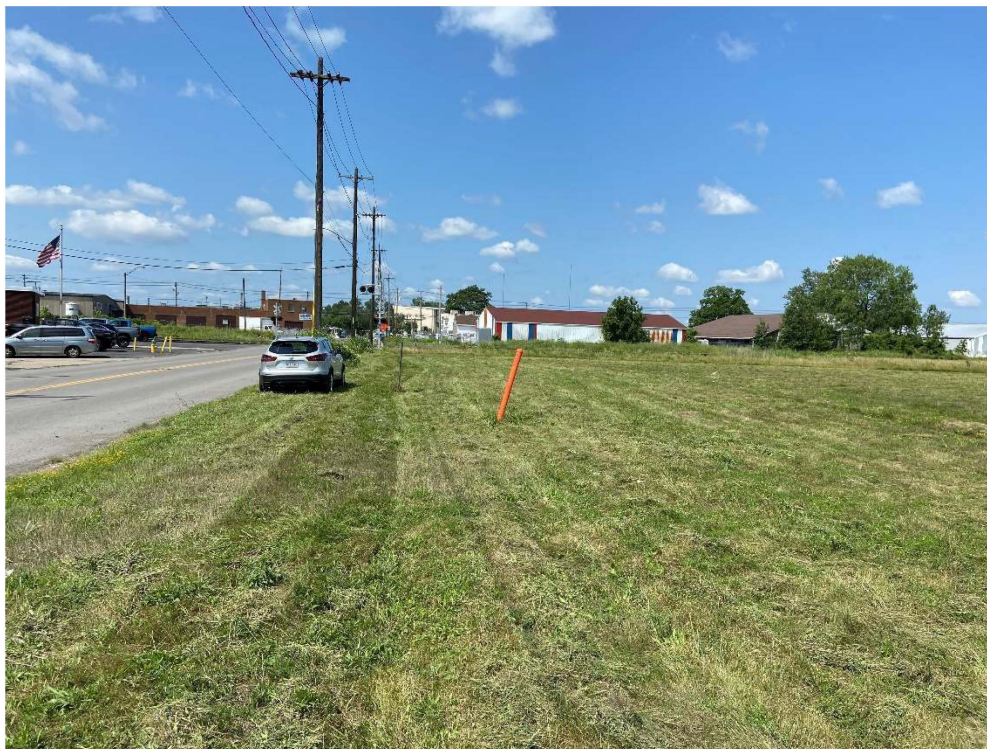
Photo 4

Facing west along Robinson Street.
