May 8, 2006

RE: **Investigation of Storm Water at the Metaullics Facility**  
Former Carborundum Site, Sanborn, NY

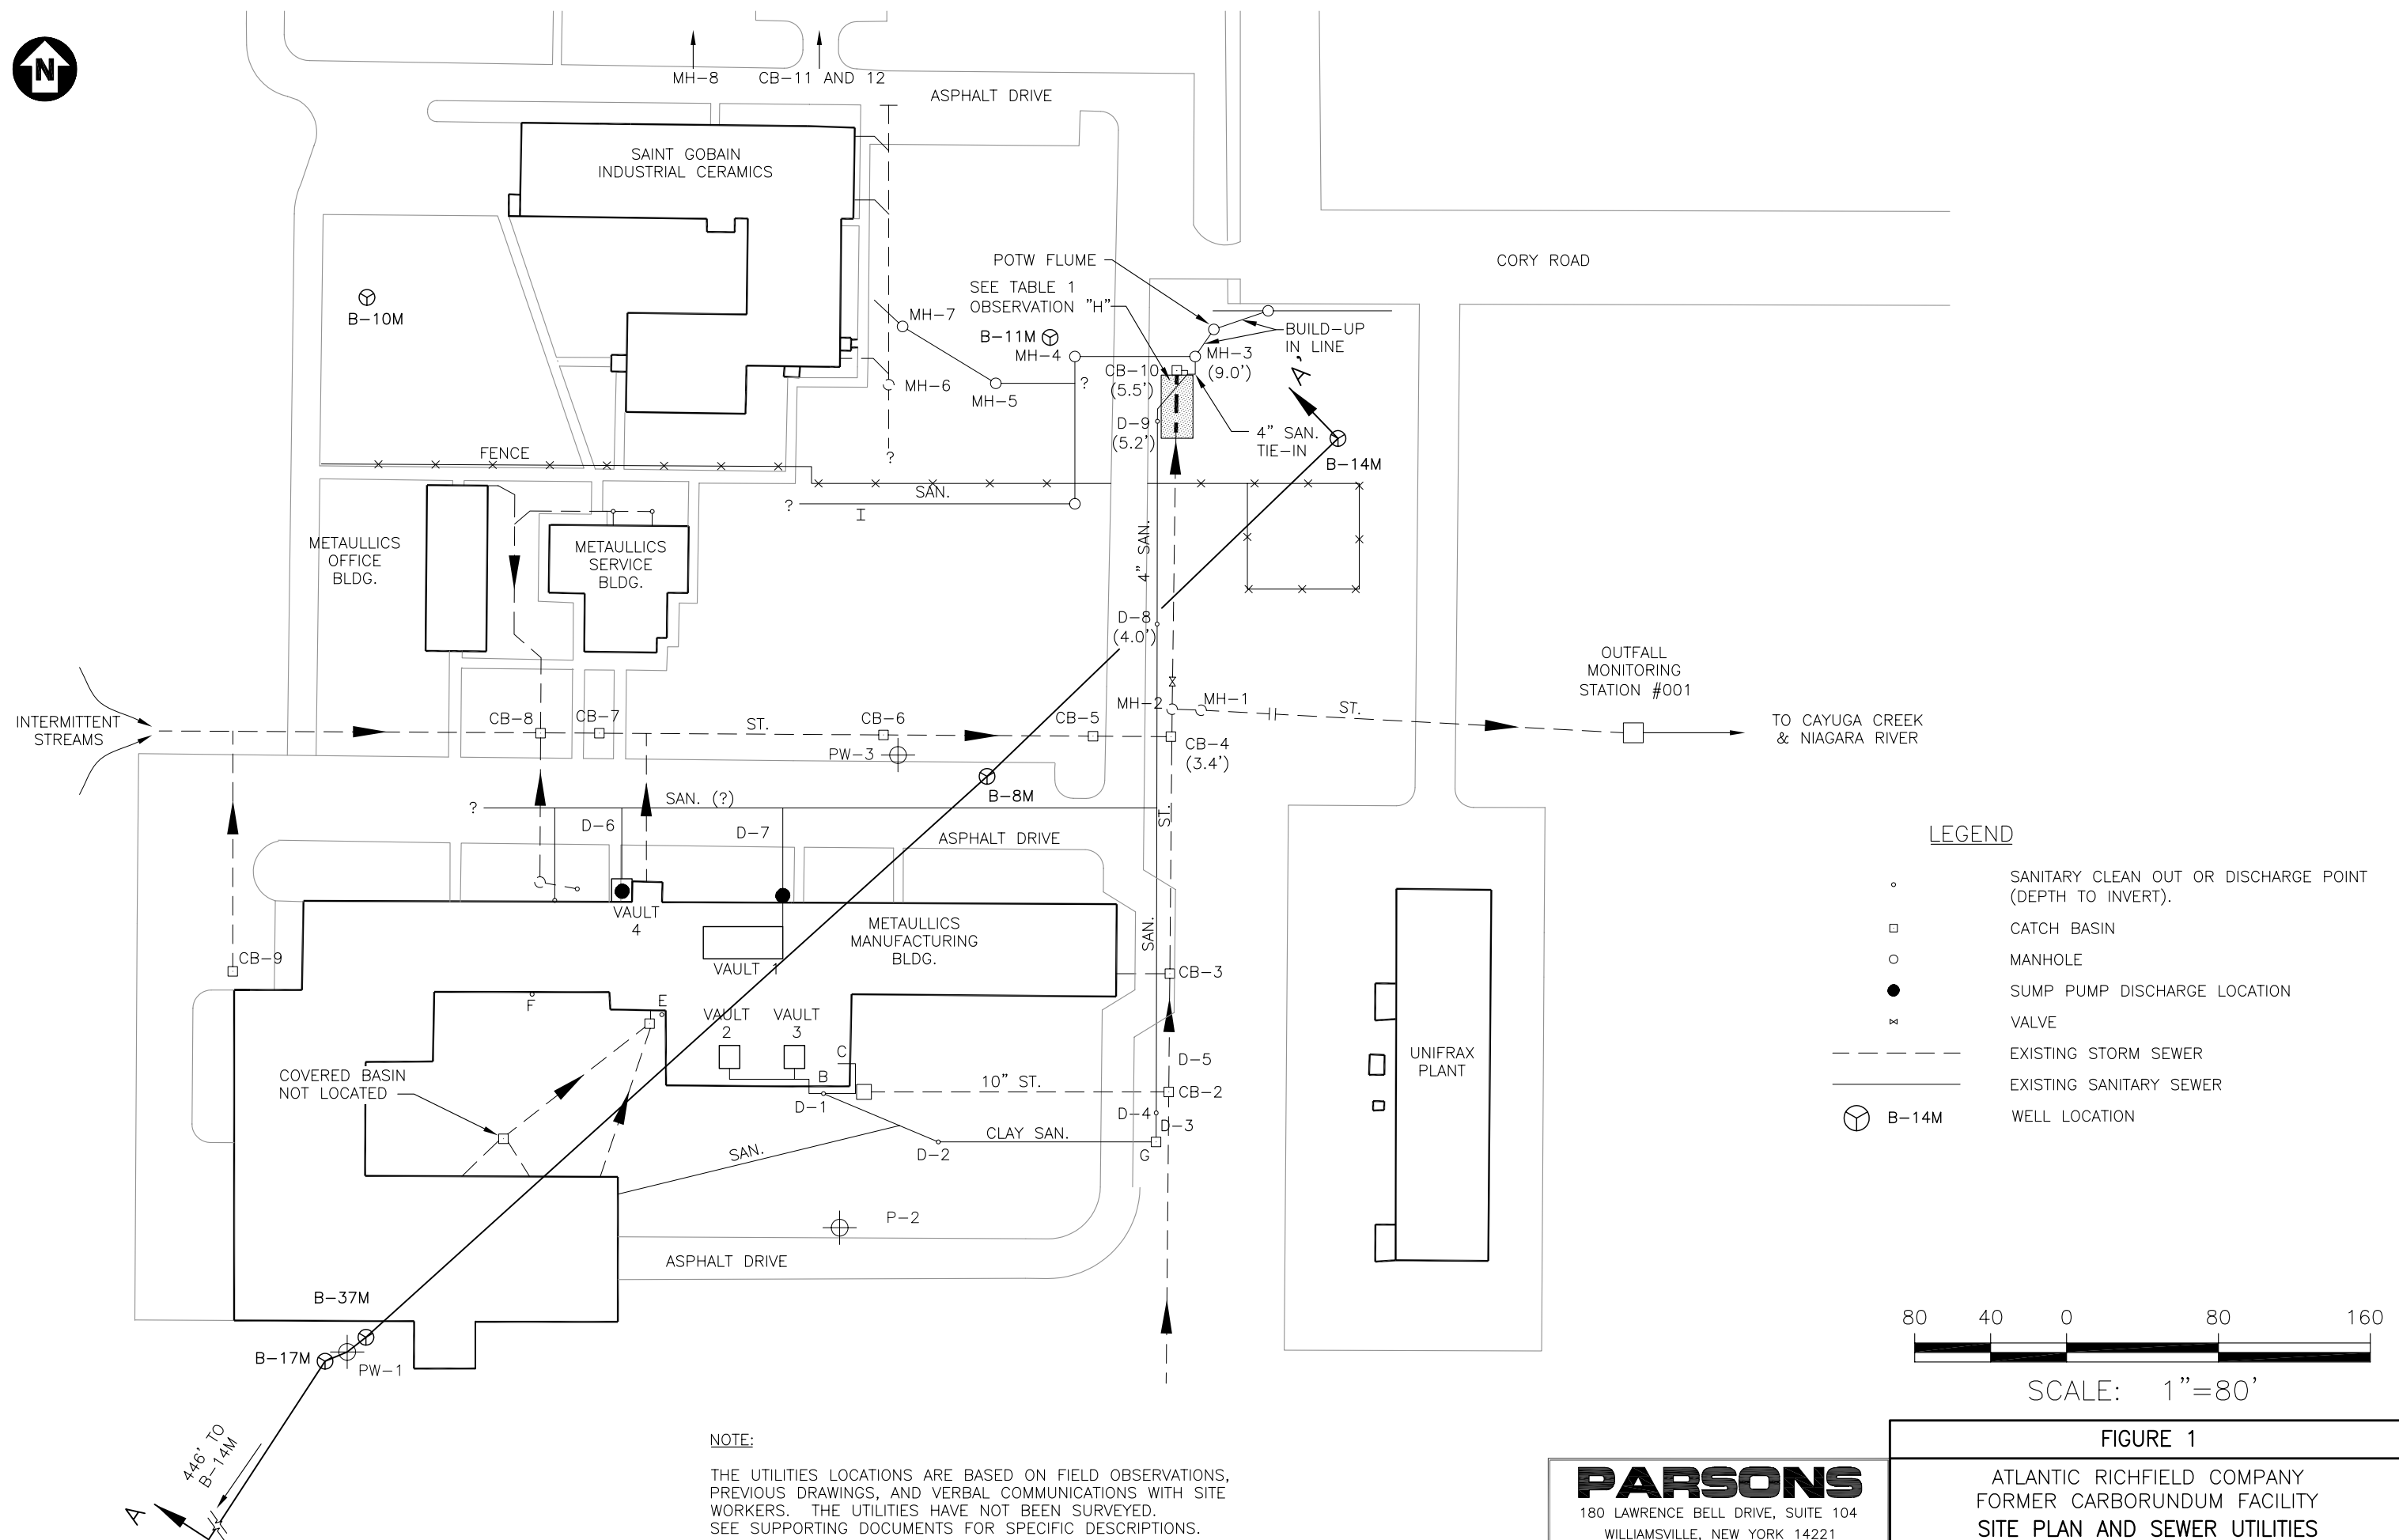
FIGURE 1

The sewer field investigation was conducted on March, 7<sup>th</sup>, 10<sup>th</sup>, and 30<sup>th</sup>, 2006. During the sewer investigation, depth to inverts and piping sizes were measured. Flow pattern and condition of the system were also inspected. Figure 1 shows a plan view of site sewers, including the storm and sanitary sewers. Figure 2 is a cross-section schematic summarizing the observations and measurements. Figure 2 shows in plan view, the approximate locations of site water supply utilities. Table 1 is a map key detailing specific observations and measurements made during the investigation. A photographic log is provided in Appendix A. Results from the 2006 investigation indicate that the storm and sanitary sewer systems are separate systems upstream of the tie-in near the POTW discharge. This tie-in is located between CB-10 and MH-3. Each system has various types of piping and various invert elevations.

The sanitary sewer is an aggregation of newer and older construction. The older system shows several separate sewer systems, each with a septic tank and leach field. The system was upgraded (date unknown) to the present configuration, but included some of the existing infrastructure. For example, the sanitary line south of the manufacturing building previously extended to a leach field east of the present-day property line. Currently, there is a lift station (G on Figure 1) that pumps water northerly into the newer sanitary system.

- Four sumps from the manufacturing building discharge to the sanitary sewer;
- Process cooling water discharges with water from Sumps 2 and 3 to the sanitary system at location D-1 (Figure 1). Based on visual observation only, there was a constant flow of approximately 5 to 10 gallons per minute (GPM) at location D-1.
- From the north side of the Metaullics building to the POTW shed, most of the sanitary sewer is near or below the March 8 hydraulic head;
- The section of sanitary sewer after the tie-in with the storm sewer (near CB-10), based on depth to inverts and historic water level measurements, may be up to five feet lower than the hydraulic head, at times; and
- Reportedly due to root penetration, a portion of the clay sanitary sewer was replaced with PVC by Metaullics (D-2 on Figure 1).

- The storm and sanitary sewers vary in construction, location, and integrity. During prolonged wet-weather conditions, groundwater may infiltrate into either sewer system through cracks, breaks and other imperfections. Based on depth of inverts and water level measurements in nearby wells, the most probable area for infiltration to occur to the sewers is on the northern side of the manufacturing building toward the POTW shed. In this area, at least part of the sanitary sewer and storm sewer is below groundwater levels.
- The sanitary sewer is typically lower in elevation than the storm sewer, and may therefore, depending on line integrity, have a higher potential for groundwater infiltration.
- The sumps directly discharge their contents to the sanitary sewer system.

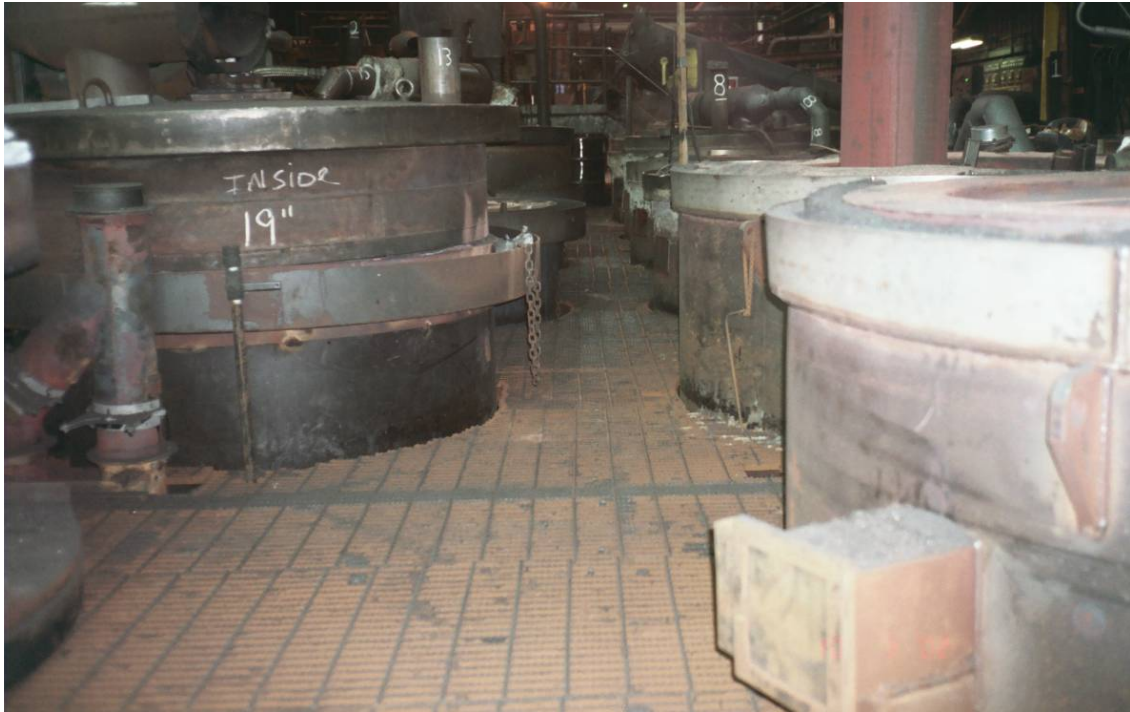
| Vault #1 (called baker pit by Metaullics): 45' x 17' x 13' (deep, top of vault about one foot above ground surface). Constructed of concrete, holds approximately 9 furnaces. Sump in the northeast corner of the vault discharged to an outside, above-ground PVC vertical pipe. The vertical pipe "T's" into the sanitary under the driveway (per verbal communication with site workers on March 7, 2006). |

Photograph 3: Vault 1 (bake pit). The grated floor covers the vault. The large cylinders are furnaces that stand vertically in the vault.

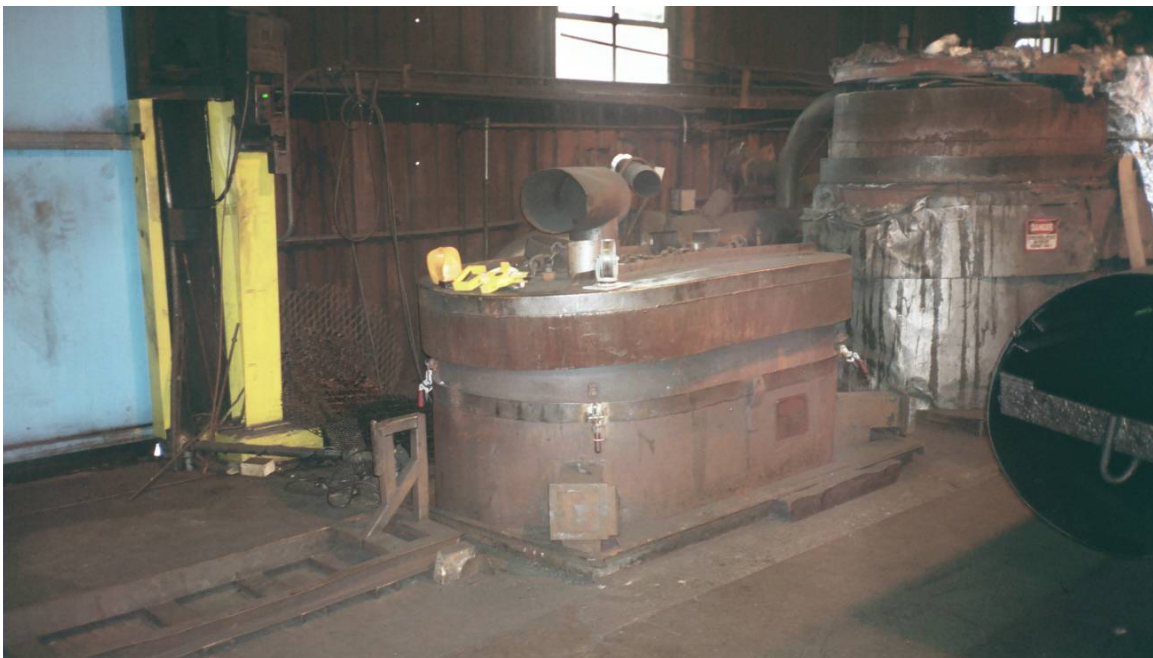
| Vault #2 (Preheater 1): 8' x 5' x 11.5' (depth was below top of vault, which is 0.4' above floor.) This vault holds one furnace, located on the south side of the building. The discharge line connects with line from Vault #3 and discharges into a pipe that goes through the south wall of the building, and into the sanitary line vertical pipe, D-1 (verbal communication with site workers on March 7, 2006). |

Photograph 4: Vault 2 (preheater vault). The preheater fills most of the vault volume. The steel rim of the vault is visible adjacent to the floor.

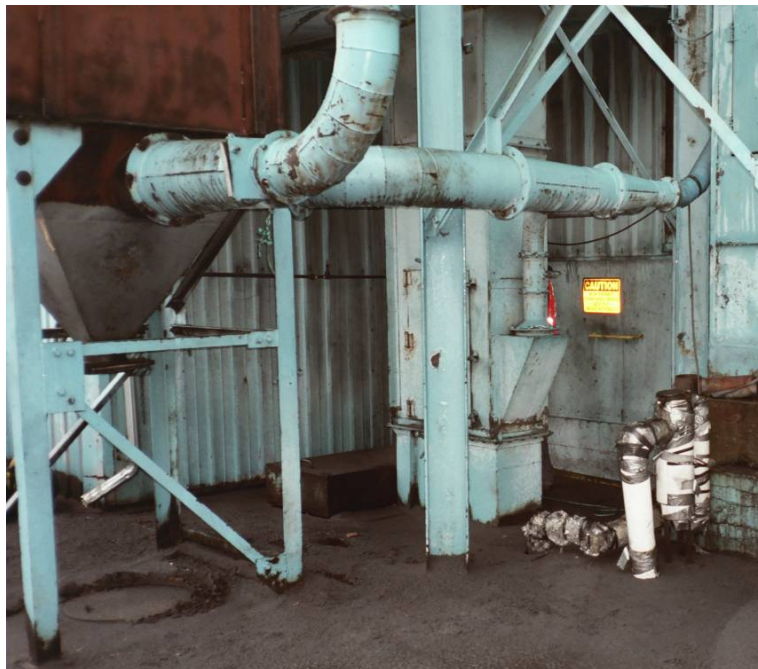
| Sump #4 (elevator pit): 9.7' x 9' x 7' (depth is below parking lot/drive way level.) This sump is outside the north side of the building. This sump houses the elevator for the process sand tank. Sand in bottom of vault. Sump discharge line has a filter on it to catch sand. Sump discharged to the sanitary under the driveway (verbal communication with site worker on March 7, 2006). |

Photograph 6: Vault 4 (sand elevator). The top of the vault is flush with ground level. The vault surrounds the vertical elevator shaft. The PVC sump piping (wrapped in silver tape) is shown on the right.
