RE: Former Carborundum Site, Sanborn, New York
Sanitary and Storm Sewer Infiltration Evaluation

SITE PLAN AND SEWER UTILITIES

**INVESTIGATION OF STORM WATER AT THE METAULLICS FACILITY
MAY 2006**

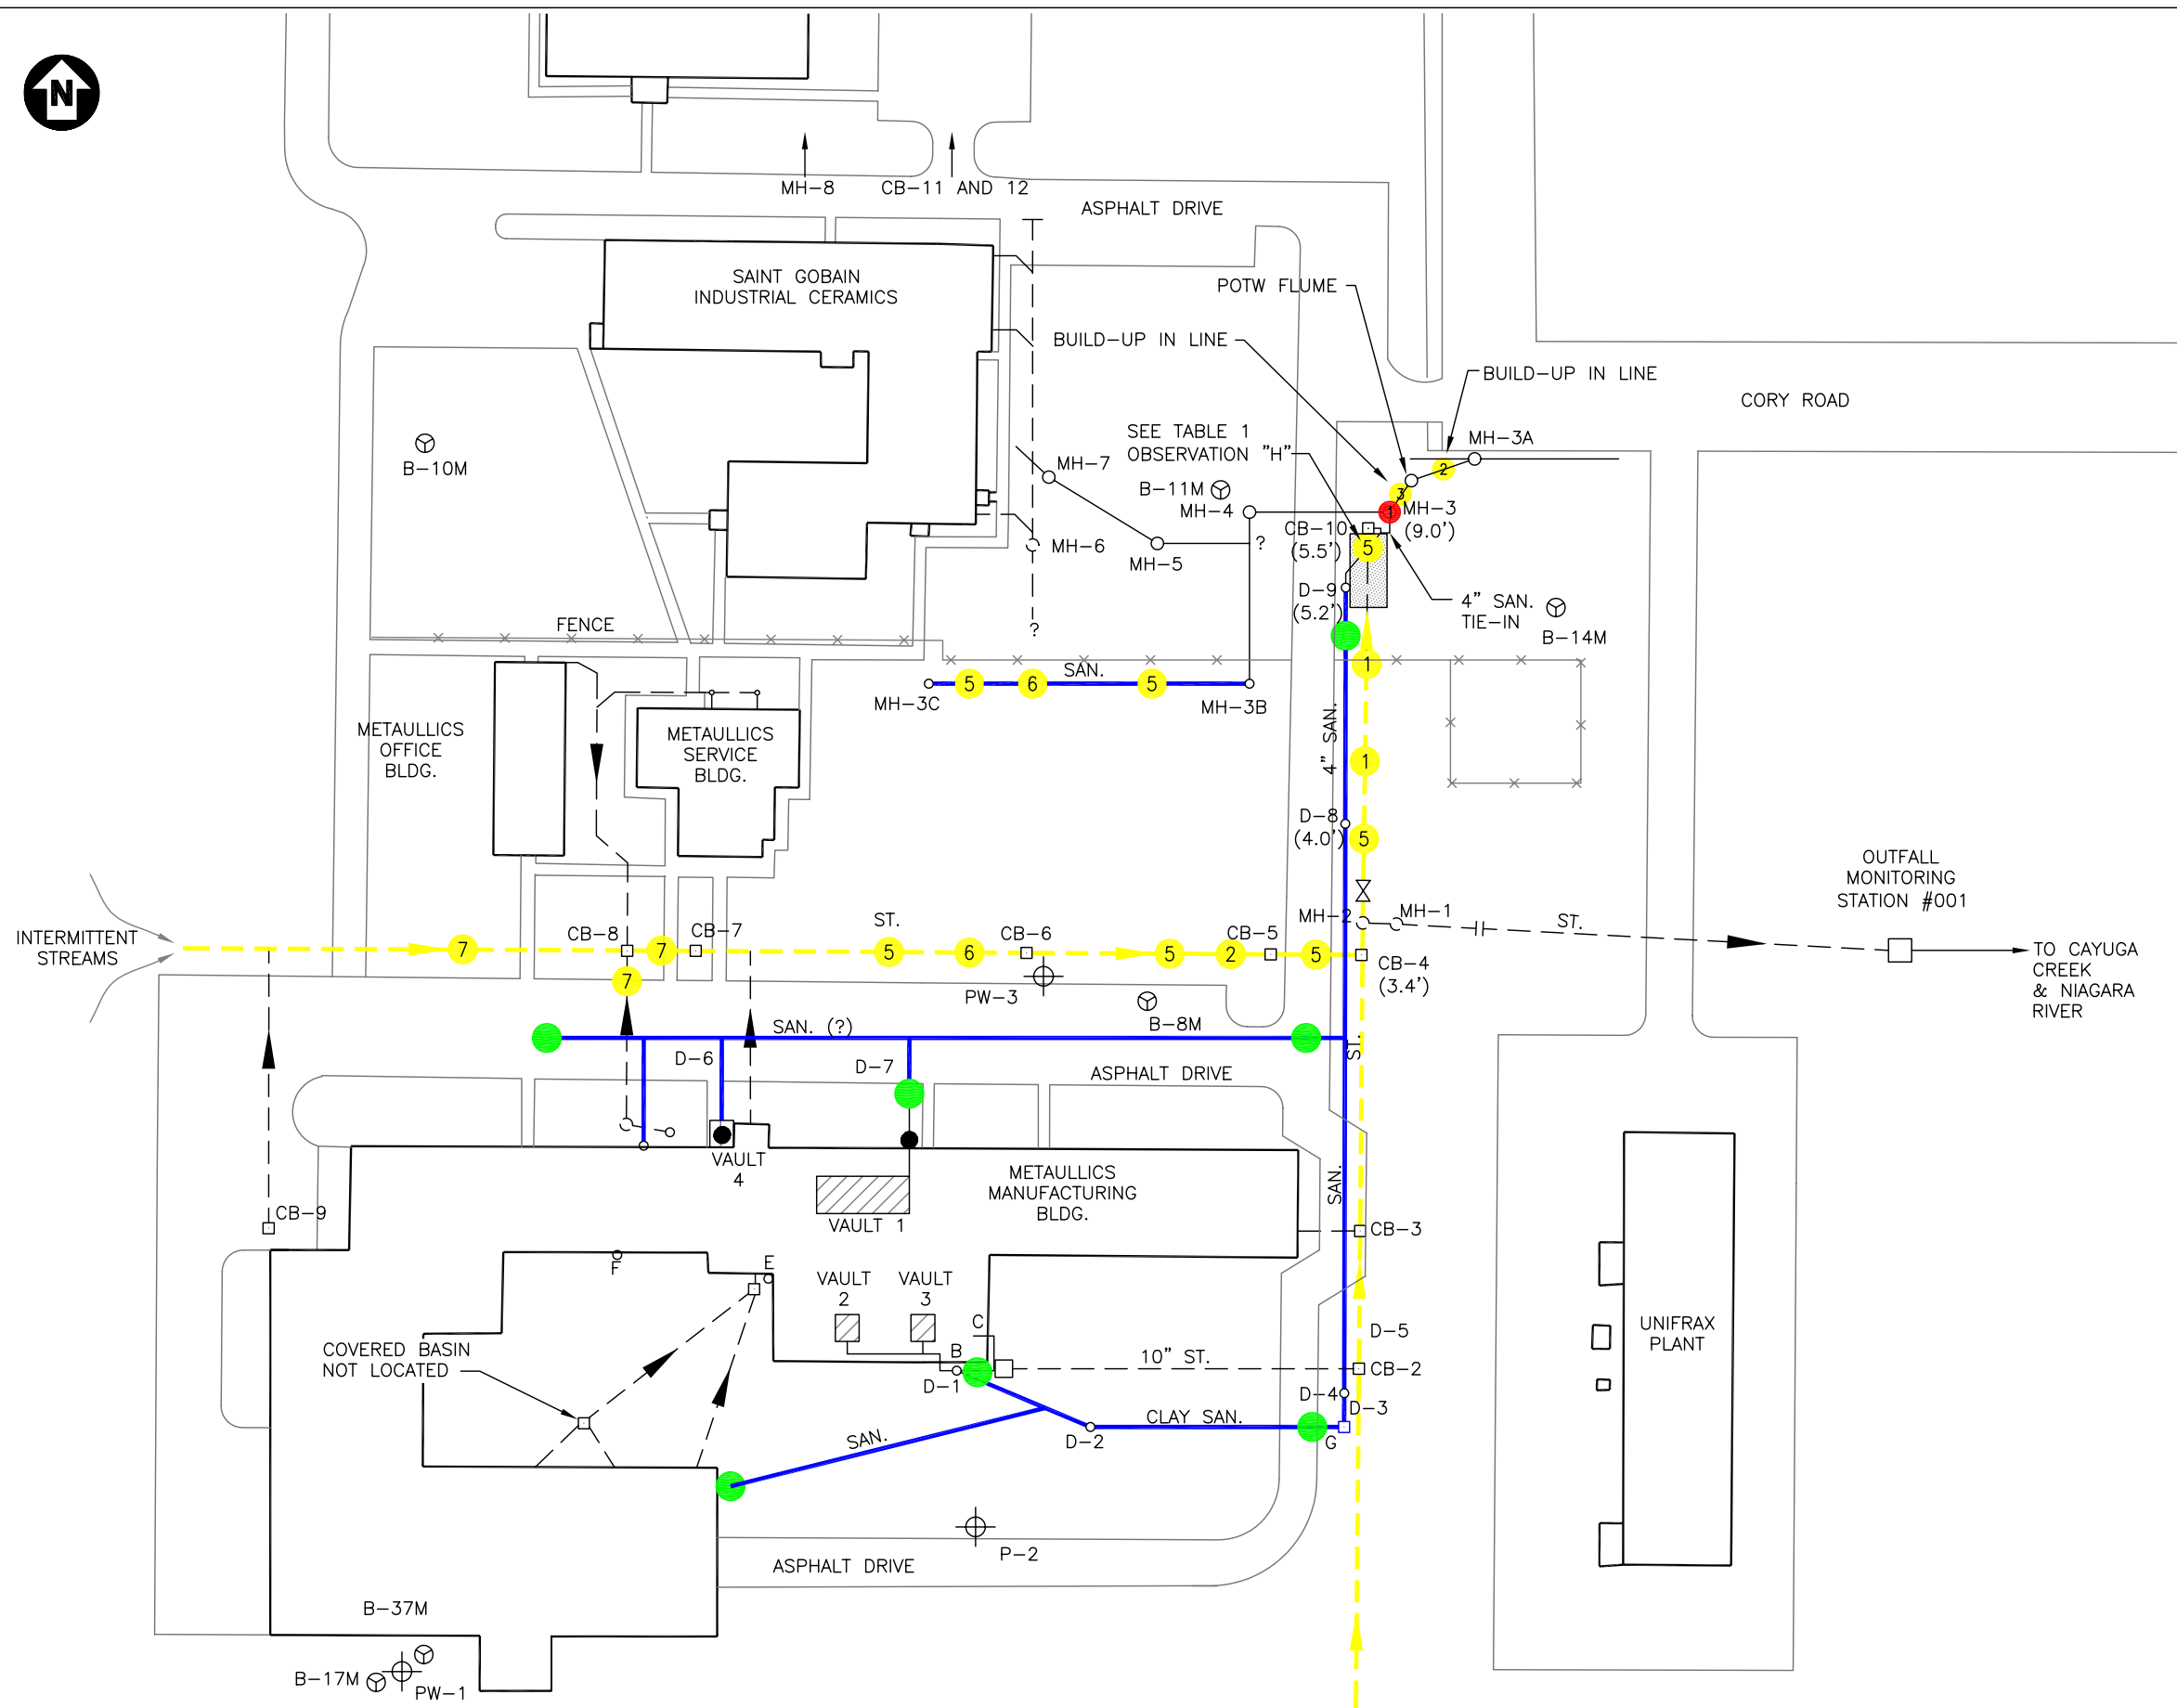
FIGURE 1

Based on the CCTV information, the only significant inflow of water into the sewer system was in the vicinity of Manhole 3A (MH-3A on Figure 1). This manhole and two nearby catch basins can be lined to reduce the inflow of water into the storm sewer system. The lining material would be comprised of a hydraulic epoxy cement.

- Starting in sanitary manhole 3A (MH-3A) video taping upstream west to POTW Flume (Meter). Severe ground water infiltration coming into MH-3A around the upstream pipe, and at 12.3 feet blockage in pipe, video camera could not pass, end of inspection.

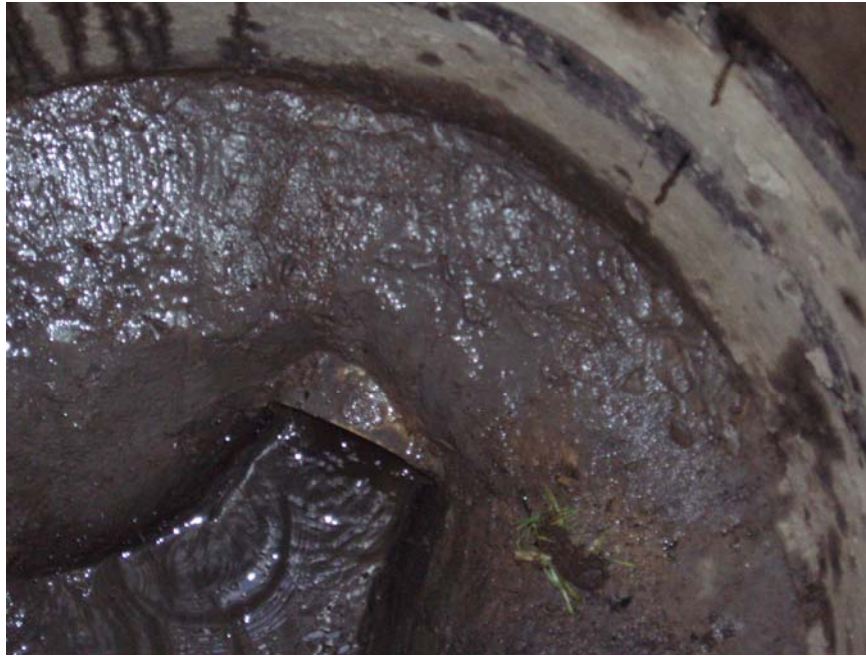
Photograph Number: 1

The CCTV inspection results indicated that infiltration was largely absent in the sewer pipes that were inspected. However, infiltration was observed from the walls of two catch basins and the bottom of MH-3 (see Photographs 1 and 2 in Attachment 1). Detailed written descriptions of the CCTV inspection are also provided in Attachment 1.

Description: Infiltration at the bottom of Manhole # 3.

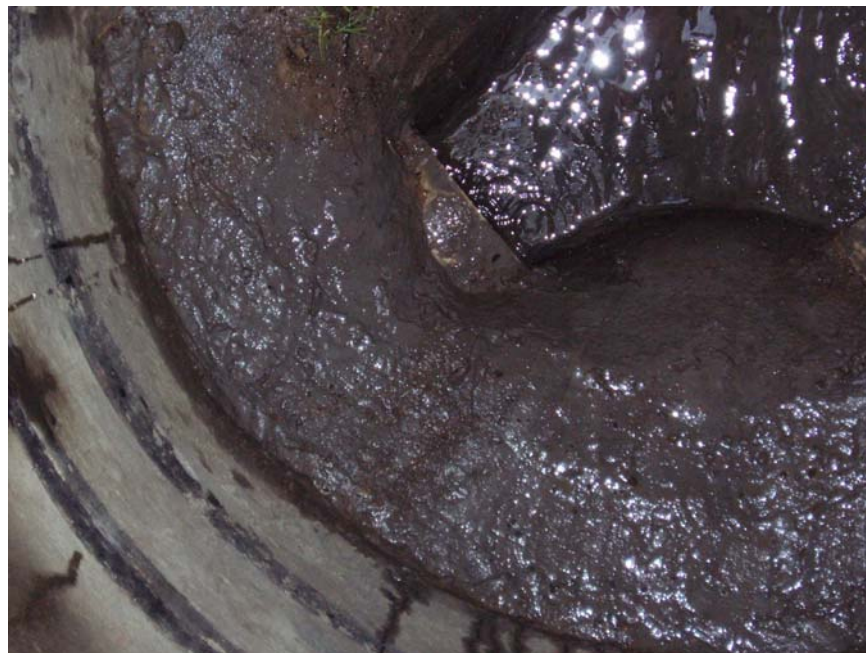
Photograph Number: 2

Description: Infiltration at the bottom of Manhole # 3

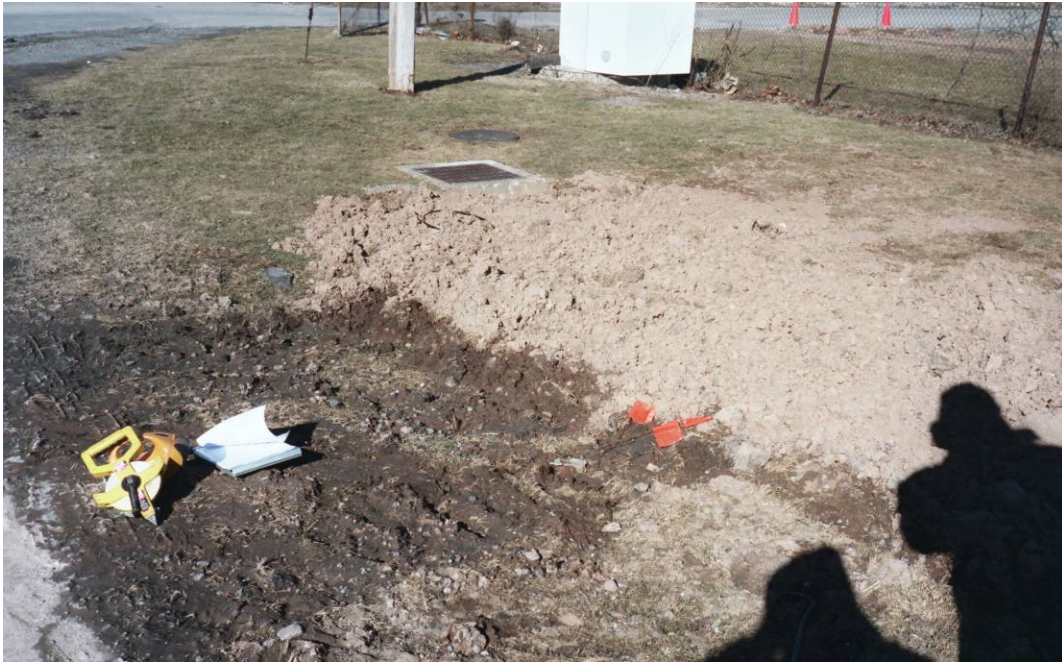
Photograph 1: Area south of CB-10 and MH-3, showing excavated soils from the storm-sewer line replacement by Metaullics in February 2006. Broken sanitary clean-out visible near orange flags. POTW shed in background.

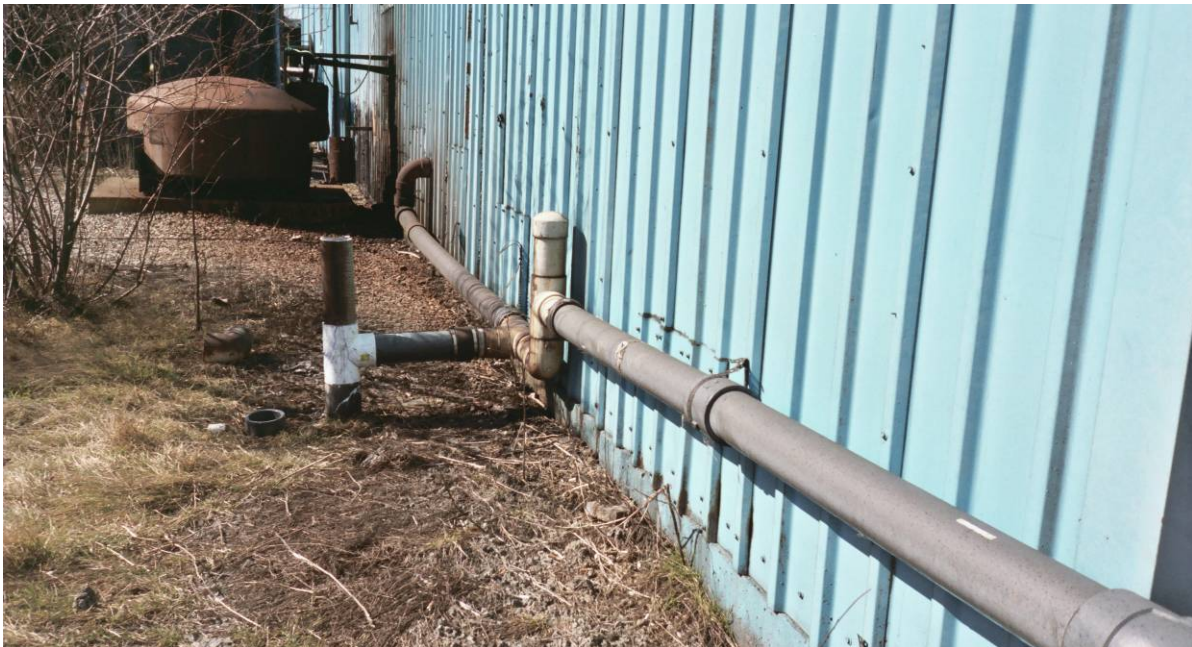
Photograph 2: Pipe D-1 connects to the sanitary sewer. Water from process cooling, Sump 2, and Sump 3 is pumped into D-1.

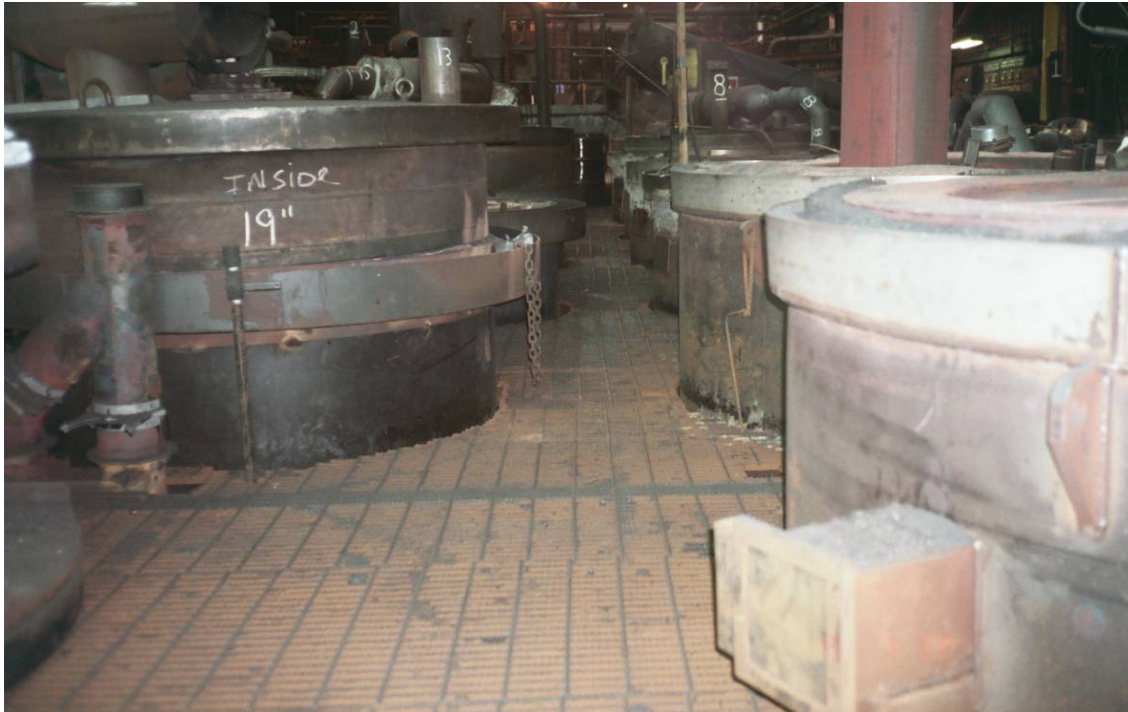
Photograph 3: Vault 1 (bake pit). The grated floor covers the vault. The large cylinders are furnaces that stand vertically in the vault.

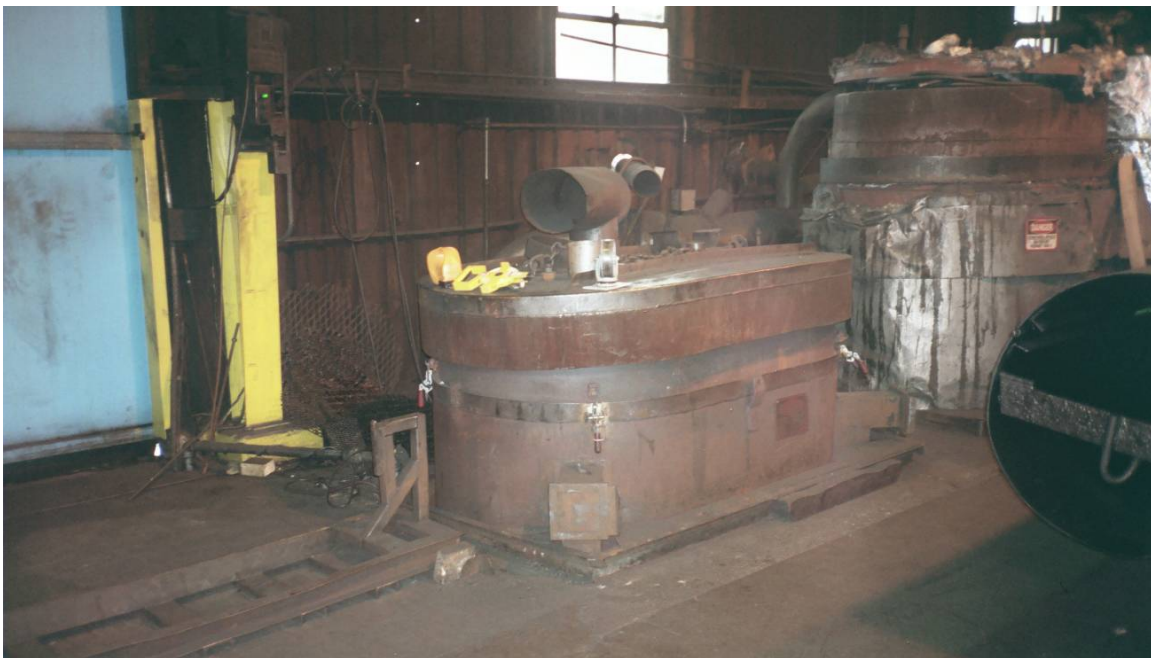
Photograph 4: Vault 2 (preheater vault). The preheater fills most of the vault volume. The steel rim of the vault is visible adjacent to the floor.

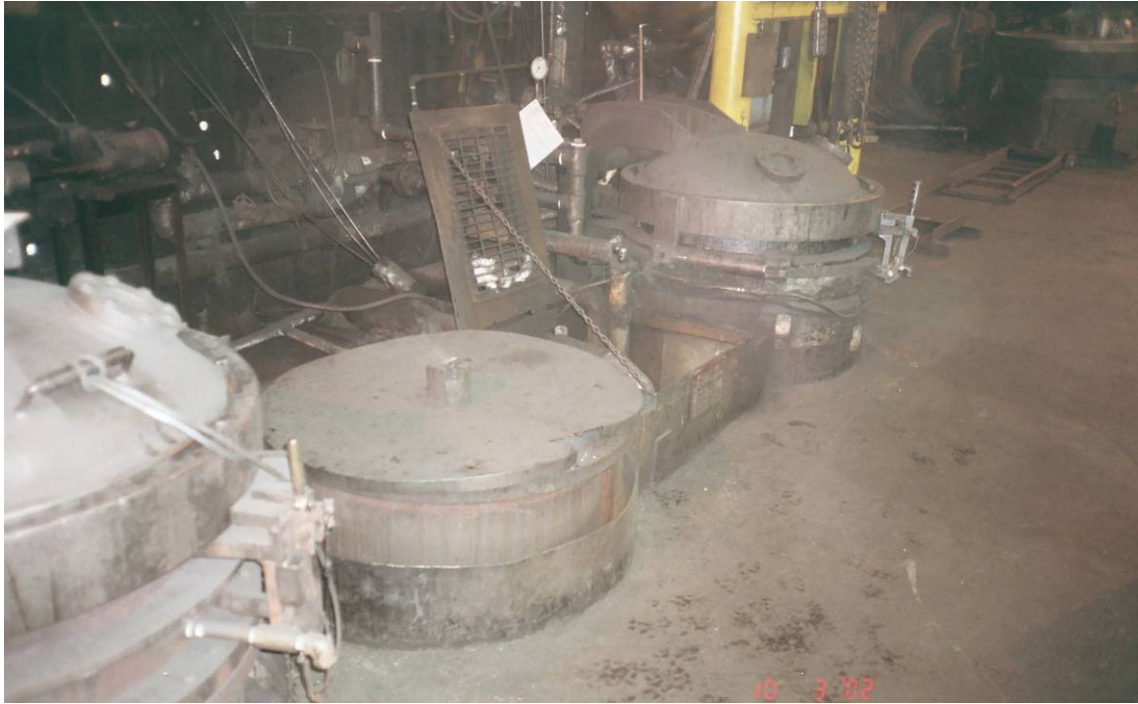
Photograph 5: Vault 3 (Autoclave vault). The vault houses two pieces of equipment, one on each side of the vault. The open grate is over the middle of the vault.

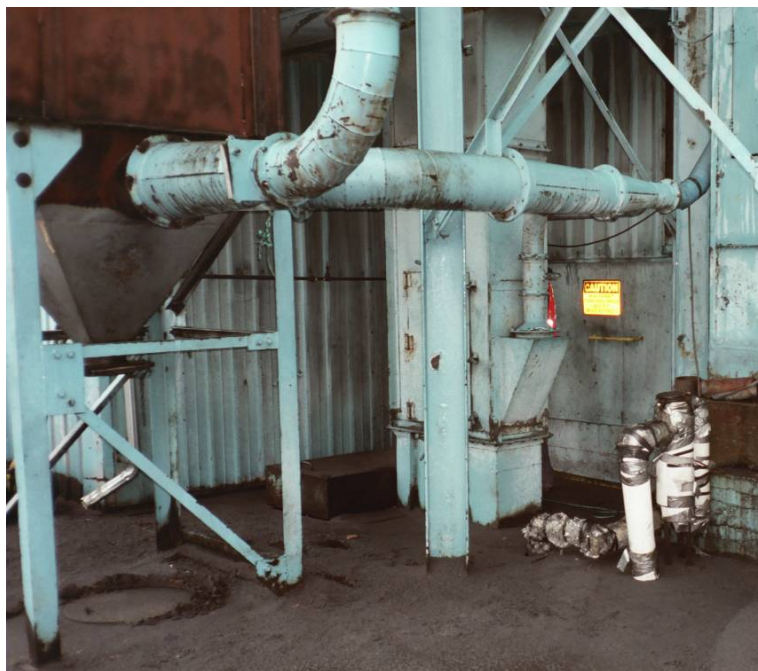
Photograph 6: Vault 4 (sand elevator). The top of the vault is flush with ground level. The vault surrounds the vertical elevator shaft. The PVC sump piping (wrapped in silver tape) is shown on the right.
