# Remedial Investigation Report

## **Eighteenmile Creek Corridor, Lockport, Niagara County, New York Site Number 932121**

September 2006

New York State Department of Environmental Conservation  
Region 9  
270 Michigan Avenue  
Buffalo, New York 14203-2999

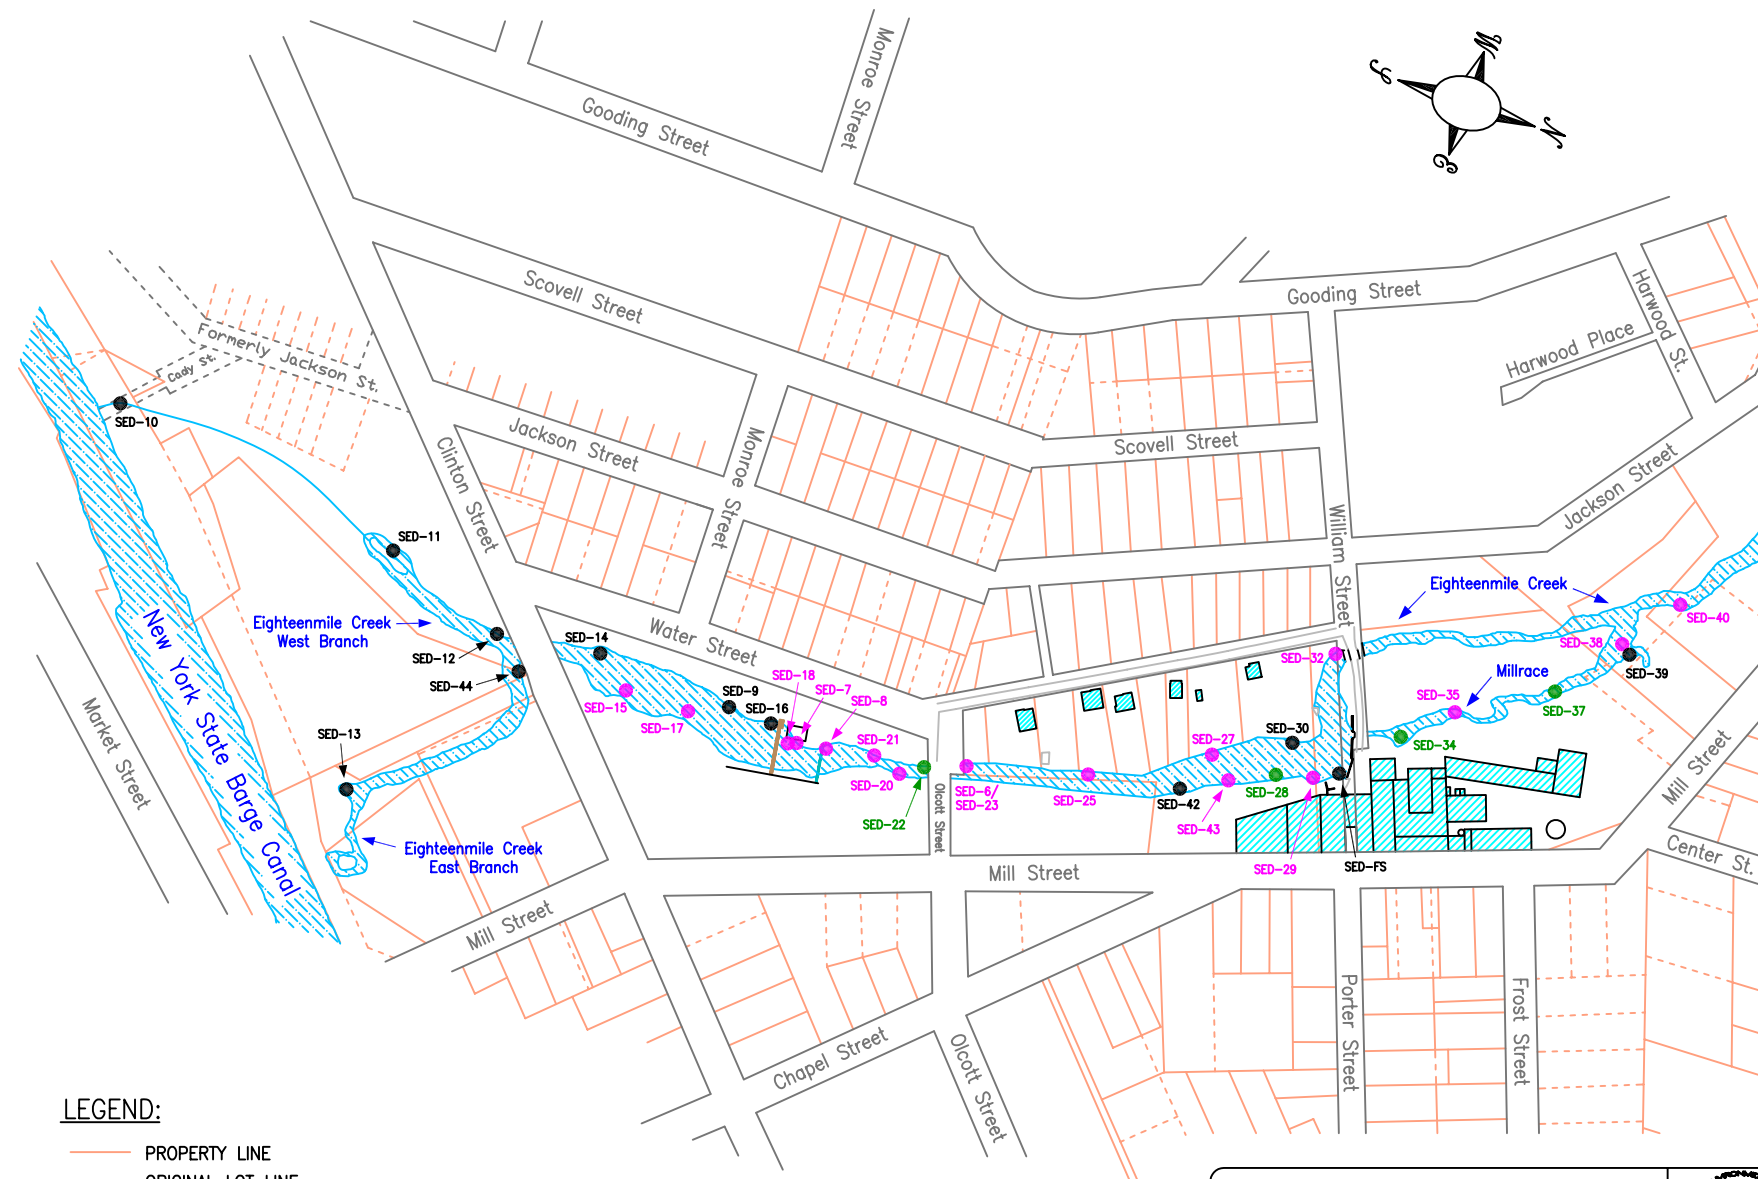
**FIGURE 5-9**

PCB concentrations increase downstream of the Clinton Street dam and generally remain elevated throughout the remainder of the Eighteenmile Creek Corridor Site. Figure 5-9 shows that sediment in Eighteenmile Creek between the Clinton Street dam and Olcott Street contained PCBs at concentrations that exceeded the NYSDEC sediment criteria. The PCB concentrations in sample SED-22 (201,000 and 1,400,000 µg/kg; Table 5-1) also exceeded the hazardous waste criterion. The PCB concentrations of the remaining samples ranged from 840 to 12,300 µg/kg (Table 5-1).

Figure 5-9 also shows that sediment in Eighteenmile Creek between Olcott and William Streets, with the exception of samples SED-30, SED-42 and SED-FS, contained PCBs at concentrations that exceeded the NYSDEC sediment criteria. The PCB concentrations of these samples ranged from 639J to 16,800 µg/kg, while the PCB concentrations of the samples that did not exceed the NYSDEC sediment criteria ranged from ND to 420J µg/kg (Table 5-1). The PCB concentration in the deep sample collected from the SED-28 location (150,000J µg/kg; Table 5-1) also exceeded the hazardous waste criterion.

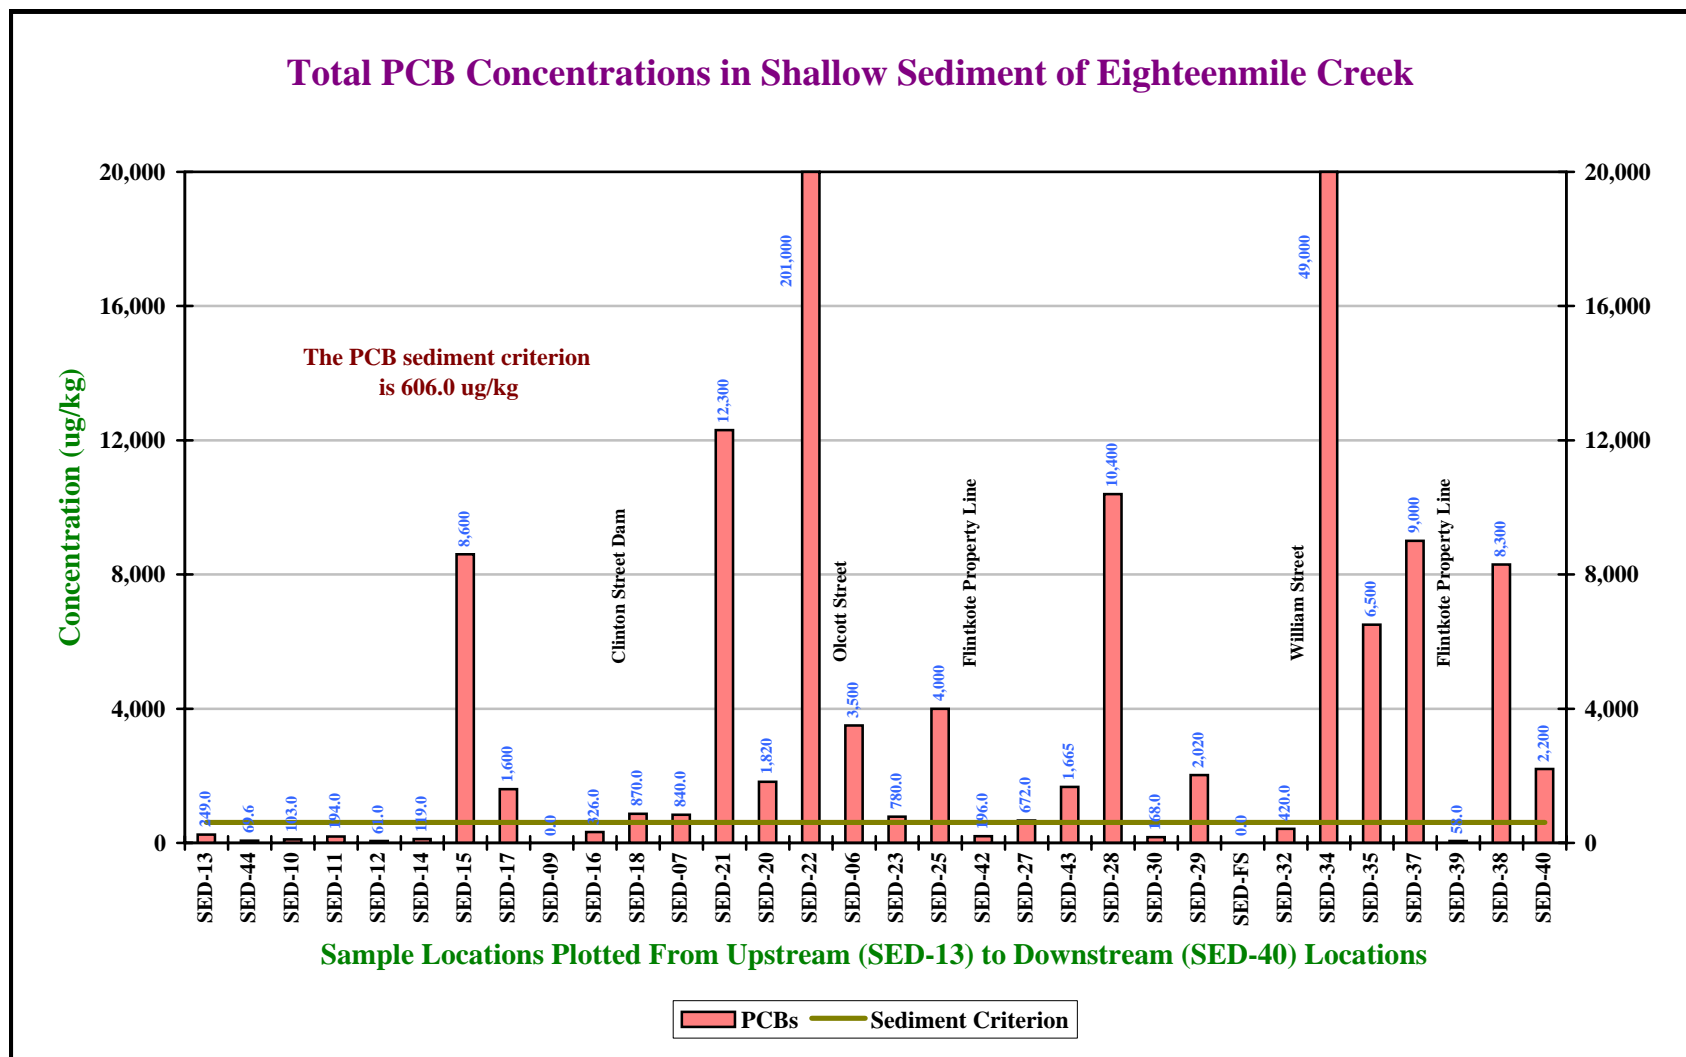
Figure 6-1. PCB concentrations in shallow sediment of Eighteenmile Creek from the New York State Barge Canal (SED-13) to Harwood Street (SED-40). A scale was selected that best presents the data at lower concentrations.

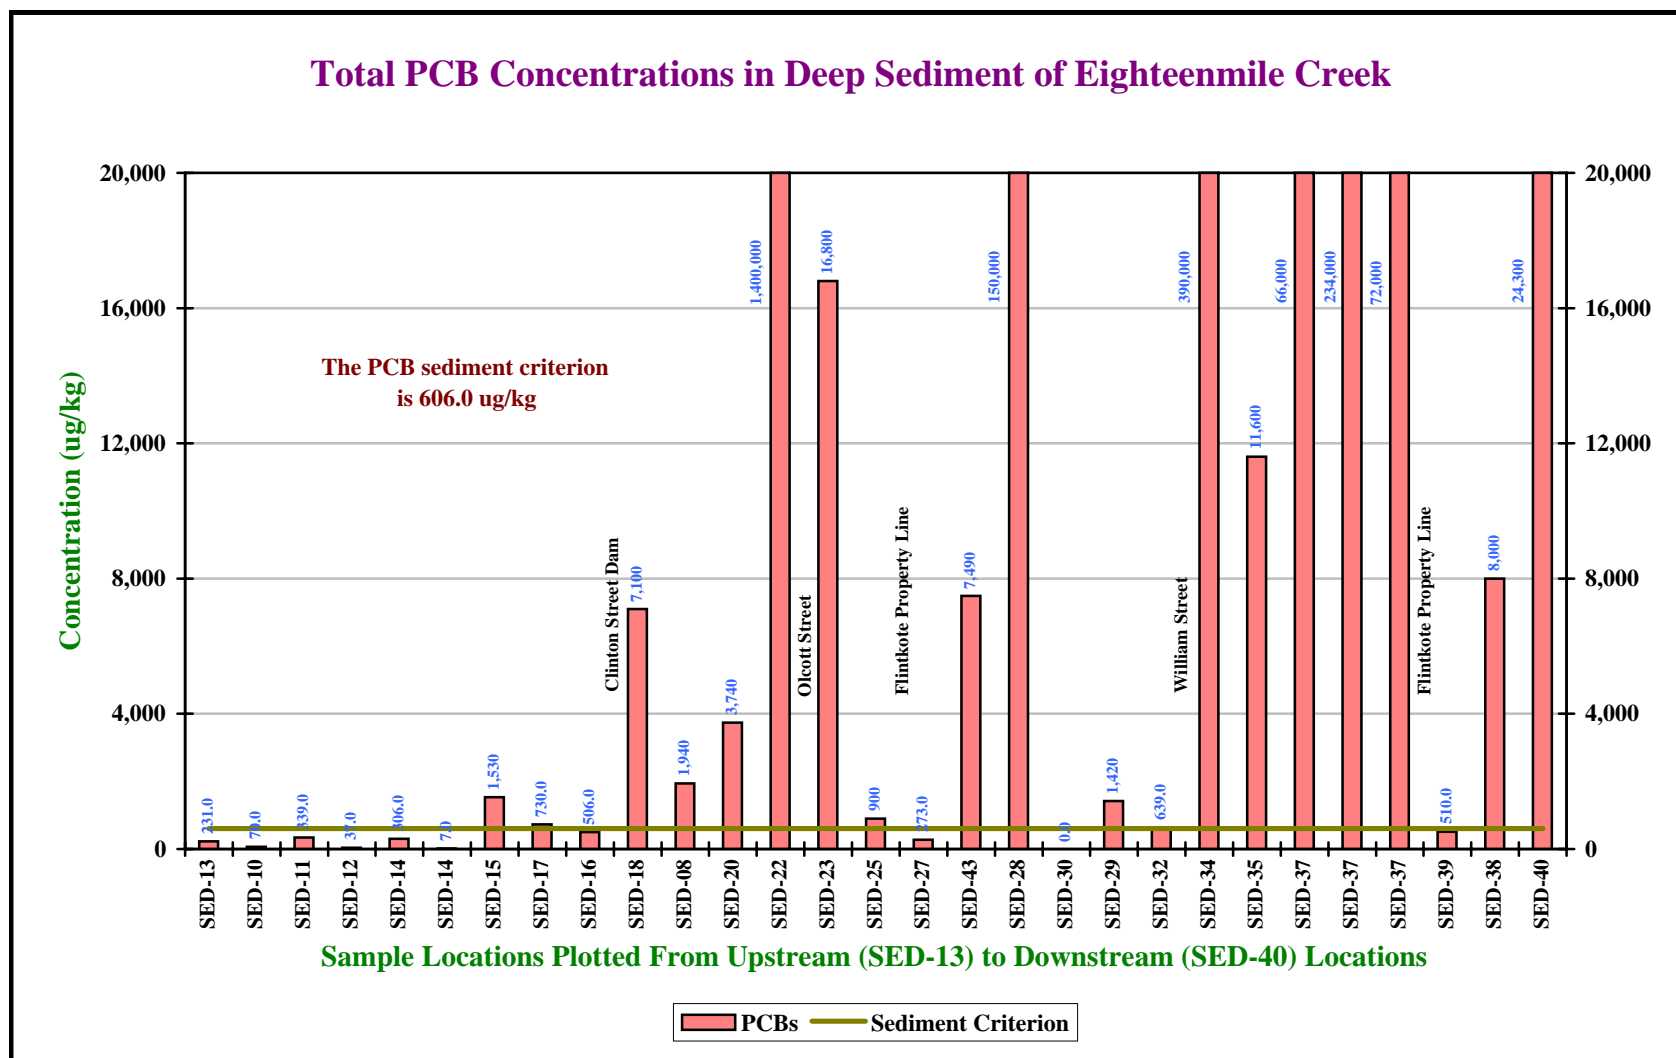
Figure 6-2. PCB concentrations in deep sediment of Eighteenmile Creek from the New York State Barge Canal (SED-13) to Harwood Street (SED-40). A scale was selected that best presents the data at lower concentrations.

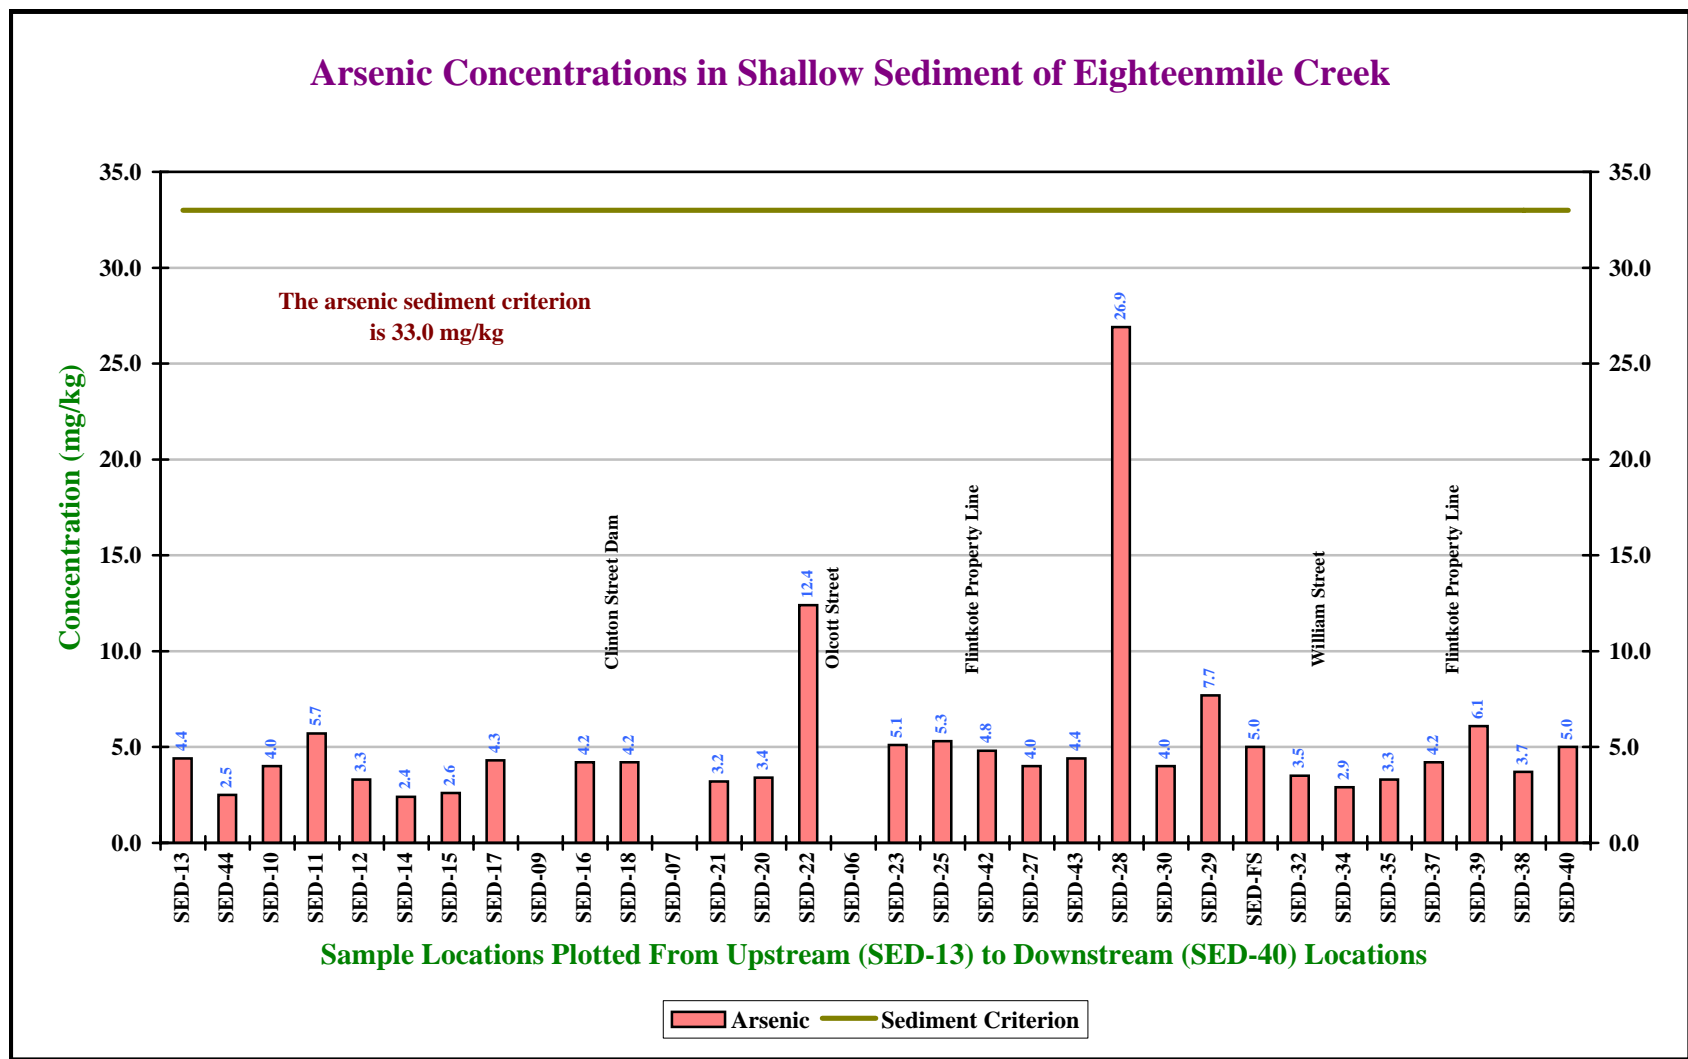
Figure 6-3. Arsenic concentrations in shallow sediment of Eighteenmile Creek from the New York State Barge Canal (SED-13) to Harwood Street (SED-40). The blanks indicate that the sample was not analyzed for arsenic.

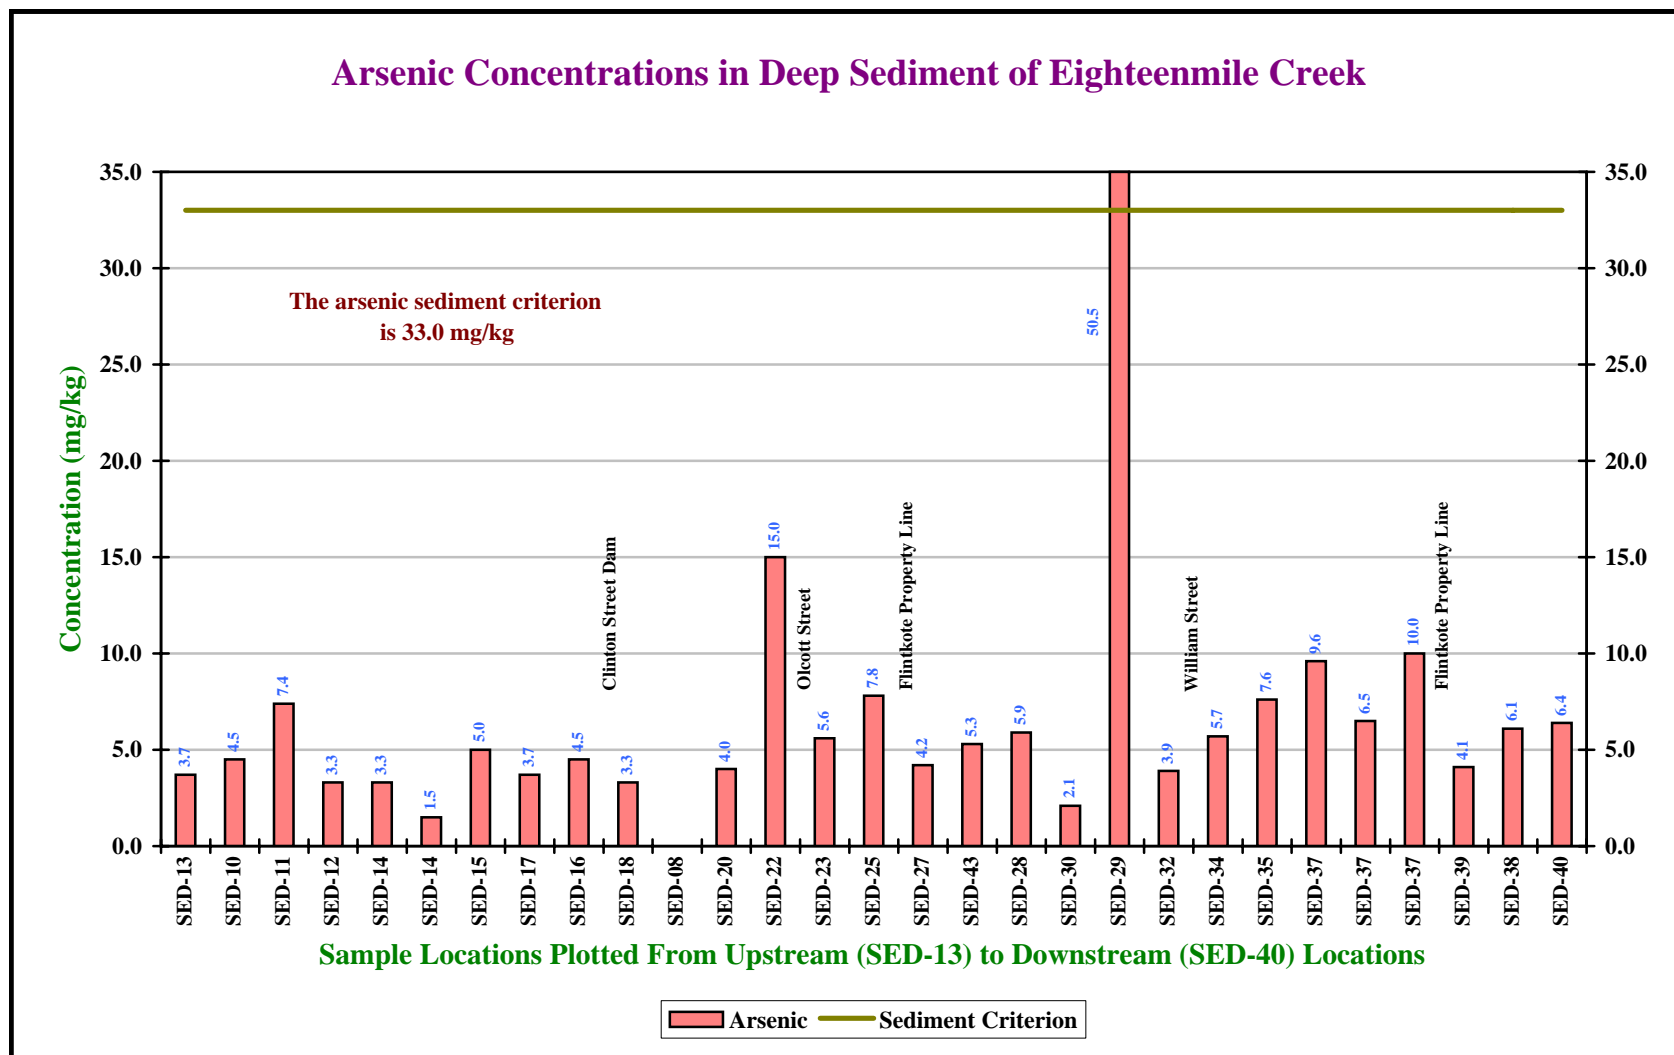
Figure 6-4. Arsenic concentrations in deep sediment of Eighteenmile Creek from the New York State Barge Canal (SED-13) to Harwood Street (SED-40). A scale was selected that best presents the data at lower concentrations.

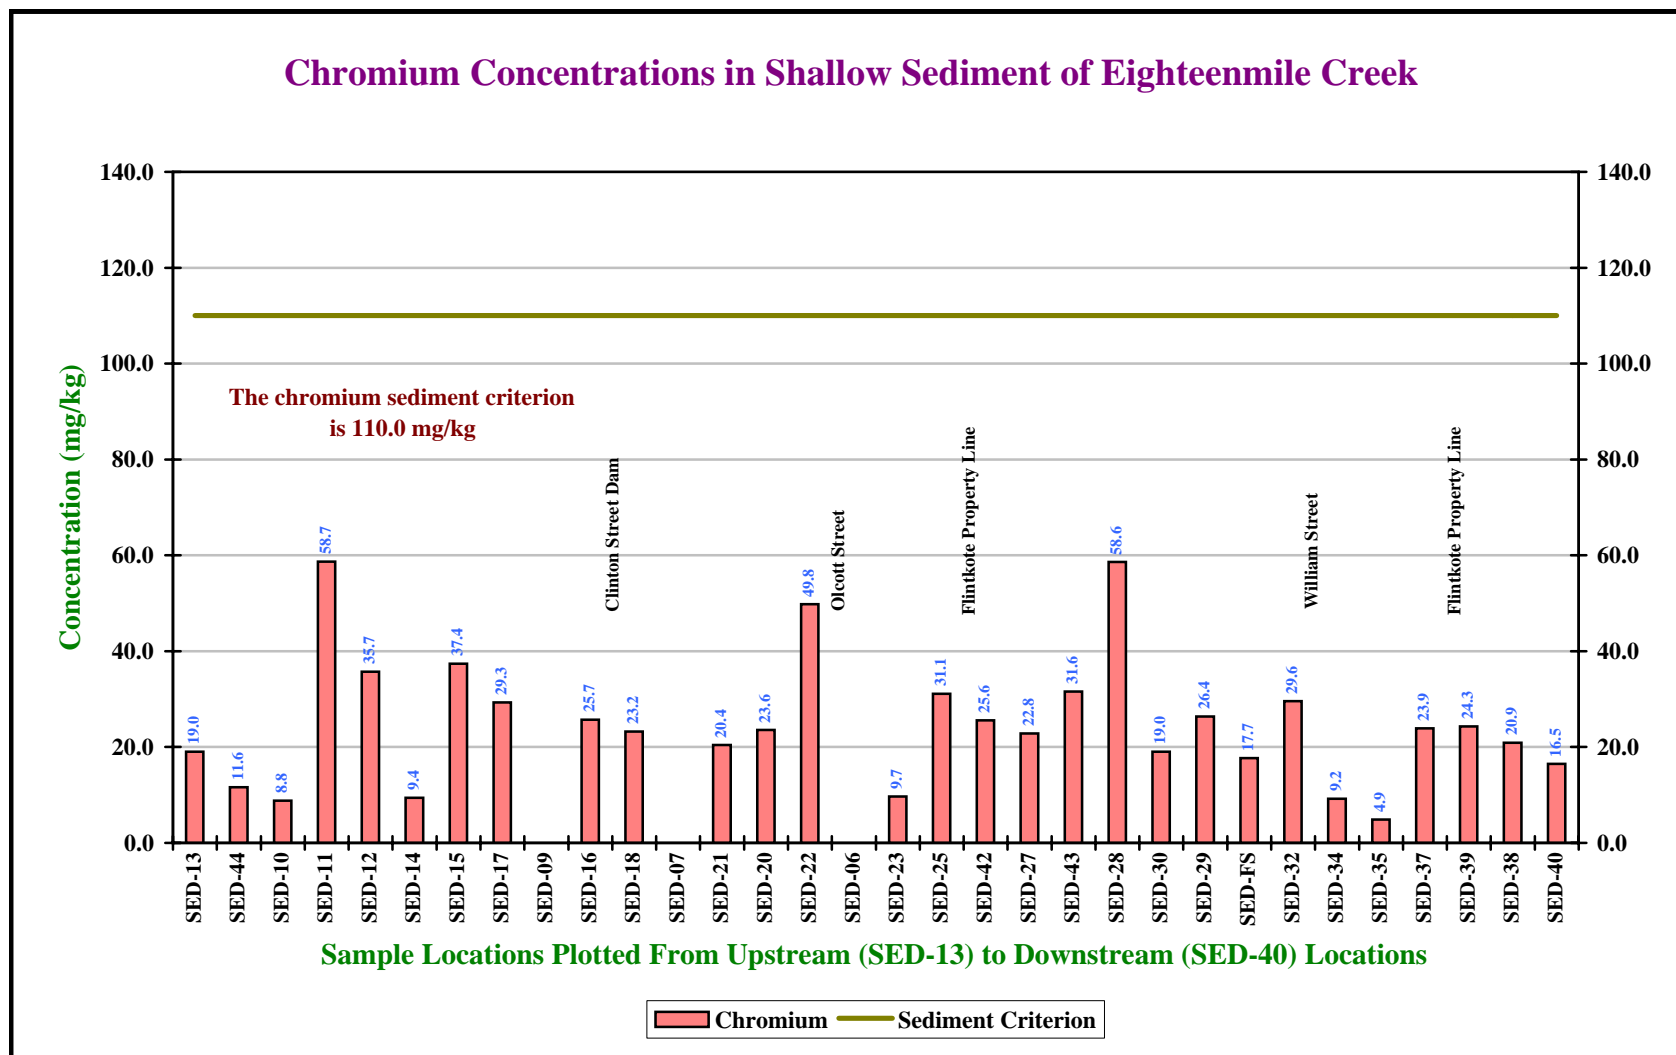
Figure 6-5. Chromium concentrations in shallow sediment of Eighteenmile Creek from the New York State Barge Canal (SED-13) to Harwood Street (SED-40). The blanks indicate that the sample was not analyzed for chromium.

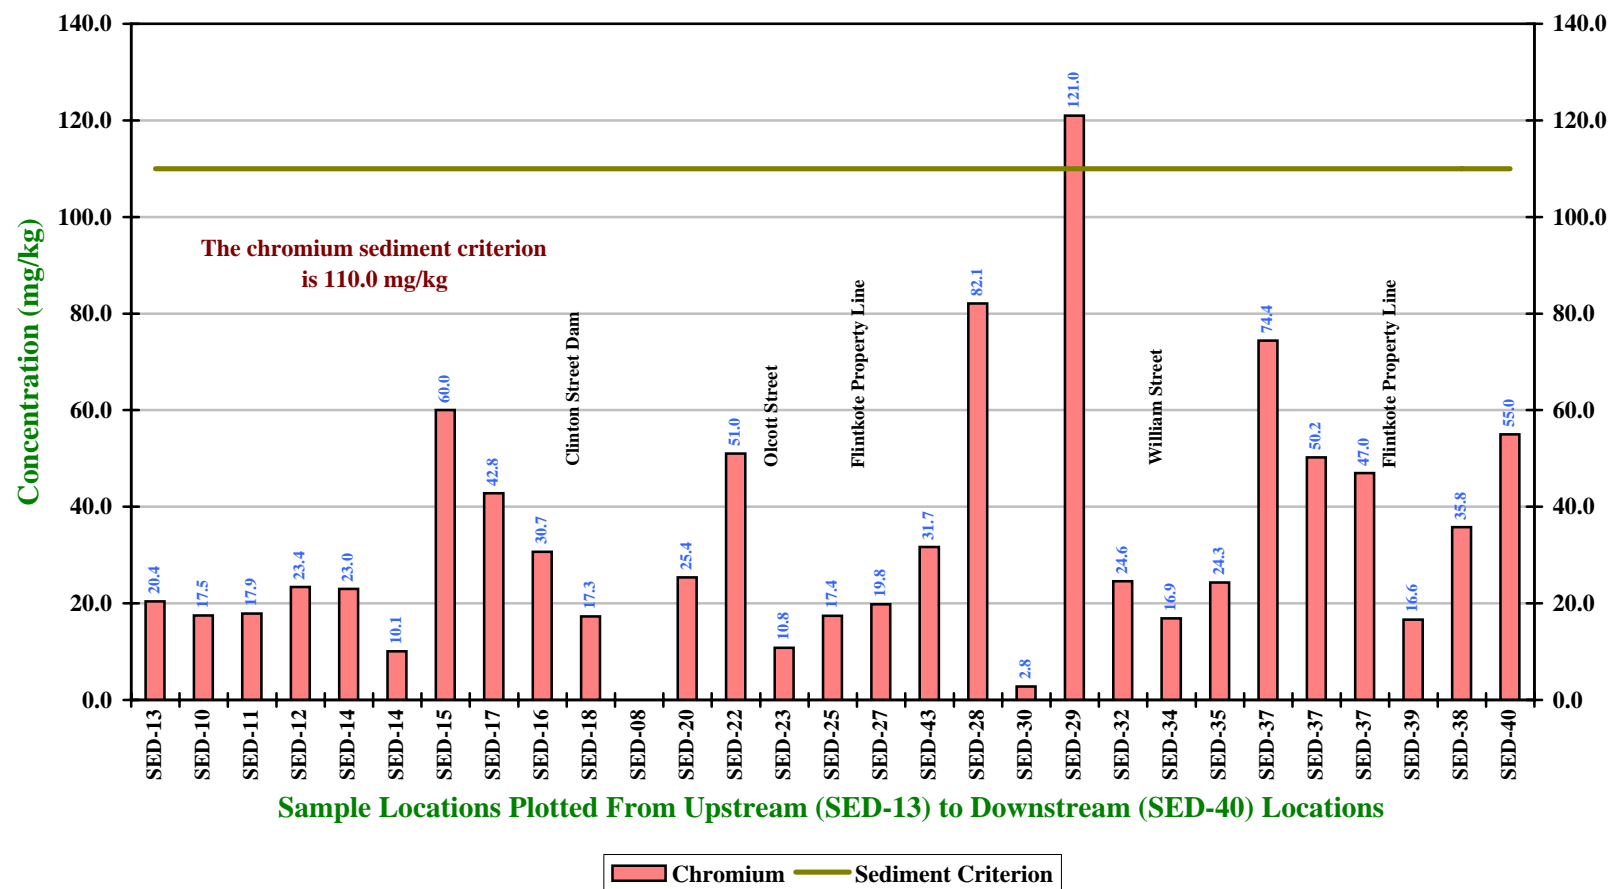
Figure 6-6. Chromium concentrations in deep sediment of Eighteenmile Creek from the New York State Barge Canal (SED-13) to Harwood Street (SED-40). The blanks indicate that the sample was not analyzed for chromium.

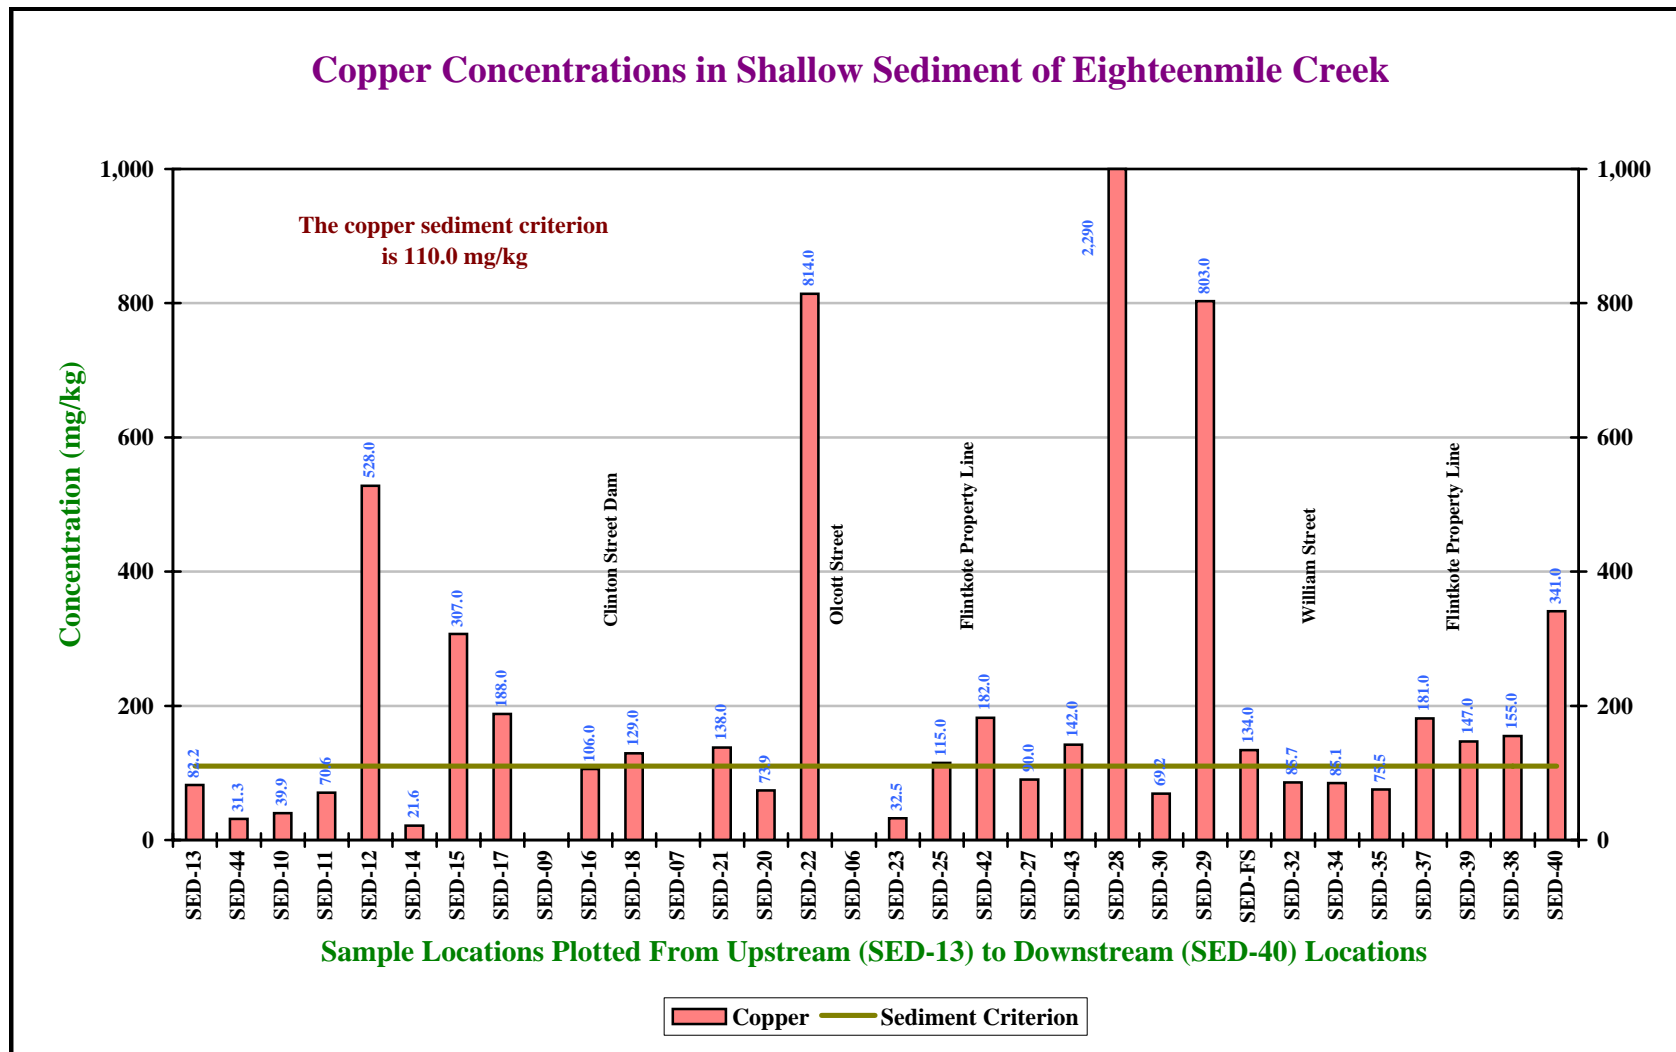
Figure 6-7. Copper concentrations in shallow sediment of Eighteenmile Creek from the New York State Barge Canal (SED-13) to Harwood Street (SED-40). A scale was selected that best presents the data at lower concentrations. The blanks indicate that the sample was not analyzed for copper.

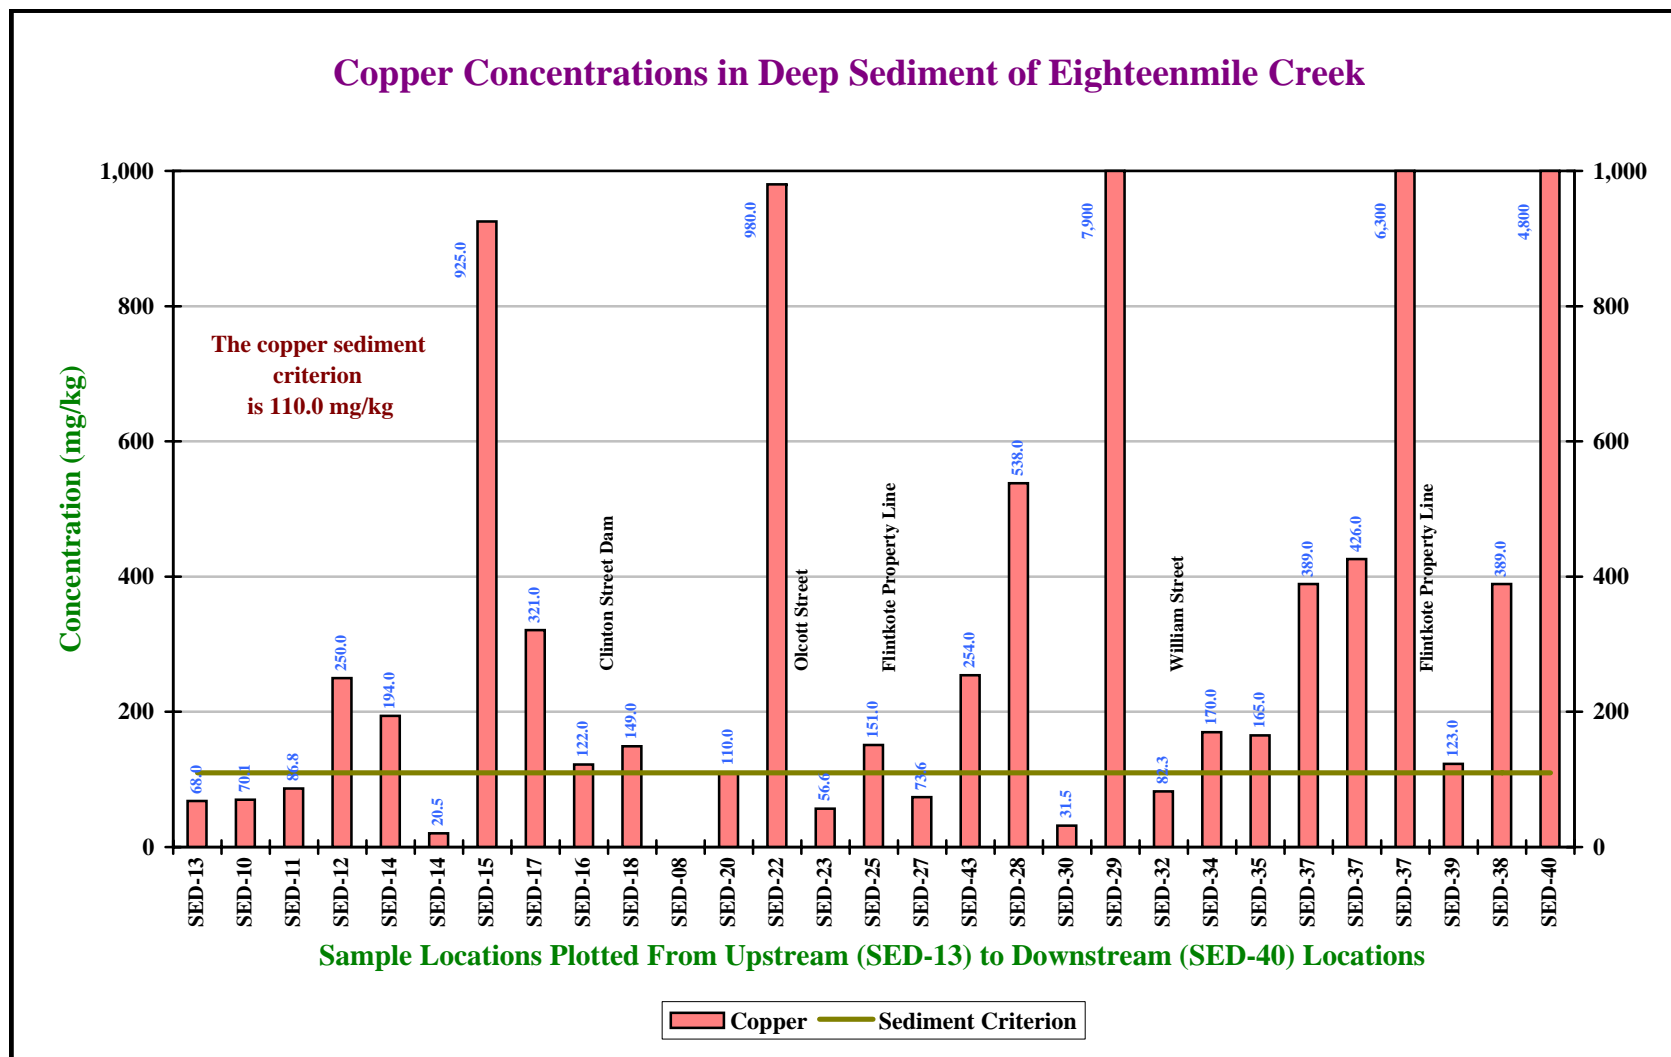
Figure 6-8. Copper concentrations in deep sediment of Eighteenmile Creek from the New York State Barge Canal (SED-13) to Harwood Street (SED-40). A scale was selected that best presents the data at lower concentrations. The blanks indicate that the sample was not analyzed for copper.

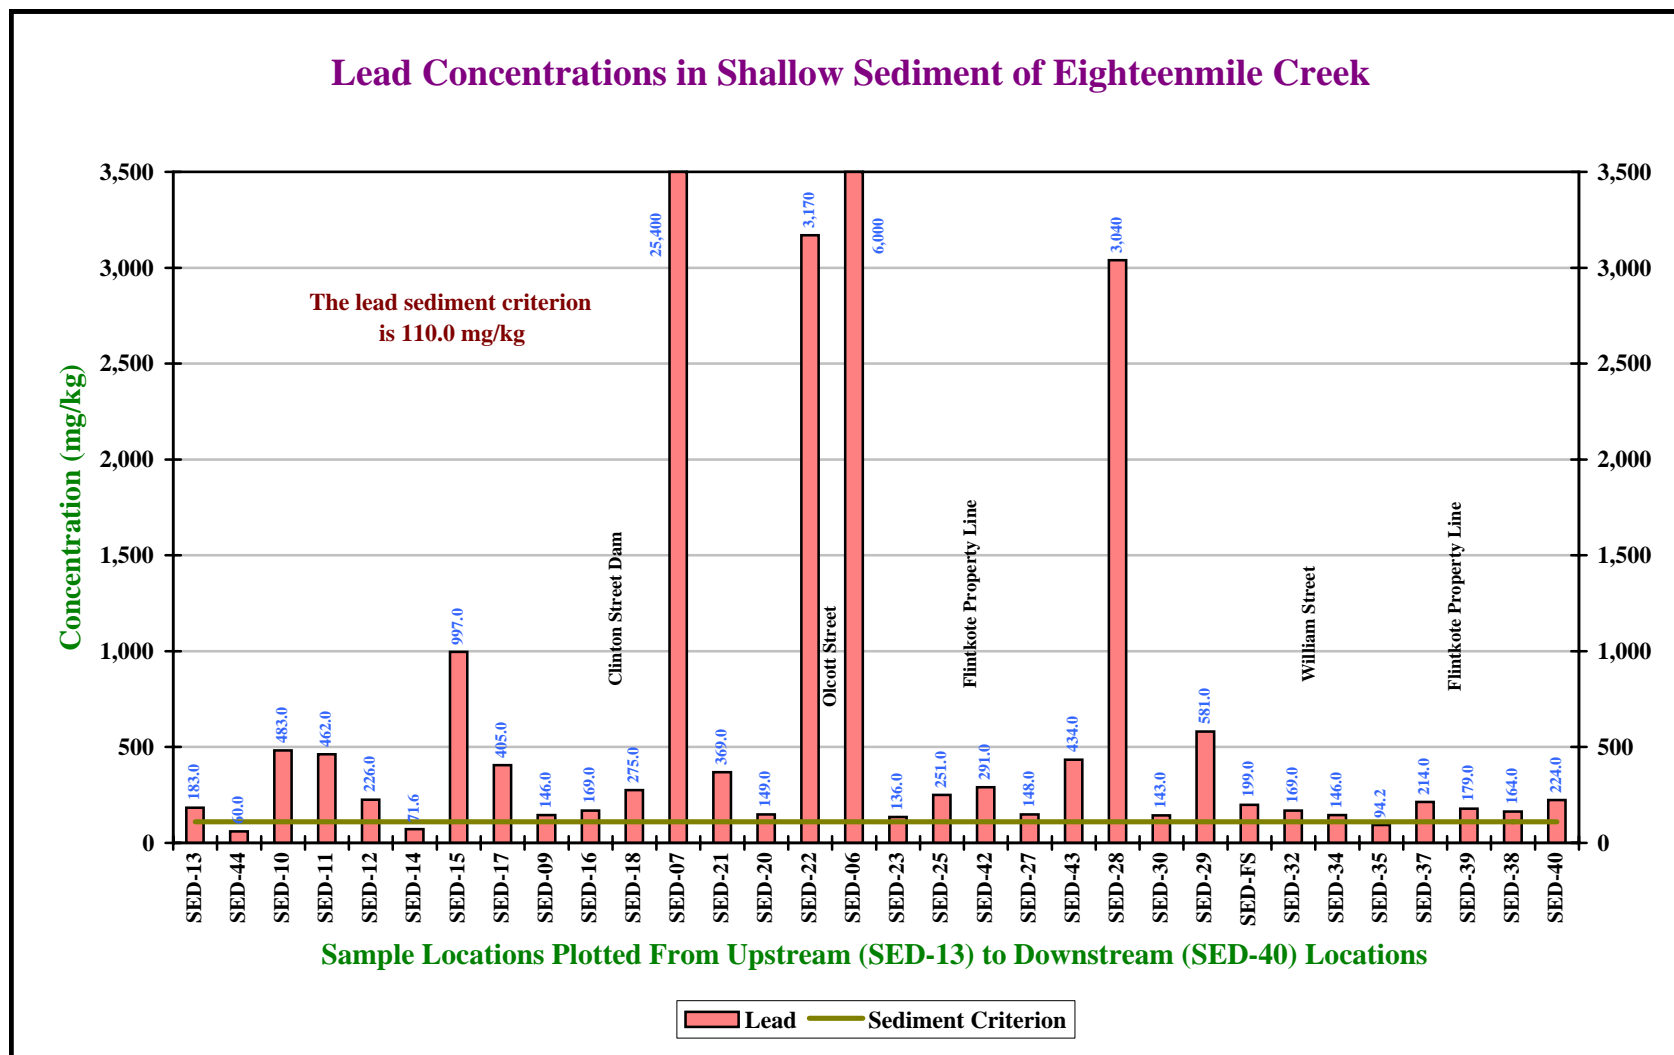
Figure 6-9. Lead concentrations in shallow sediment of Eighteenmile Creek from the New York State Barge Canal (SED-13) to Harwood Street (SED-40). A scale was selected that best presents the data at lower concentrations.

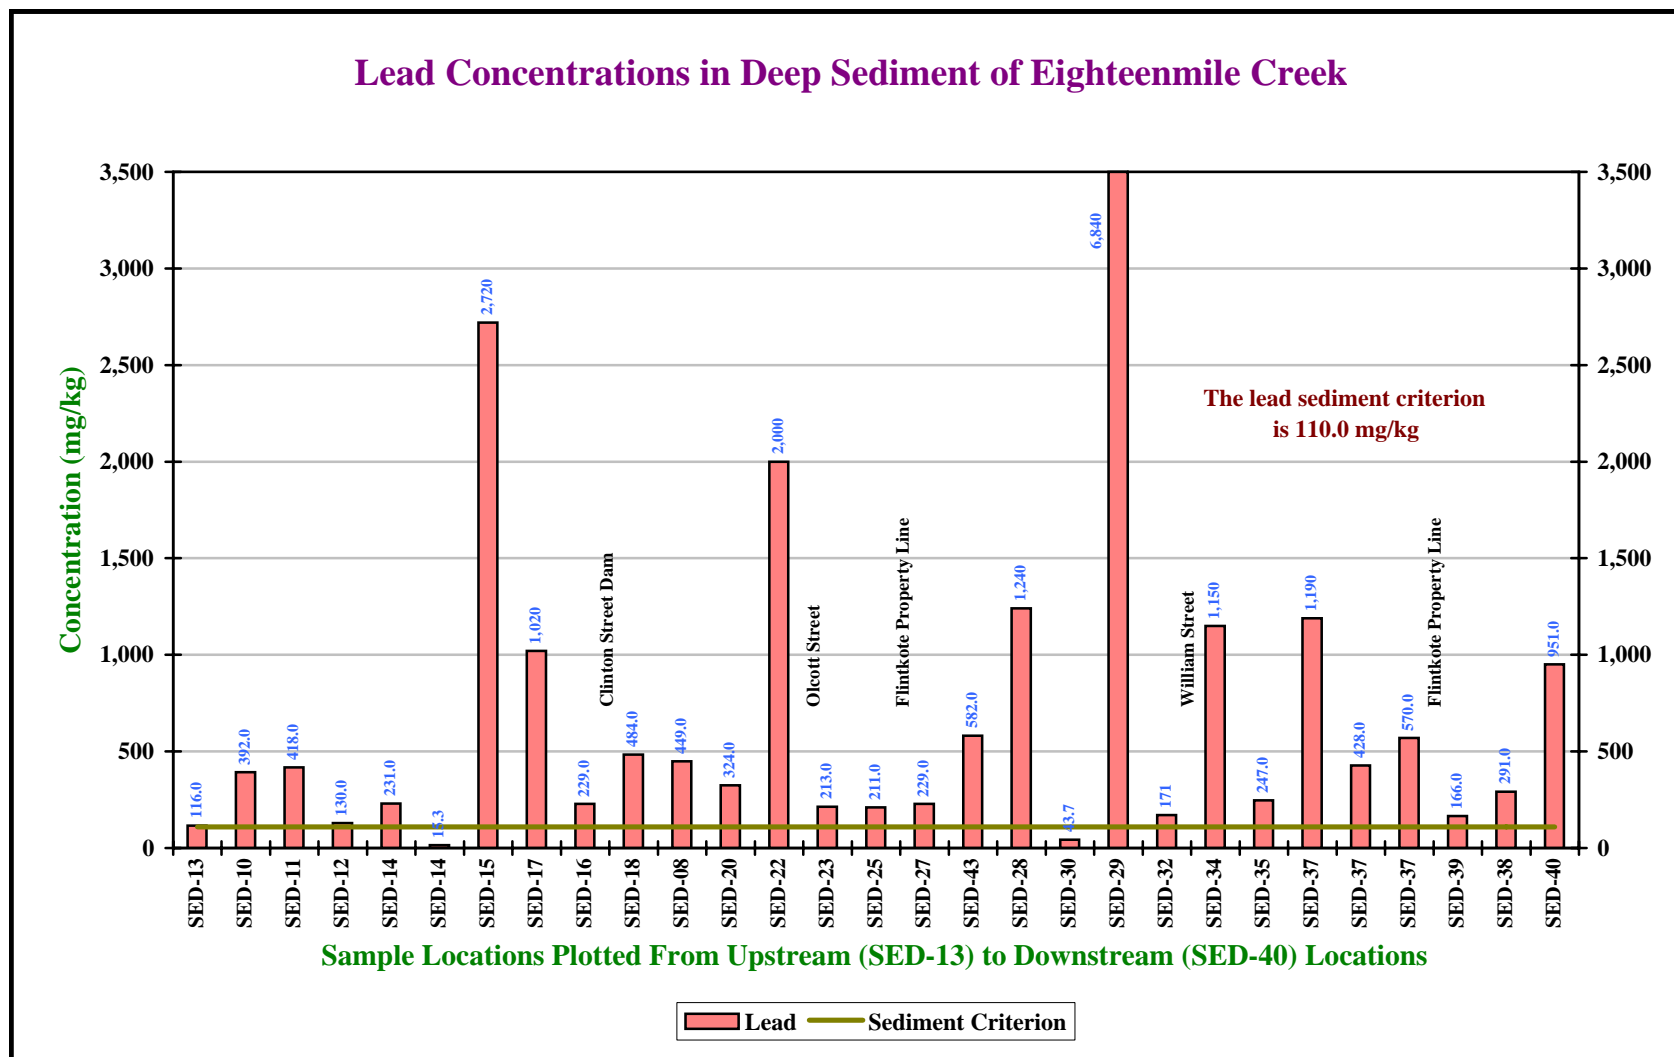
Figure 6-10. Lead concentrations in deep sediment of Eighteenmile Creek from the New York State Barge Canal (SED-13) to Harwood Street (SED-40). A scale was selected that best presents the data at lower concentrations.

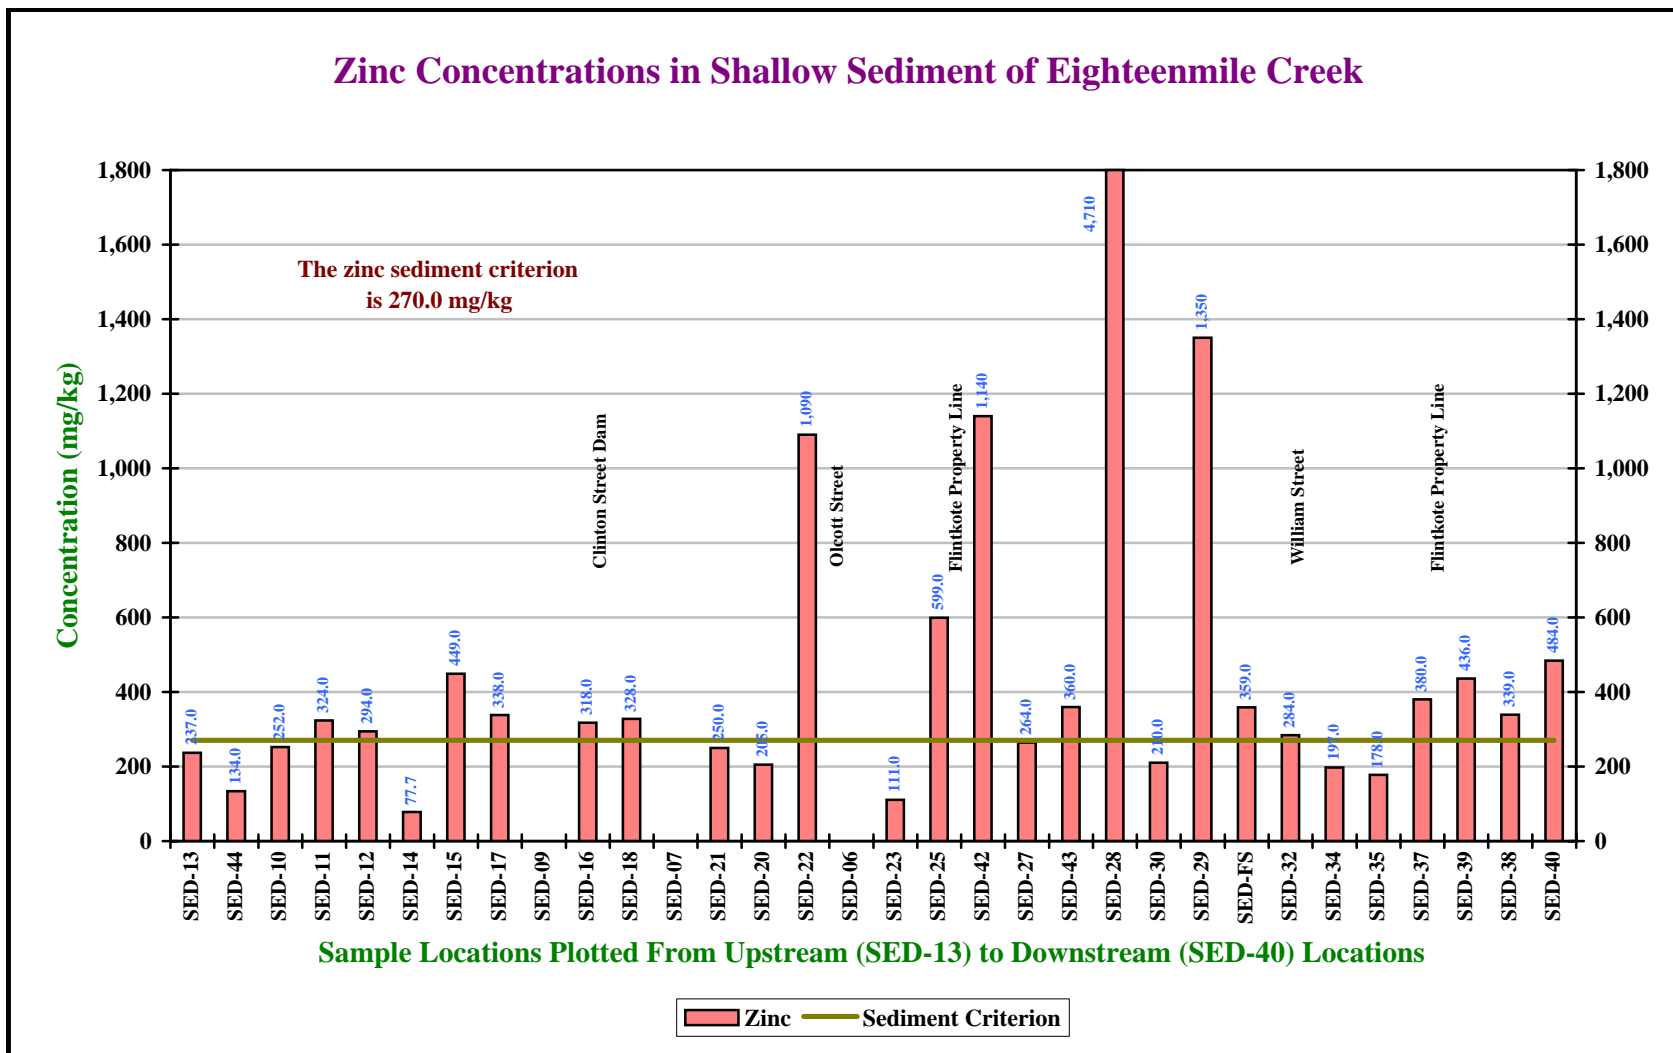
**Figure 6-11. Zinc concentrations in shallow sediment of Eighteenmile Creek from the New York State Barge Canal (SED-13) to Harwood Street (SED-40). A scale was selected that best presents the data at lower concentrations. The blanks indicate that the sample was not analyzed for zinc.**
