# Remedial Investigation Report

## **Eighteenmile Creek Corridor, Lockport, Niagara County, New York Site Number 932121**

September 2006

New York State Department of Environmental Conservation  
Region 9  
270 Michigan Avenue  
Buffalo, New York 14203-2999

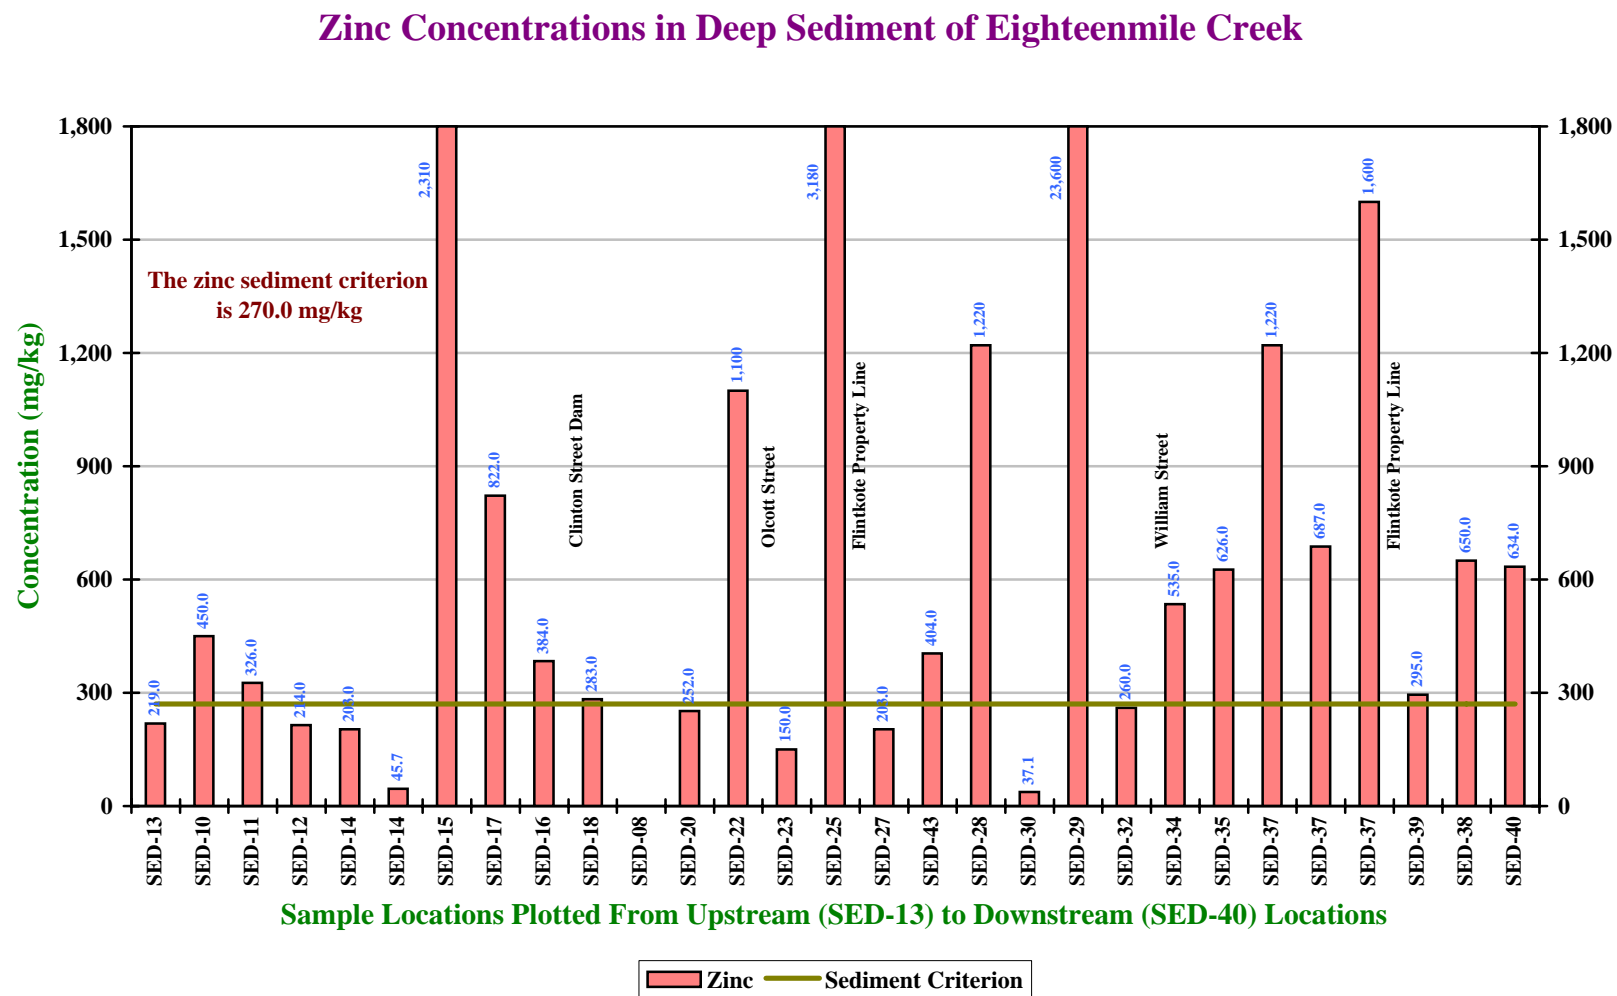
**Figure 6-12.** Zinc concentrations in deep sediment of Eighteenmile Creek from the New York State Barge Canal (SED-13) to Harwood Street (SED-40). A scale was selected that best presents the data at lower concentrations. The blanks indicate that the sample was not analyzed for zinc.
