*Preliminary Site Assessment
Soil/Subsurface Structure
Investigation Report and Interim
Remedial Measures Plan*

Niagara Mohawk Power Corporation
Harper Substation
Niagara Falls, New York

December 2000

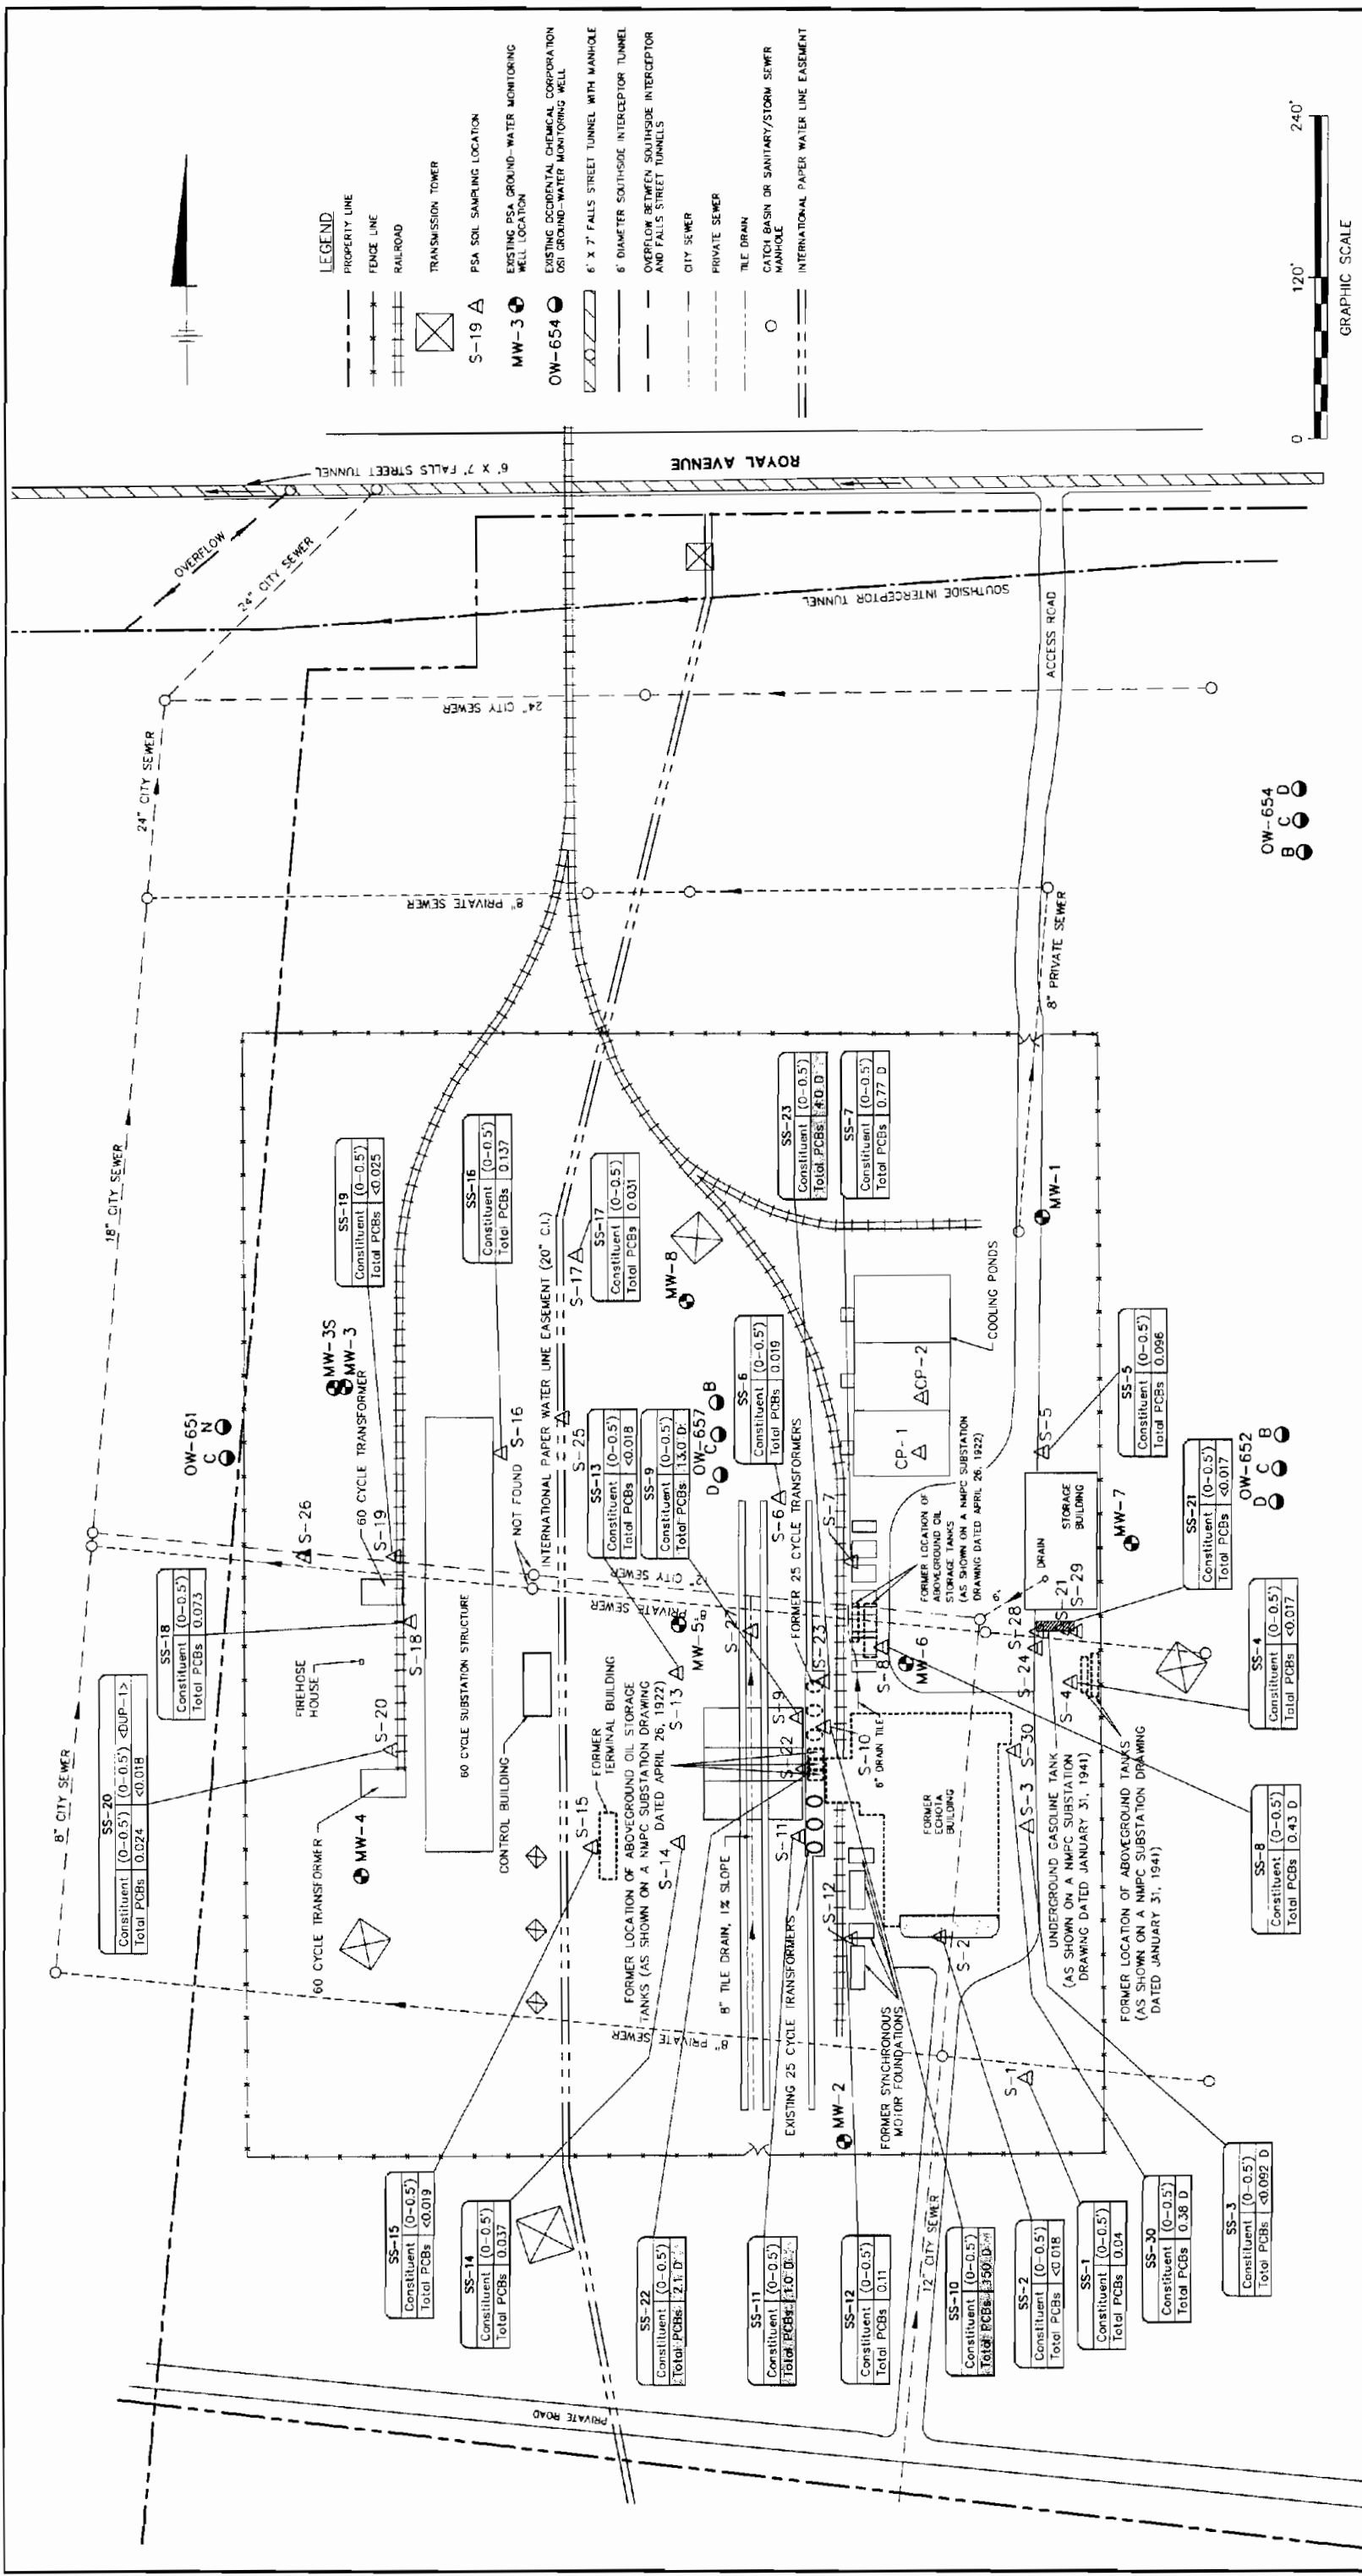
NIAGARA MOHAWK POWER CORPORATION
HARPER SUBSTATION
NIAGARA FALLS, NEW YORK
PRELIMINARY SITE ASSESSMENT
SURFACE SOIL SAMPLING
RESULTS - TOTAL PCBs (ppm)

- PCBs were detected at concentrations exceeding laboratory detection limits in 17 of the 24 surface soil samples that were submitted for laboratory analysis. The concentrations of PCBs detected in surface soil samples SS-9, SS-10, SS-11, SS-22, and SS-23 (located in the vicinity of the 25-cycle substation) exceed the 1 ppm NYSDEC-recommended surface soil cleanup objective presented in TAGM 4046. The concentration of PCBs detected in surface soil sample SS-10 (150 ppm) exceeds the New York State hazardous waste/TSCA regulatory limit of 50 ppm. The analytical results obtained from the laboratory analysis of the surface soil samples for PCBs are listed in Table 3 and shown on Figure 4.

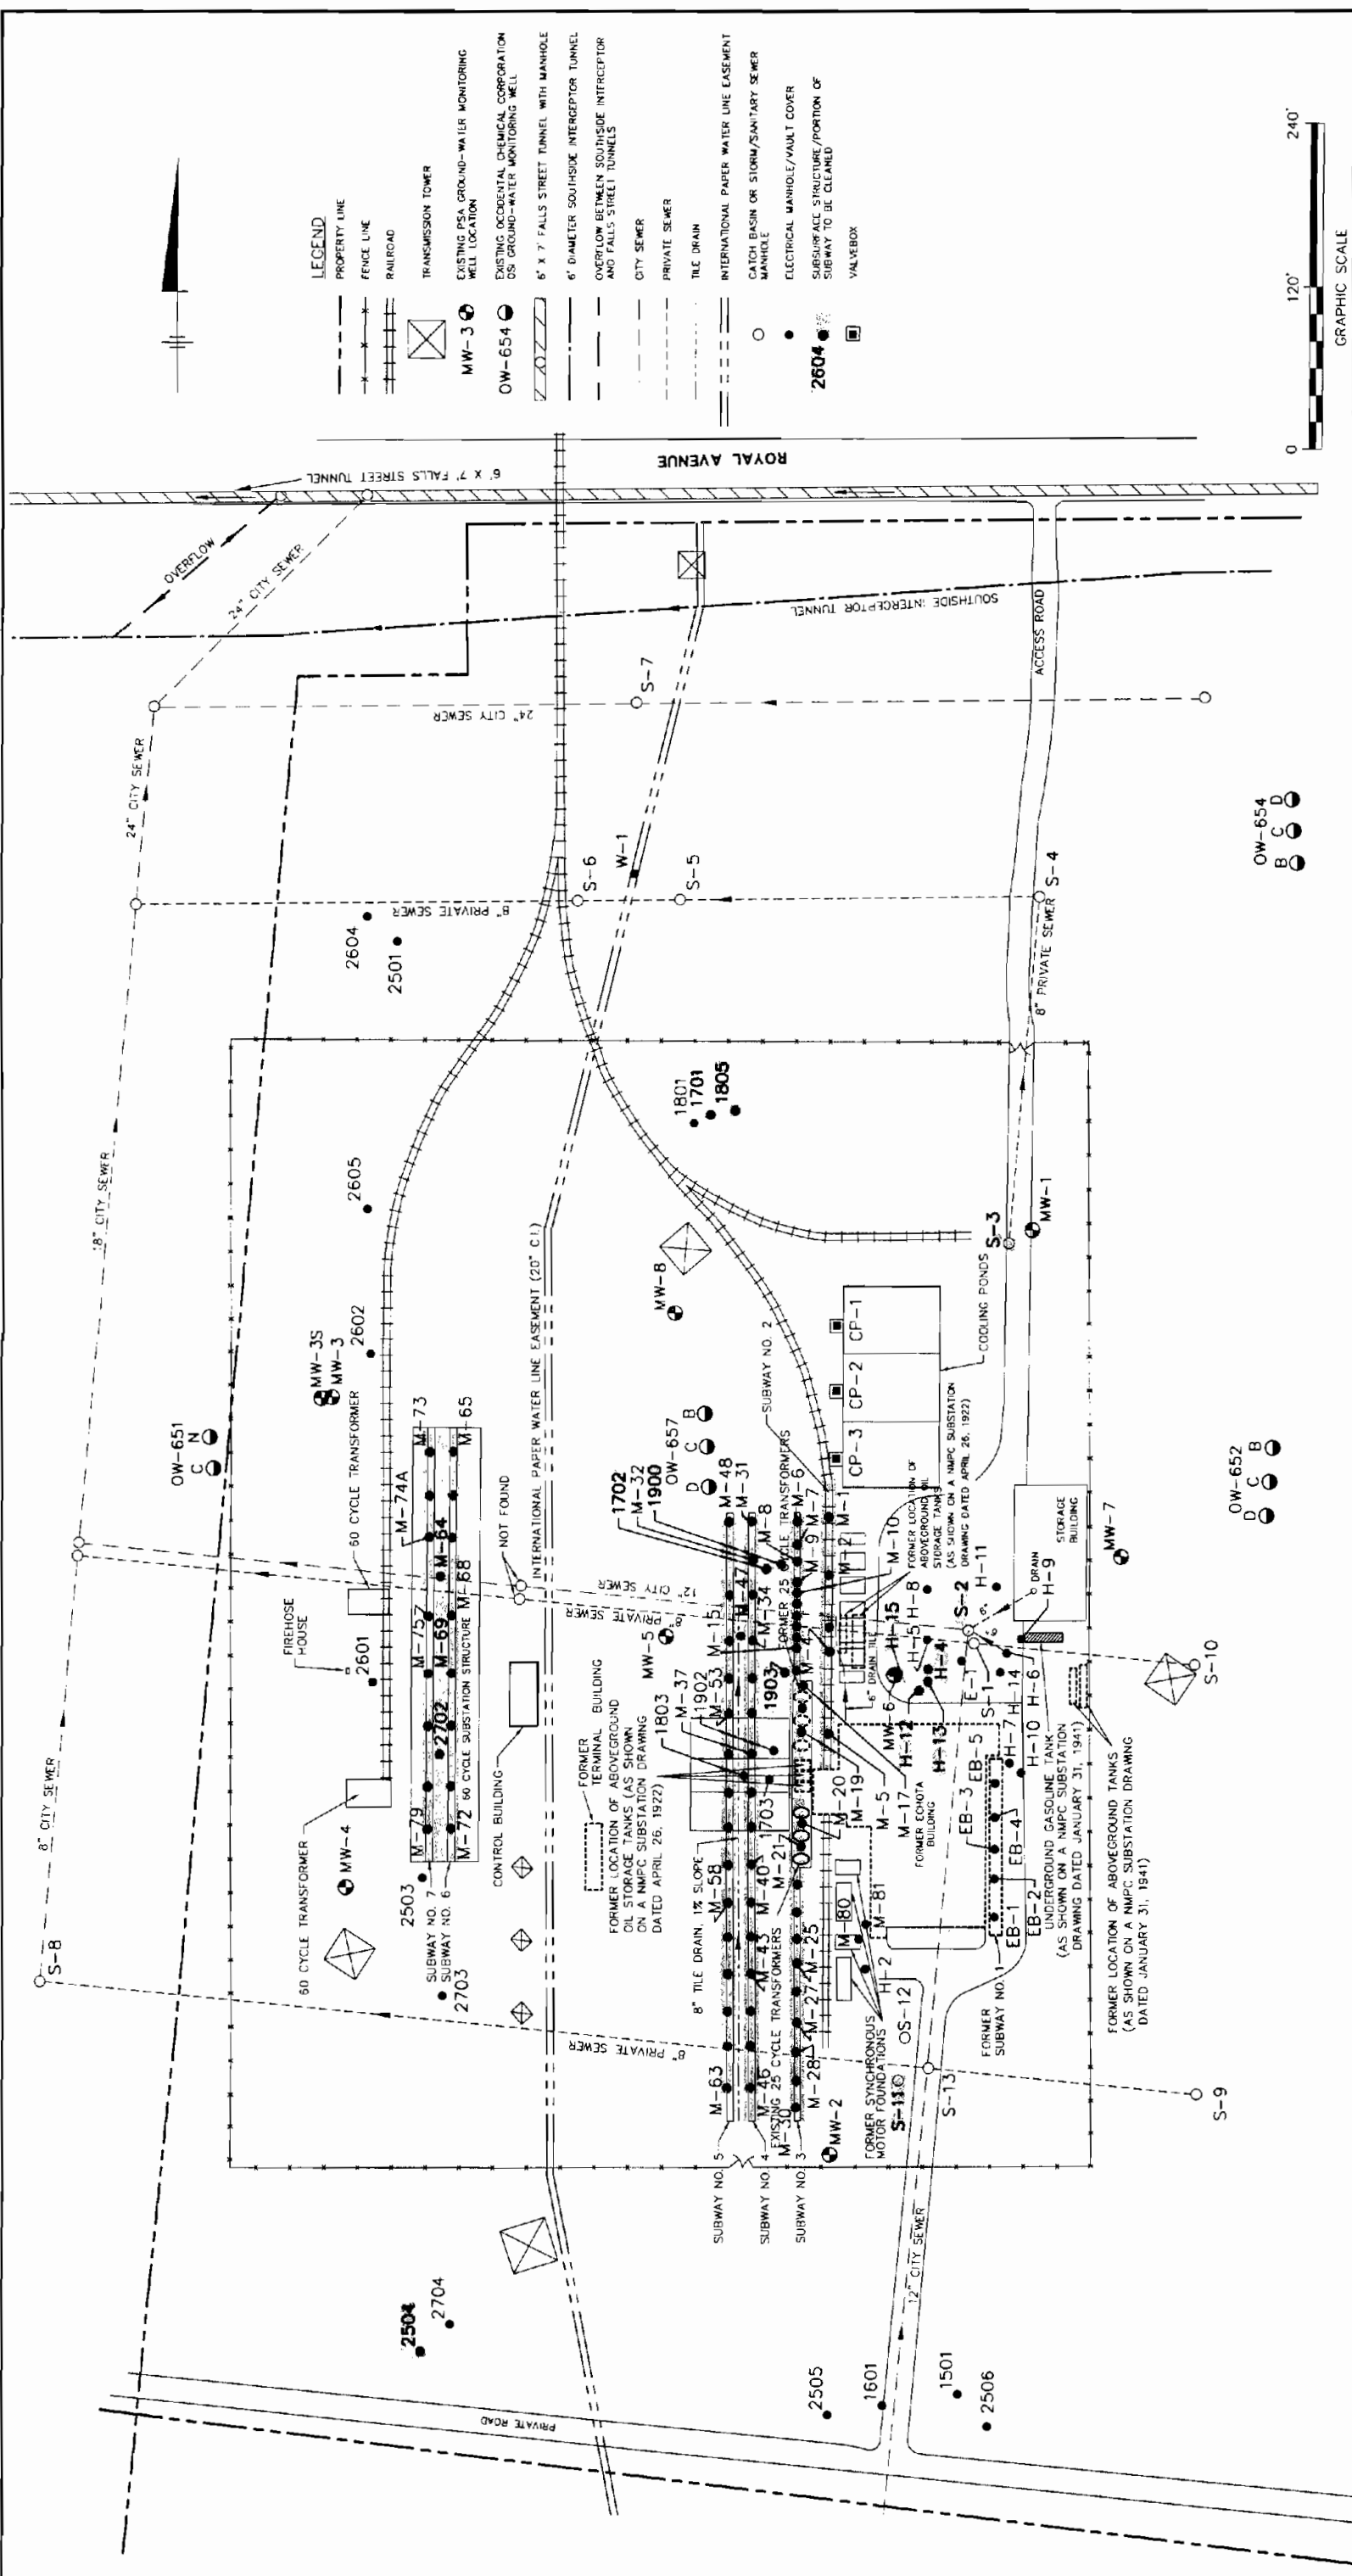
NIAGARA MOHAWK POWER CORPORATION
HARPER SUBSTATION
NIAGARA FALLS, NEW YORK
INTERIM REMEDIAL MEASURES
PROPOSED LOCATIONS OF
SUBSURFACE STRUCTURE
CLEANING ACTIVITIES

- Cleaning electrical subways, electrical manholes, and storm sewer manholes/catch basins at the site to address the presence of noticeable petroleum-type sheens/oil droplets on standing water, debris which is visibly oil-stained, and debris which contains elevated concentrations of PCBs and lead;
