Photo Documentation of the Removal Action

MRS Plating Site
310 Park Avenue
Lockport, Niagara County, New York

Removal Support Team 2
Weston Solutions, Inc.
Northeast Division
Edison, New Jersey, 08837

U. S. Environmental Protection Agency
Region II – Removal Action Branch
186 Exchange Street
Buffalo, NY 14203

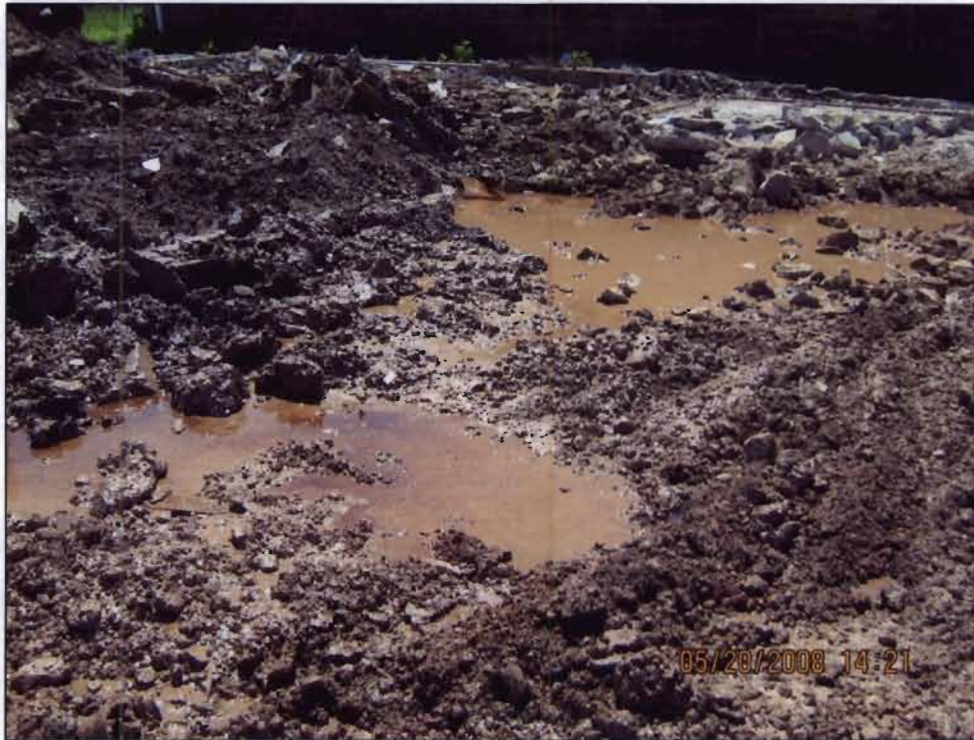
Perched/rain water with the fuel oil sheen noted underneath the floor during the removal and demolition activities at the MRS Plating Shop building.

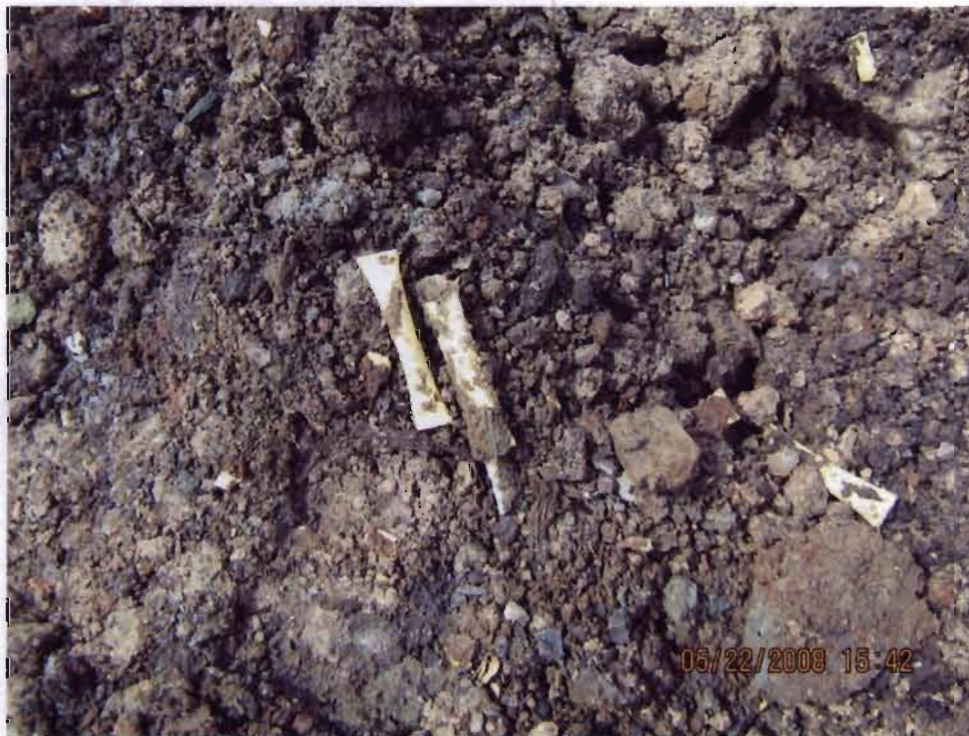
Plastic capsules uncovered during the MRS Plating Shop southern end floors removal. These plastic capsules were broken open and found empty.

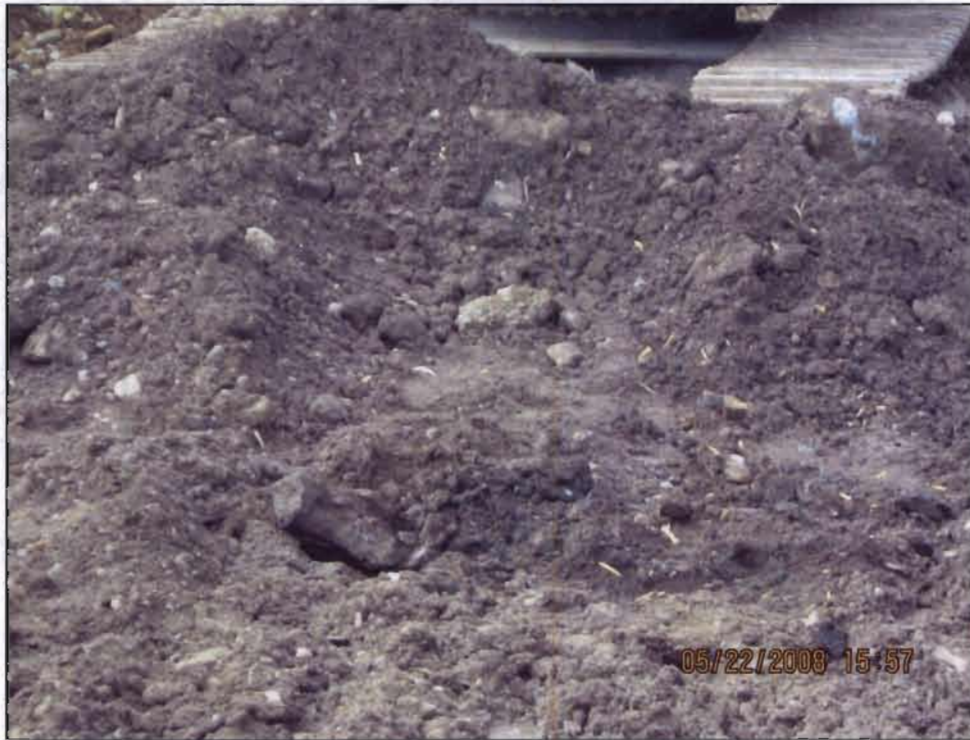
A view of the scattered plastic capsules uncovered during the MRS Plating Shop building's southern end floors removal. These plastic capsules found to be empty.

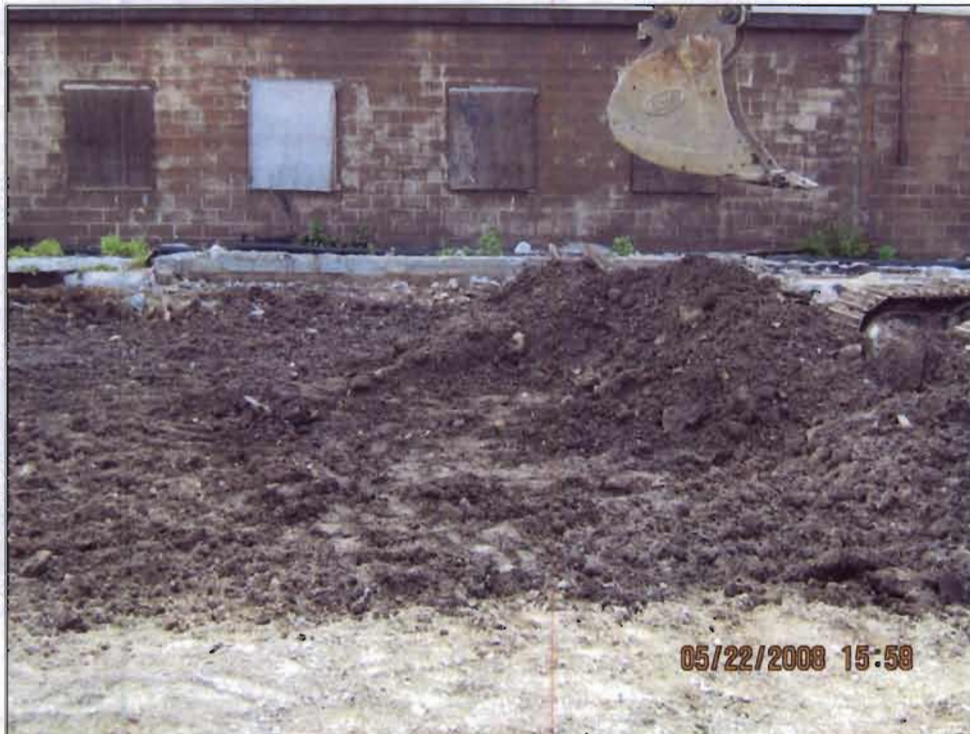
A view of the scattered plastic capsules uncovered during the MRS Plating Shop building's southern end floors removal. These plastic capsules found to be empty.

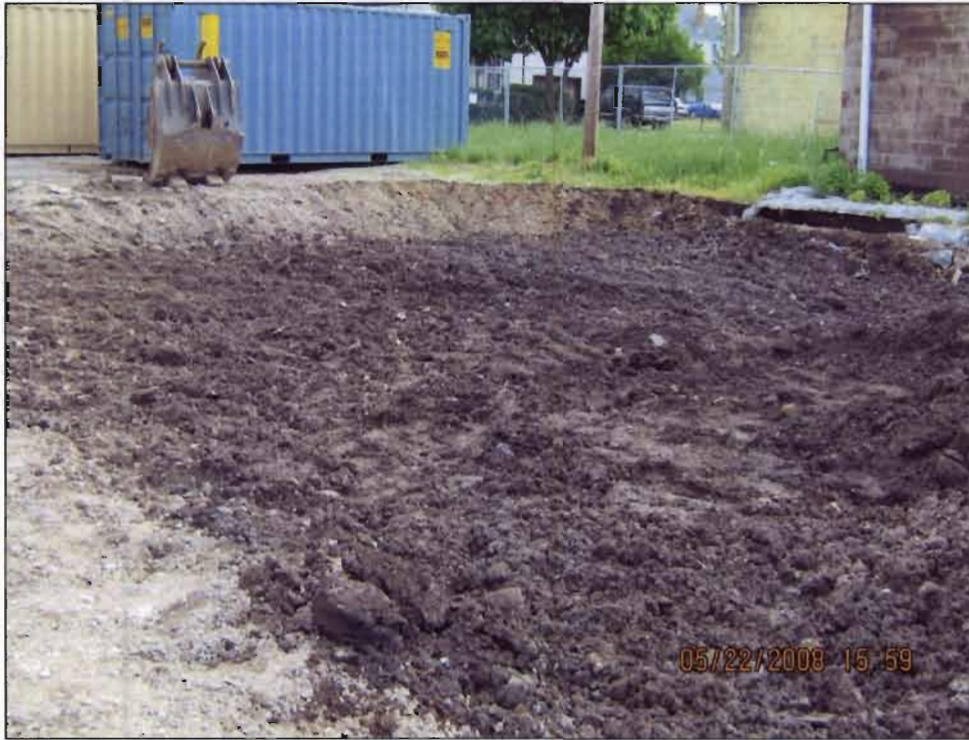
A view of the scattered plastic capsules uncovered during the MRS Plating Shop building's southern end floors removal. These plastic capsules found to be empty.

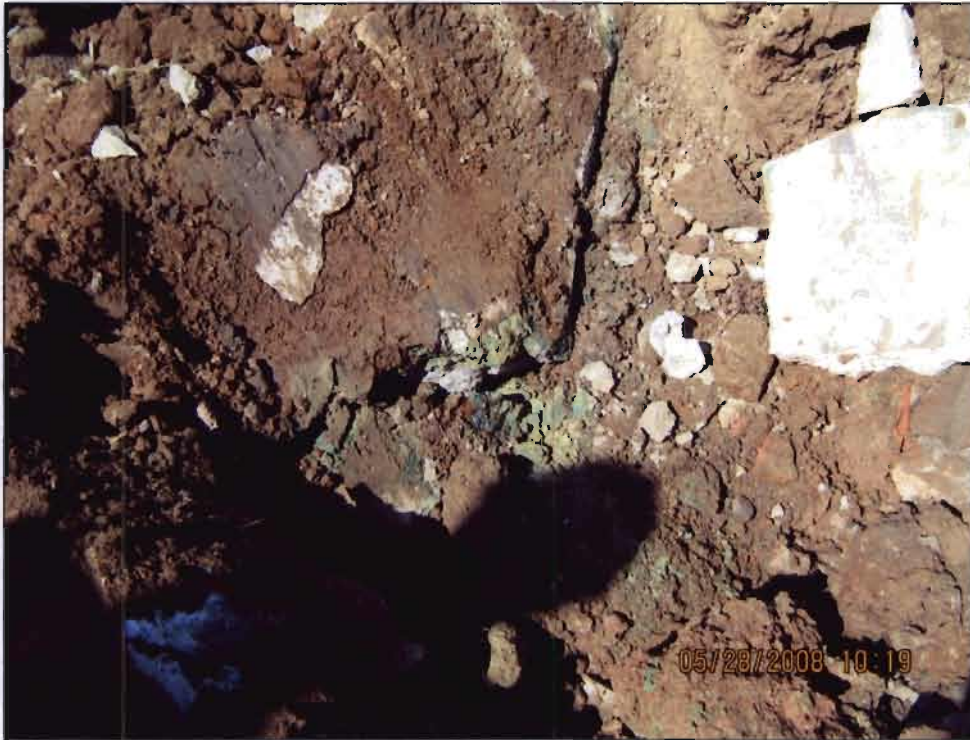
A view of the discolored soils noted during the test pit excavation at the former MRS Plating Shop building area.

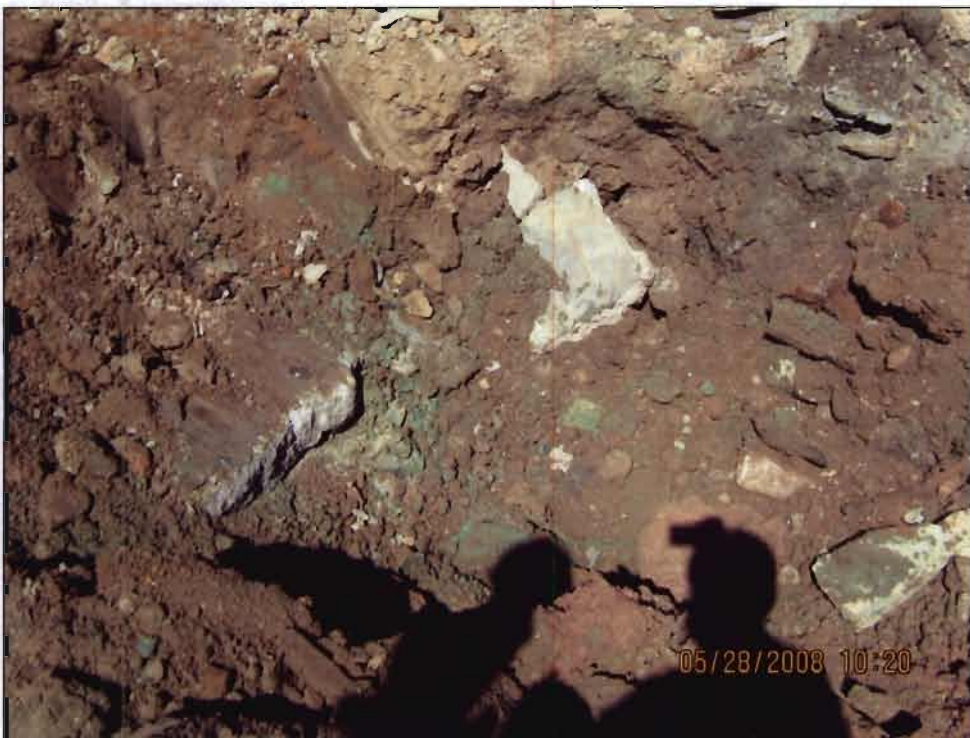
A view of the discolored soils noted during the test pit excavation at the former MRS Plating Shop building area.

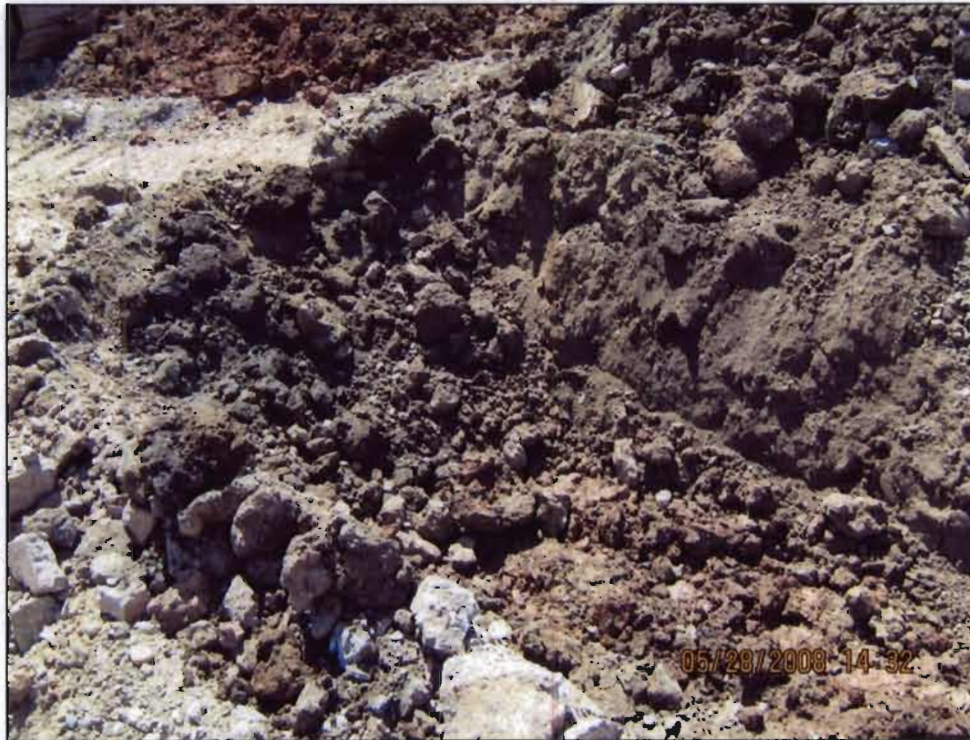
A view of the discolored soils noted during the test pit excavation at the former MRS Plating Shop building area.

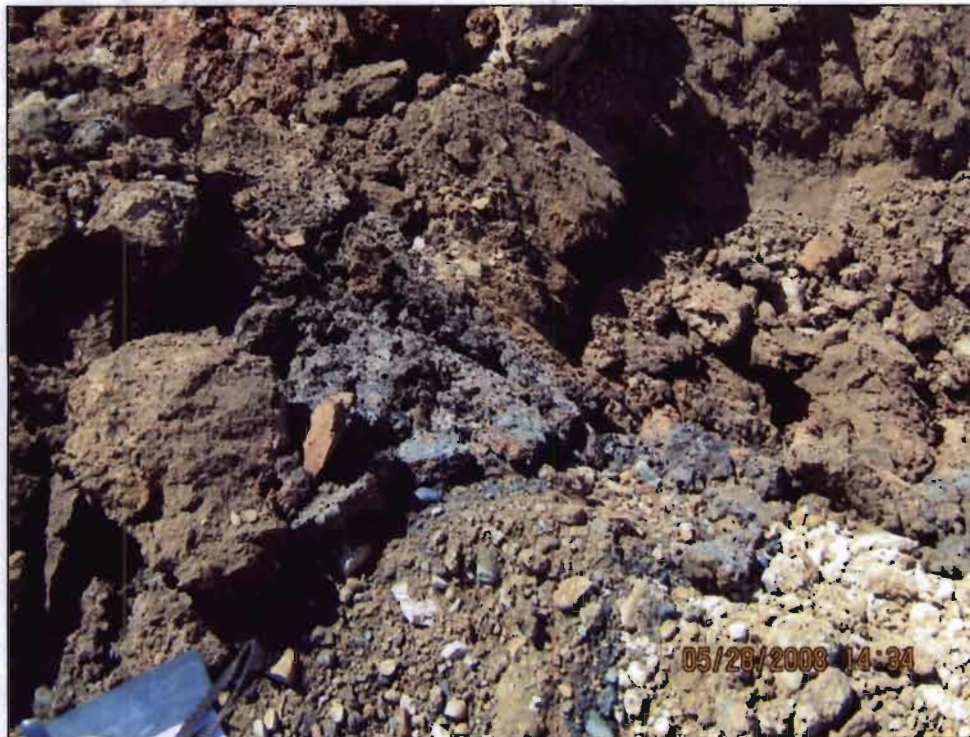
A view of the discolored soils noted during the test pit excavation at the former MRS Plating Shop building area.
