FIELD MEMORANDUM - TRIP REPORT

SUBJECT: NIAGARA FALLS USARC (NY046) SITE VISIT

SITE VISIT DATE: 06/23, 6/24, & 6/25 2008

PURPOSE OF VISIT: Christine Alba, of the 77th ARIM Environmental Division, visited the Niagara Falls USARC to oversee the investigation of the 24" corrugated pipe that leads to outfall 5, and the 6" pipe that flows into the 24" line about midway. The 6" line was formerly used as a drain for the former 500,000 gallon water reservoir, however, an oily substance has been discovered flowing from the line. Initial sample results taken on 1 May 2008 from the outfall area showed 2.81 ug/L Aroclor 1254.

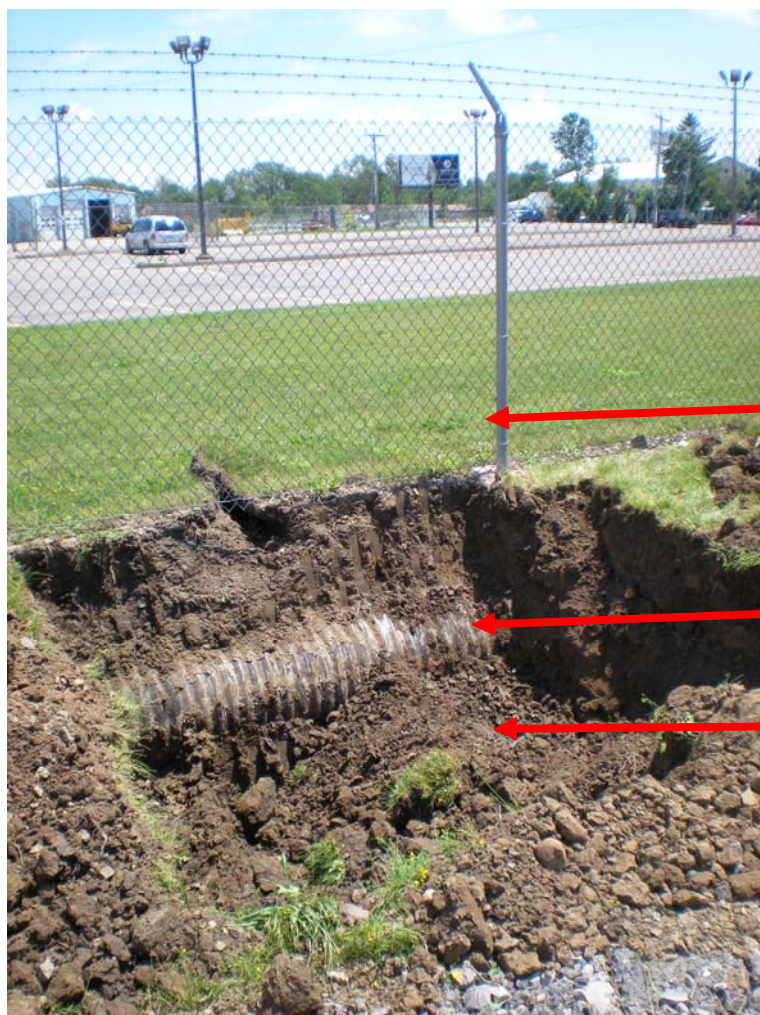
Pat, Jon, & Bruce used an excavator and shovels to excavate the 24" pipe where it is met by the 6" line.

24" corrugated pipe that drains to Outfall 5

6" pipe that formerly drained the reservoir. It now has oily substance flowing out of it and into the 24" pipe.

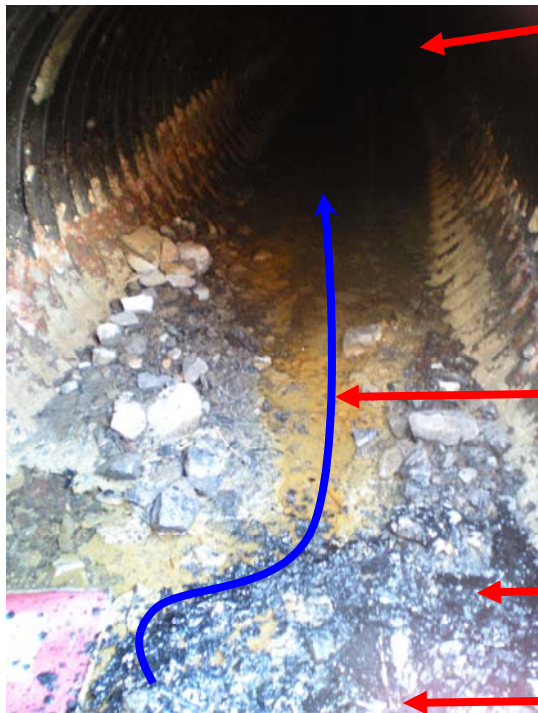
Pat then used an acetylene & oxygen torch to open the 24" pipe over the spot where the 6" pipe comes into it.

Path followed by effluent from the 6" pipe as it heads towards outfall 5.

Black substance is from the burning of the corrugated pipe. Mr. Patterson had to use an acetylene torch to open it.

Location of 6" pipe, entering the 24" pipe from the west side.

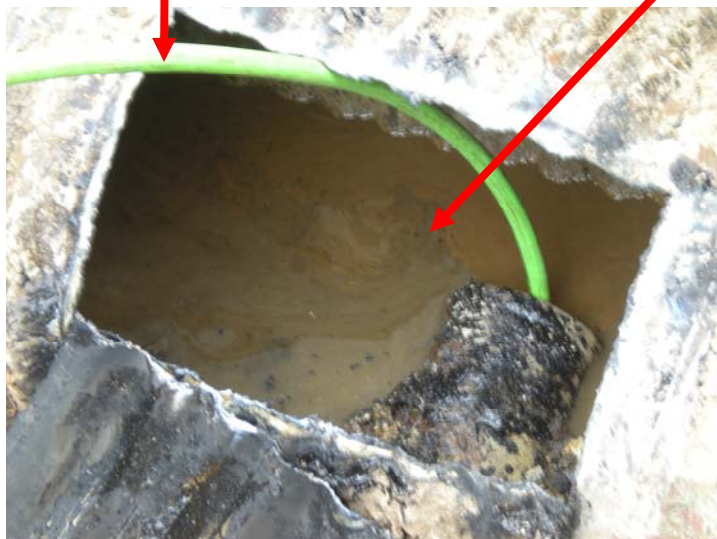
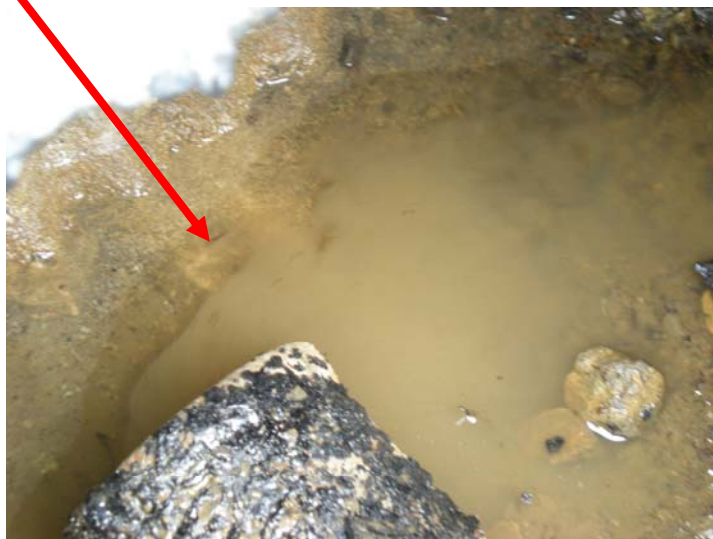
JA Brundage was hired to come and send a camera up the 6" line to try to find the source of the oily substance. Prior to sending the camera, they used a hose to clean out the pipe. When Mr. Brundage saw the oil with black flecks, he said he suspected it was PCB oil.

Hose used to clean out the 6" pipe.

Oily substance coming out of the 6" pipe once the hose was inserted.

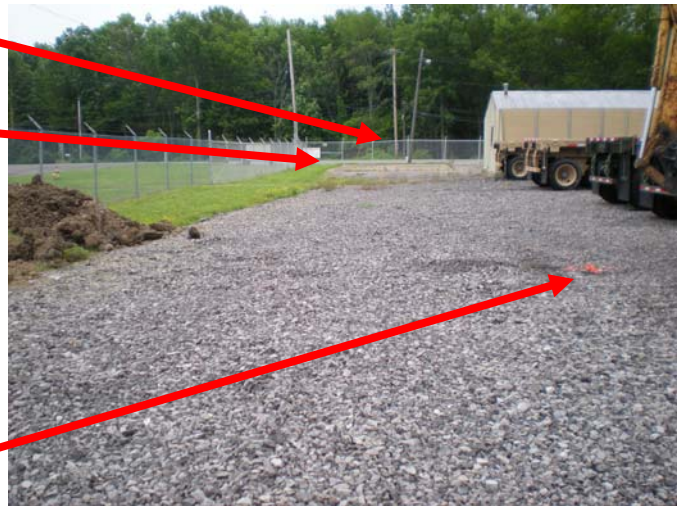
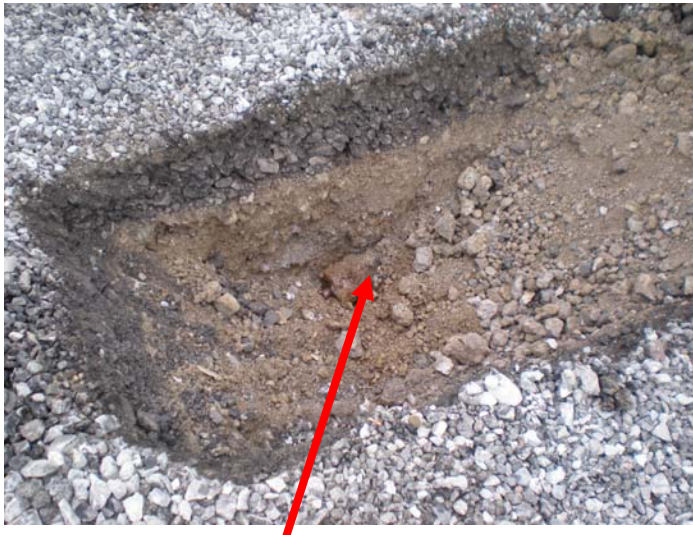
Brundage got the hose about 15'-20' into the 6" line when he hit a blockage. They used a sensor to detect where the blockage was and marked it with orange marking paint.

"X" marks the spot where the blockage was sensed.

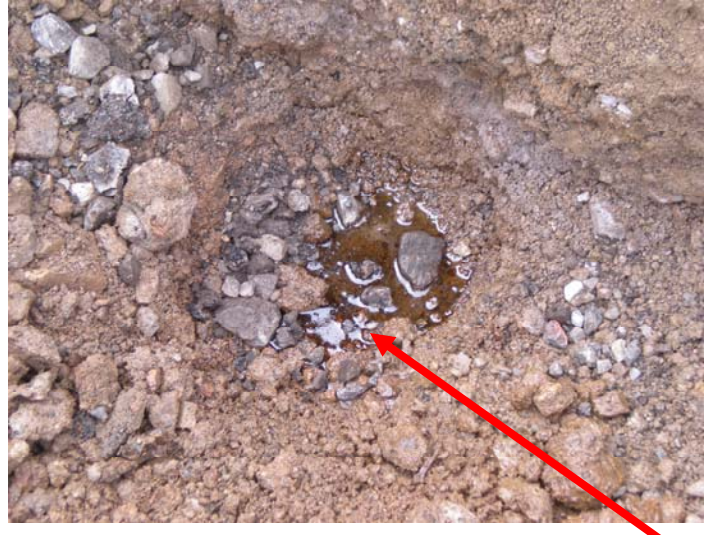
Valve discovered while excavating.

Jon used the excavator to excavate where the "X" had been marked. They wanted to verify that this was the location where the valve on the 6" pipe had been. At about 2' – 3' below grade, we found the top of the valve, dislodged from the pipe.

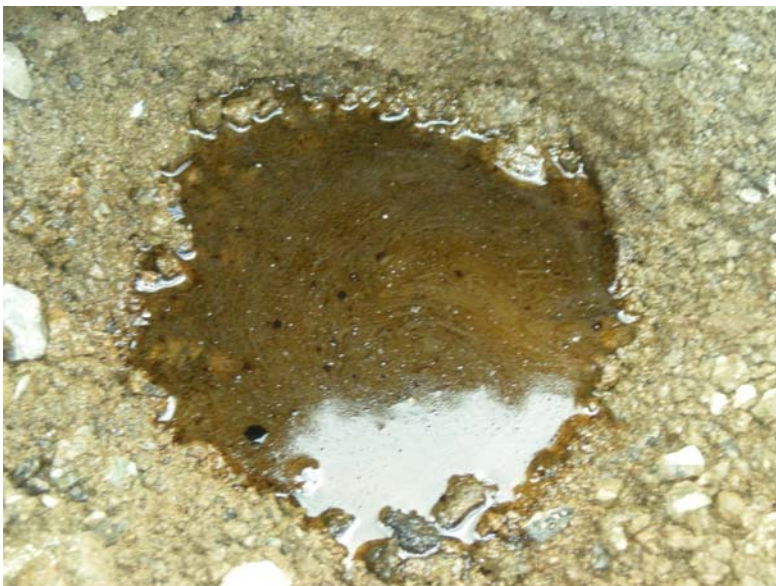
They moved the valve out of the way and used the shovel to start to dig to where the pipe was, but the hole where the valve was began to fill with an oily substance. It had a strong odor, similar to motor oil.

Due to the amount of oil found in the ground, and the oil coming out of the pipe, Brundage did not want to send their camera up the 6" line.

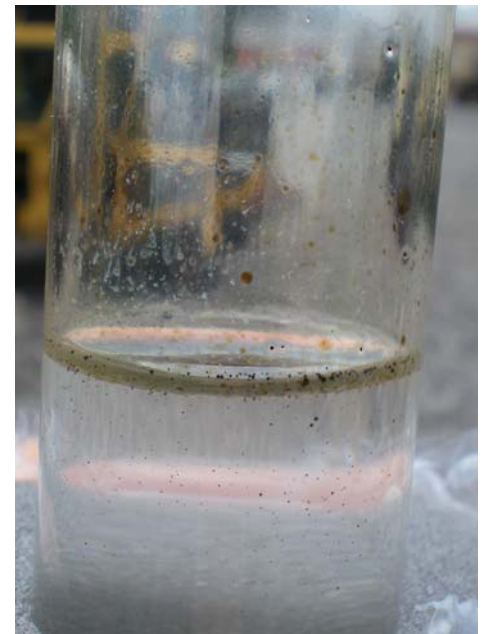
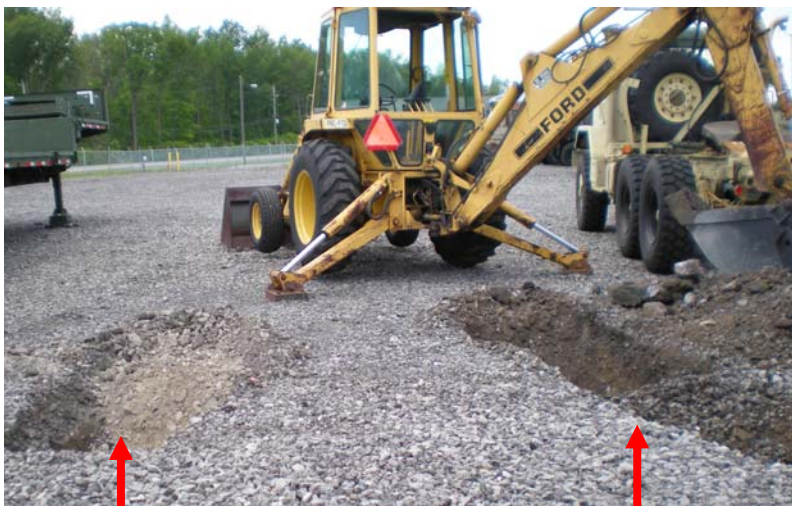
We took a pipette and sucked some of the substance from the hole in the ground, and put it into this vial that contained distilled water.

As you can see, the substance was an almost clear oil, with areas of red & brown. There were many black flecks floating in it.

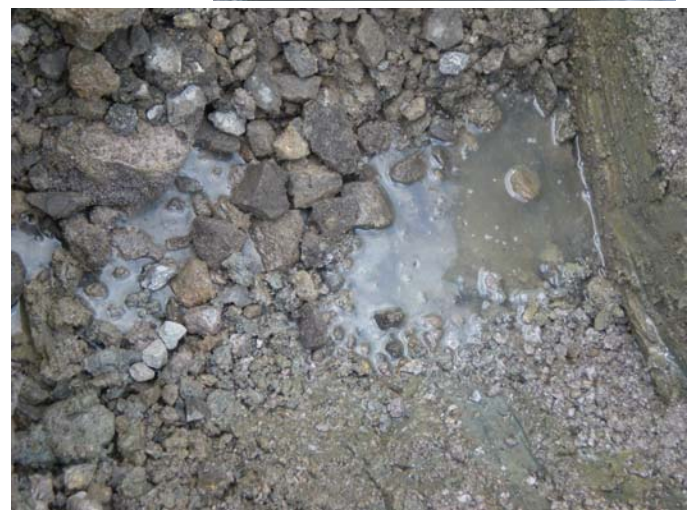
Hole with oil, over 6" pipe.

Hole with only water

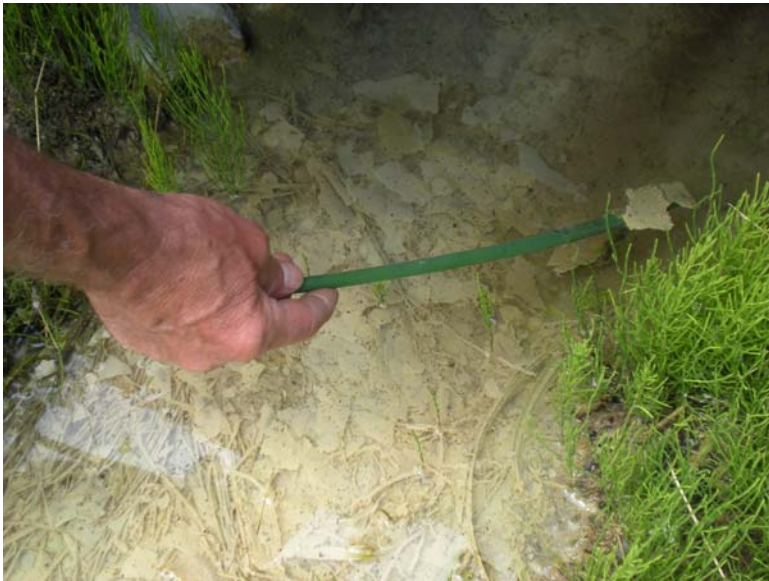
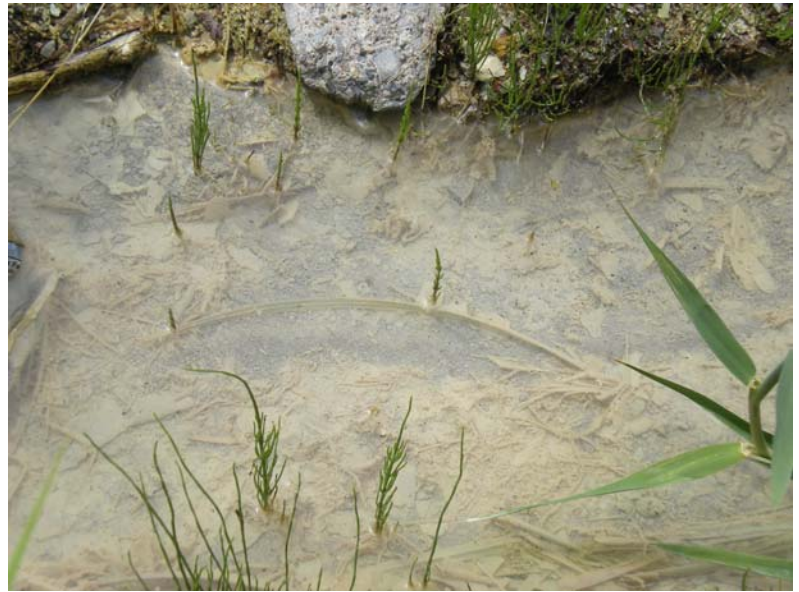
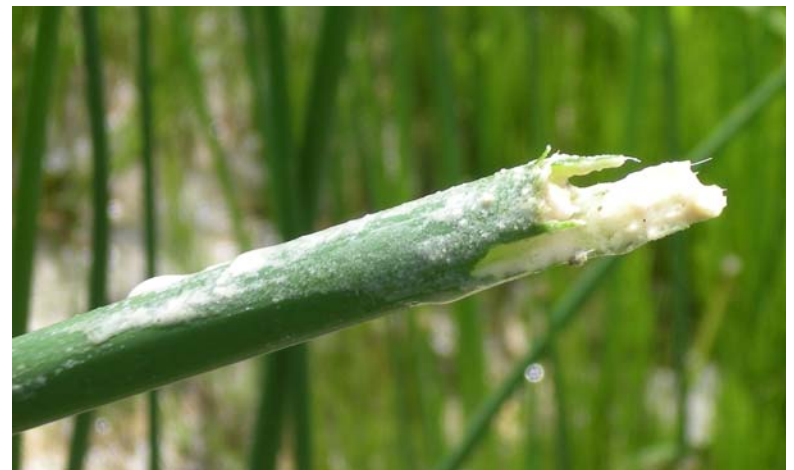
Outfall 5: You can see that the yellow substance which prompted the investigation extends from the pipe out into the ditch along Porter Road, and has started to extend westward along the ditch, towards Cayuga Creek. The area affected is approximately 25 square feet and needs to be excavated, as per NYSDEC.

Various photos showing the consistency of the substance, ranging from granular to large flakes. This is the substance that was tested that came back positive for 2.8ug/L Aroclor 1254 (a type of PCB).
