PHASE 1 RECONNAISSANCE SURVEY

Eighteenmile Creek Area of Concern

Niagara County, New York

Remedial Investigation/Feasibility Study

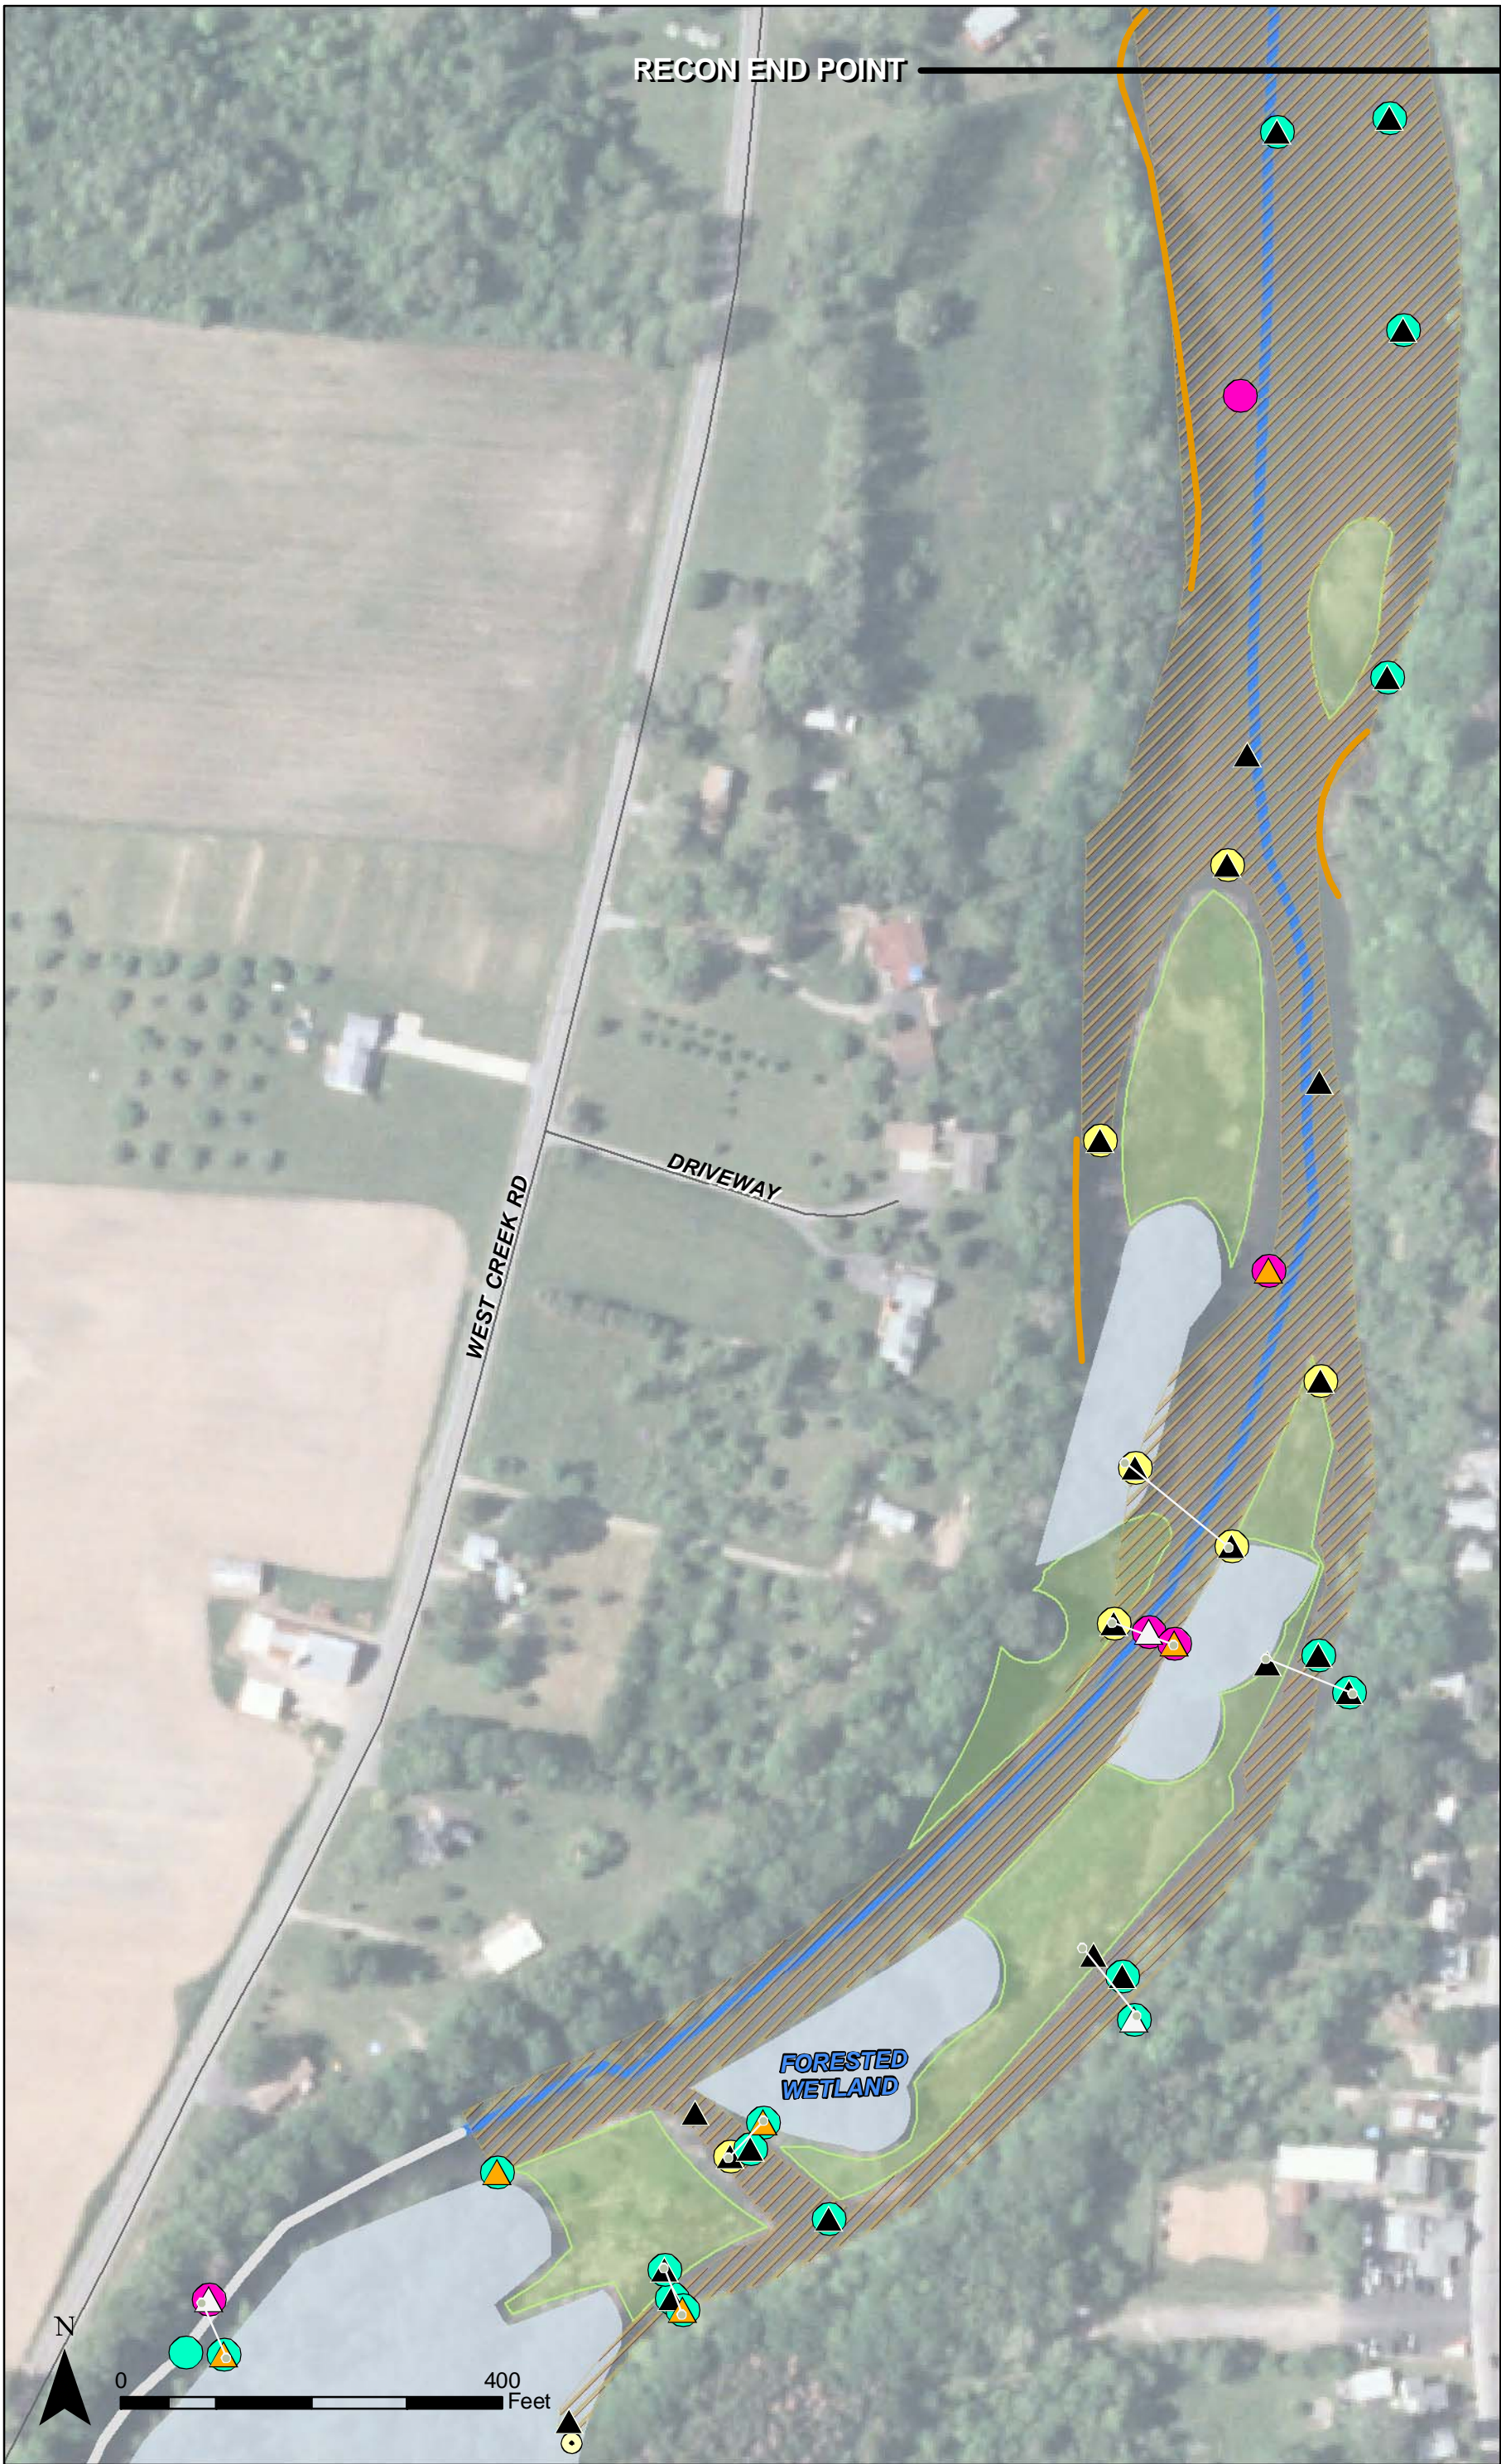
Figure 3-1 Reach 3
Eighteenmile Creek Field Reconnaissance,
Fall 2008 and Spring 2009, Niagara County, New York

Figure 3-1 and a portion of Figure 3-2 summarize the reconnaissance survey results for Reach 3. This reach is representative of a flooded stream bed with the meander of the original stream bed channel evident among islands of forested wetland and cattail marsh. The stretch is approximately 0.5 miles upstream of the deeper water of the Burt Dam impoundment (see Reach 2 on Figure 2-1). The sediment reconnaissance survey was completed on May 2, 2009. Two sediment thickness points also were probed in areas that fall within Reach 2 as shown on Table 3-1. The sediment probes indicate the deeper water in this reach is characterized by average sediment thickness of about 9 feet and relatively shallow water (less than 2 feet). Reach 2 area will also be characterized as part of the bathymetric survey.

The upstream portion of Reach 3 is characterized by a gravel bottom with swift flow and few sediment deposition areas. From SED 181 (Figure A-3-2) to the ending point of the reconnaissance survey at a point just south of the Burt Impoundment, the creek is characterized by large, deep sediment deposits due to the entrance of slack water. This lower portion has forested wetlands and cattail marsh along both banks with a mix of steep sloped sides and low floodplains. Sediment is primarily comprised of silt with fine sand, and some clay, with sediment depths generally greater than 3 feet and water depths less than 3 feet. A total of 31 sediment thickness and water depth points were collected in this area (see Table 3-1). Table 3-2 shows that total sediment depositional area was estimated at 9.75 acres with an additional 1.3 acres identified in what is Reach 2. There are several areas which are notable within this section of the creek:

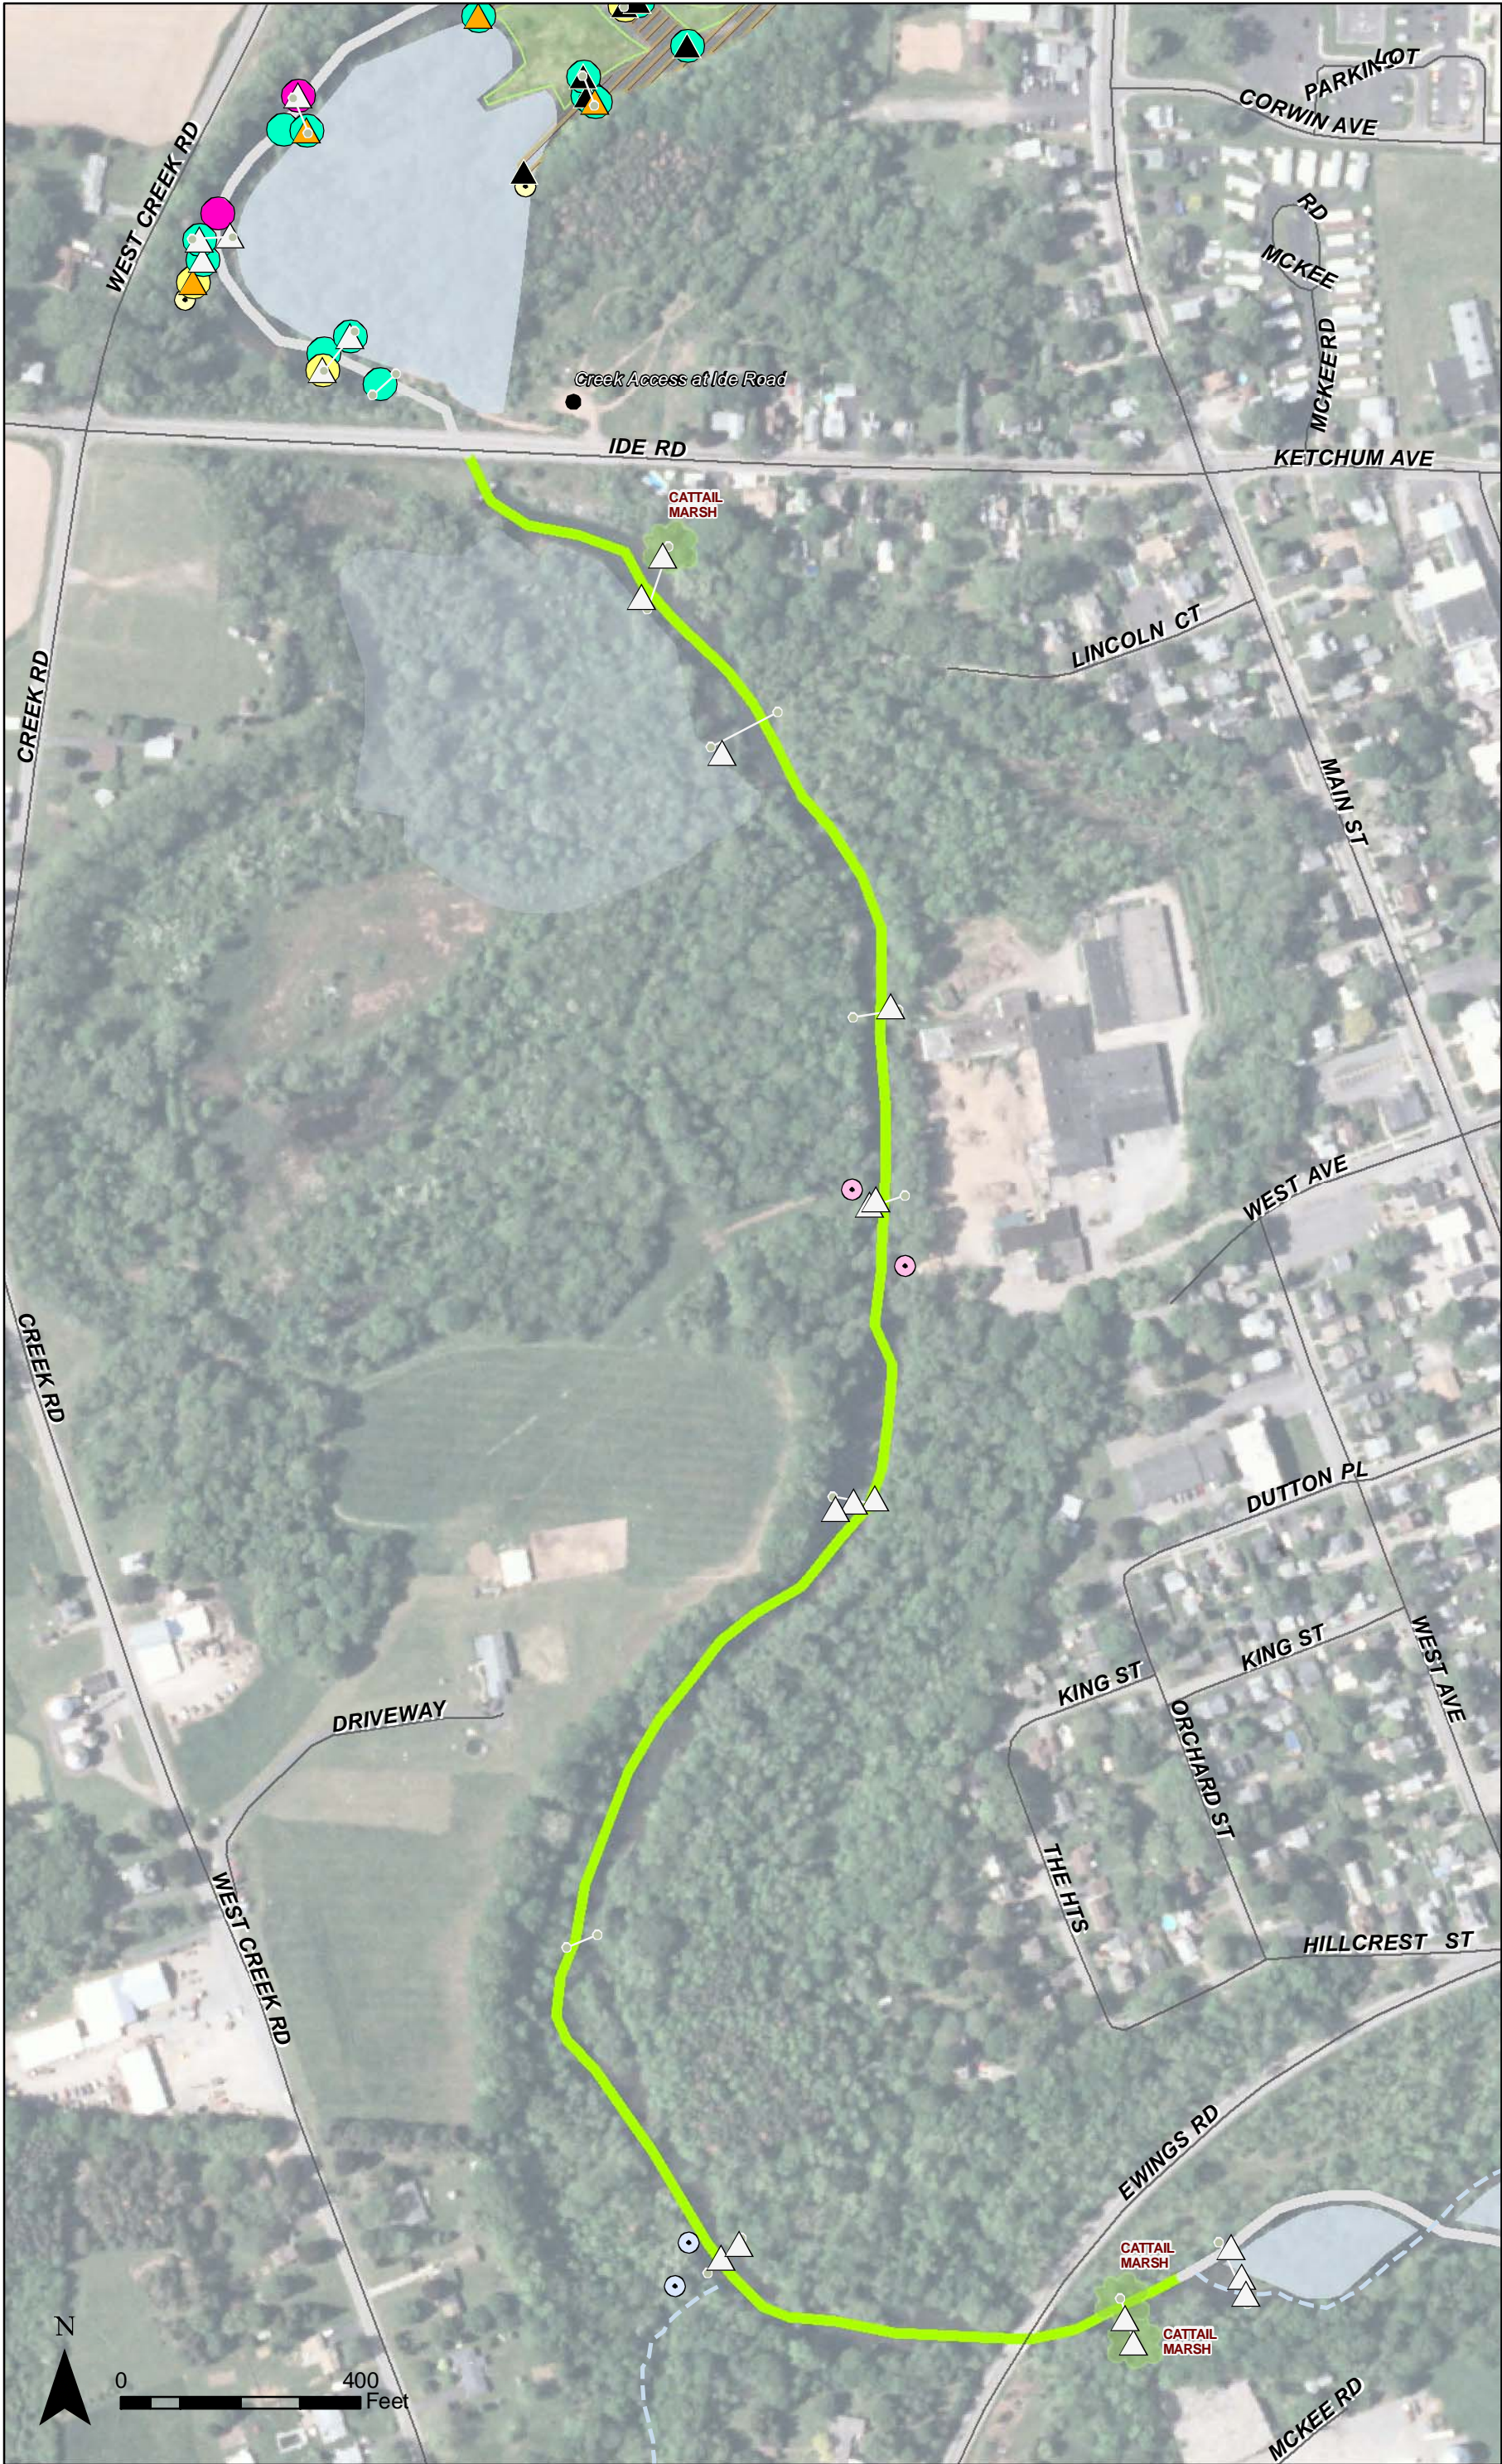
Figure 3-2 Reach 4
Eighteenmile Creek Field Reconnaissance,
Fall 2008 and Spring 2009, Niagara County, New York

Figure 3-2 summarizes the Reach 4 reconnaissance survey results for the portion of stream downstream of Newfane Dam to Ide Road. This reach is about 1 mile long and is influenced by the flow from Newfane Dam. It appears there are at least two locations along this stretch that had historic water withdrawal structures that influenced the channel and left obstructions in the creek. The survey reconnaissance effort was completed between the point immediately downstream of Newfane Dam to Ide Road on December 4 (see Figures A-1-2 to -4 and A-3-2 to -4). EEEPC encountered David Eaton, who owns the property next to Newfane Dam. He was

Reach 4 is characterized by relatively swift stream flows and fewer, shallower sediment depositional areas. Of the 22 sediment measurement points recorded, 13 exhibited sediment accumulations with an average sediment depth of 0.5 feet. The water was shallow with a depth of (generally less than 3.5 feet at all locations) with an average depth of 1 foot. Two channels depart from the dam (Photos P30 to P32); outflow from an old pump house structure along right side (Photo P56), and spillway overflow from left side. These conditions created an island over time of approximately 600 feet in length with a small, high water overflow channel reconnecting the two channels. Stream banks are 1 to 4 feet high with slopes of varying steepness that rise onto a floodplain bench. Stormwater enters the creek at the bridge at Ewings Road which contains roadside drainage pipes, and from non-point run-off along rip rapped stream banks.

Between Ewings Road North and Ide Road, areas of sediment deposits were shallow. This portion of the creek contains bedrock substrate within the main channel and was stripped of any sediment with the exception of the immediate vicinity of the banks. In these locations, less than 0.5 feet of sand, gravel, and organic material had accumulated, but it is likely that this material would be prone to washing out during higher flow events. Water depth between Ewings Road North and Ide Road (Figures A-3-2 and 3-3) was variable (0.25 feet to greater than 3.5 feet) and the flow was swift. Two small island features with right and left channels can be found along this stretch, the first is located approximately 600 feet downstream from the Ewings Road bridge. This island creates a small rapid adjacent to it that is choked with fallen trees and branches and not navigable by canoe (see P65A). Giant Hogweed was observed on this island. The second island is located 300 feet upstream from the Ide Road bridge and is defined by a giant willow that is split which has created a pond area that flushes during high water flow. A concrete structure along the west bank is situated upstream from the only tributary observed entering the

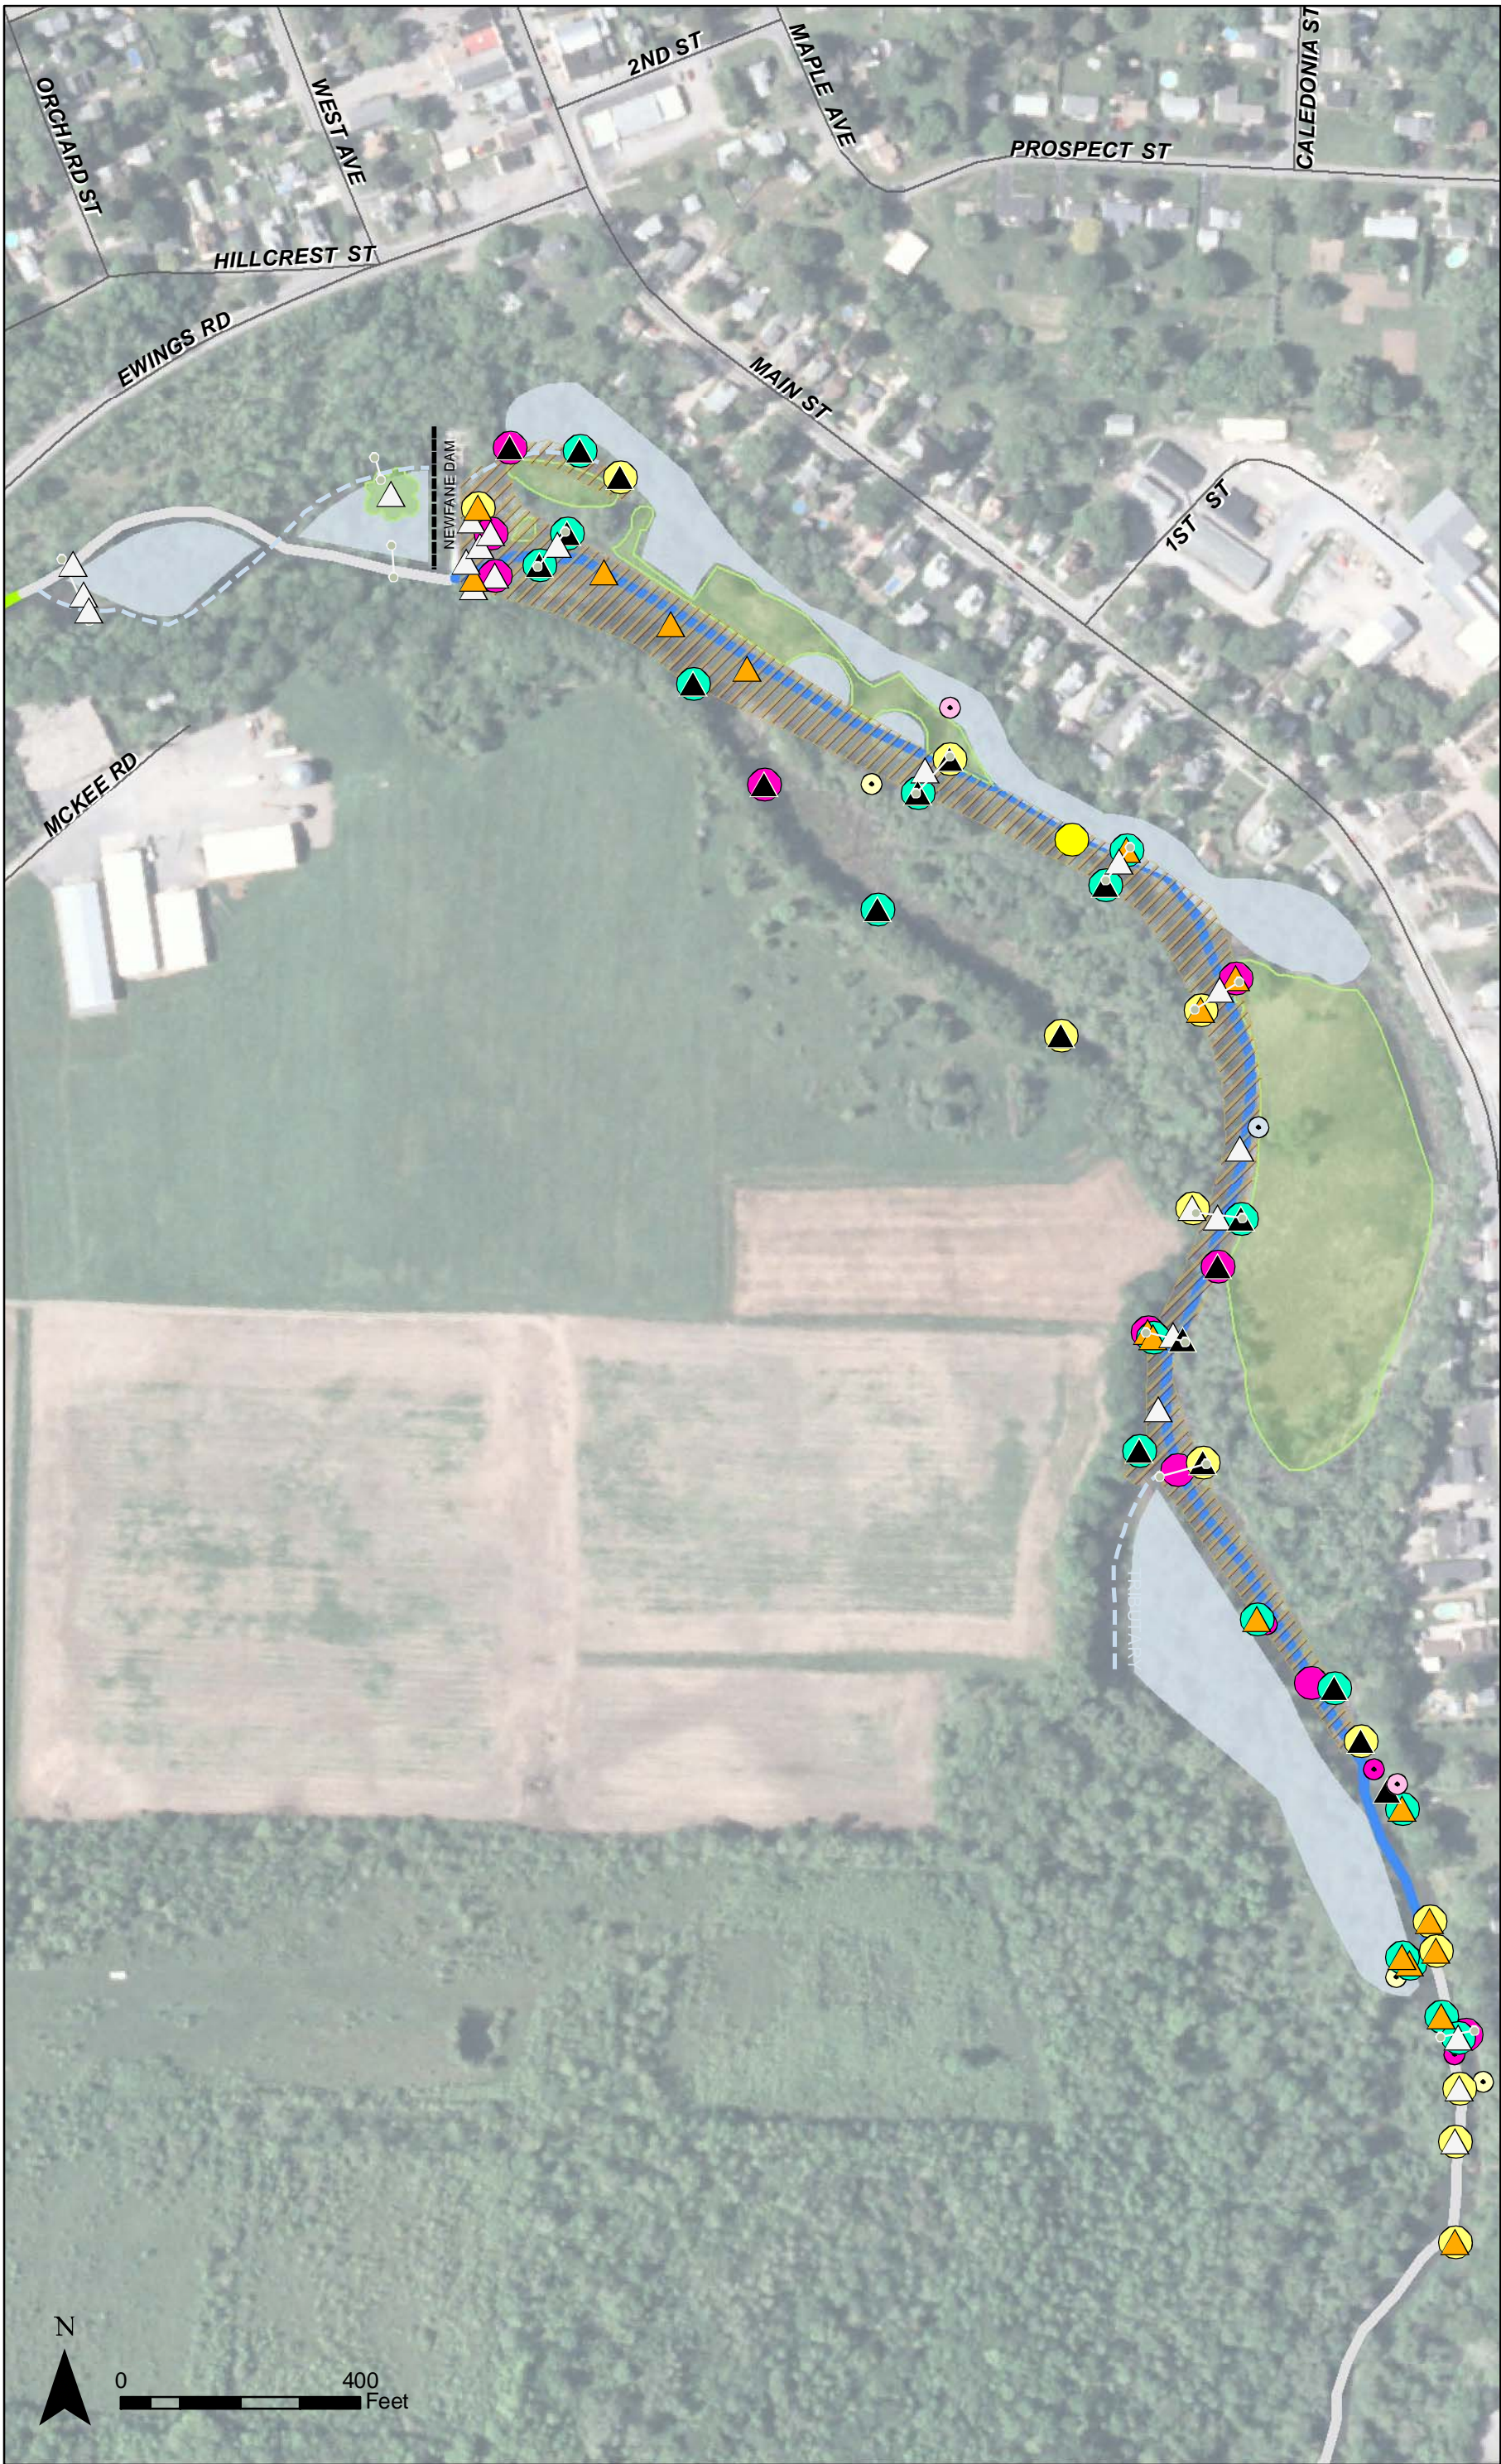
Figure 3-3 Reach 5
Eighteenmile Creek Field Reconnaissance,
Fall 2008 and Spring 2009, Niagara County, New York

Figure 3-3 summarizes the Reach 5 reconnaissance survey results for the area immediately upstream of Newfane Dam. The dam creates an impoundment/slack water section that extends approximately 4000 feet upstream (see Table 2-1). Reach 5 is characterized by deeper water and large sediment deposition areas. A total of 52 locations were probed in this reach of which 42 locations contained had sediment deposits averaging 3 feet. The water depths in this reach were on average greater than 3 feet and up to 10 feet deep in areas immediately behind the dam. The area shows the presence of wetlands, cattail marshes, and increased sediment deposition along creek banks and bottom. The use of a canoe was necessary in this portion of the creek as the water depth is greater than five feet. Sediments in this stretch are primarily comprised of silt with some fine sands and some clay, with a gravelly mid-channel between SED 133 to SED 152

(Figures A-3-4, -5). The relatively long stretch of creek (approximately 244 linear feet) is influenced by the presence of the dam and almost entirely depositional, and was estimated to be 5.4 acres (see Table 3-2).
