# A

## Survey Figures

# B Survey Data Tables

**Table B-1 Sediment Thickness Points, Eighteenmile Creek, Niagara County, New York**

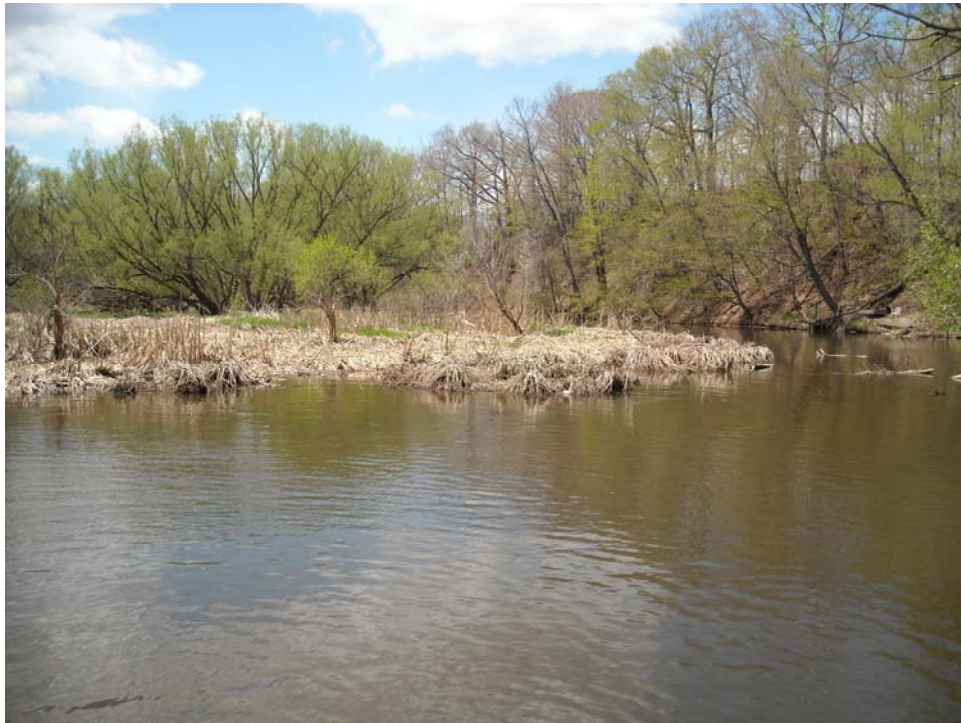
Description: Surface water input to creek from cattail area (DRN-054).

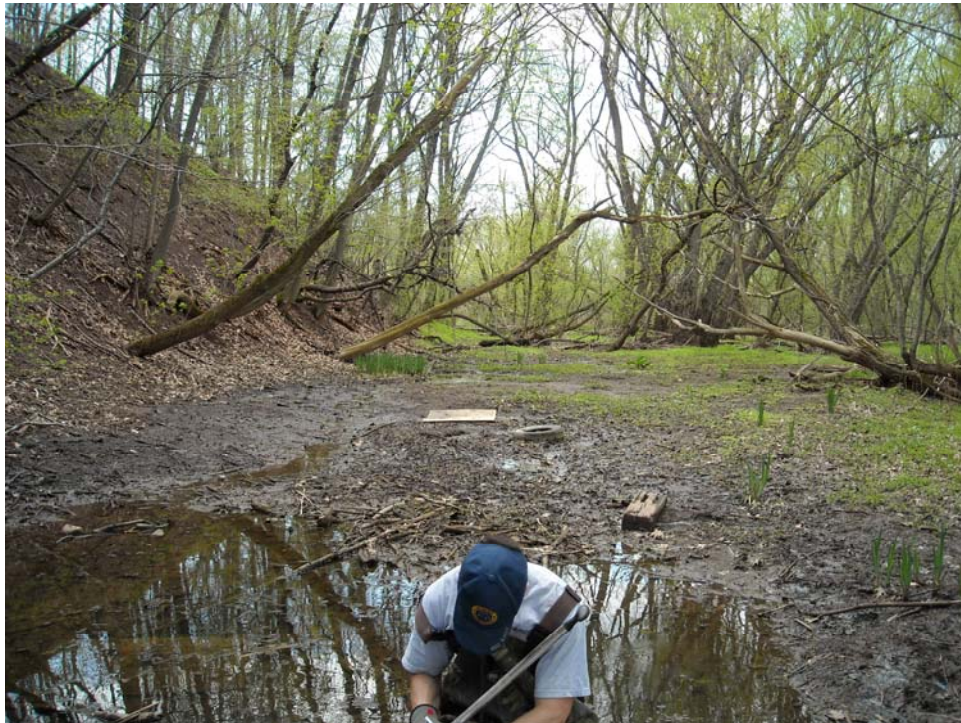
Description: Downstream portion of cattail marsh from connection channel.

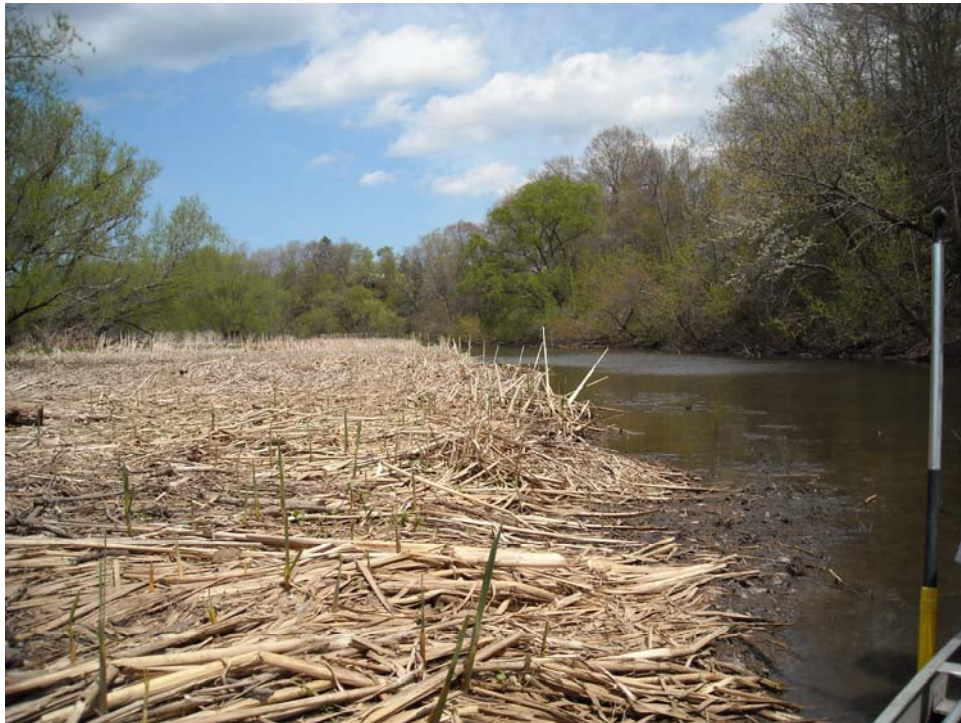
Description: Groundwater seepage.

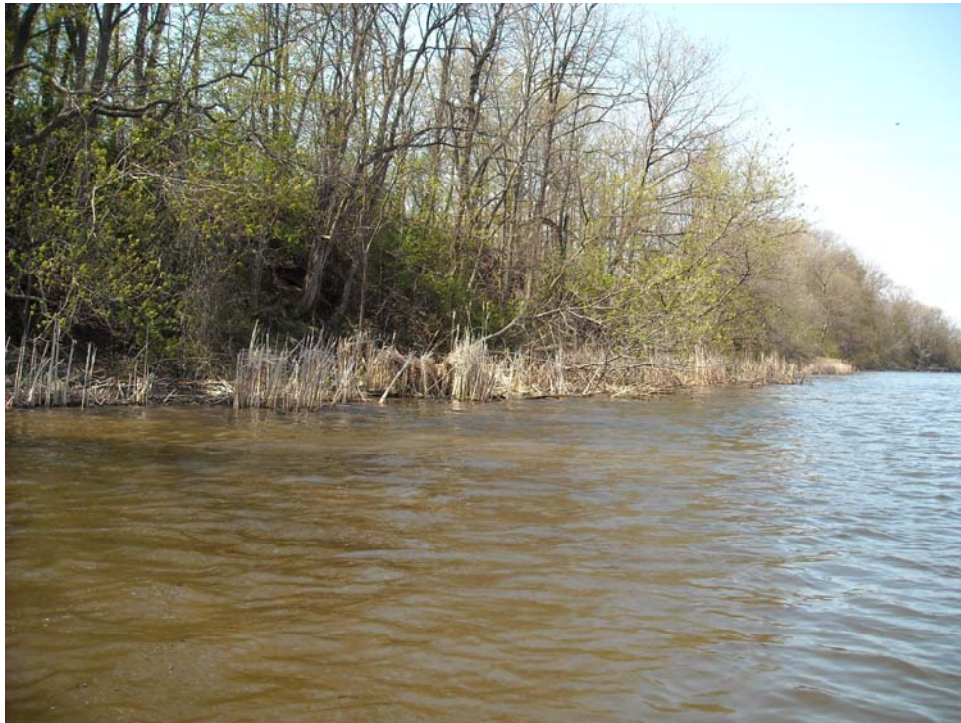
Description: Cattail marshes along creek.

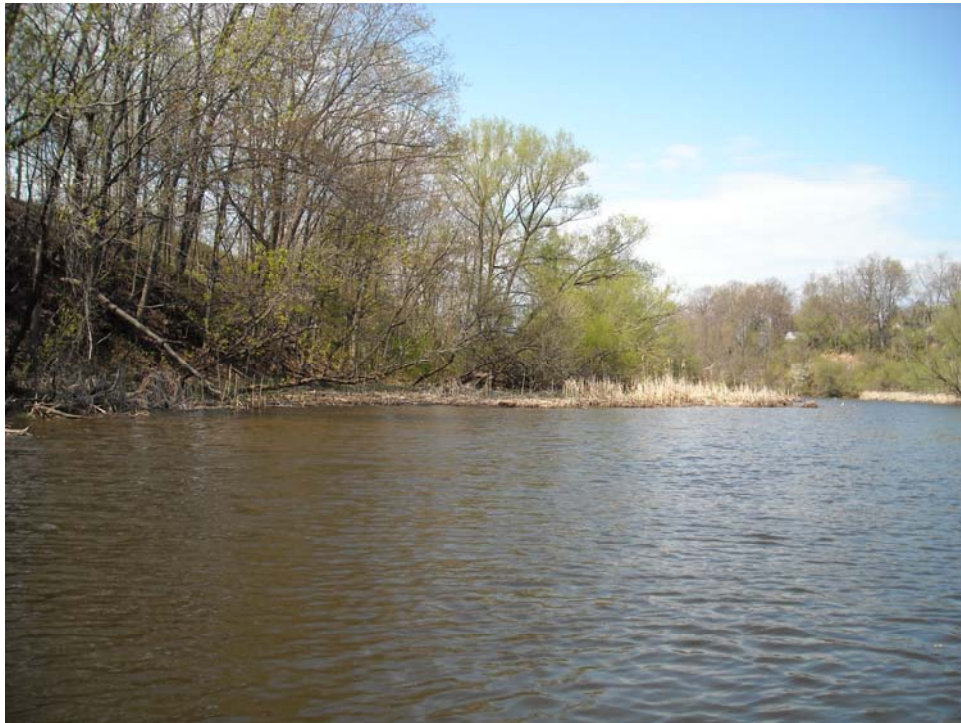
Description: Cattail marsh and slough like channel to east of creek main stem.

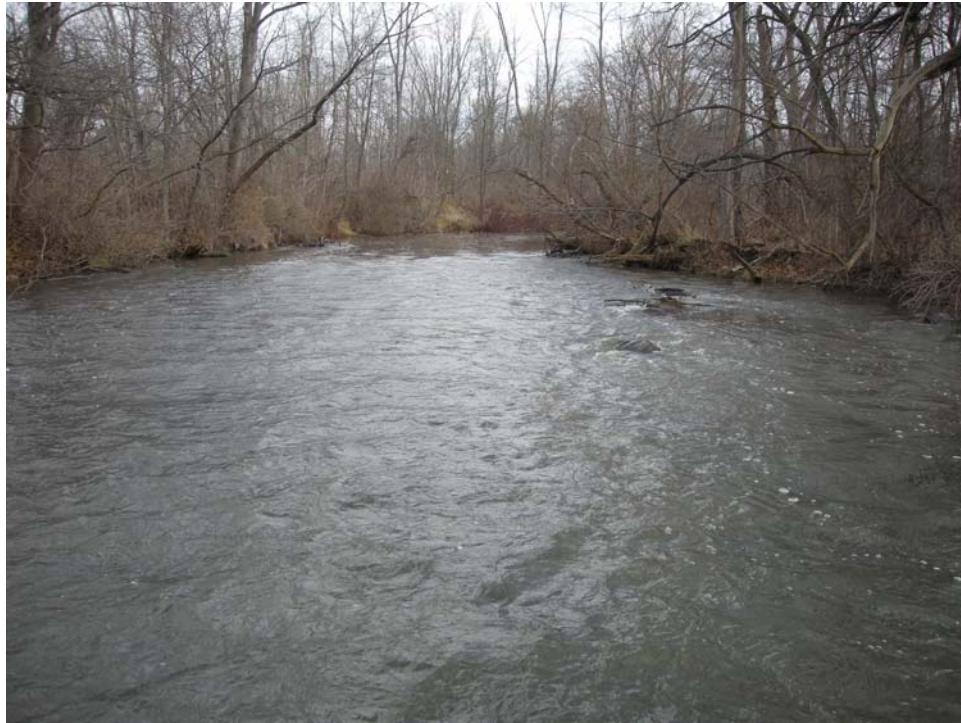
Description: View from LDB to RDB, along left channel.

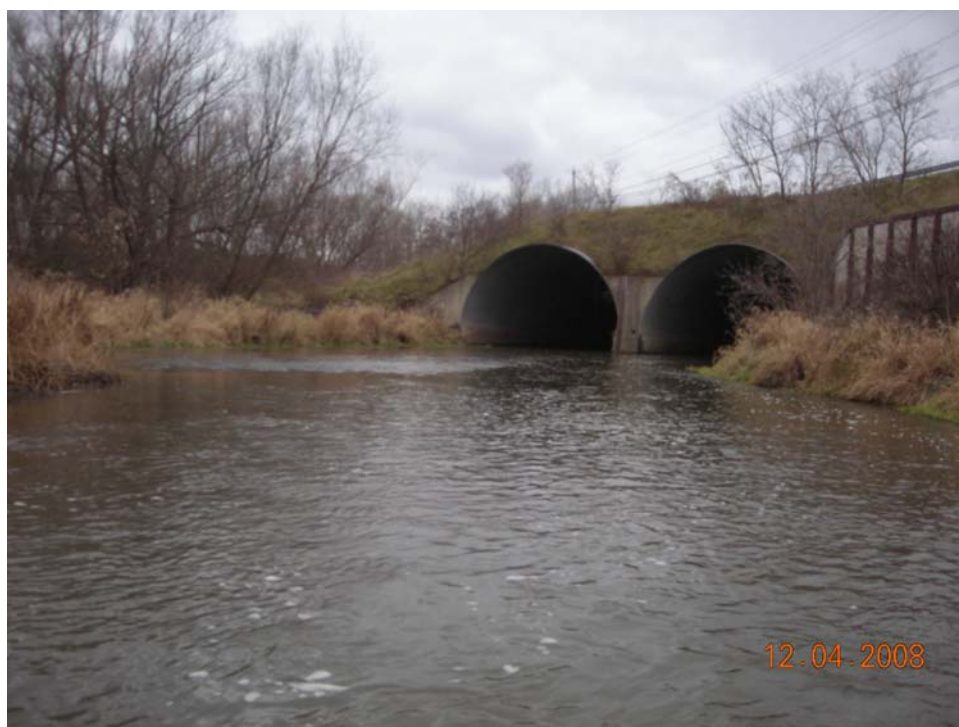
Photo: P72A  
 Direction of view: N  
 Description: Entering the culverts at Ide Road.

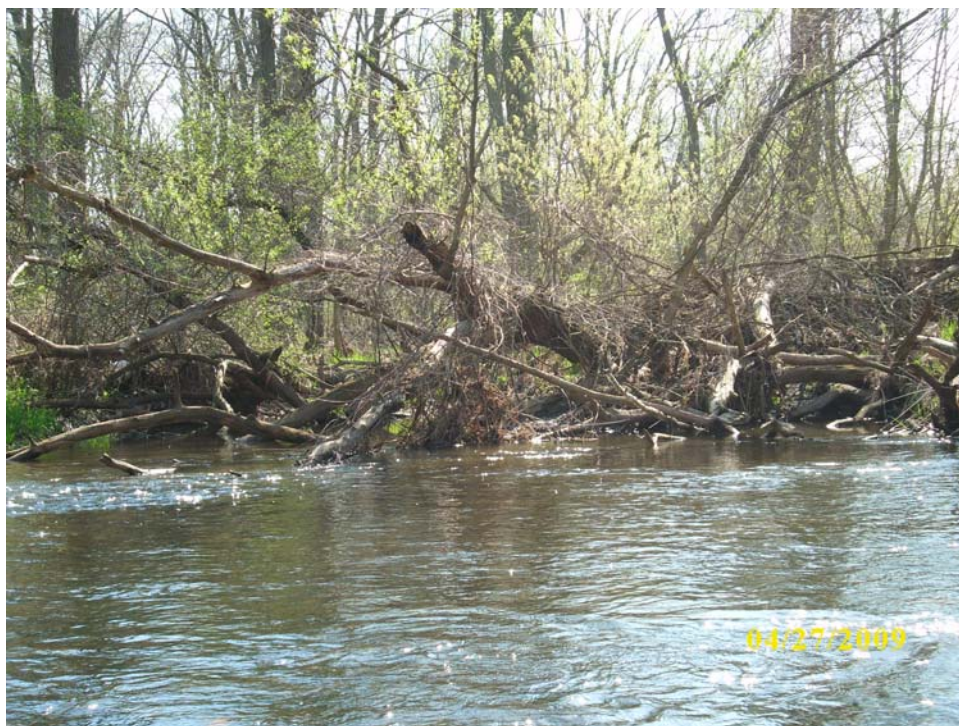
Description: Run-off along LDB with flow (DRN-046).

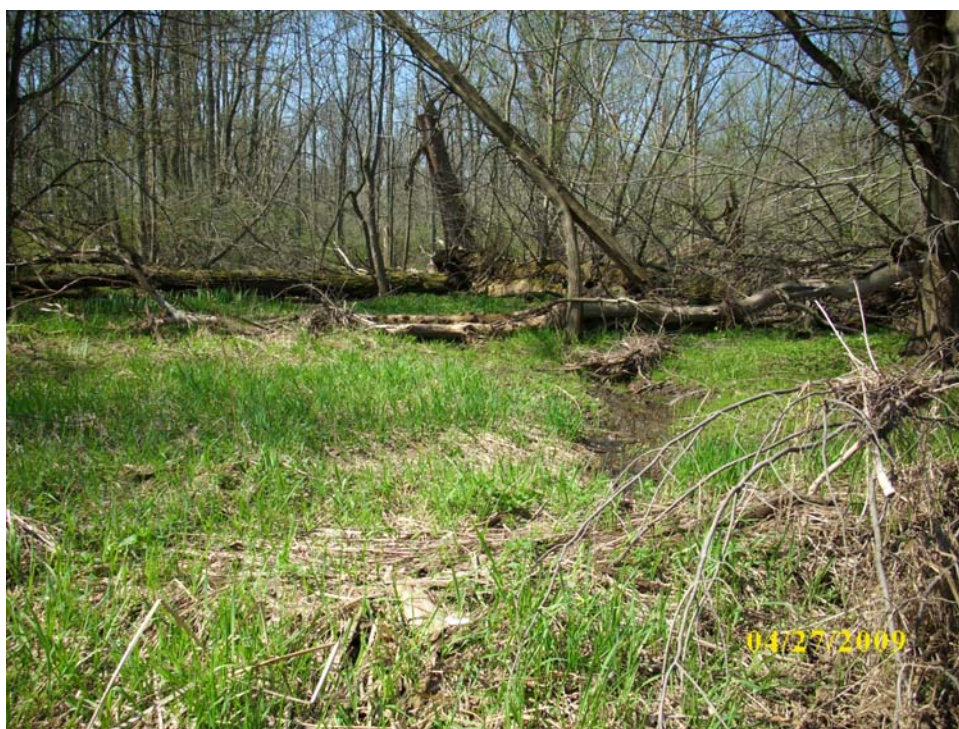
Photo: P68

Description: Wetland along RDB, flow during high water events (WD-028).

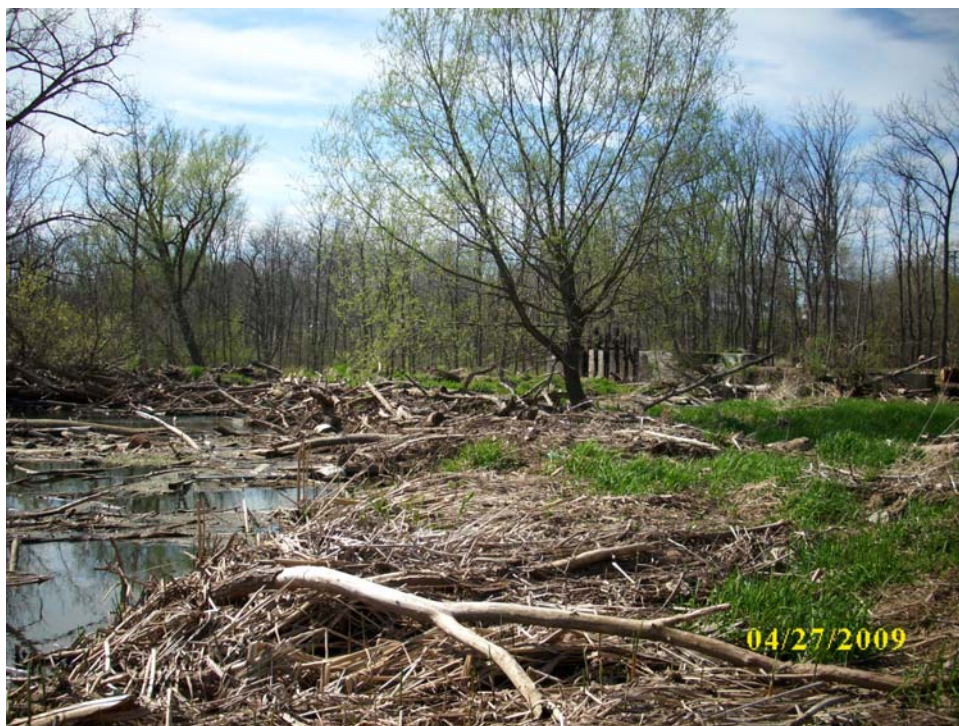
Description: View of culvert upslope from creek channel along RDB (OUT-027).

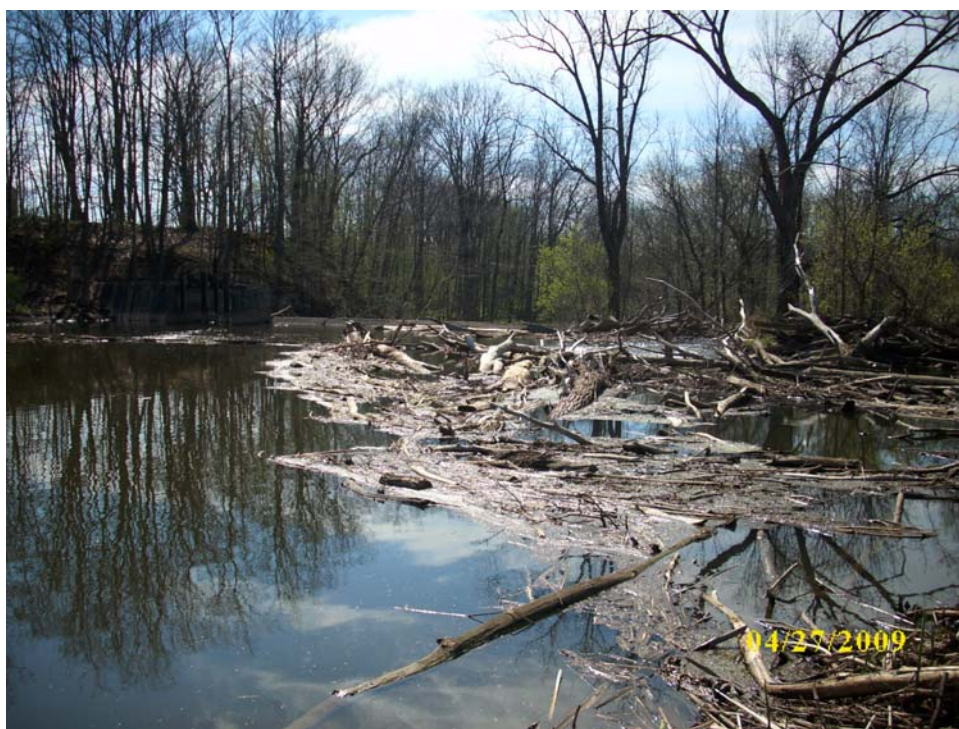
Photo: P80a  
 Direction of view: NW  
 Description: View of areas upstream of Newfane Dam.

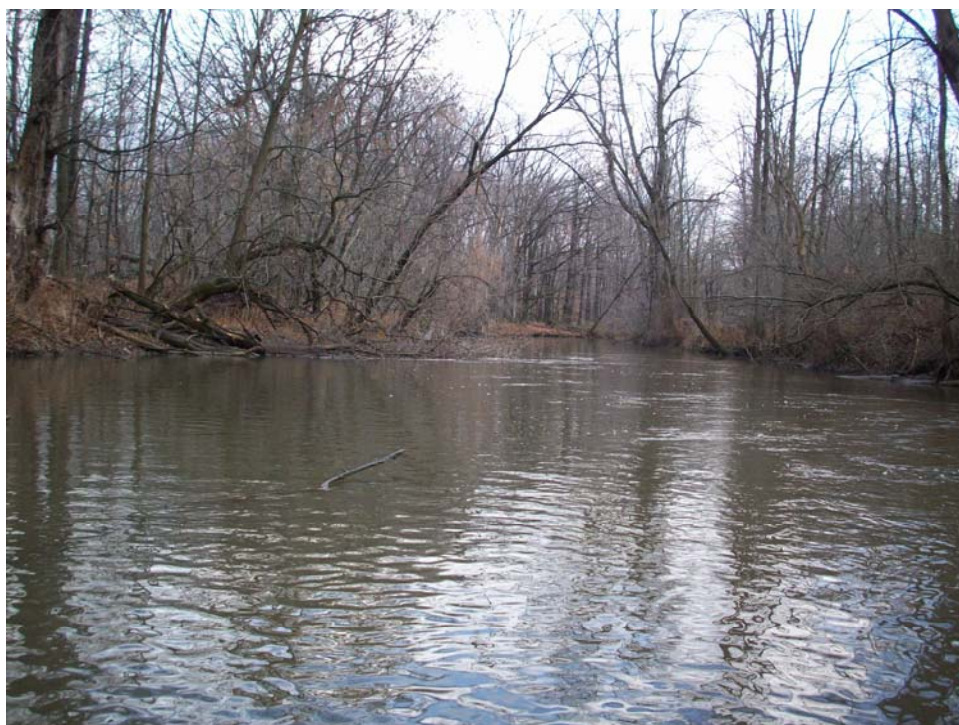
Photo: P04

Description: Gooseneck.

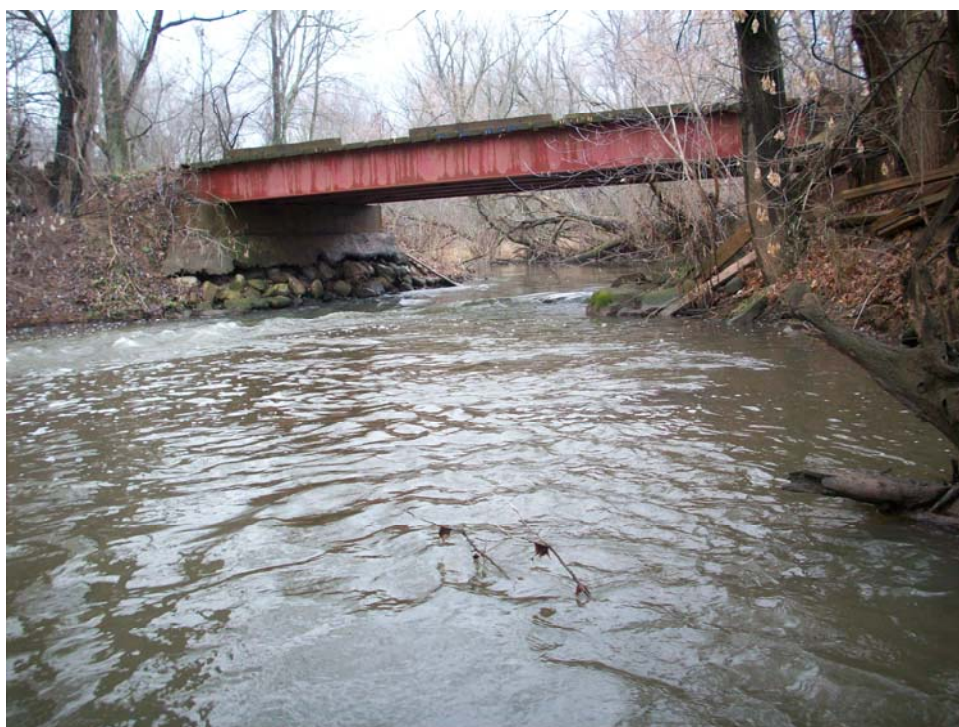
Photo: P05

Description: Downstream of farm bridge.

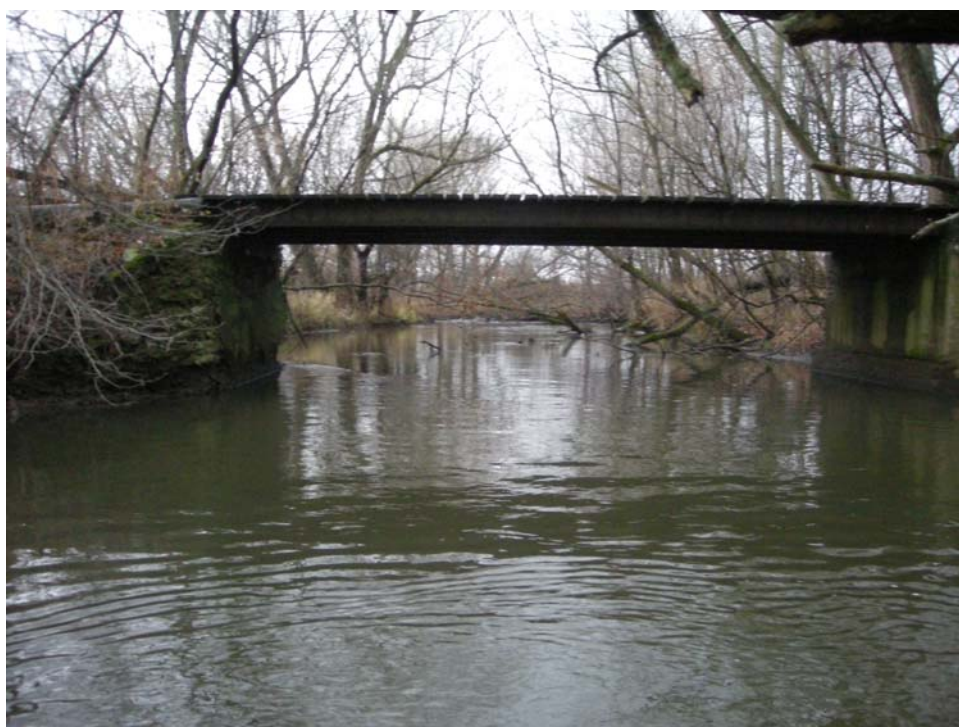
Photo: P22A  
 Direction of view: SE  
 Description: Farm bridge #1 from RDB.

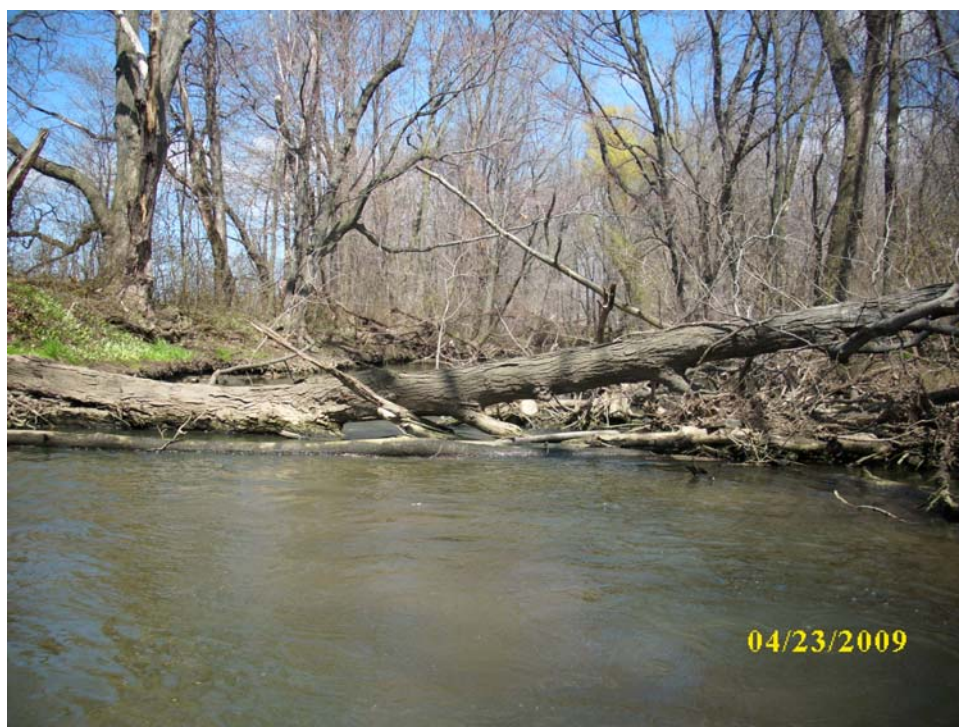
Description: Agricultural drainage along LDB (DRN-025).

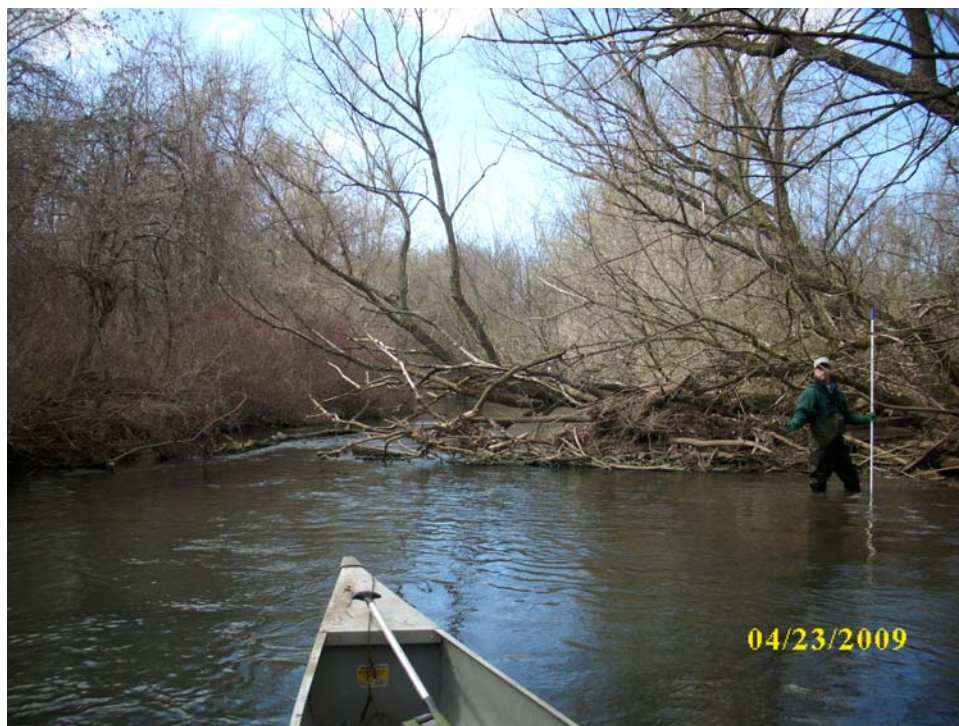
Description: Overland drainage to creek along LDB.

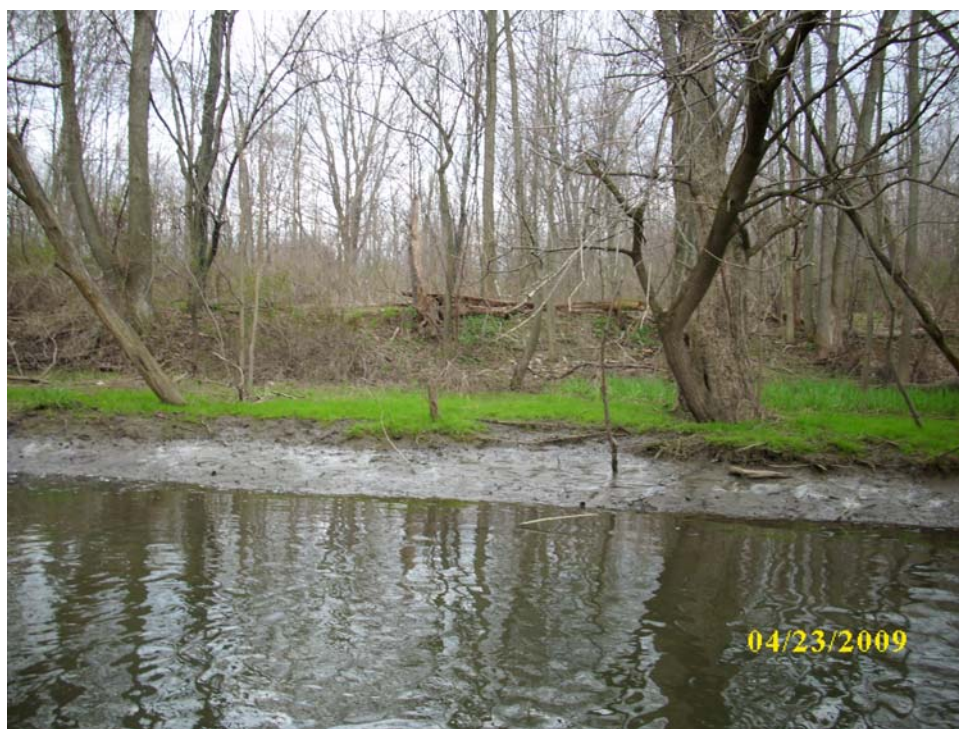
Photo: P56

Description: LWD obstruction covering most of creek (OBS-032).

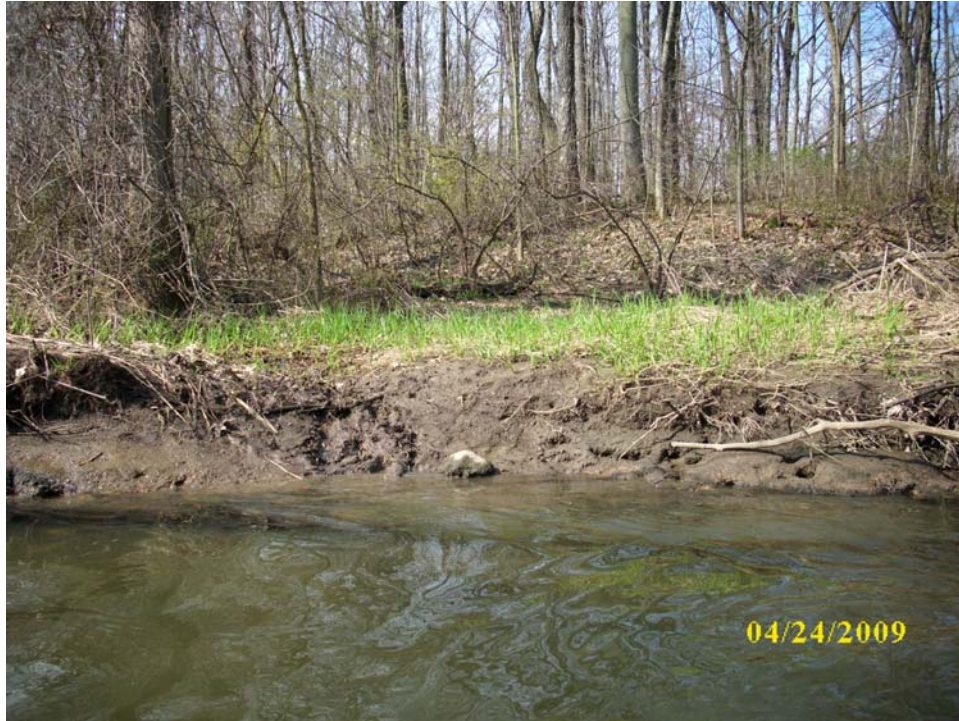
Description: Tar-like material found on LDB.

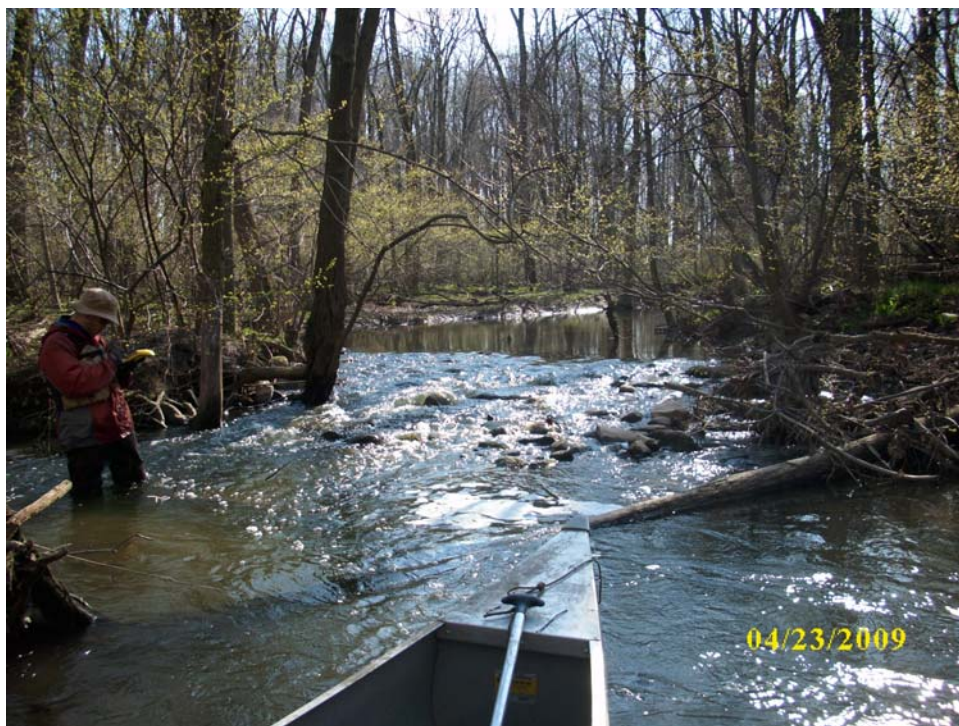
Photo: P97  
 Direction of view: SW  
 Description: Discharge from large forested wetland (WET-021)

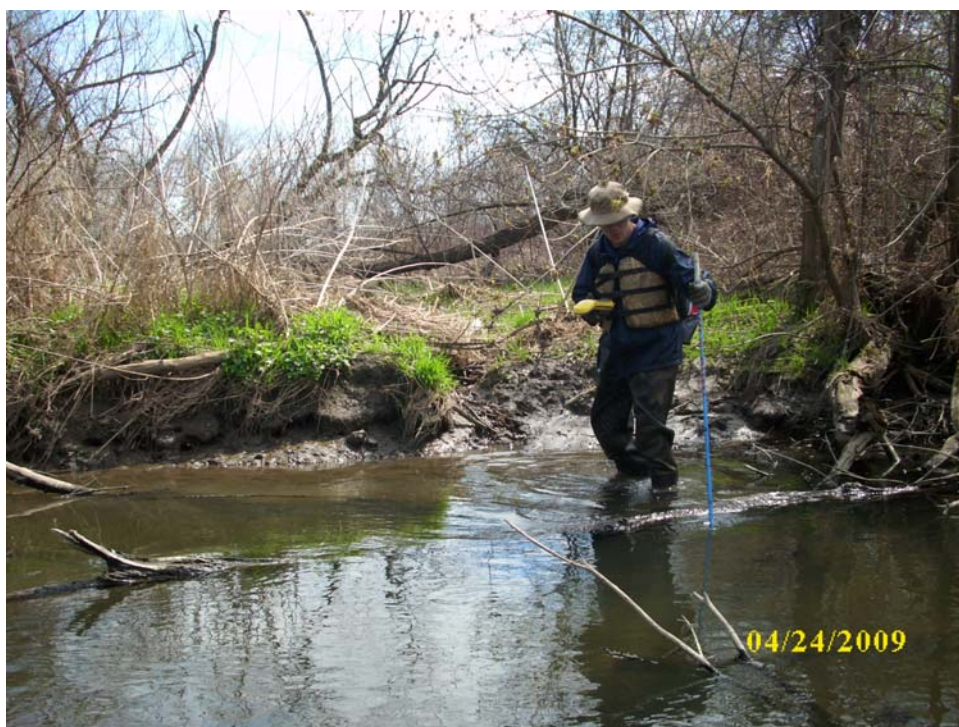
Photo: P98

Description: Tributary along LDB with riffle at confluence (TRB-024).
