## PHASE II ENVIRONMENTAL SITE ASSESSMENT

INDEPENDENT POWER PLANT

ROME, NEW YORK

Atlantic Energy Systems

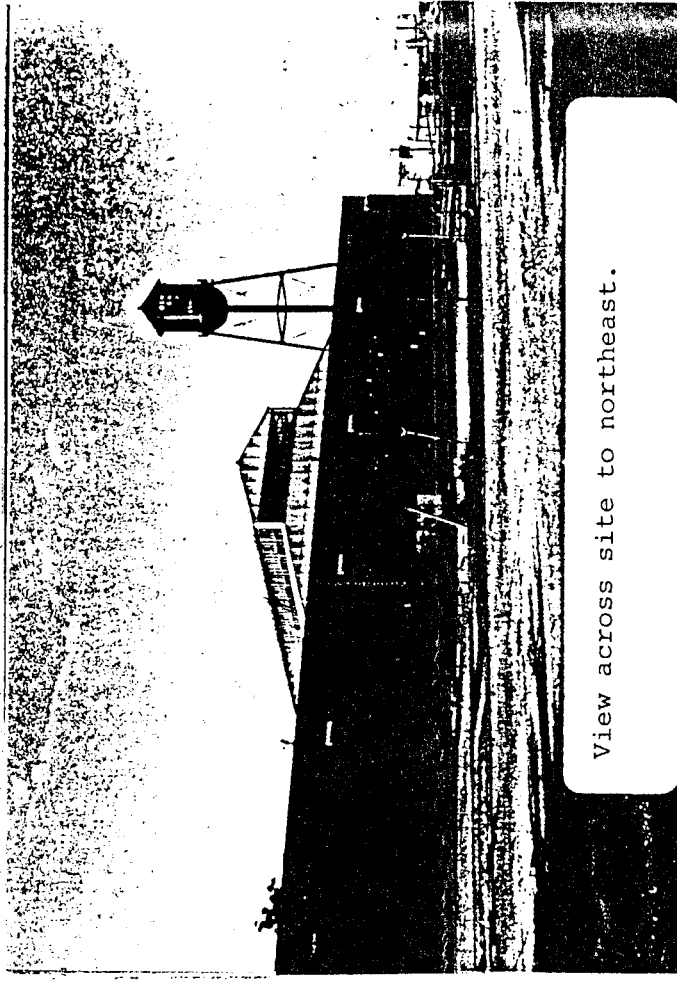
View across site to northeast.

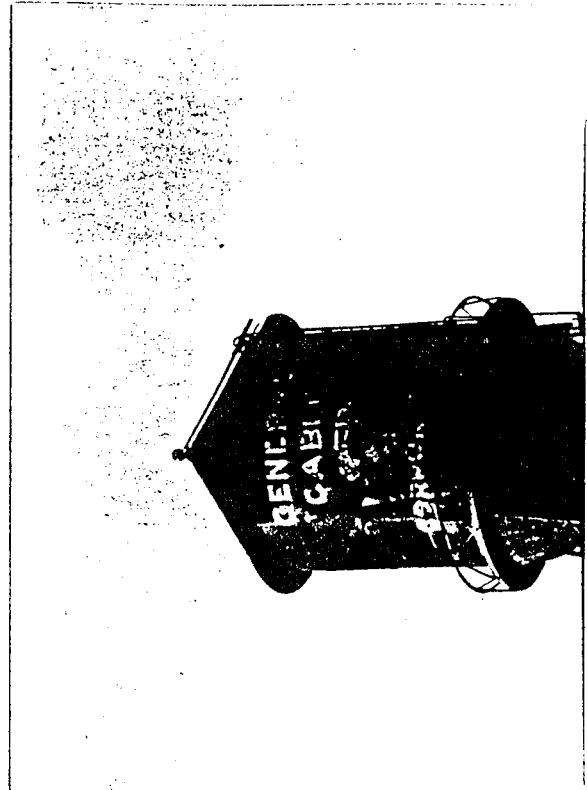
Water storage tower for General Cable Corp.

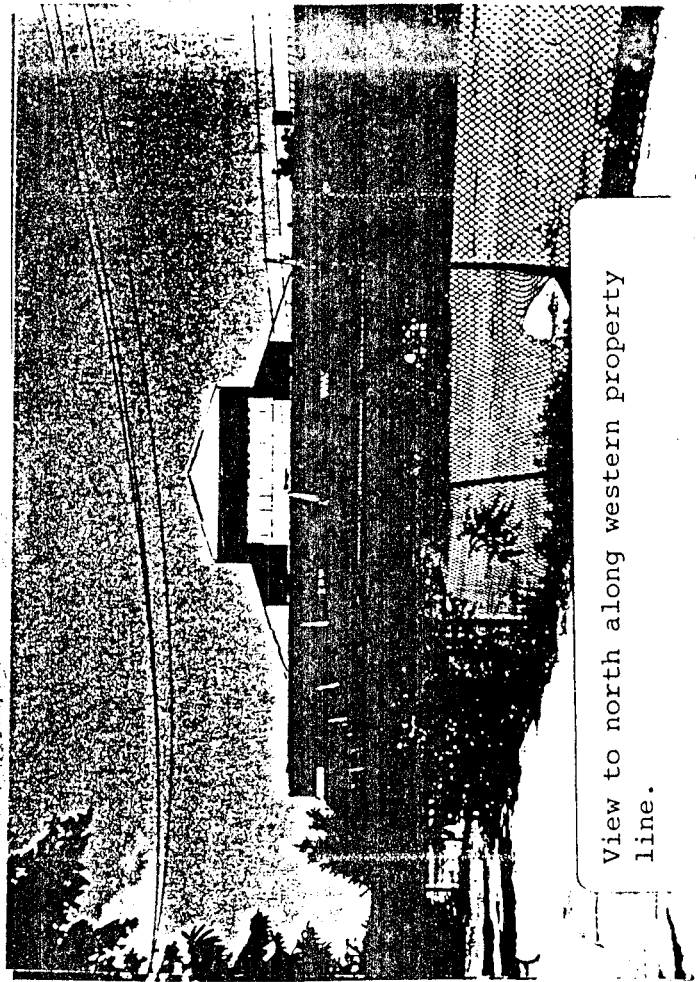
View to north along western property line.
