Asbestos Survey Report

Asbestos Materials Survey

Former Photech Facility
1000 Driving Park Avenue
Rochester, New York

LaBella Project No. 209288.03

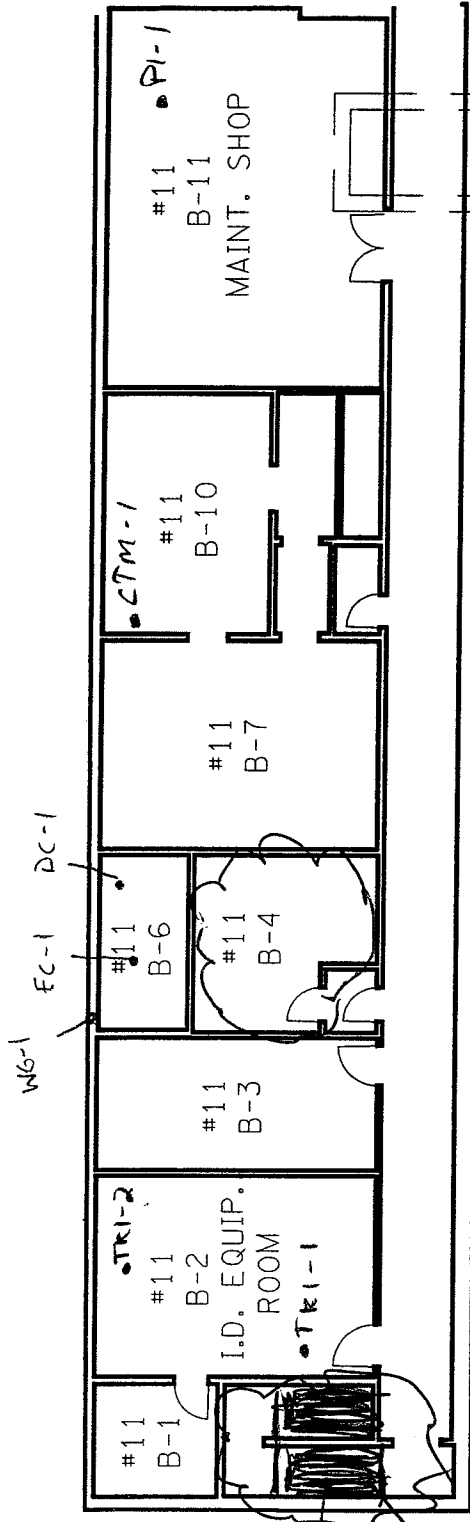
BUILDING #11 CHEM. LAB. BASEMENT

Throughout Basement - white Pipe Insulation - 800 linear ft
 - Grey Window Glaze - 200 sq. ft.
 Debris on Floor - white Pipe Insulation - 2,000 linear ft.
 Room B-4 - Grey Expansion Cloth - 4 sq. ft.
 - Red Duct Caulk
 Stairway - Orange sheet Vinyl & Mastic 130 sq. ft.

THIS ENTIRE AREA HAS BOTH INTACT & DISLODGED
 ACM P.W. - ALL AREAS OF P.W. ARE NOT SHOWN
 ALL ROOMS & HALL CONT @ ACM DEBRIS

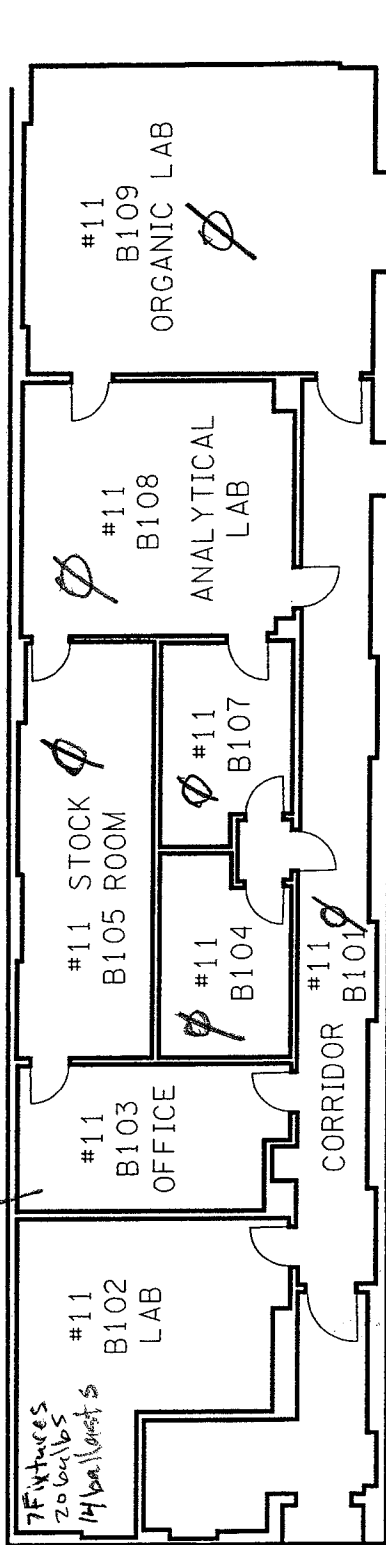
BUILDING #11
CHEM. LAB.
1ST FLOOR

Throughout 1st floor - White Fire Door Insulation - 420 sq. ft
 - White Pipe Insulation - 160 linear ft
 Office B103 - Brown 12x12 Floor tile & Mastic - 225 sq. ft
 Labs B108 & 109 - Grey Transite (cabinet liners & hoods) - 300 sq. ft

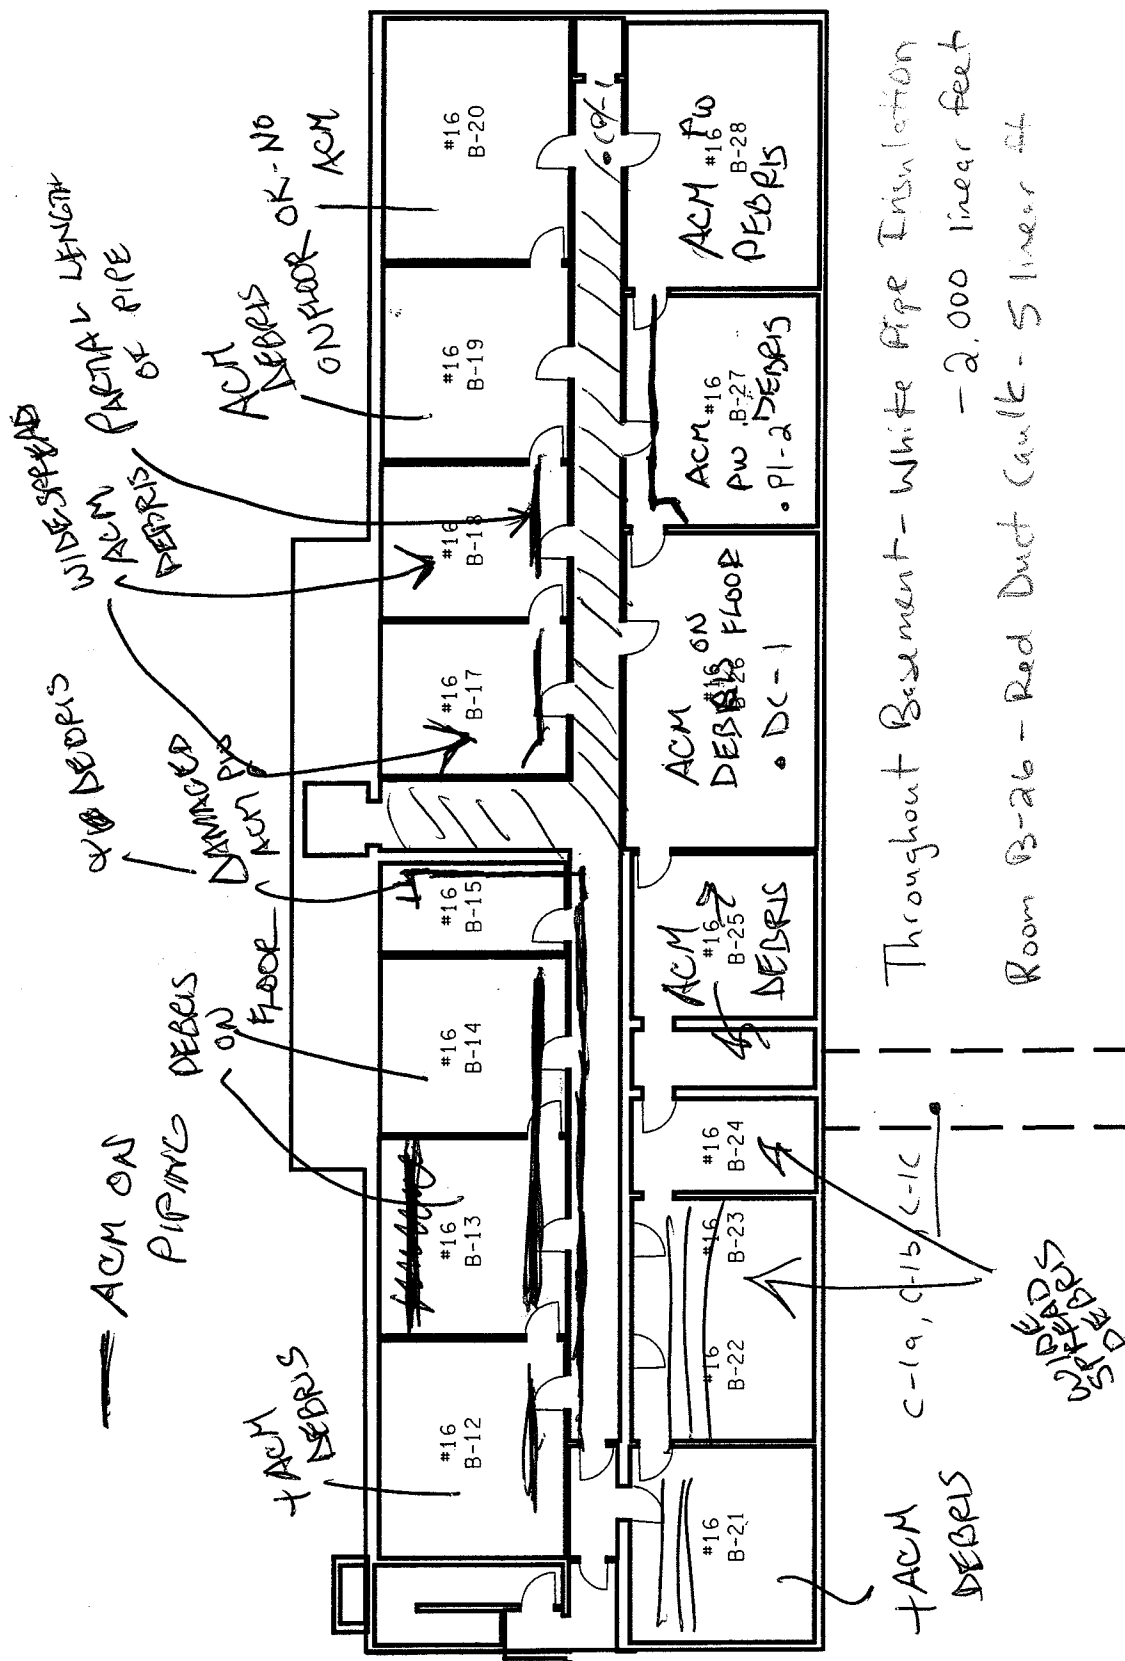
**BUILDING #16
PROCESS BUILDING
BASEMENT**

Throughout Basement - White Pipe Insulation
- 2,000 linear feet
Room B-26 - Red Duct Caulk - 5 linear ft

GRAY 9X9 FT/MAS.
IS LOOSE, DAMAGED

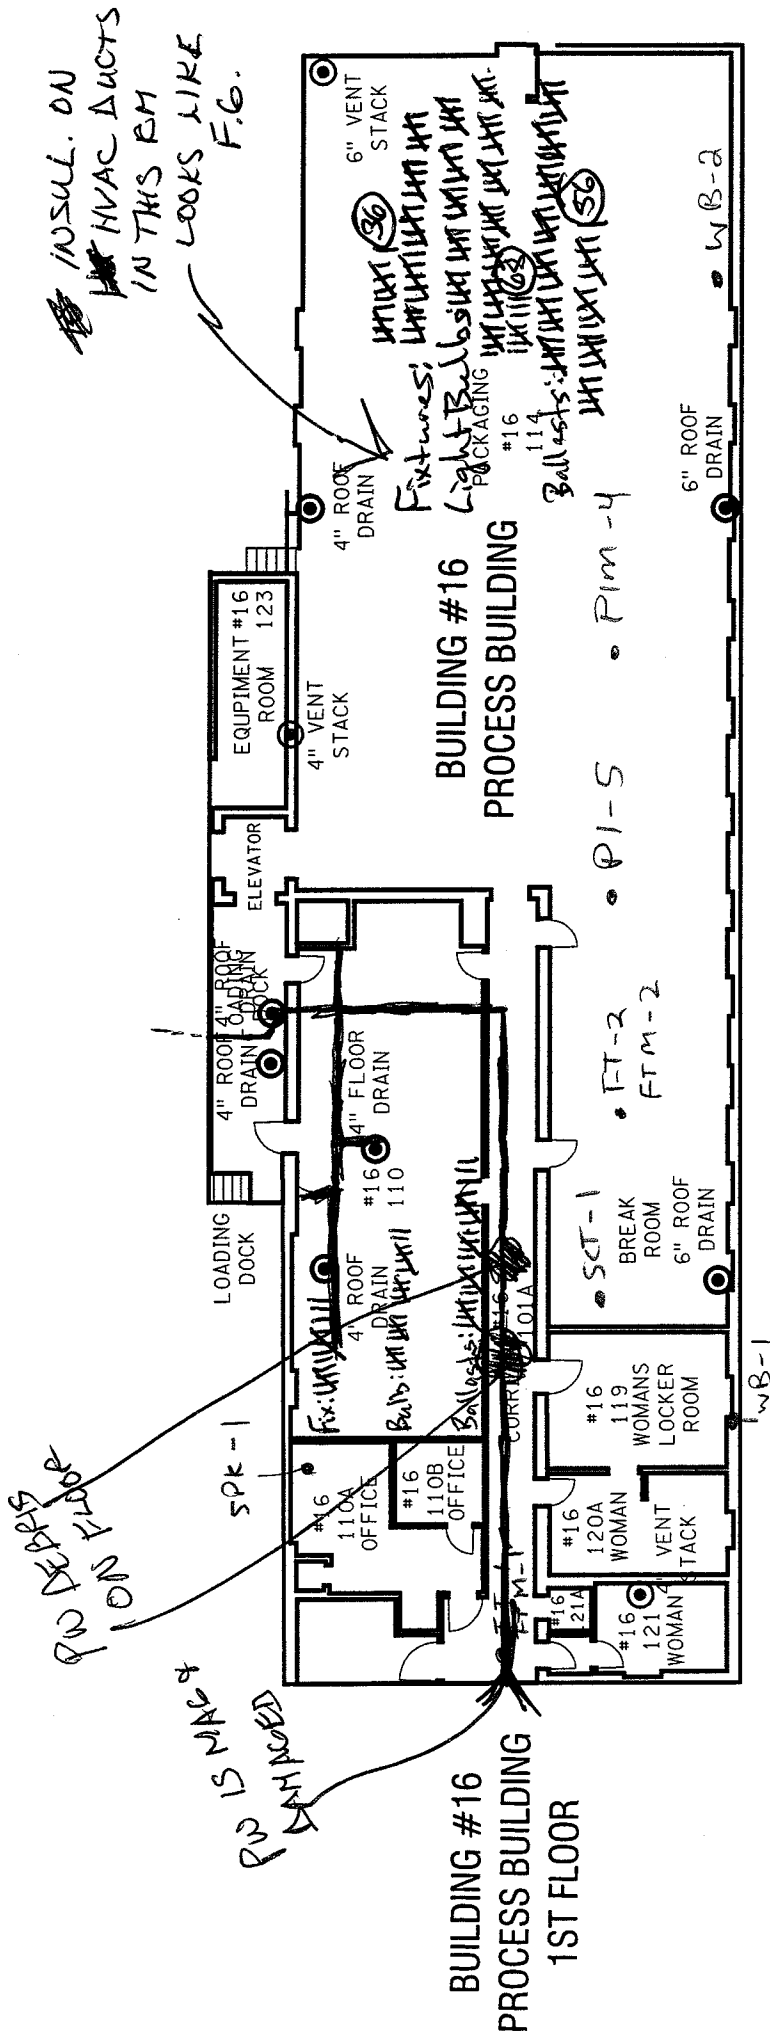
Throughout 1st floor - White Pipe Insulation & Black Pipe Insulation Mastics

Packaging Room - Grey 9x9 floor tile & plastic
-1,300 sq. ft.

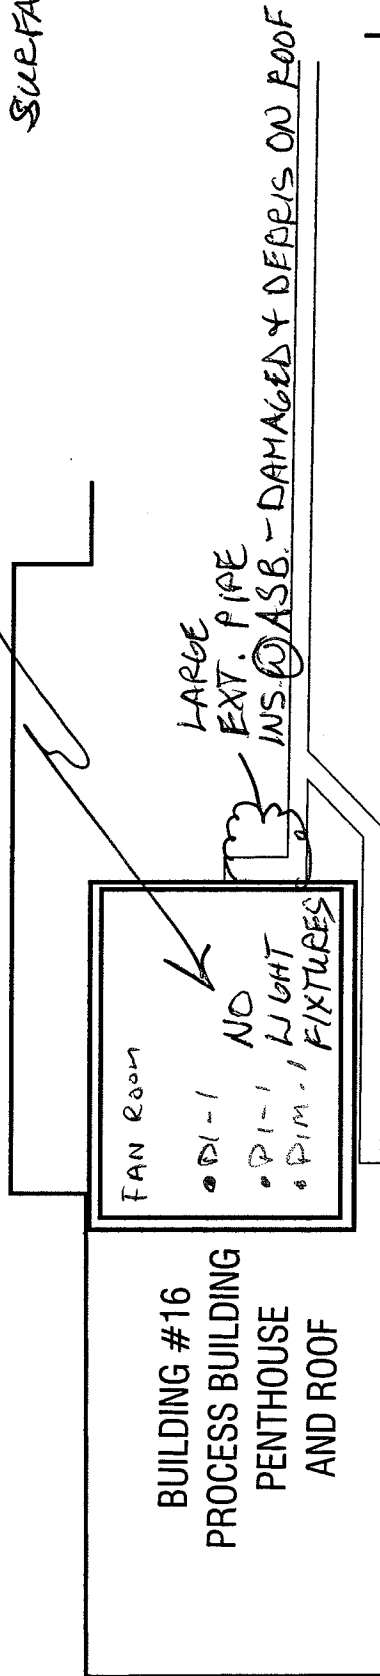
FAN Room (Interior & Exterior)

ENTIRE PENTHOUSE CONT. @ A. DEBRIS
SCATTERED ON FLOOR & ALL HORIZ.
SURFACES

- White Pipe Insulation & Black Pipe Ins. Master ✓ OK
- 350 linear ft. & DEBRIS - SCATTERED IN ENTIRE ROOM
- White Duct Insulation - 600 sq. ft. ✓ OK

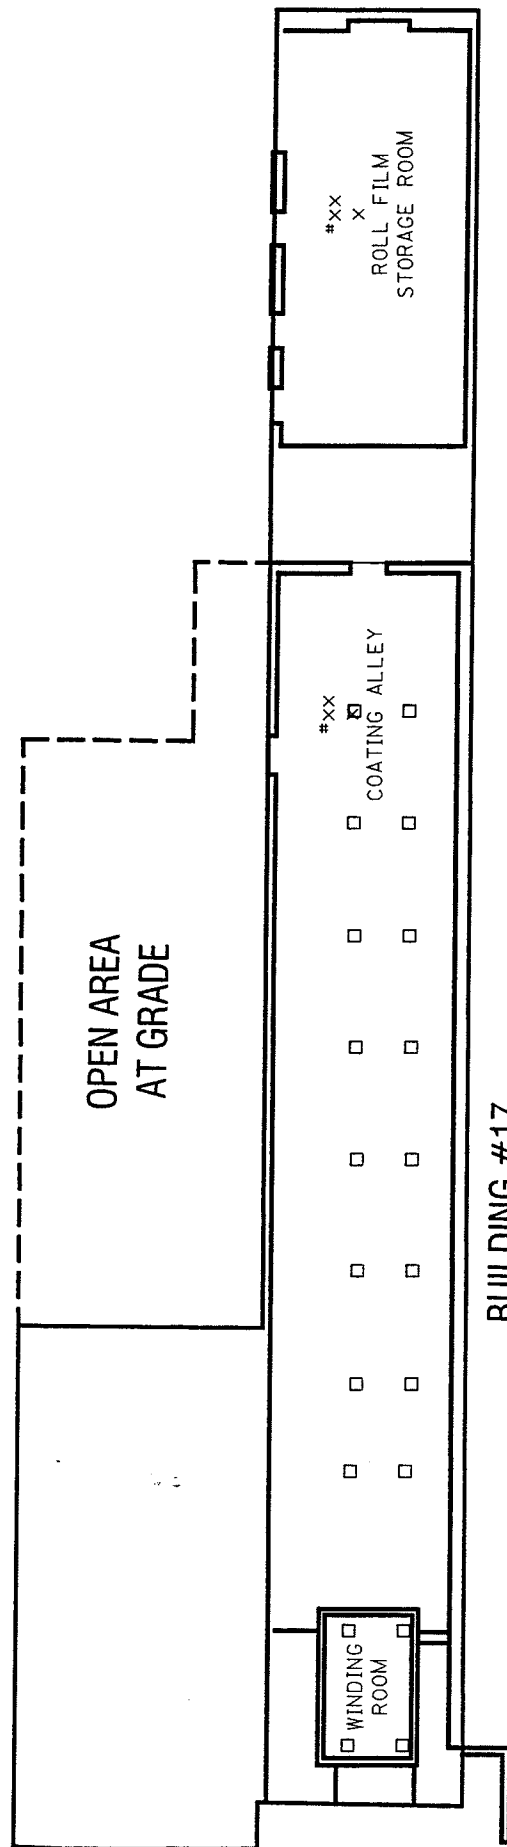
BUILDING #17

Throughout Floor - White fire door Ins. - 120 sq ft

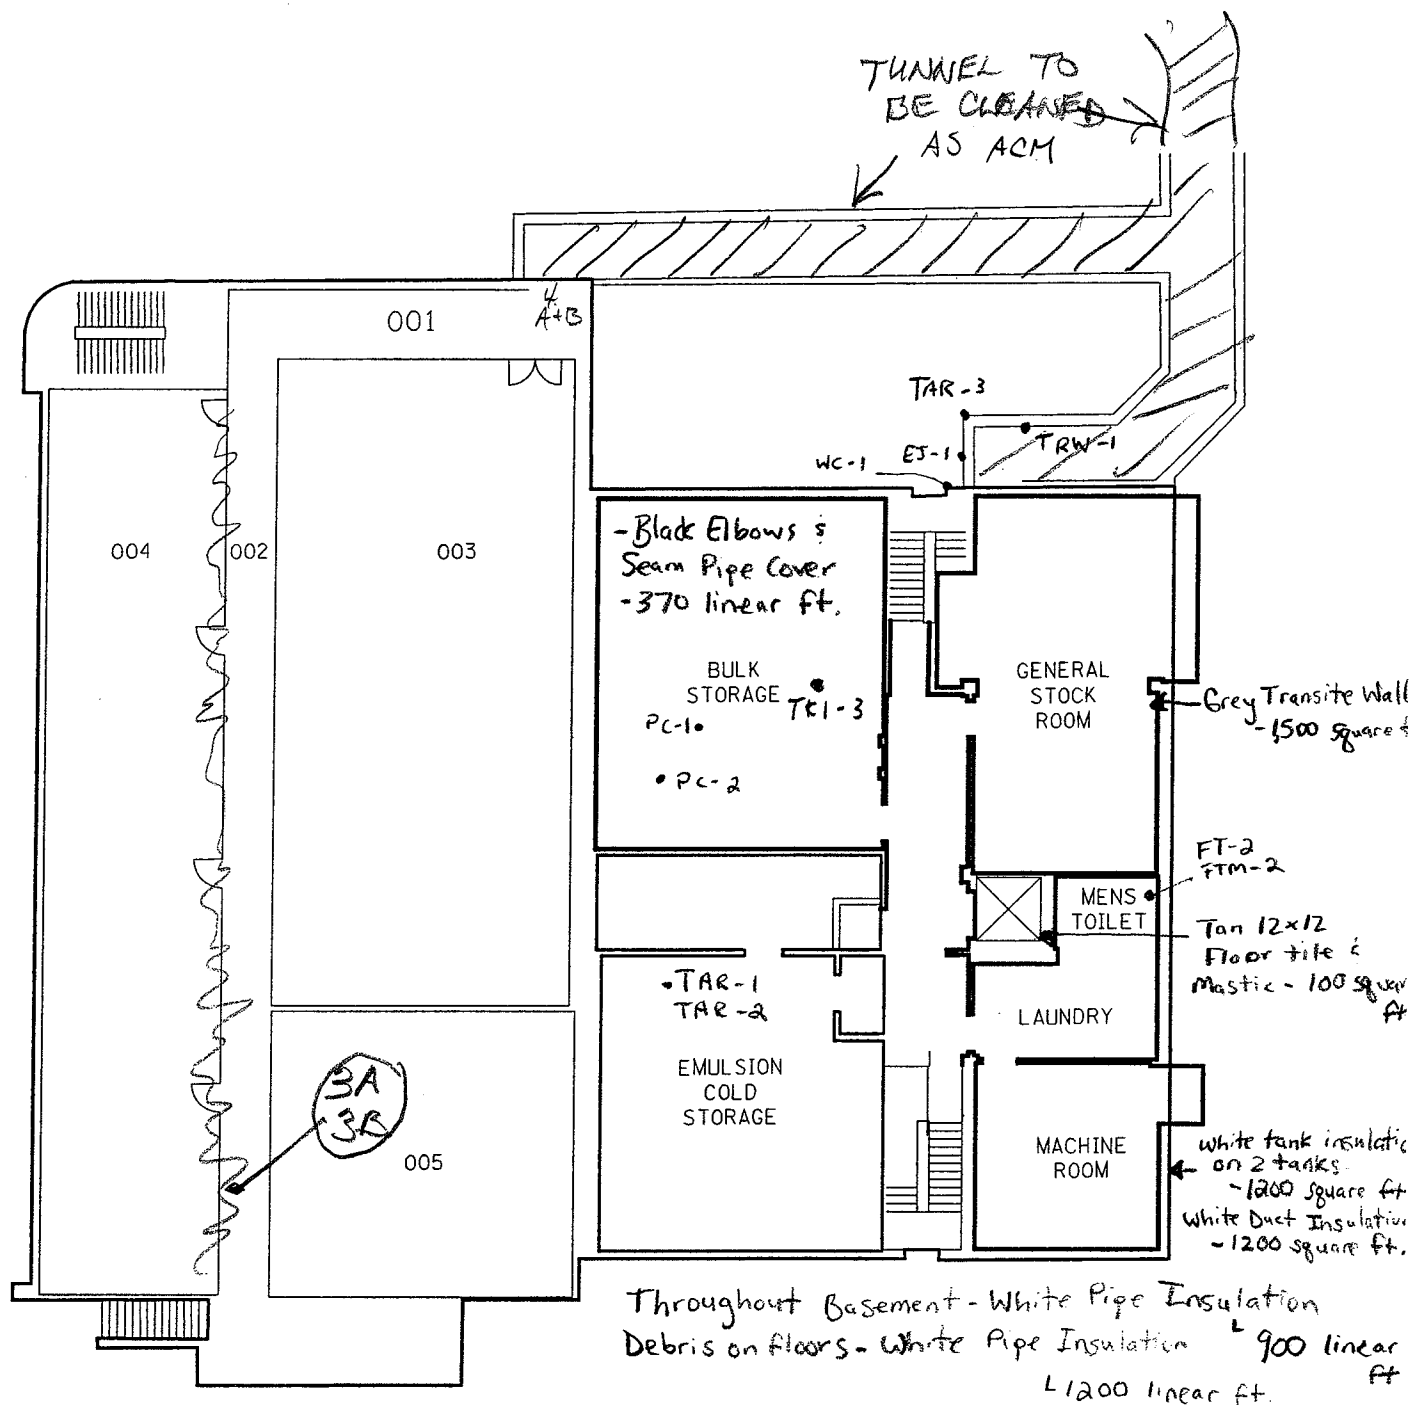
BUILDING #1
R&D
ADDITION
BASEMENT

Storage Area - Black Tank Coating 650 square ft.
Chill Room (under Cork Wall) Black Tar (2 layers)
-4000 square ft.

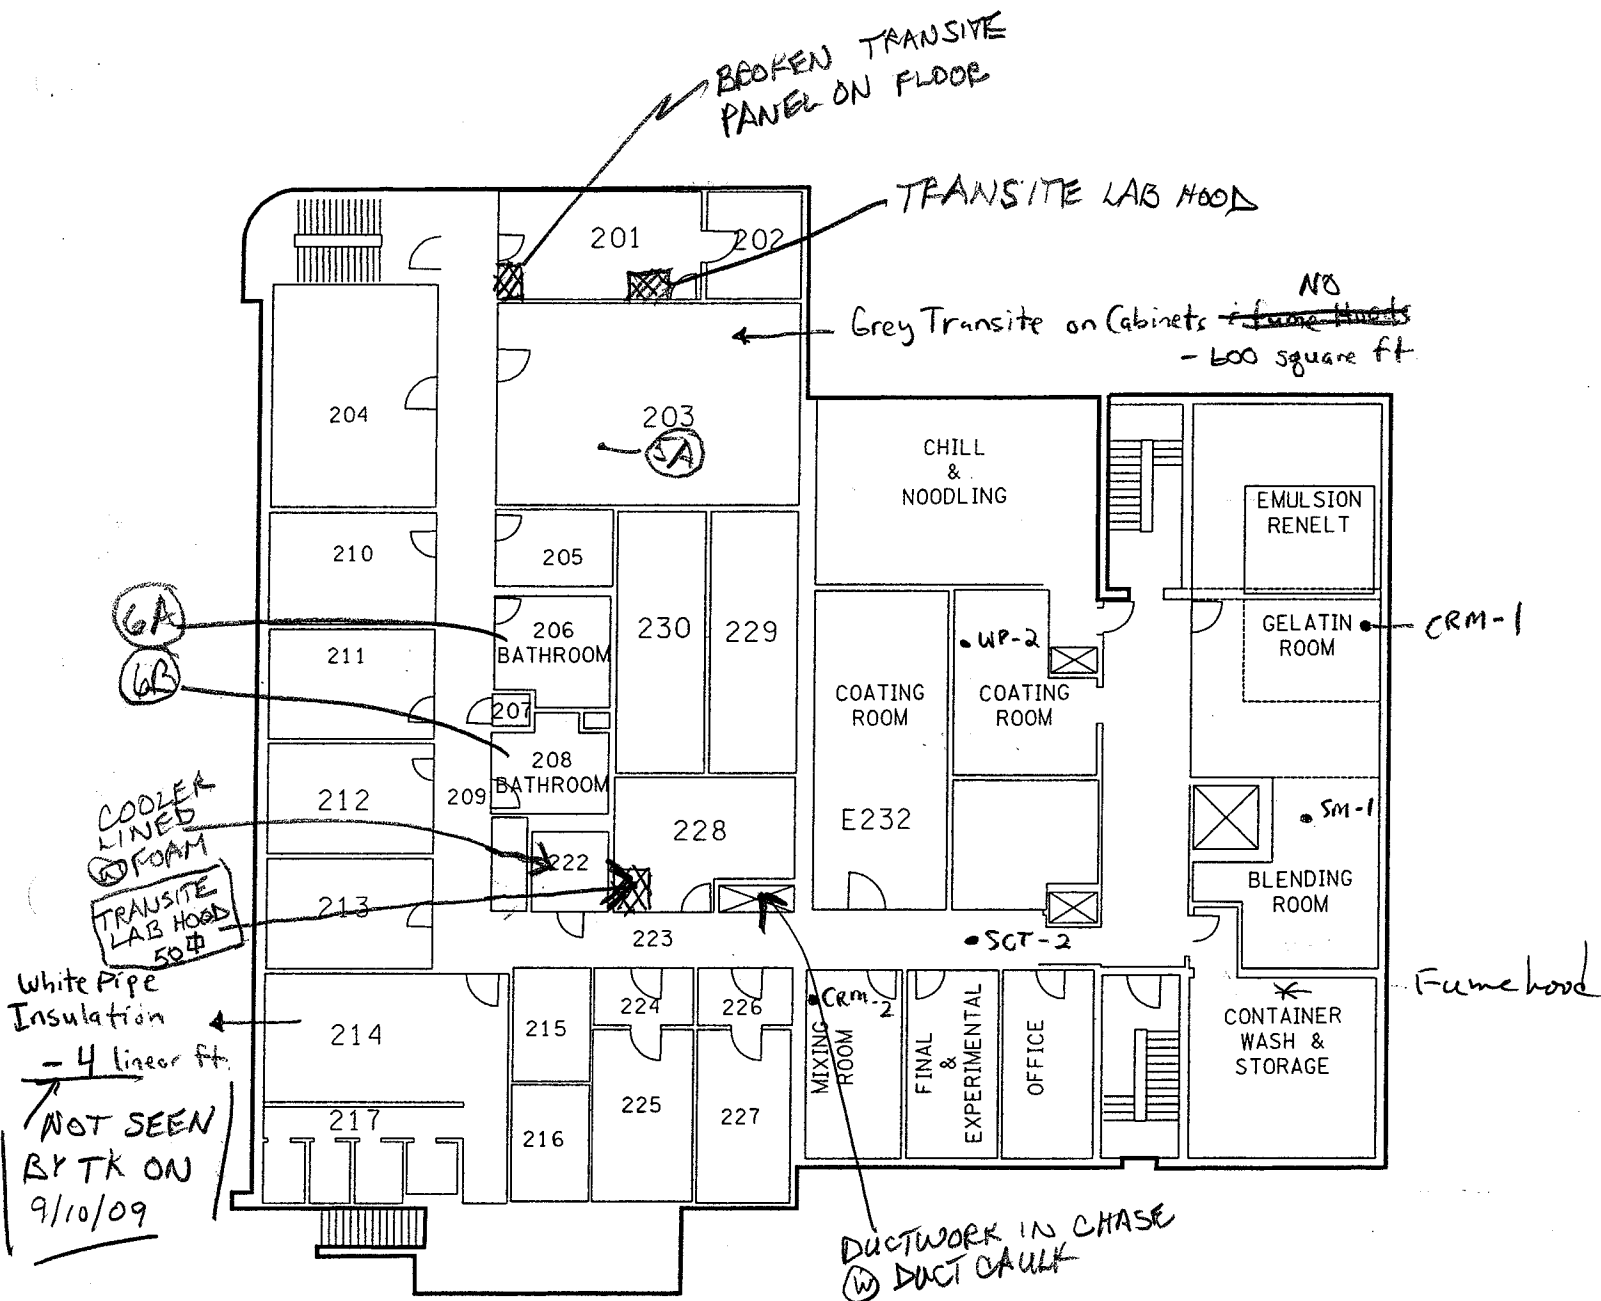
BUILDING #1
R&D
ADDITION
2ND FLOOR

ENTIRE 2ND FLOOR
SHOULD BE NOTED AS HAVING
THE POT FOR ASD; CONT.
DUCT CAULK

Throughout 2nd floor - Grey Duct Insulation - 875 sq. ft.
Debris in Corridors & rooms - White Pipe Insulation - 1200 linear ft
Laboratory Rooms - Transite Fume Hood - 80 sq. ft.
Room 227 - Black Sink Mastic - 30 sq. ft.

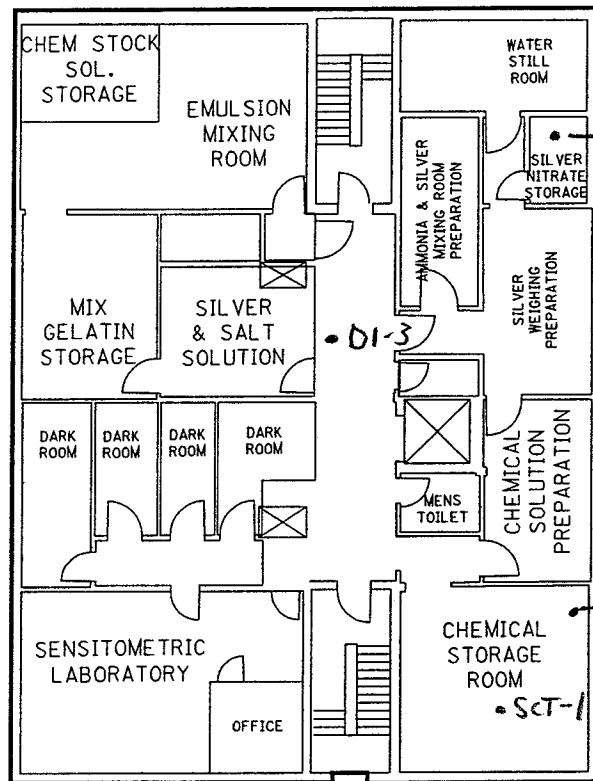
BUILDING #2
 EMULSION
 BUILDING
 3RD FLOOR

Throughout 3rd floor - Grey Duct Insulation
 Debris in Corridors & Rooms - White Pipe Insulation
 - 600 sq. ft
 - 1000 linear ft

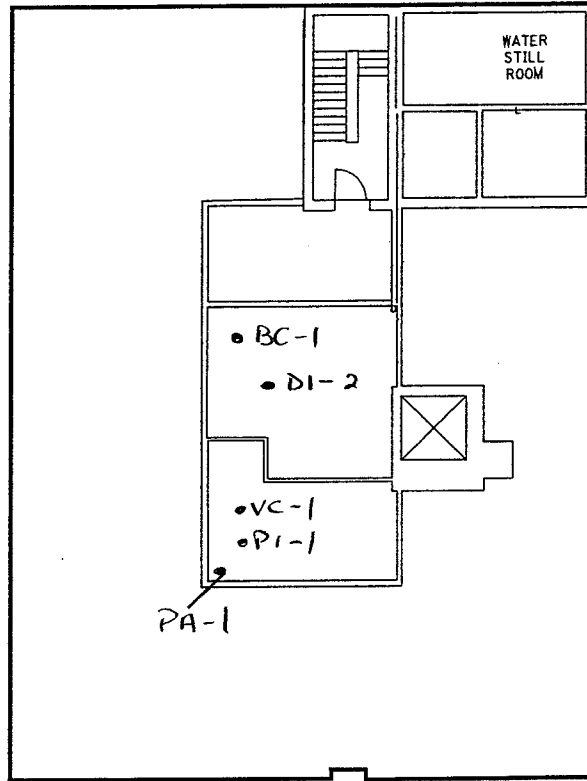
BUILDING #2
EMULSION
BUILDING
4TH FLOOR
PENTHOUSE

White Pipe Insulation - 260 linear ft.
Grey Vibration Cloth - 60 linear ft.
Grey Duct Insulation - 2,800 sq. ft.
Grey Wall Insulation - 30 sq. ft.
