Foundation Design, P.C.

June 1, 2012

Reference Photech Imaging Corporation Site – Phase II
1000 Driving Park Avenue, Rochester, NY
Construction Close-Out Letter, 3446.1

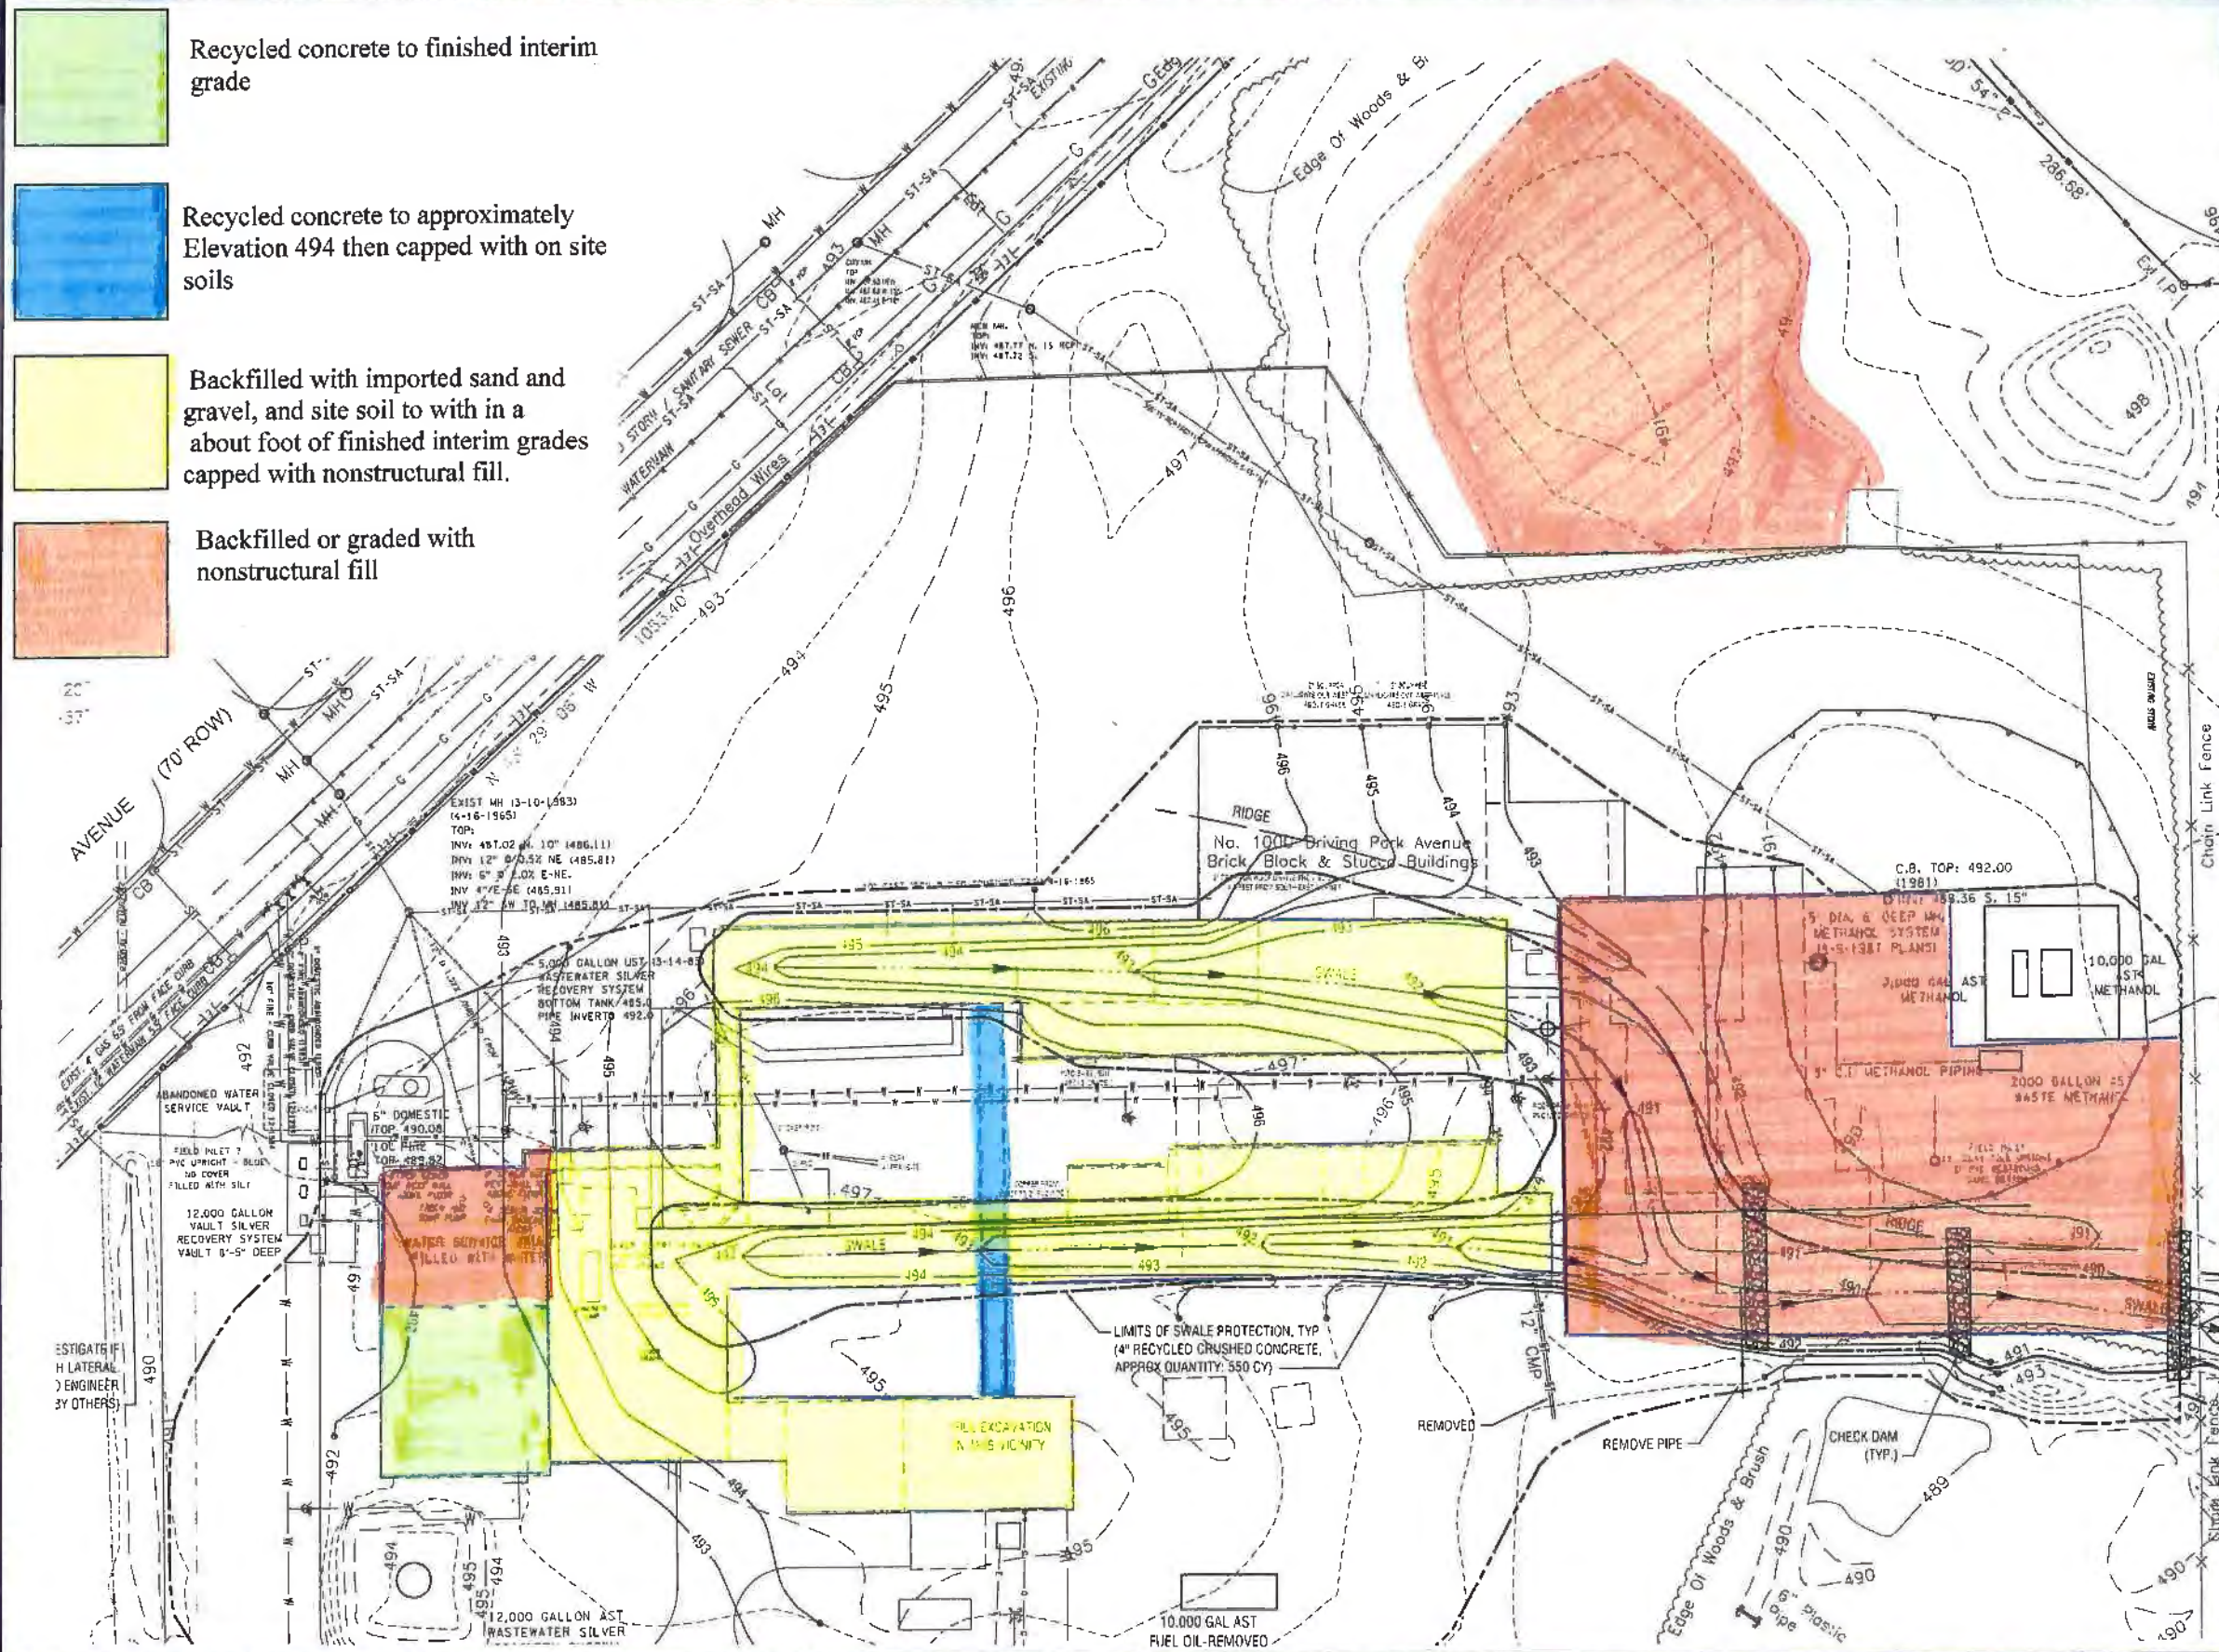
Phototech - Phase I Environmental
 1000 Driving Park, Rochester, New York
Fill Placement Plan
 Adapted from: LaBella Associates, P.C.
 Revised Grading Plan

On site fill material generally 3% to 5% above optimum moisture content for compaction
