Re: Site Management Periodic Review Report and IC/EC Certification
Submittal for Barretto Point, B00032

2019–2021 Periodic Review Report
Barretto Point Site
Bronx County, New York
NYSDEC Site Number: B00032-2
HP-238 Hunts Point WWTP New Anaerobic Digester Facilities

Prepared for
New York City Department of Environmental Protection
March 2021

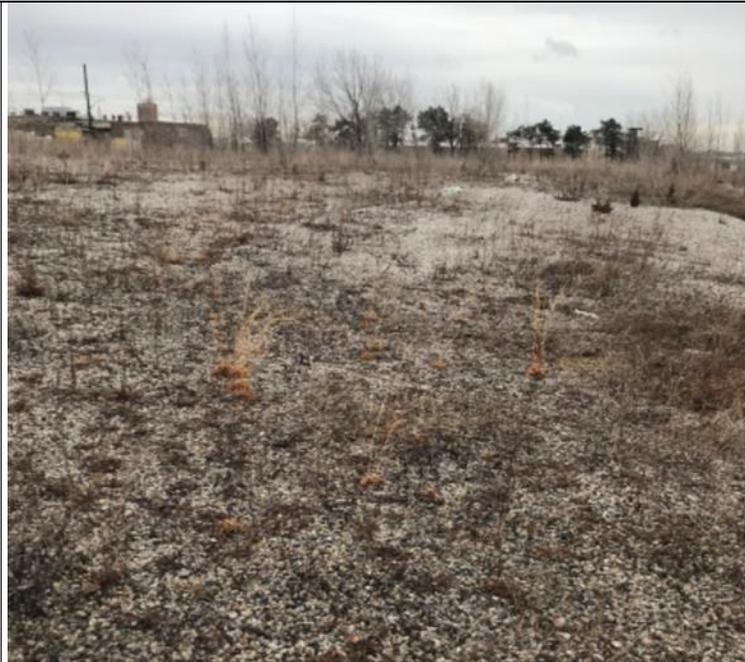
Photograph #1 – General View of Smaller 2.5-Acre Area of Site Looking South

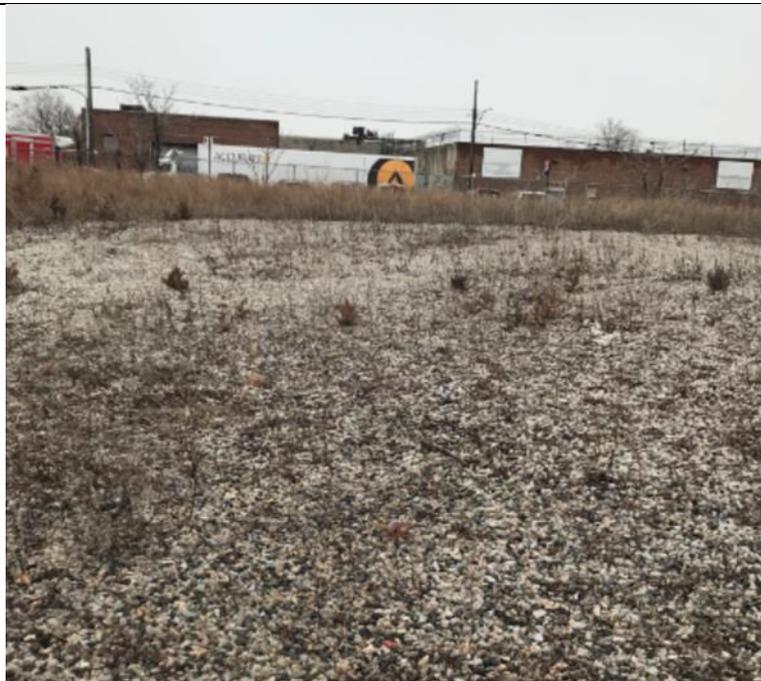
Photograph #2 – General View of Smaller-2.5 Acre Area of Site – Looking North

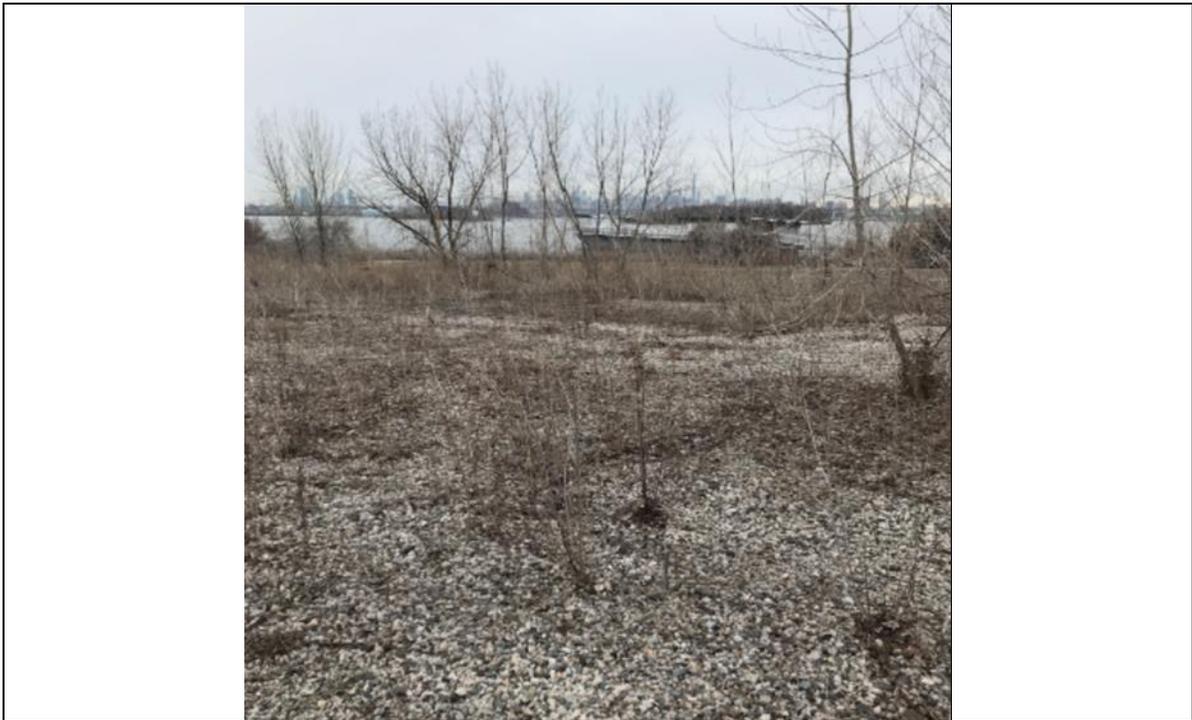
Photograph #3 – View of Smaller 2.5-Acre Area of Site Looking West

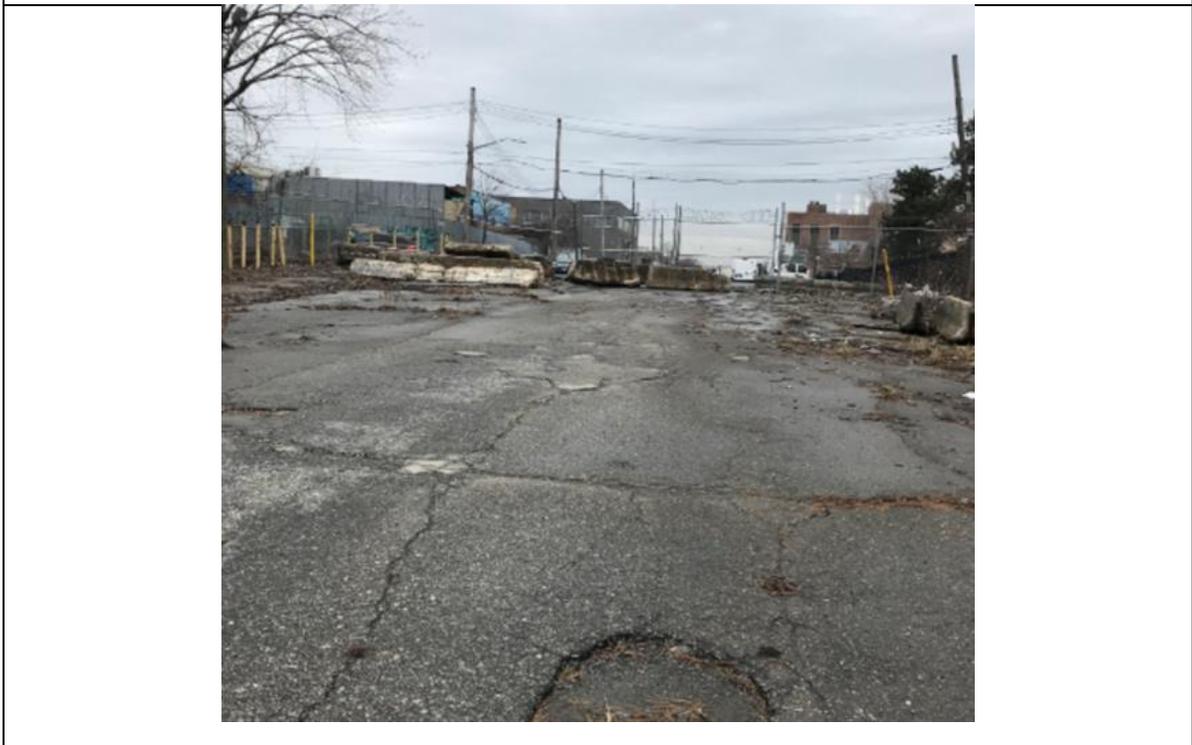
Site includes de-mapped unused roads at the extensions of Ryawa Avenue and Barretto Street where there is asphalt roadways with visible deterioration. Deteriorating roadways are nearly never used and appear to be in similar condition as last year's inspection.

Photograph #4 – View of Asphalt on demapped length of Ryawa Ave. Looking West

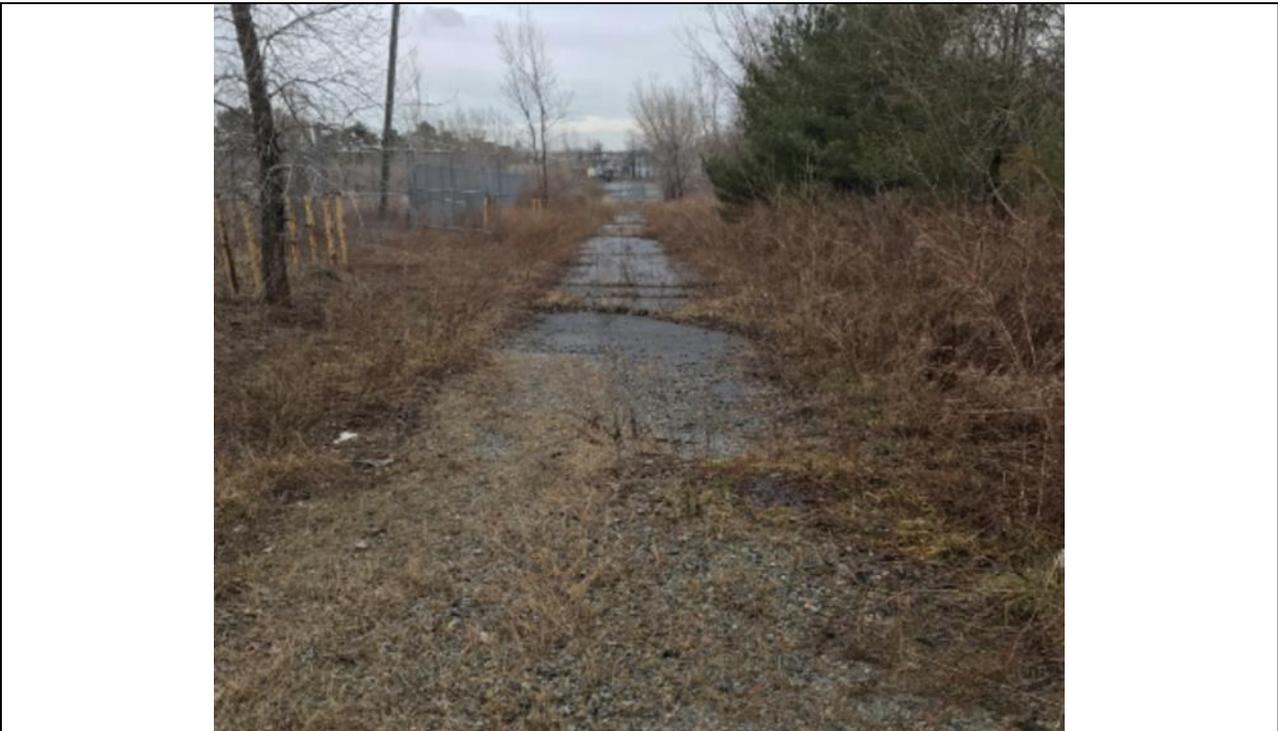
Photograph #5 – View of Asphalt Roadway (Barretto Street Extension)

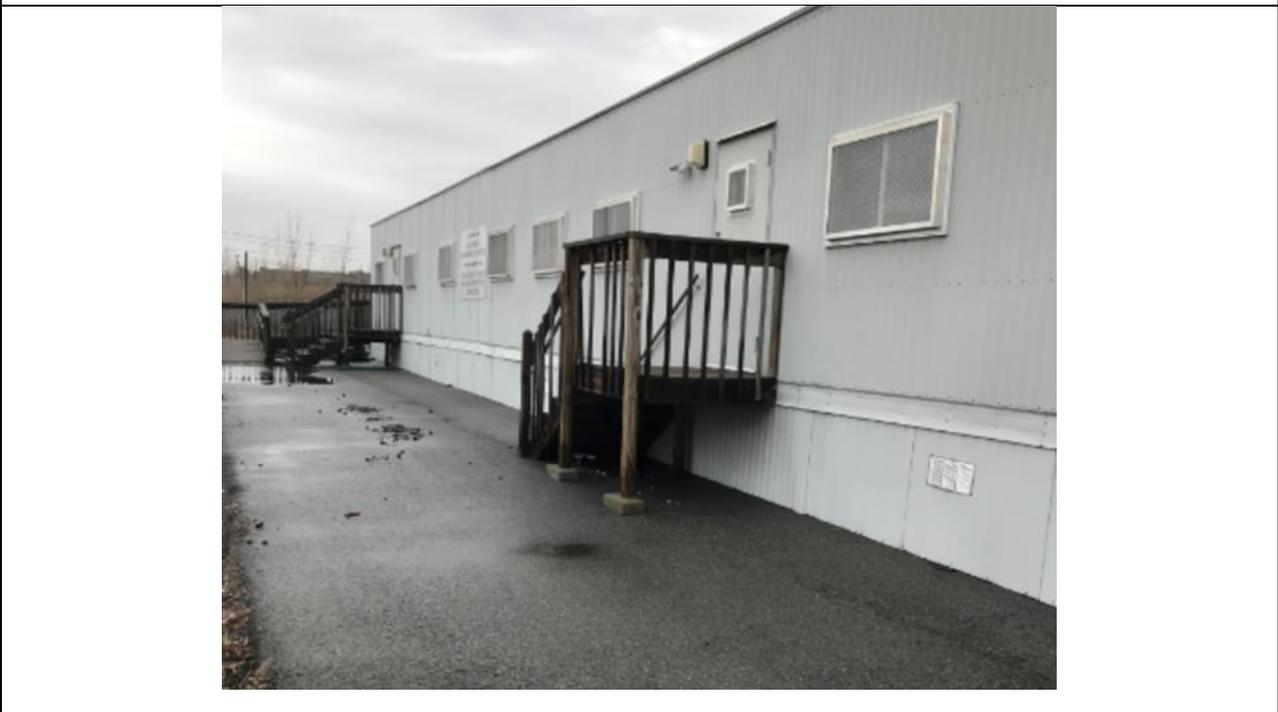
Photograph #6 – View of DEP Construction Trailer

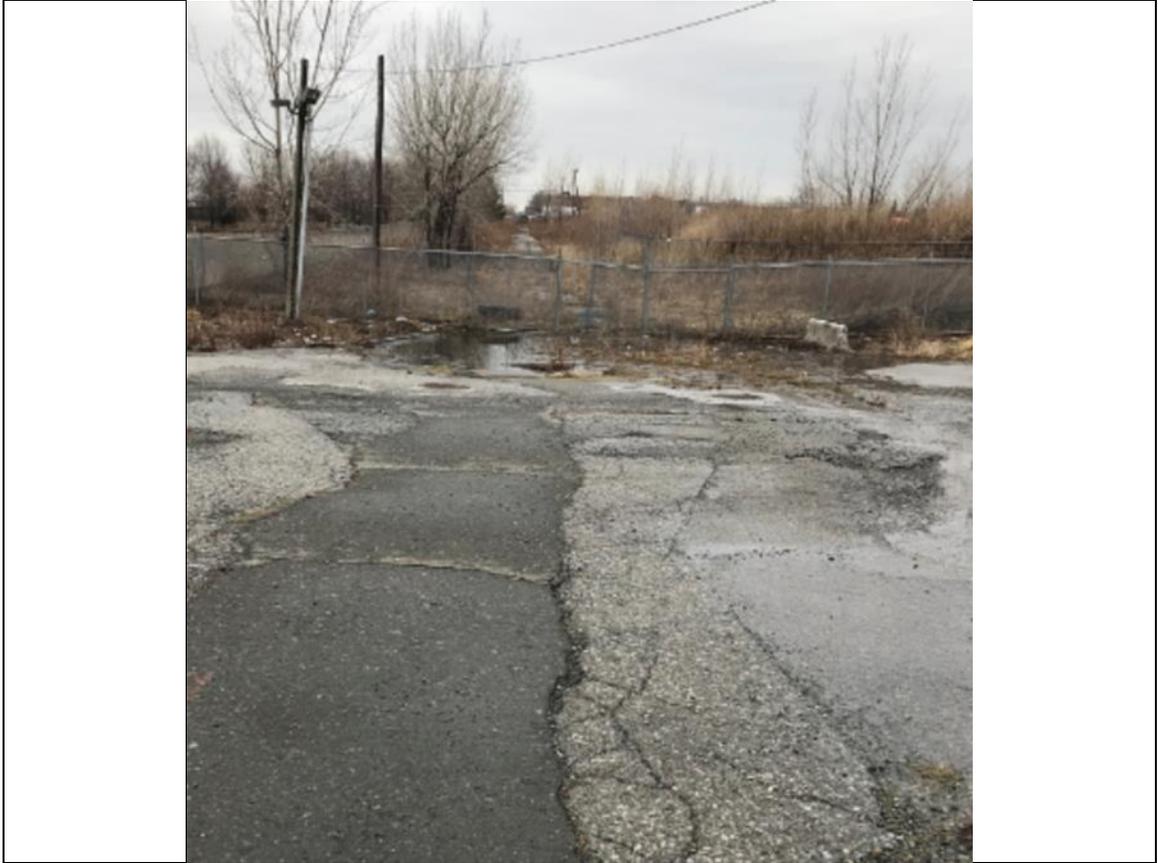
Photograph #7 -View Looking North from Trailer Area Parking to Barretto St.

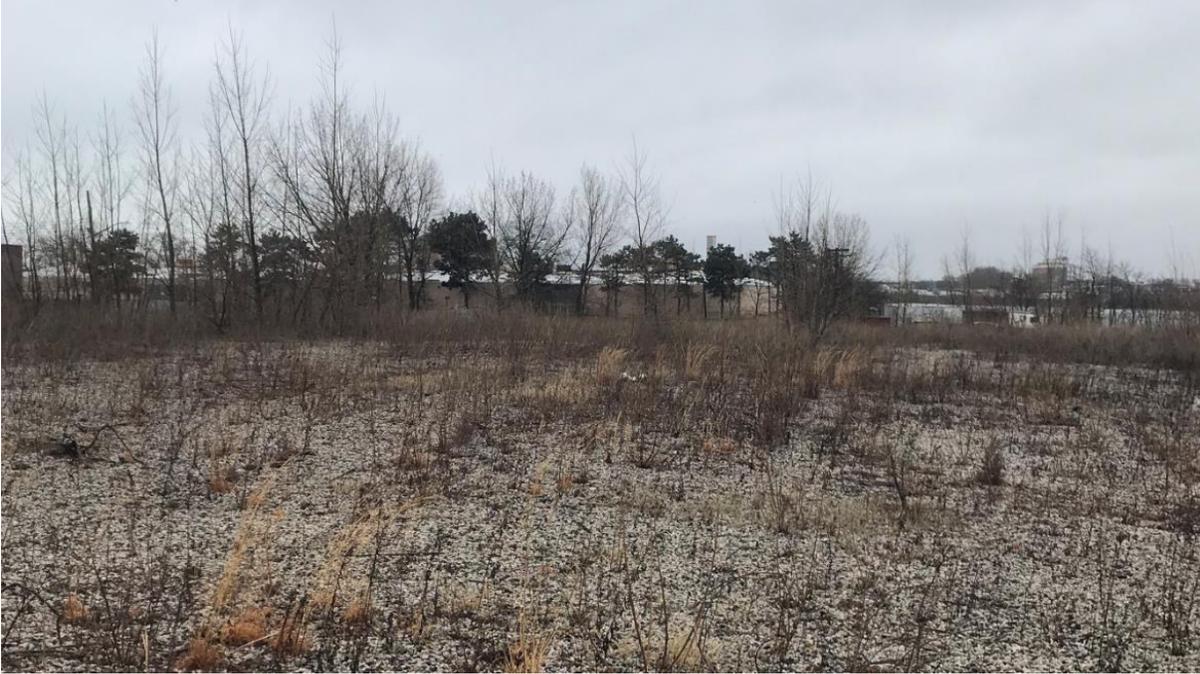
Photo 1 - General View of Smaller 2.5-Acre Area of Site

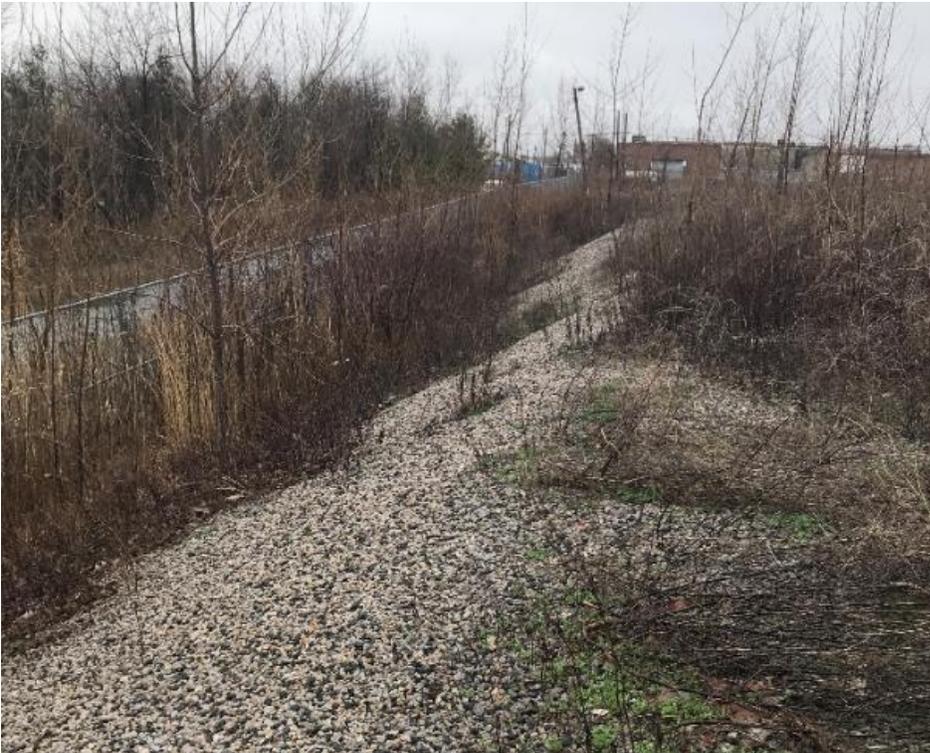
Photo 2 - General View of Smaller-2.5 Acre Area of Site

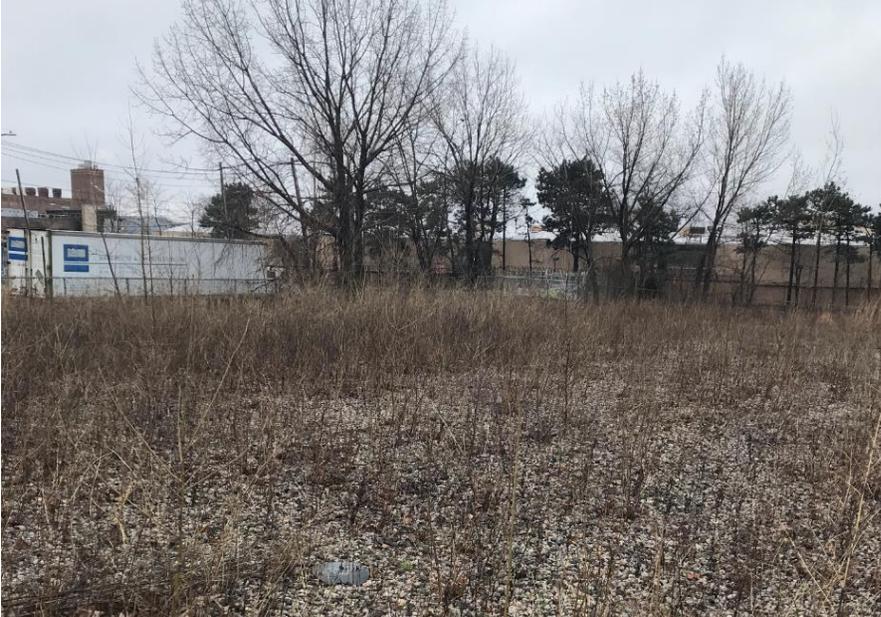
Photo 3 – View of Smaller 2.5-Acre Area of Site

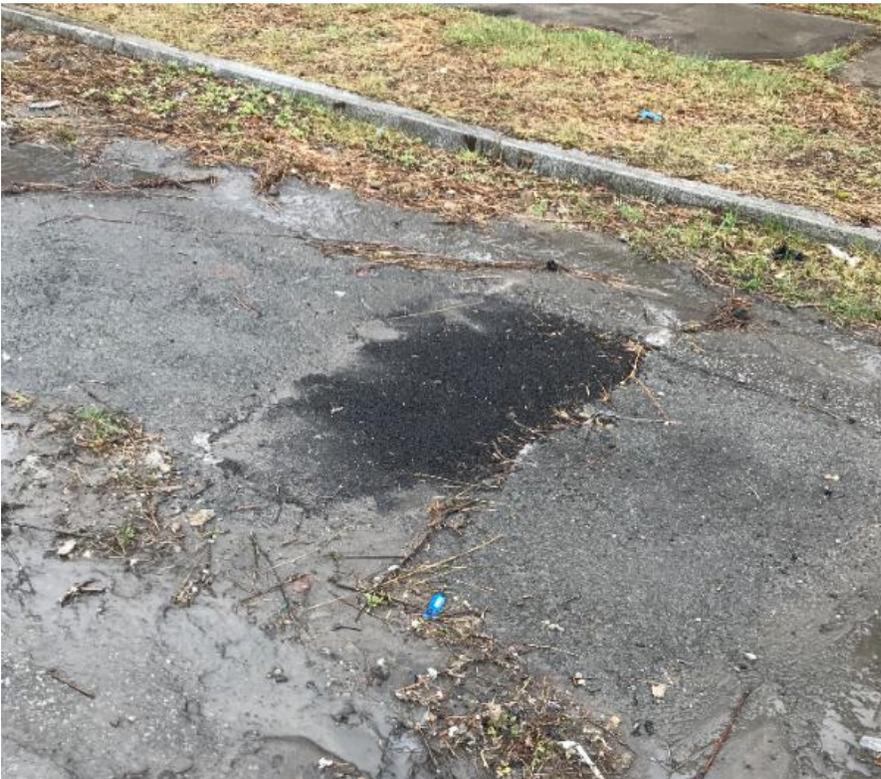
Vacuum excavation report is available and indicates that material excavated was largely asphalt and roadway subbase material. Roadway subbase and broken asphalt removed during vacuum excavation were returned to the test pit as backfill and excess roadway material was disposed as construction debris.

Deteriorated paving does not appear to be causing underlying soils to be exposed. All vacuum excavation areas have been covered with asphalt patches and are stable.

Photo 4 – View of Asphalt Patch Where Vacuum Excavation Occurred

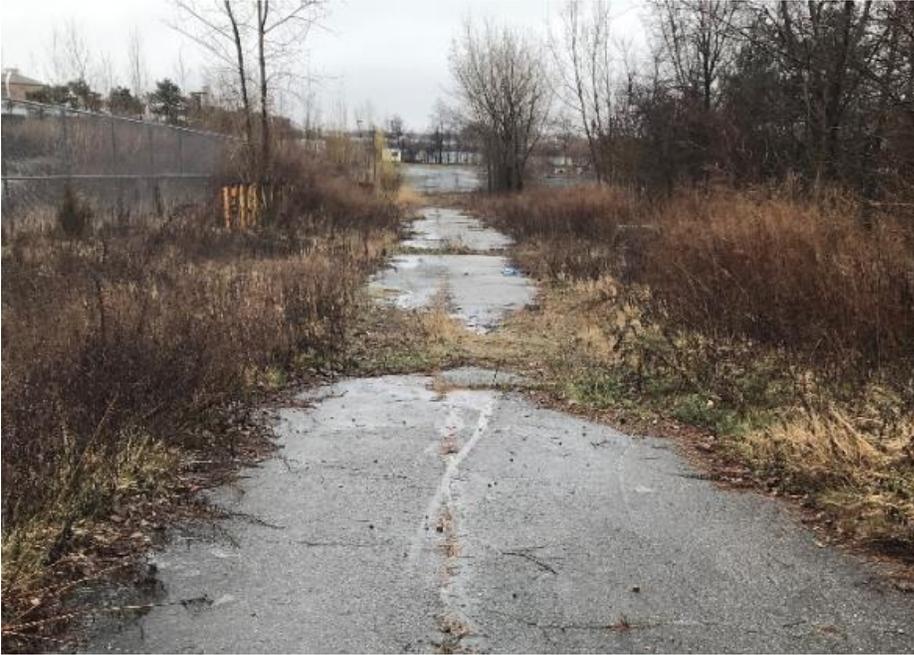
Site includes de-mapped unused roads at the extensions of Ryawa Avenue and Barretto Street where there are asphalt roadways with deterioration. Deteriorating roadways are nearly never used and appear to be in similar condition as last year's inspection.

Photo 5 – View of Asphalt Roadway (Barretto Street Extension)

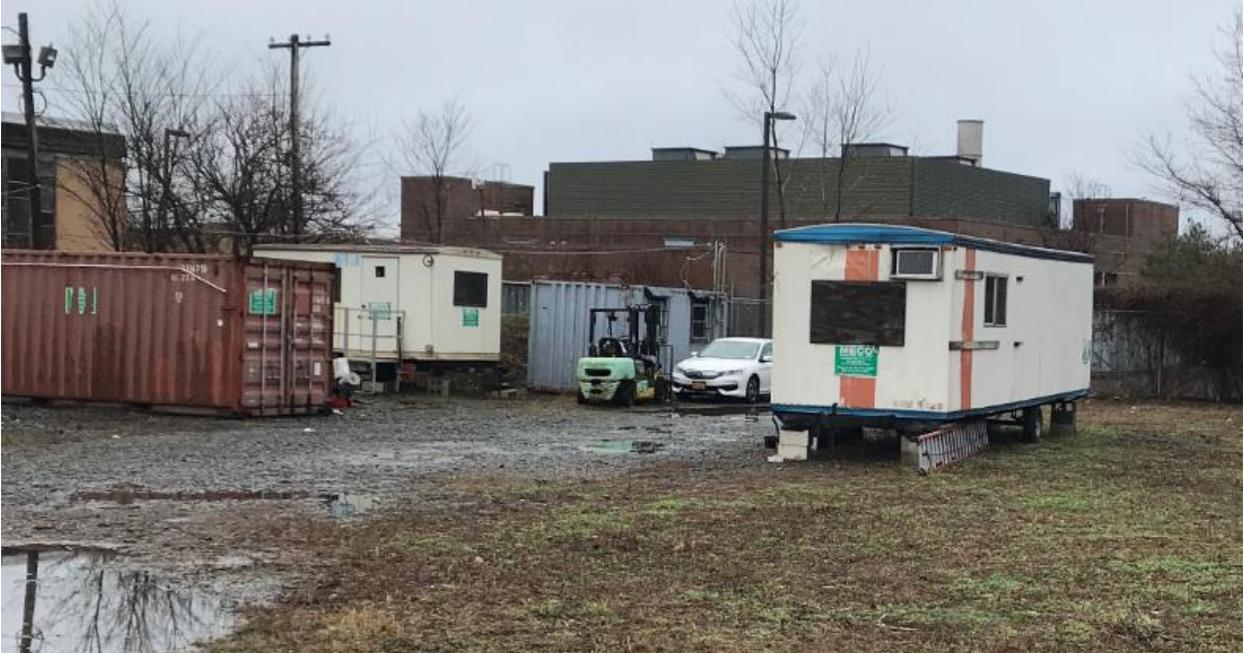
Photo 6 – View of Construction Trailers

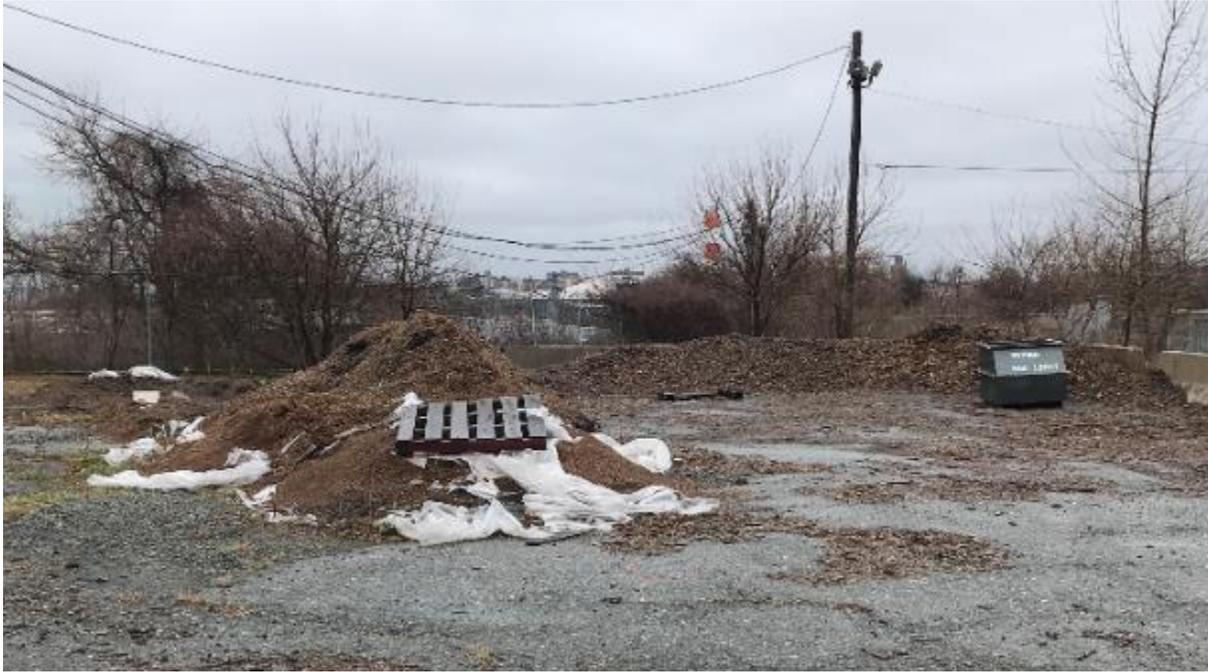
Photo 7 - View of Mulch Stockpile

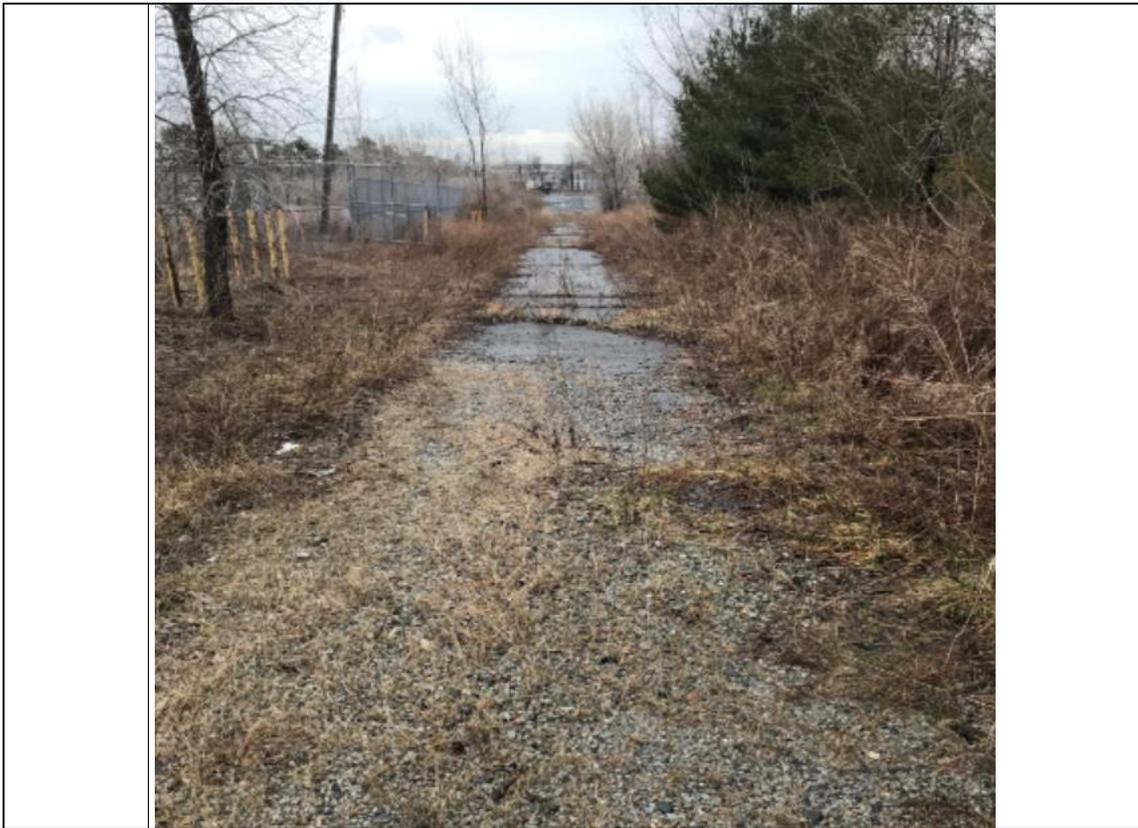
Photograph #1 – View of Barretto Street, facing south. Fenced, 2.5-acre Primary Remediation Area

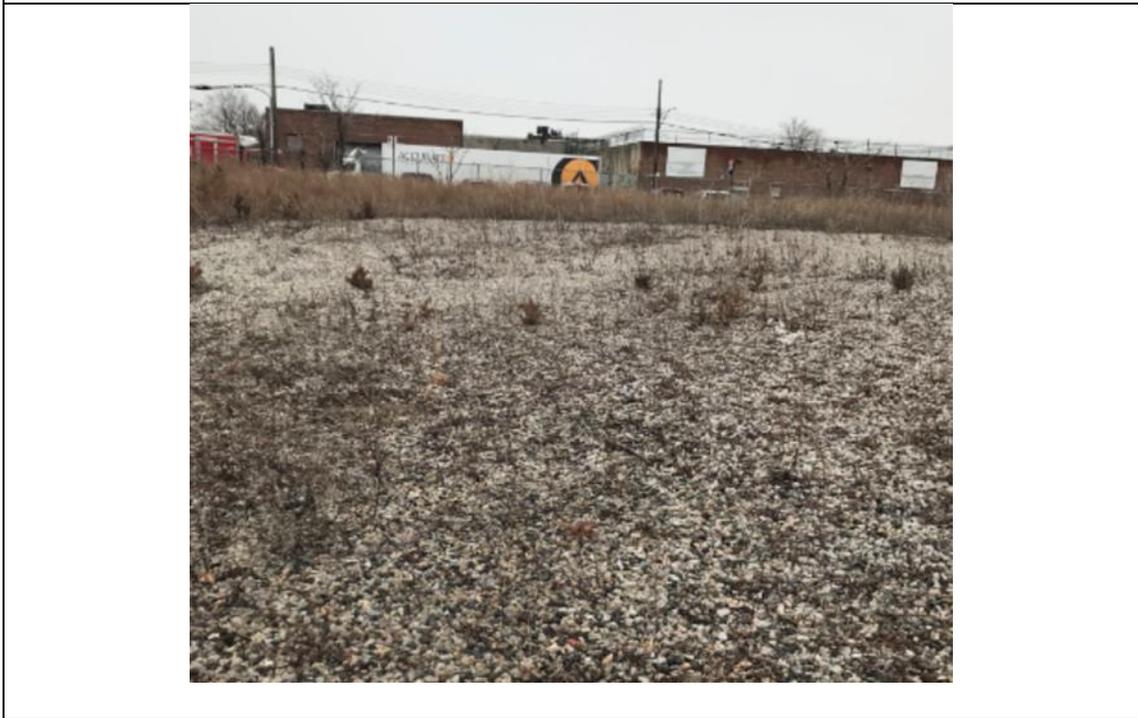
Photograph #2 – General View of Smaller-2.5 Acre Area of Site – Looking North

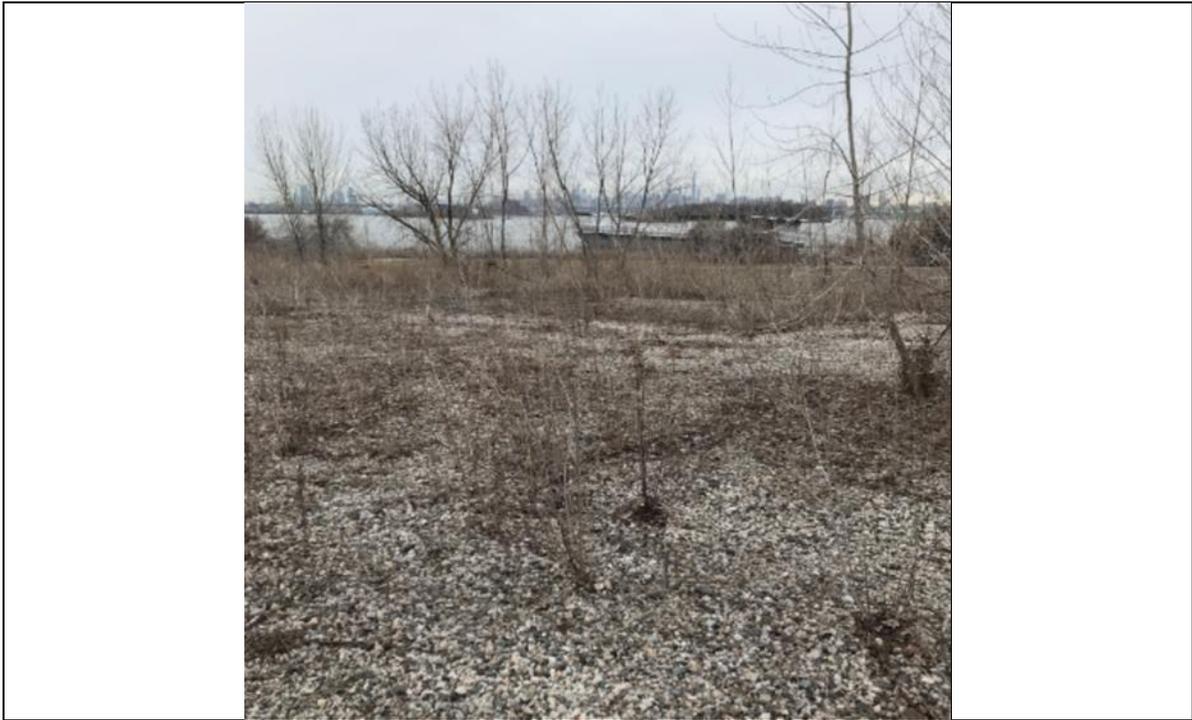
Photograph #3 - View of Smaller 2.5-Acre Area of Site Looking West

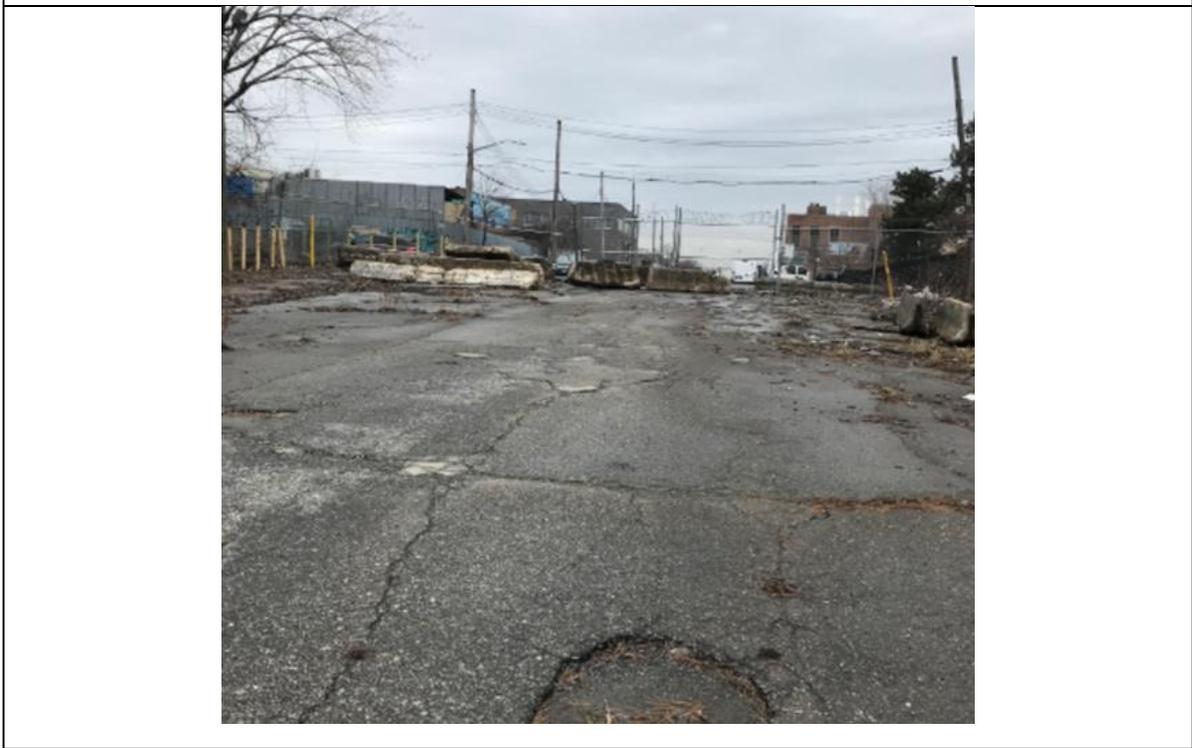
Photograph #4 - View of Asphalt on demapped length of Ryawa Ave. Looking West

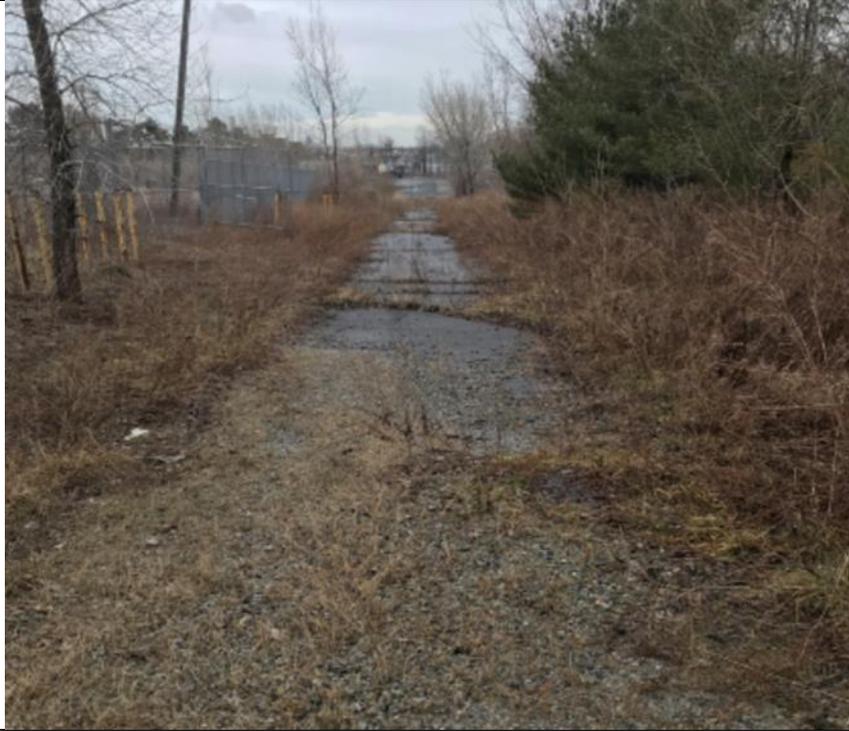
Photograph #5 – View of Asphalt Roadway (Barretto Street Extension)

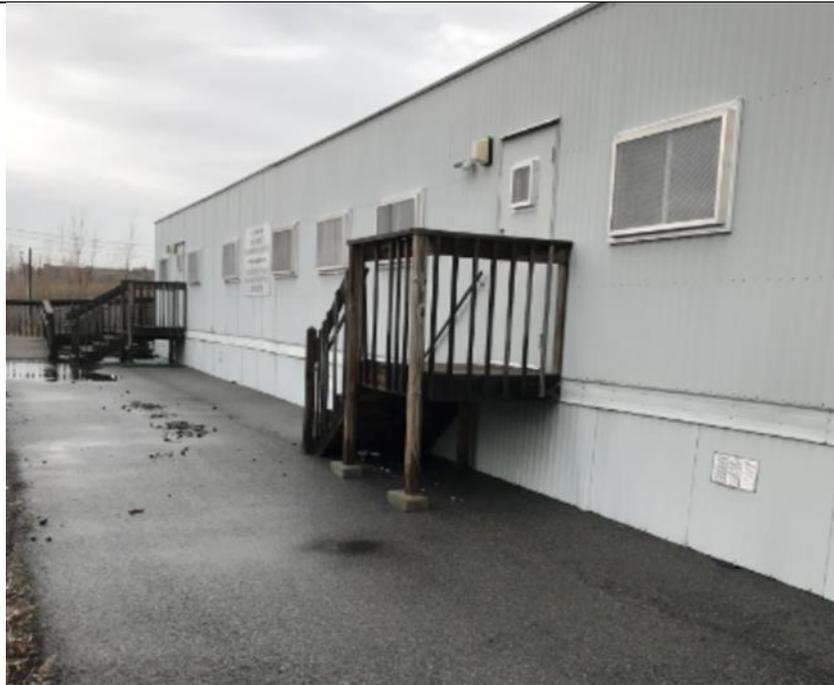
Photograph #6 – View of DEP Construction Trailer

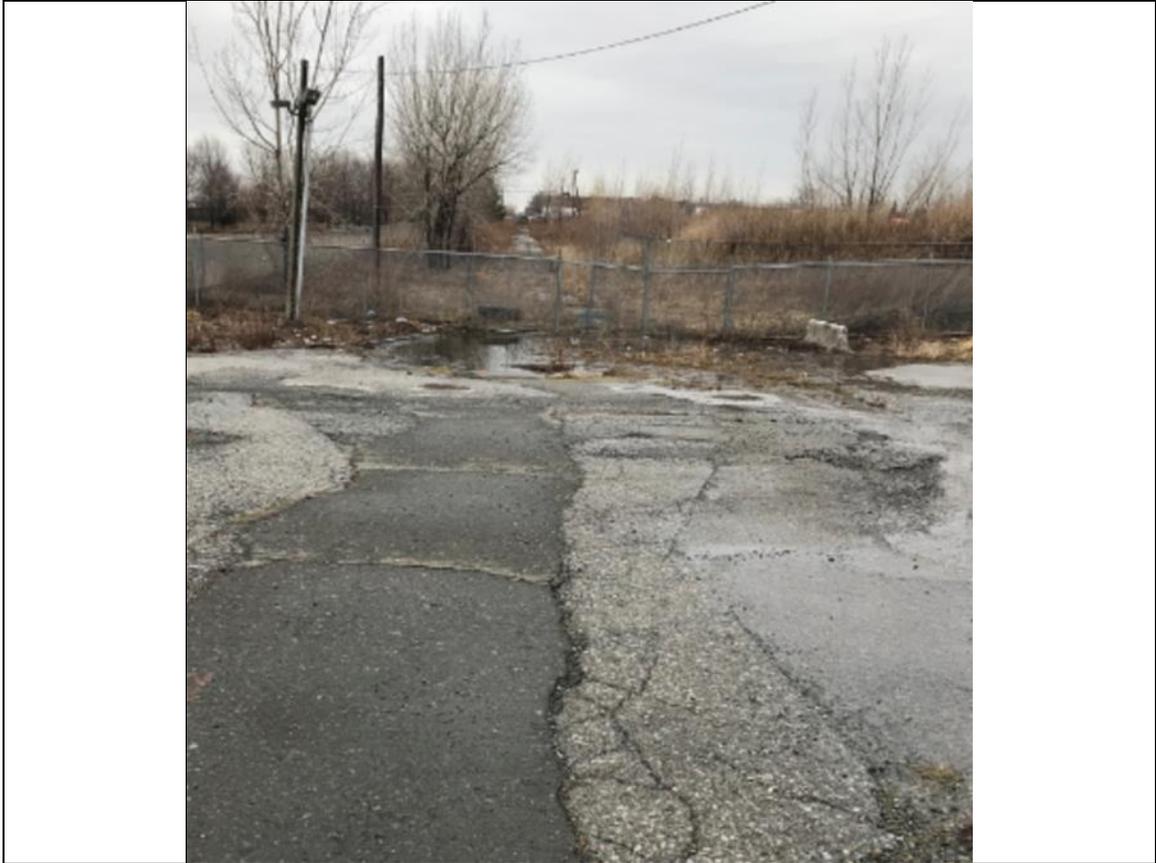
Photograph #7 -View Looking North from Trailer Area Parking to Barretto St.

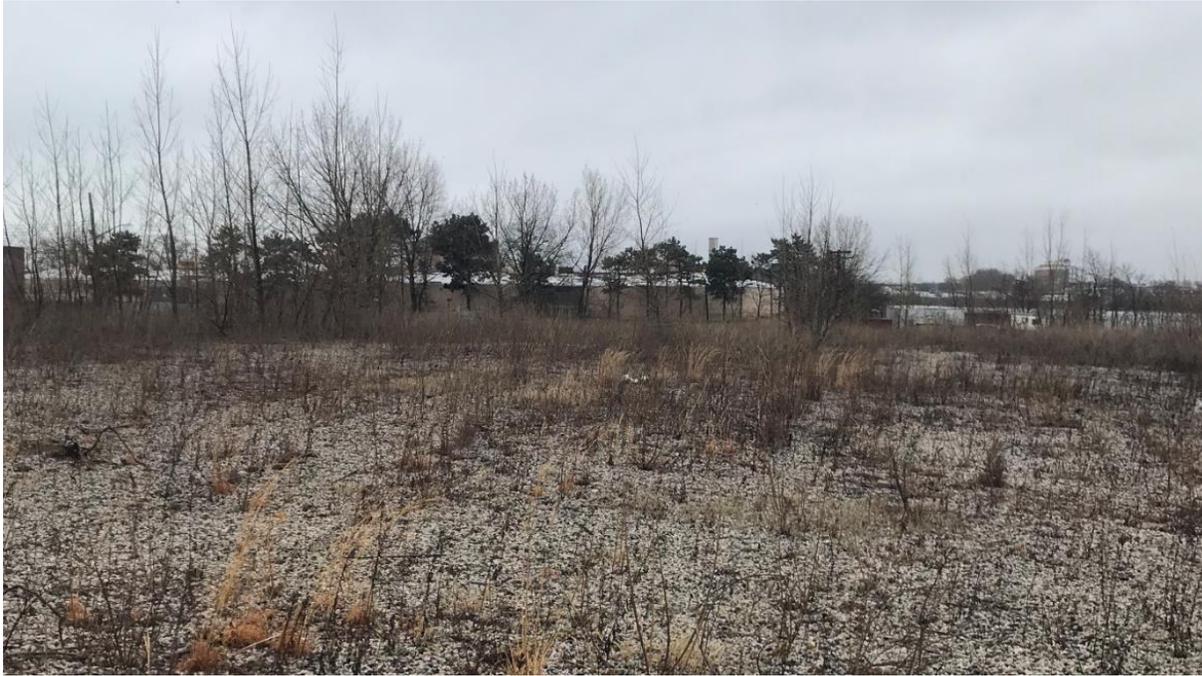
Photo 1 - General View of Smaller 2.5-Acre Area of Site

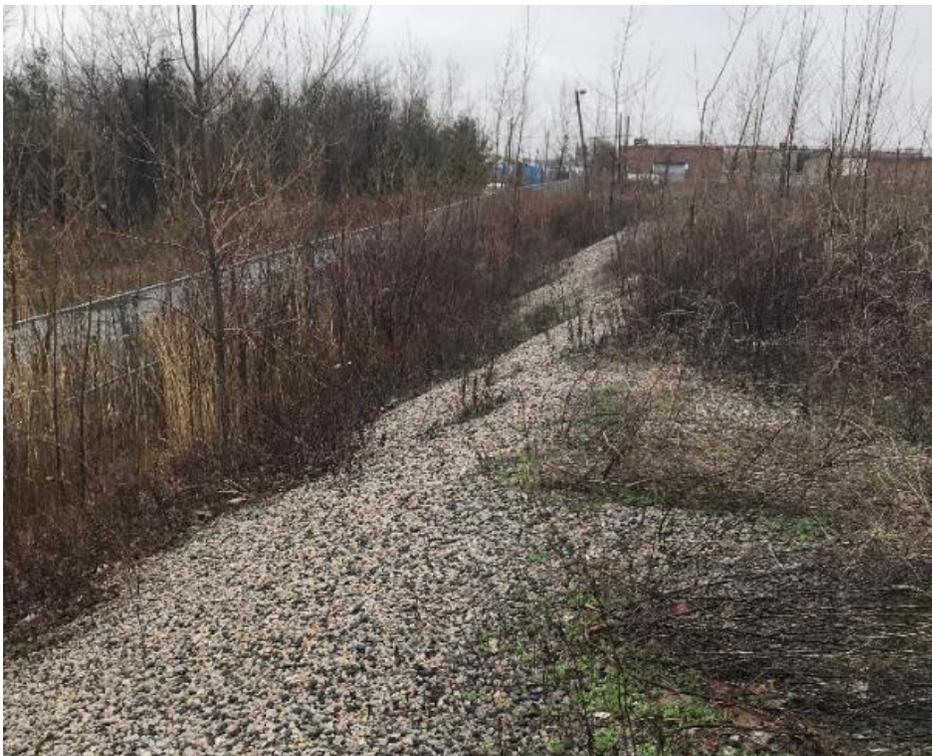
Photo 2 - General View of Smaller-2.5 Acre Area of Site

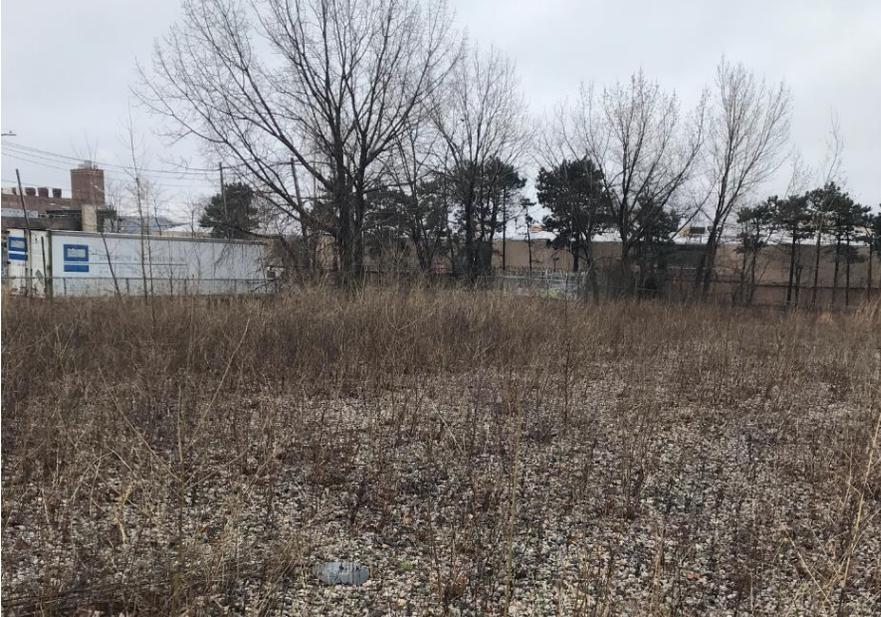
Photo 3 – View of Smaller 2.5-Acre Area of Site

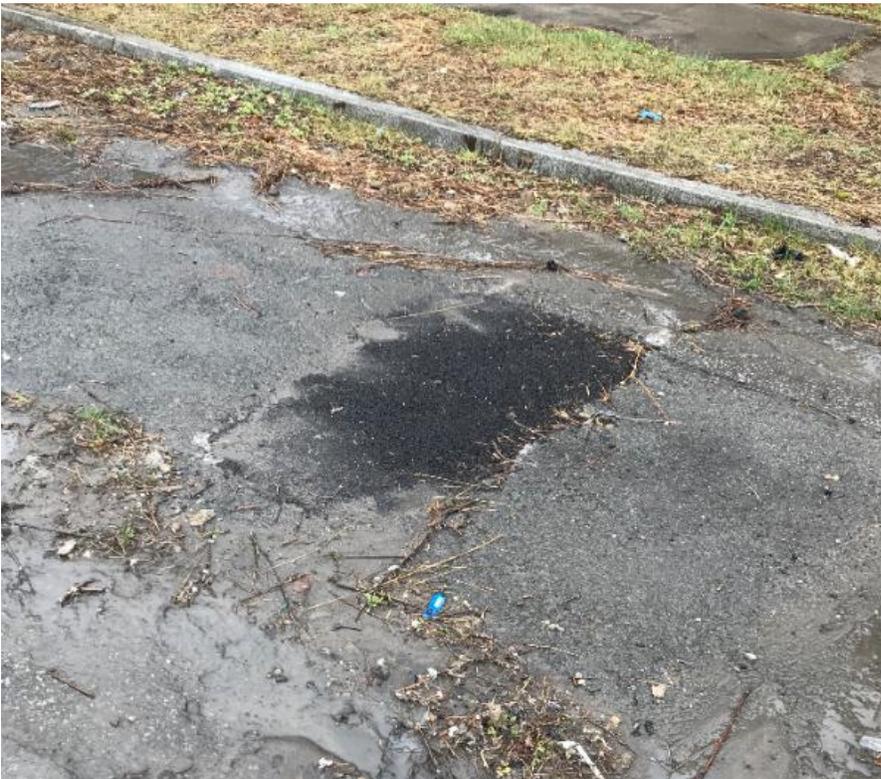
Photo 4 – View of Asphalt Patch Where Vacuum Excavation Occurred

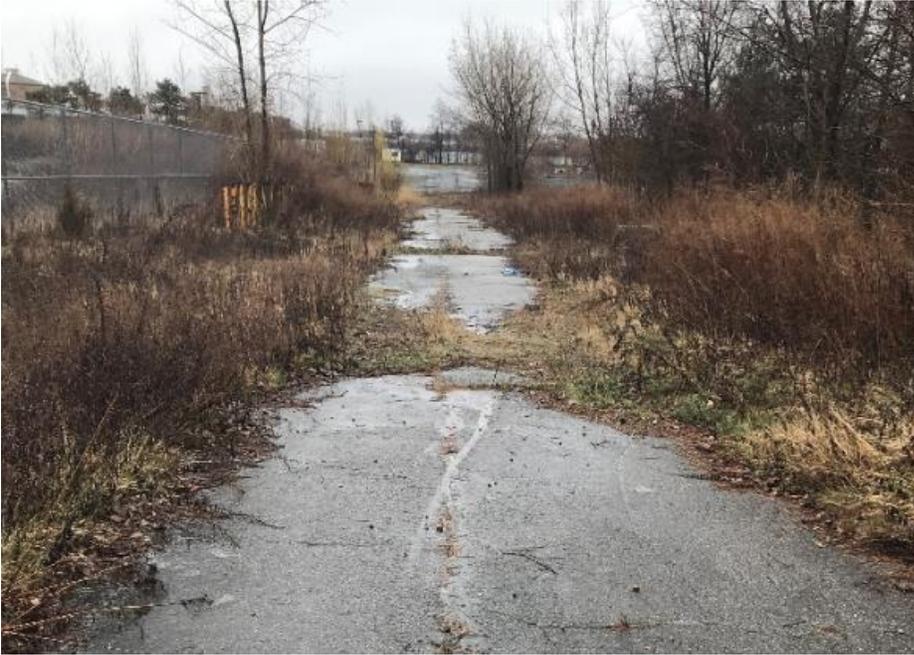
Photo 5 – View of Asphalt Roadway (Barretto Street Extension)

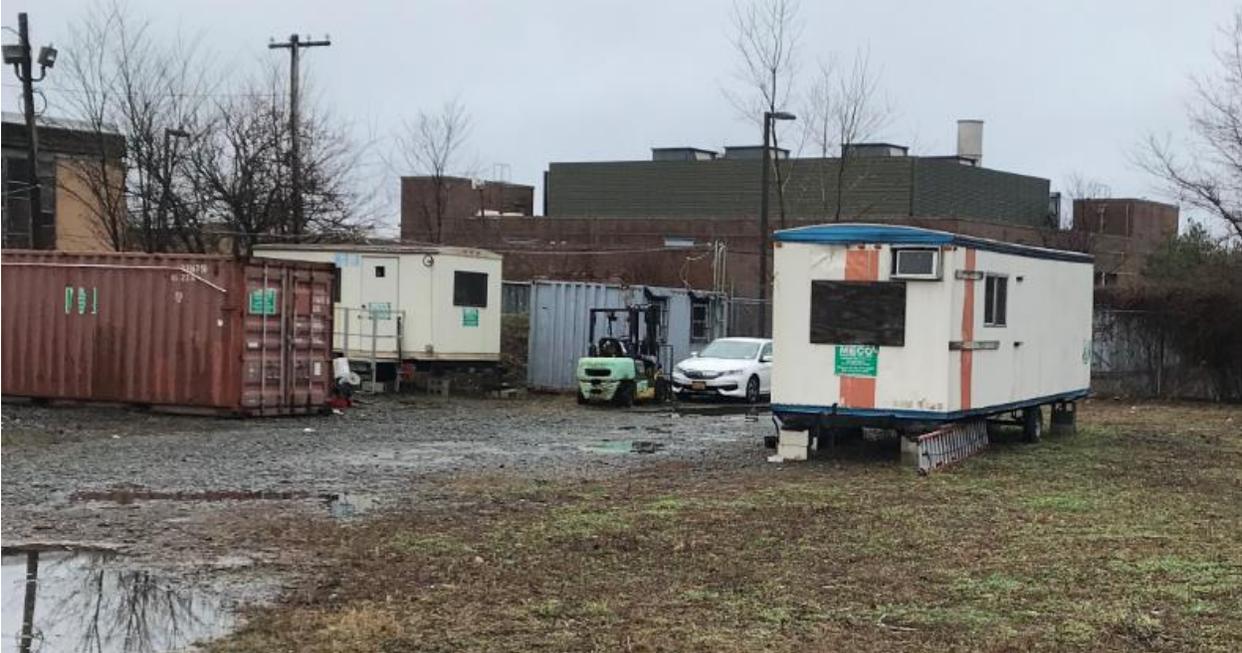
Photo 6 – View of Construction Trailers

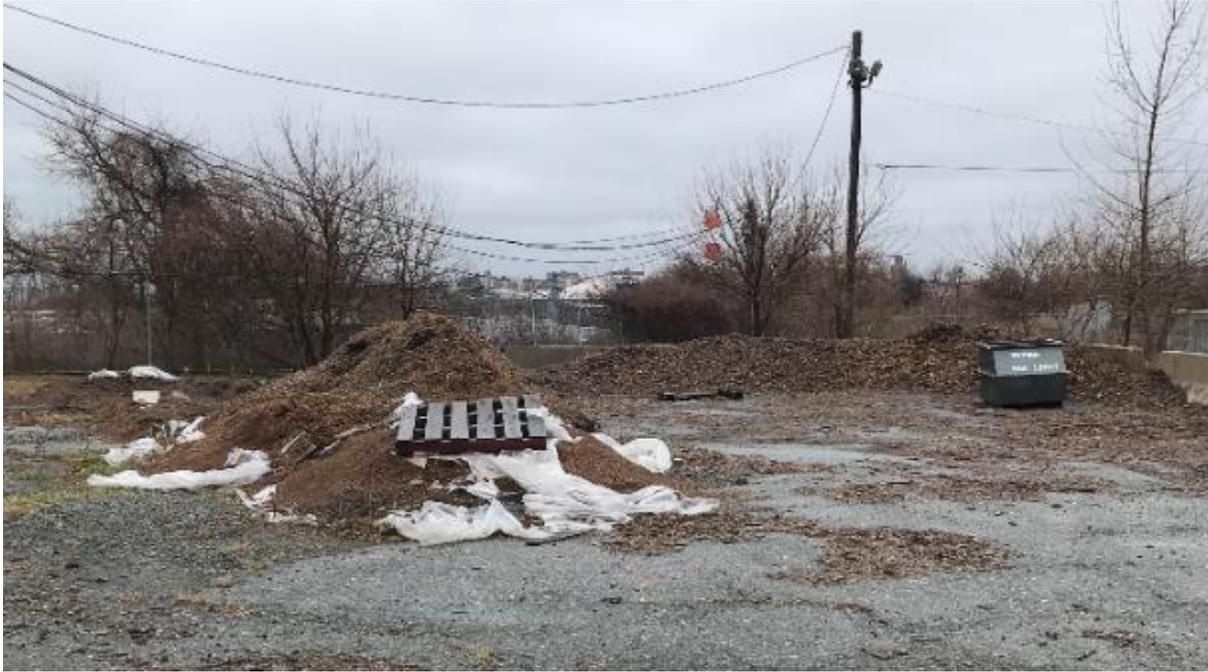
Photo 7 - View of Mulch Stockpile
