November 14, 2022

**Re: Former Mohasco Mills Complex – 2022 Annual Site Inspection  
Forest Avenue & Lyon Street  
Amsterdam, Montgomery County, New York  
NYSDEC Site #: B-00052-4**

**ATTACHMENT A**  
Site Inspection Checklist and Site Map

**ATTACHMENT B**  
Photographic Log

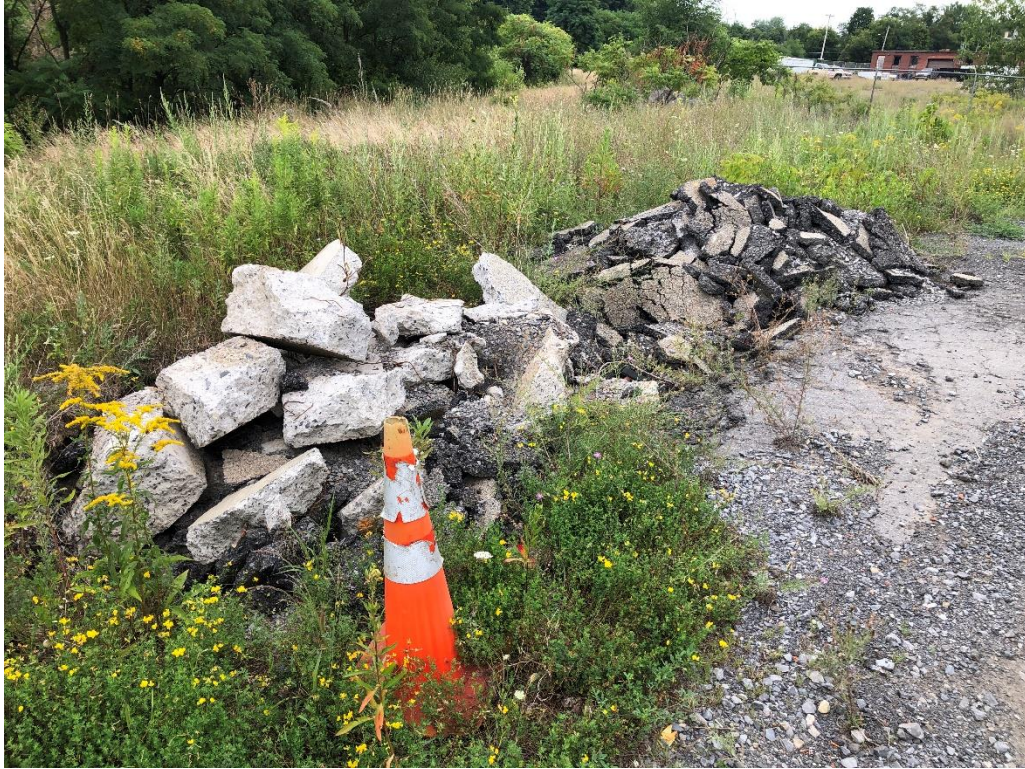
Potential foundation settling along the north portion of "foundation ~~remains~~" area north of the 7 story building.

Photograph 1 – Settling of the former foundation north of the existing building

- The settling of the former building foundation should be properly stabilized and filled in by the responsible party;
- The pothole in the pavement along the northern portion of the Chuctanunda Creek should be properly closed and taken care of by the responsible party; and,
- The missing rails on the footbridge and, the damaged and missing railings on the retaining wall should be replaced by the responsible party.

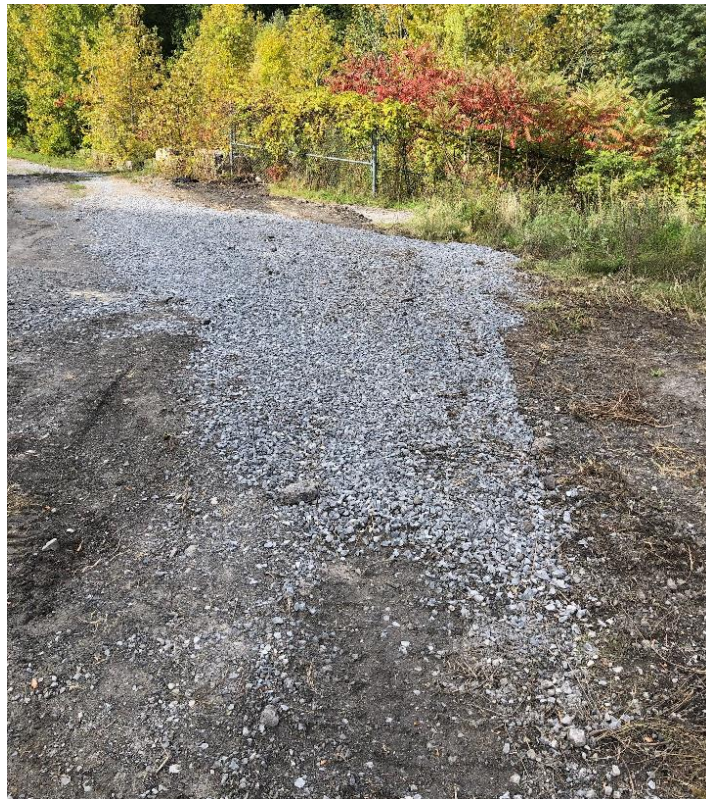
Photograph 1A – Repairs to the settling of the former foundation north of the existing building

Repairs were made to the former building foundation, the pothole in the pavement, and missing side rails on the footbridge and retaining wall north of the Chuctanunda Creek by Sticker Mule on October 6, 2022. Photographs of the repairs are included in Attachment B (Photographs 1A – 4A).

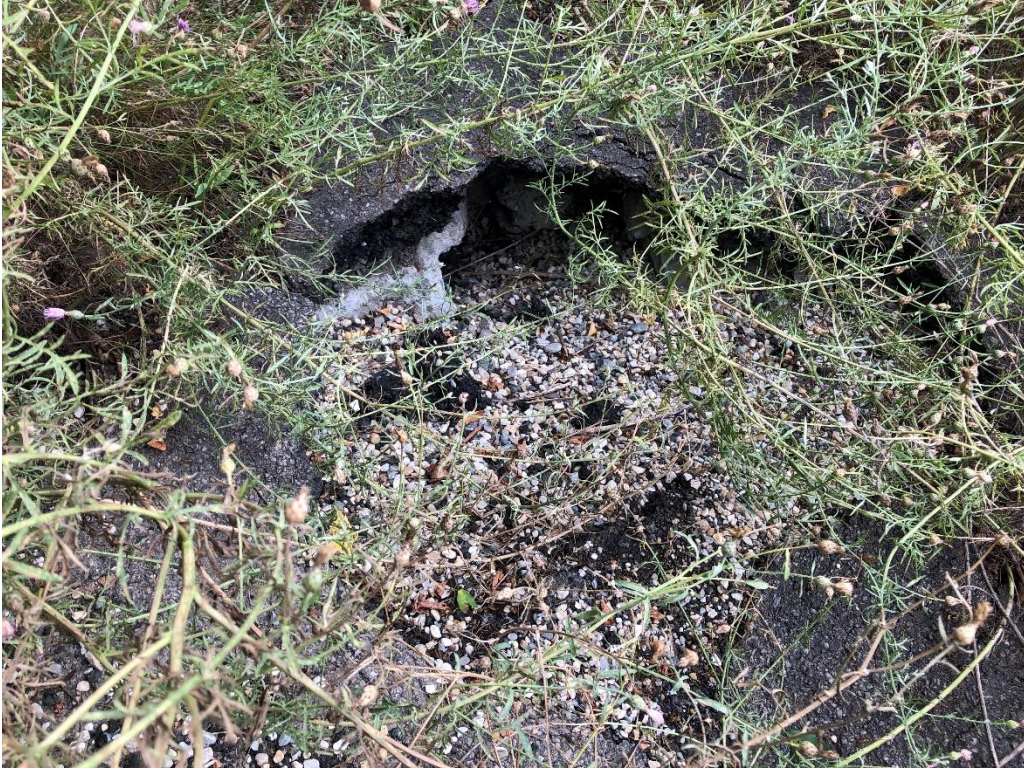
Photograph 2 – Pothole along the north side of the creek and retaining wall

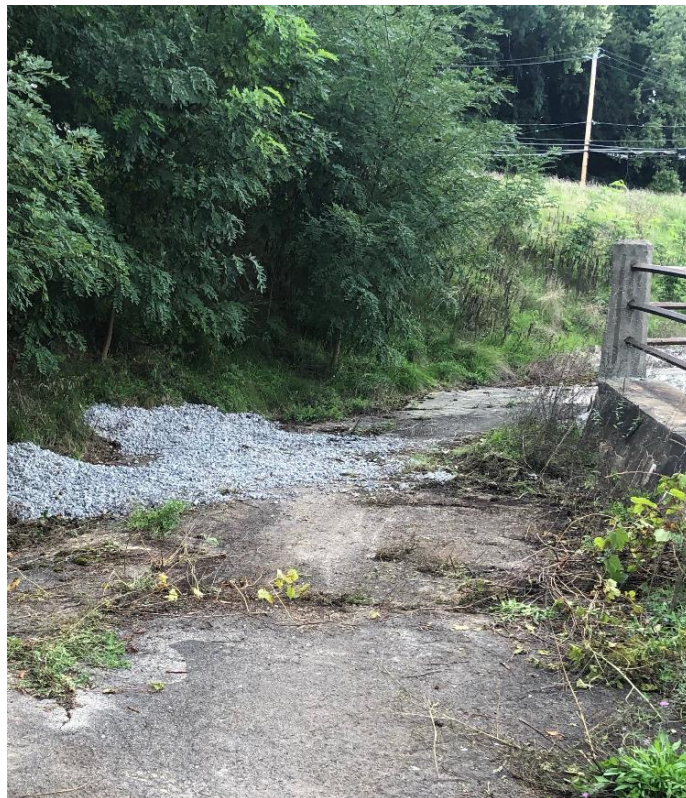
Photograph 2A – Pothole repairs along the north side of the creek and retaining wall

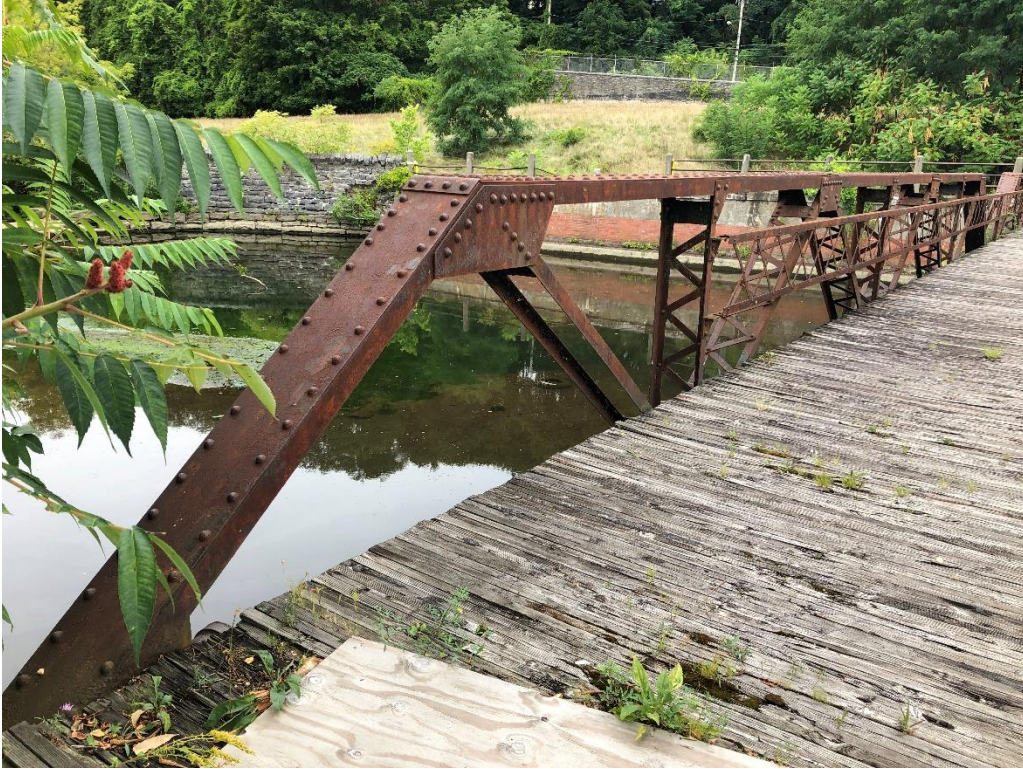
Missing side rails on the footbridge were observed.

Photograph 3 – Missing side rails on the footbridge

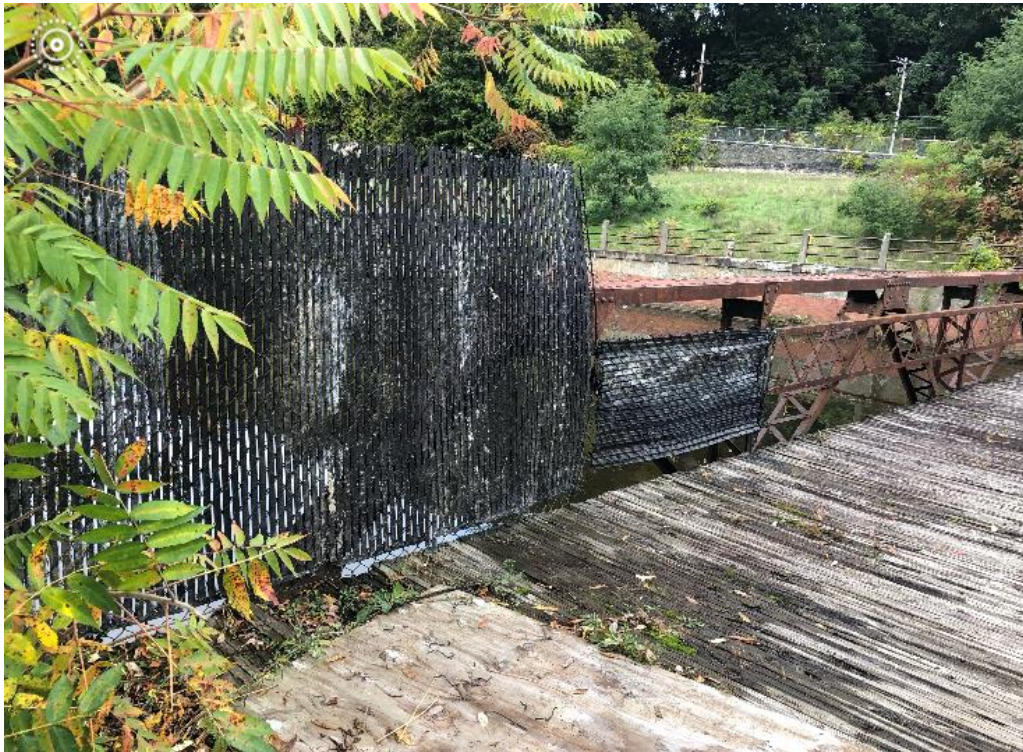
Photograph 3A – Repairs to the missing side rails on footbridge and missing railings on the retaining wall north of the creek

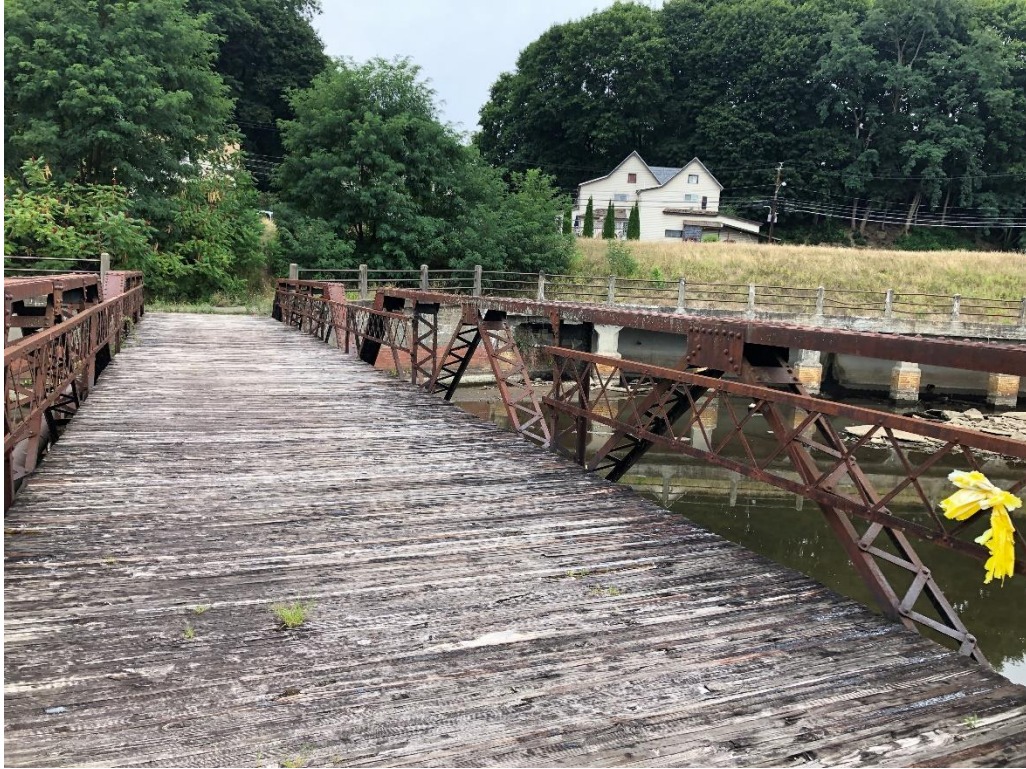
Photograph 4 – Missing side rails on the footbridge

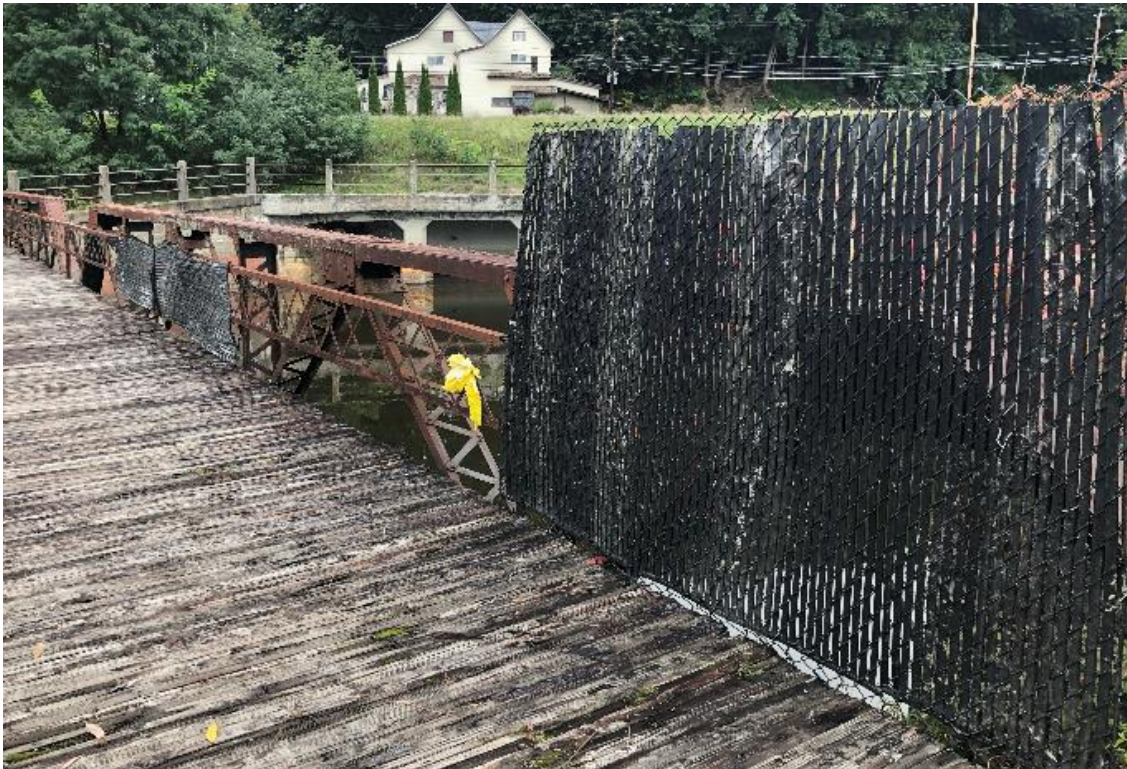
Photograph 4A – Repairs to the missing side rails on the footbridge

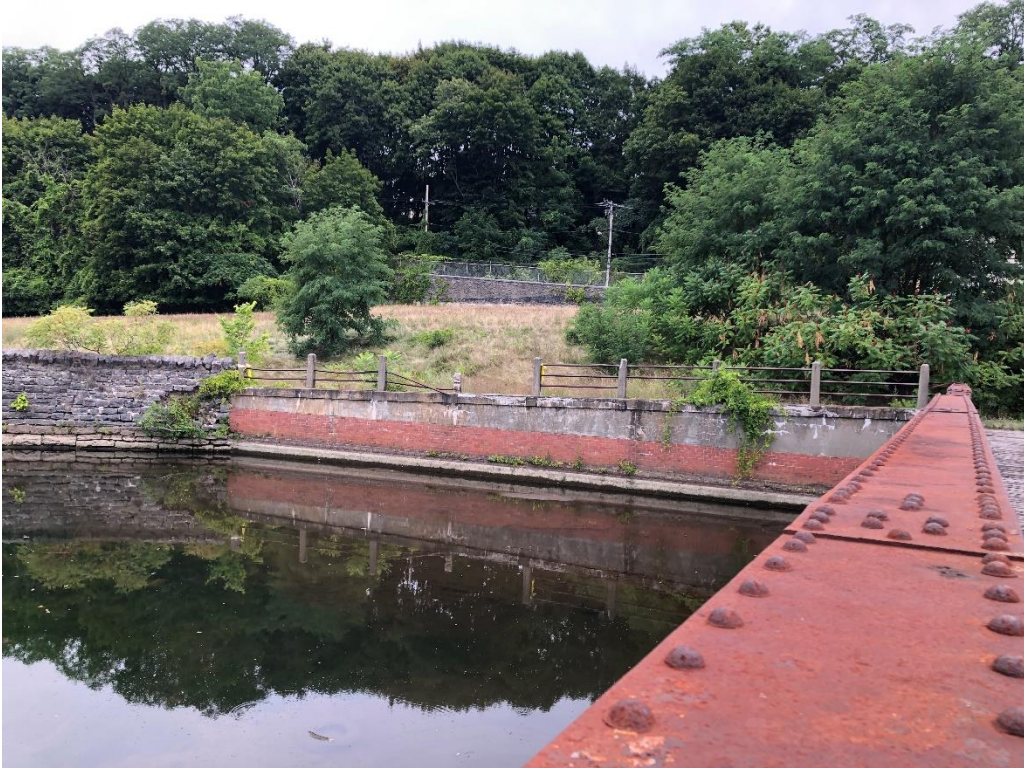
COMMENTS/FOLLOW UP NEEDS: A pothole in the asphalt, ~18" wide  
was observed along the northeast side of the Chutanunda  
Creek and footbridge. Damaged and missing railings were  
observed on the retaining wall on the north side of the  
creek. These should be replaced as safety precautions.

Photograph 5 – Damaged and missing railings on the retaining wall north of the creek
